Factual Data Report. Hydrogeological Site Investigation, Touquoy In-Pit Tailings Disposal

Final Report

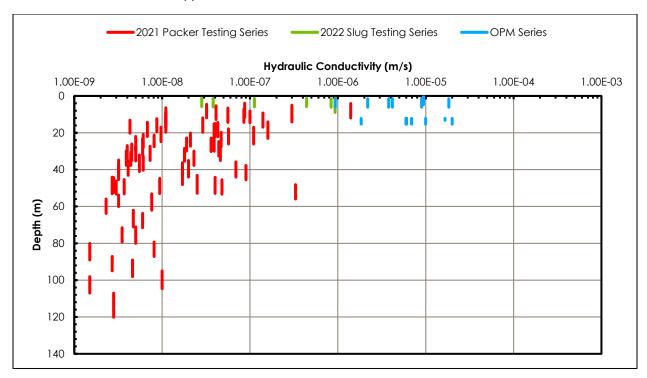
Figure 6-2 Hydraulic Conductivity of Bedrock - Open Pit Mine Area

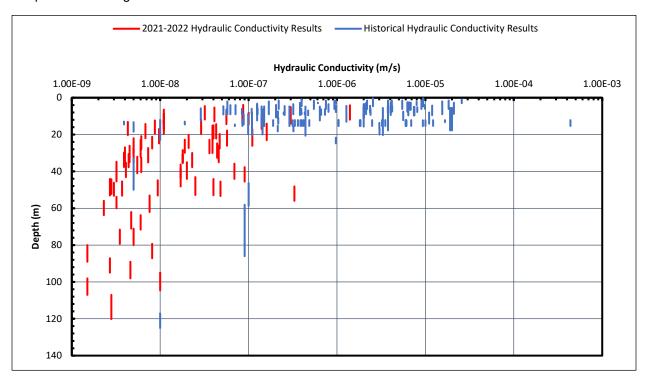
Figure 6-3 Compilation Bedrock Hydraulic Conductivity (Historical and 2021 Investigation)
