NSPI NEW WIND  
BEAR LAKE

Possible Turtle Habitat

# APPENDIX B

## Fish Habitat Assessment Fact Sheets

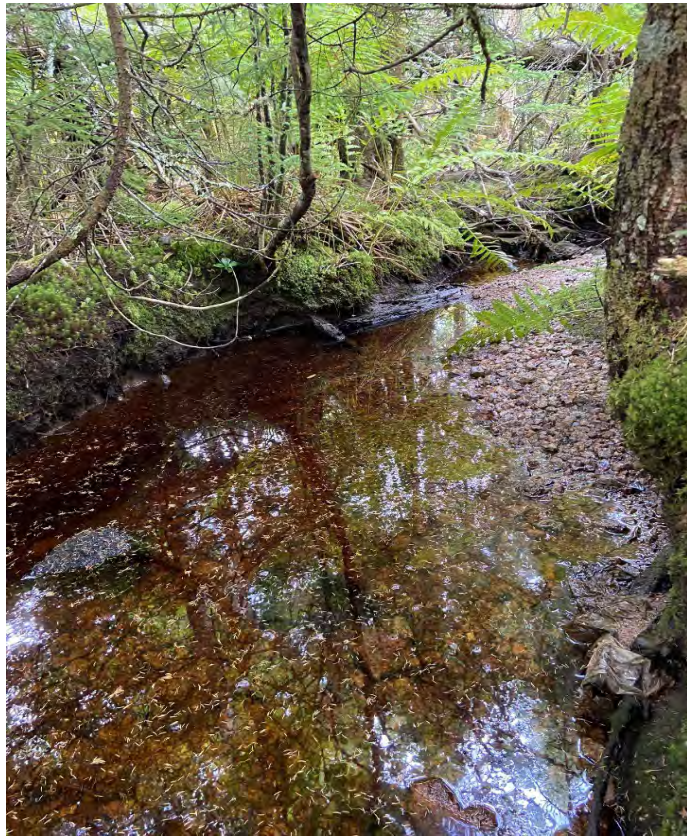
**Photo 1: Upstream of WC-15**

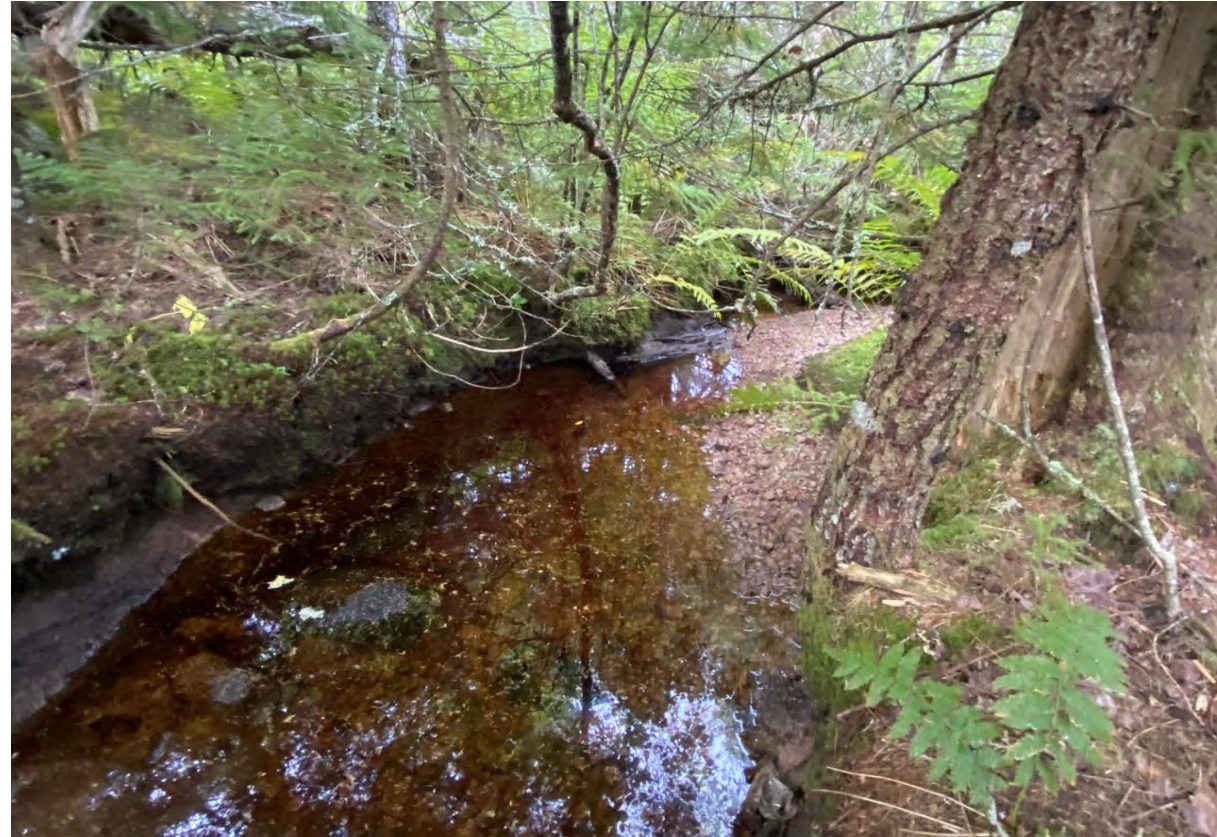
**Photo 2: Downstream of WC-15**

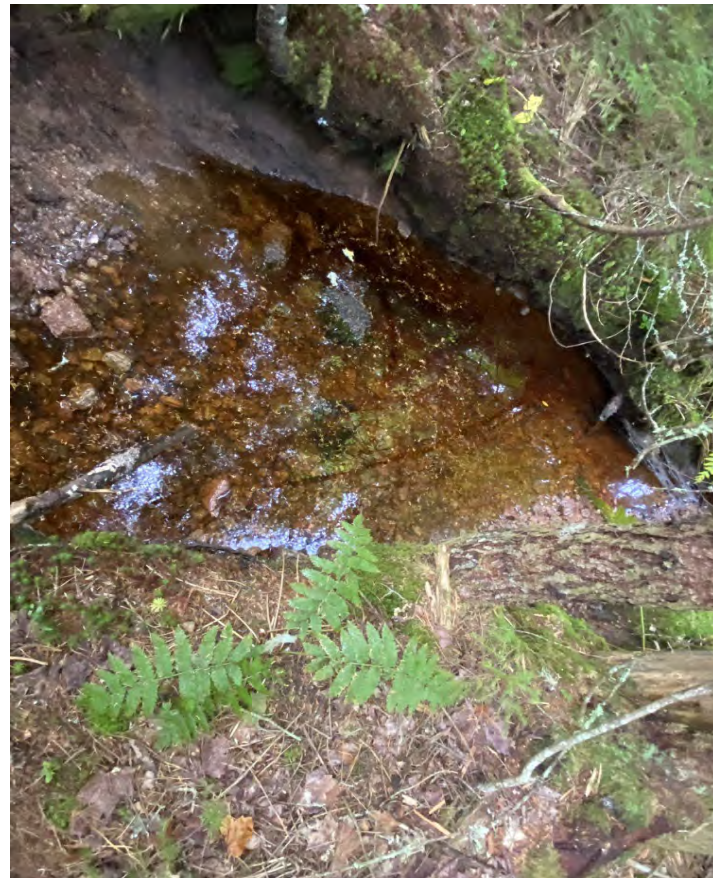
**Photo 3: Underground section in U/S reach**

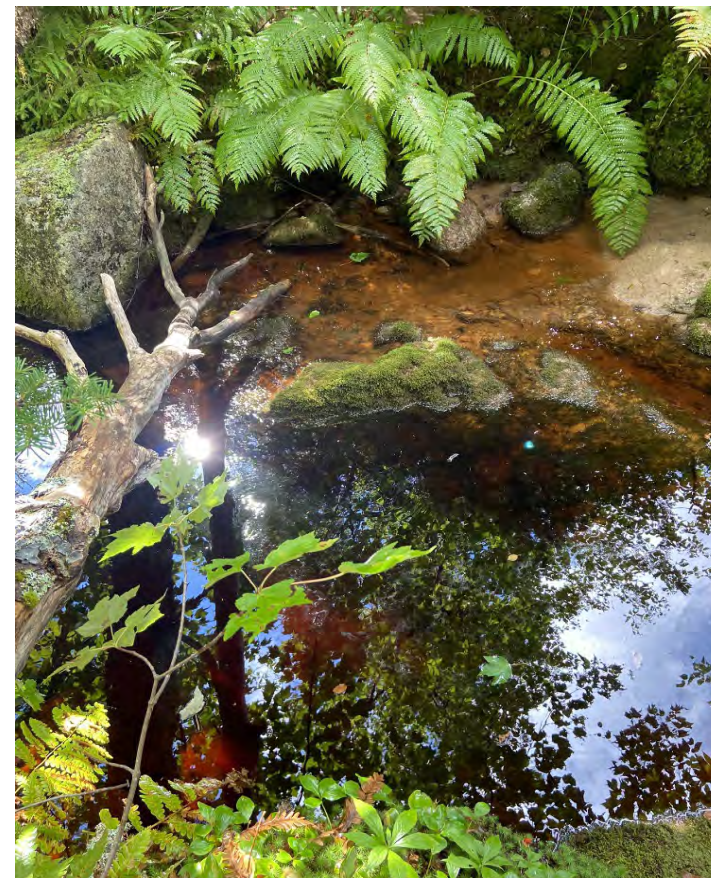
**Photo 4: Deep pool on the D/S section of WC**

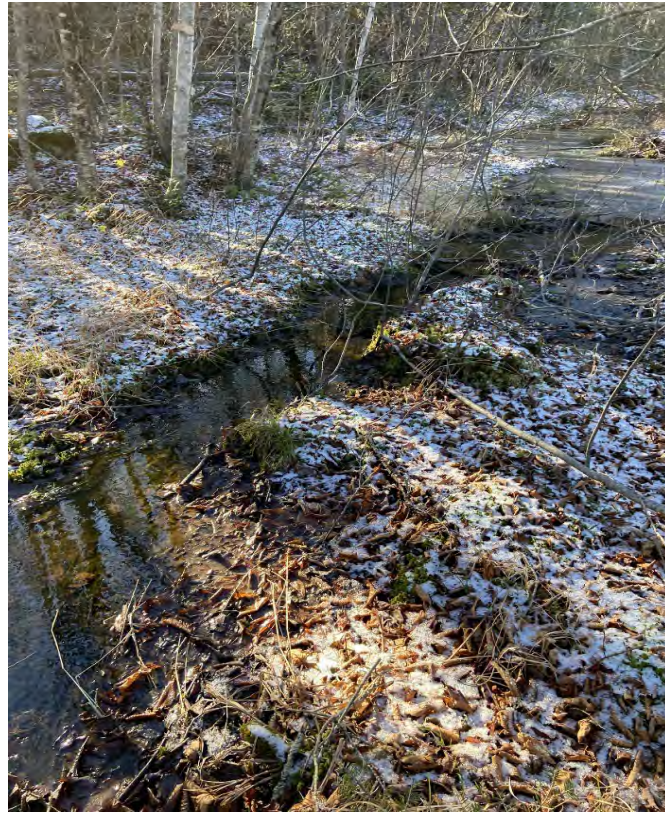
**Photo 1: Upstream at Crossing Location**

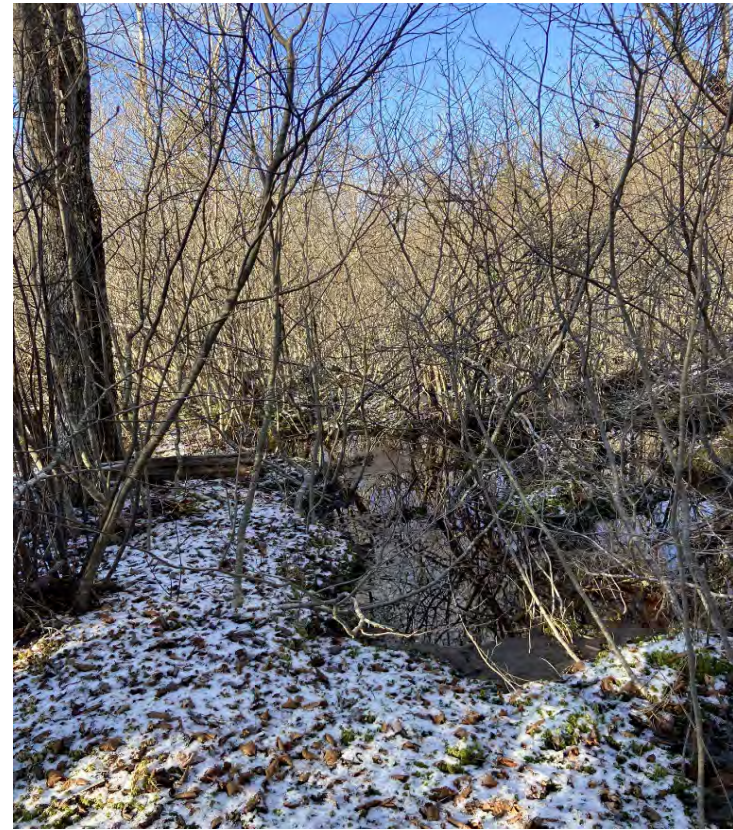
**Photo 2: Downstream at Crossing Location**

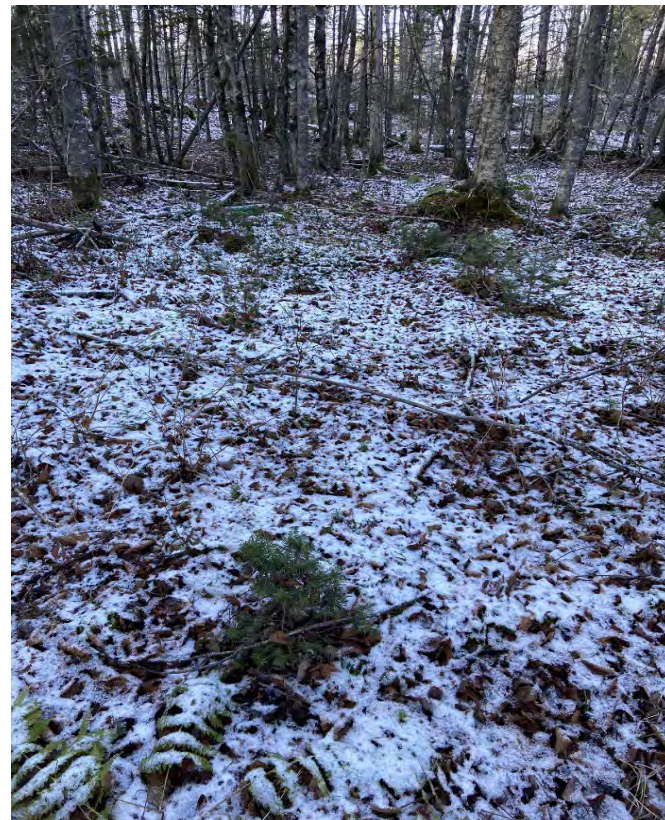
**Photo 3: Upstream loss of channel**

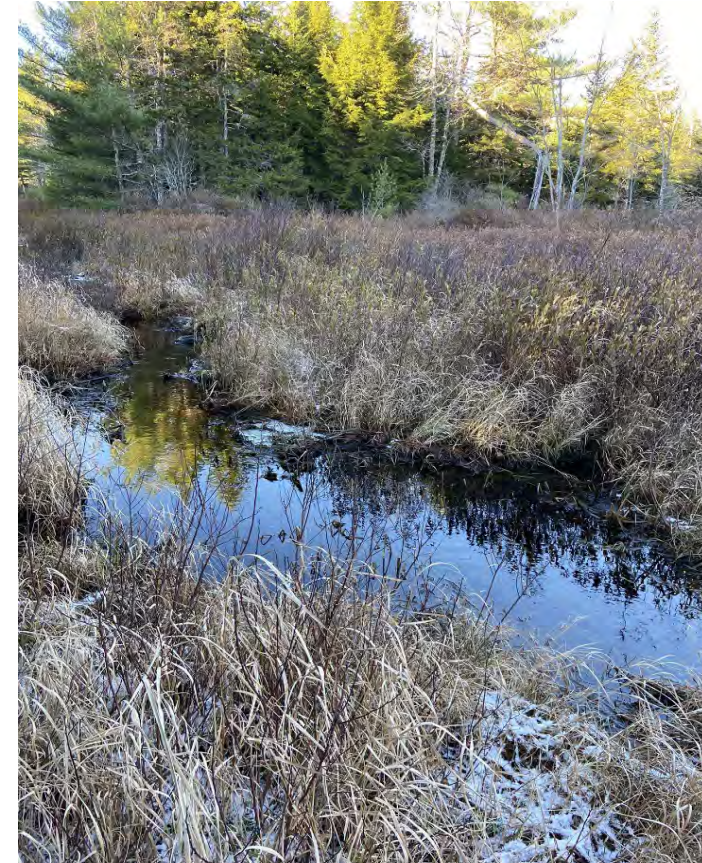
**Photo 4: Downstream area leading to waterbody**

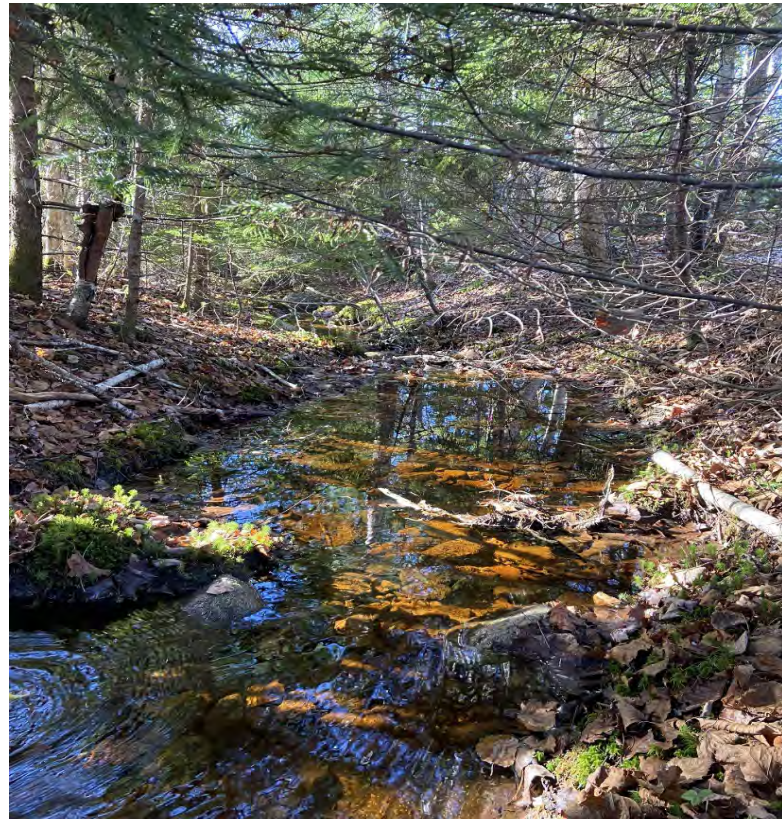
**Photo 1: Upstream at Crossing Location**

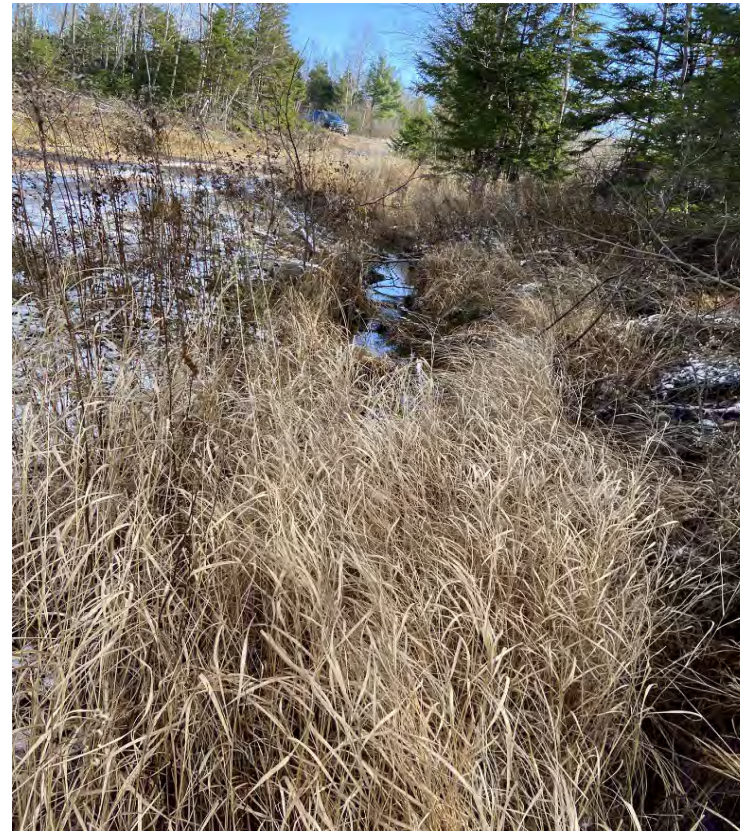
**Photo 2: Downstream at Crossing Location**

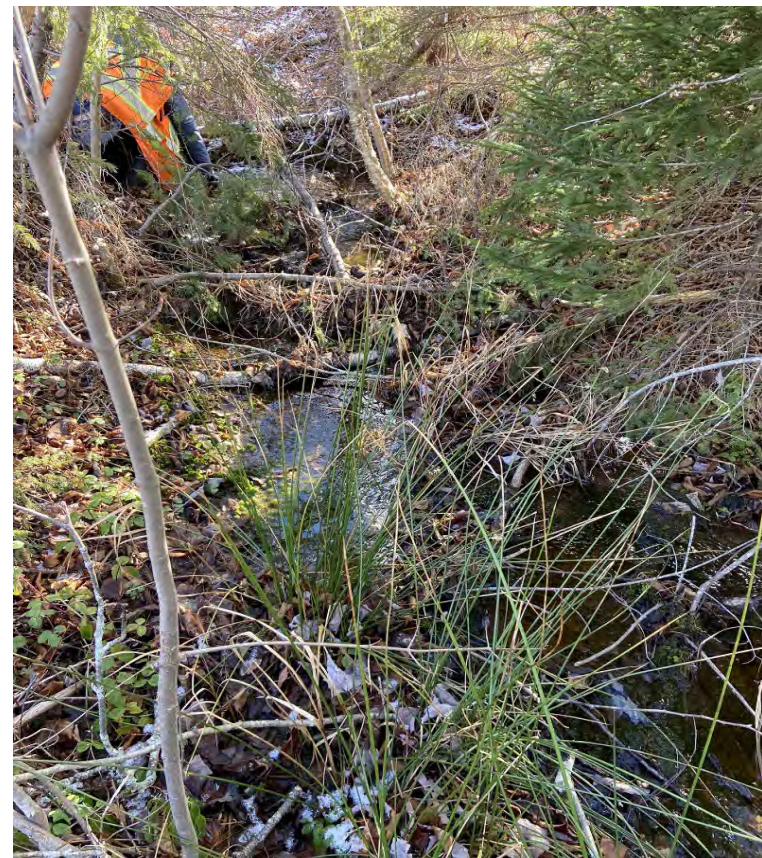
**Photo 3: Down Stream, General Habitat**

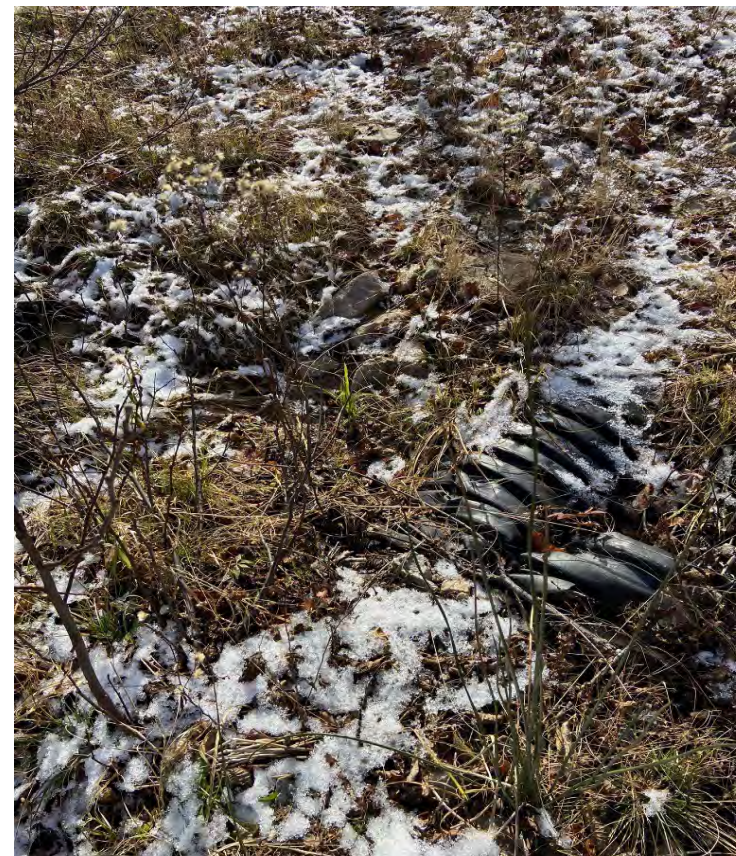
ADDITIONAL NOTES		
Watercourse seems diverted into ditch by whomever built the road. Barrier Notes: Underground section - Wp. 1985m @12:37 loss of definition into WL. Hanging/Perched/Blocked Culvert - @12:08 Culvert crushed on US side, water moving through. Loss of Channel Definition - Wp. 1982 @12:20 US channel lost definition into ditch. Partial barrier because could be conductivity during high water events.

**Photo 4: Feature 1 Crushed Culvert**

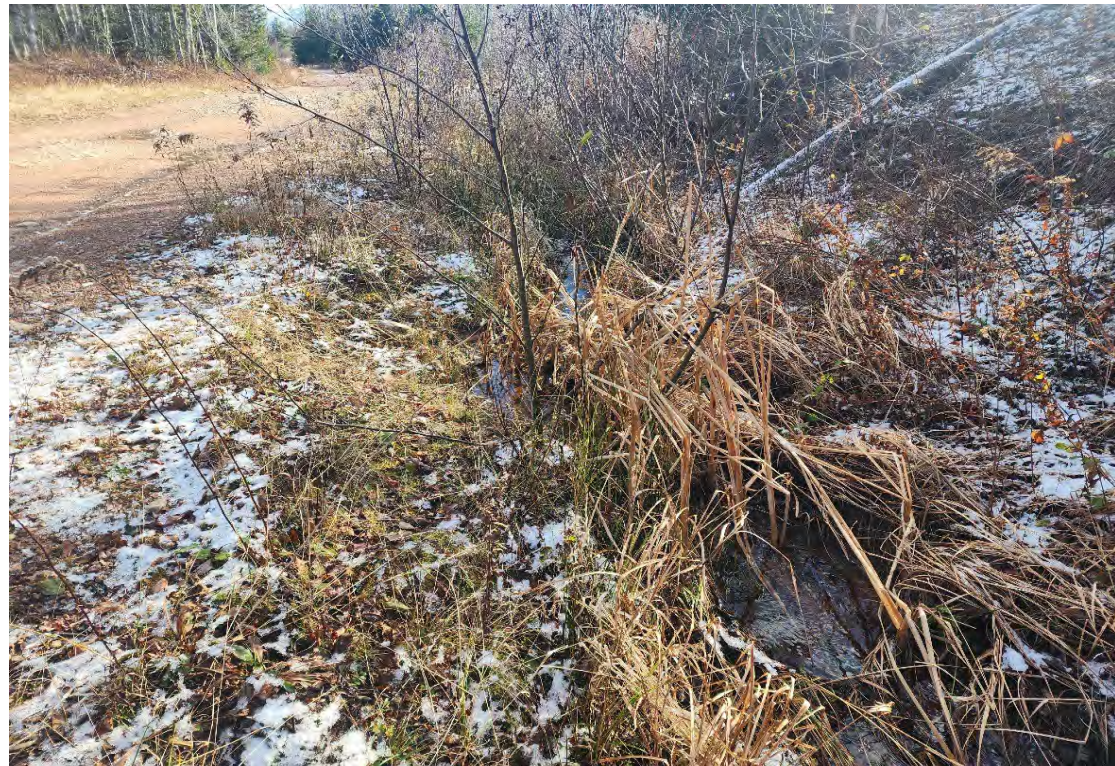
**Photo 1: Upstream at Crossing**

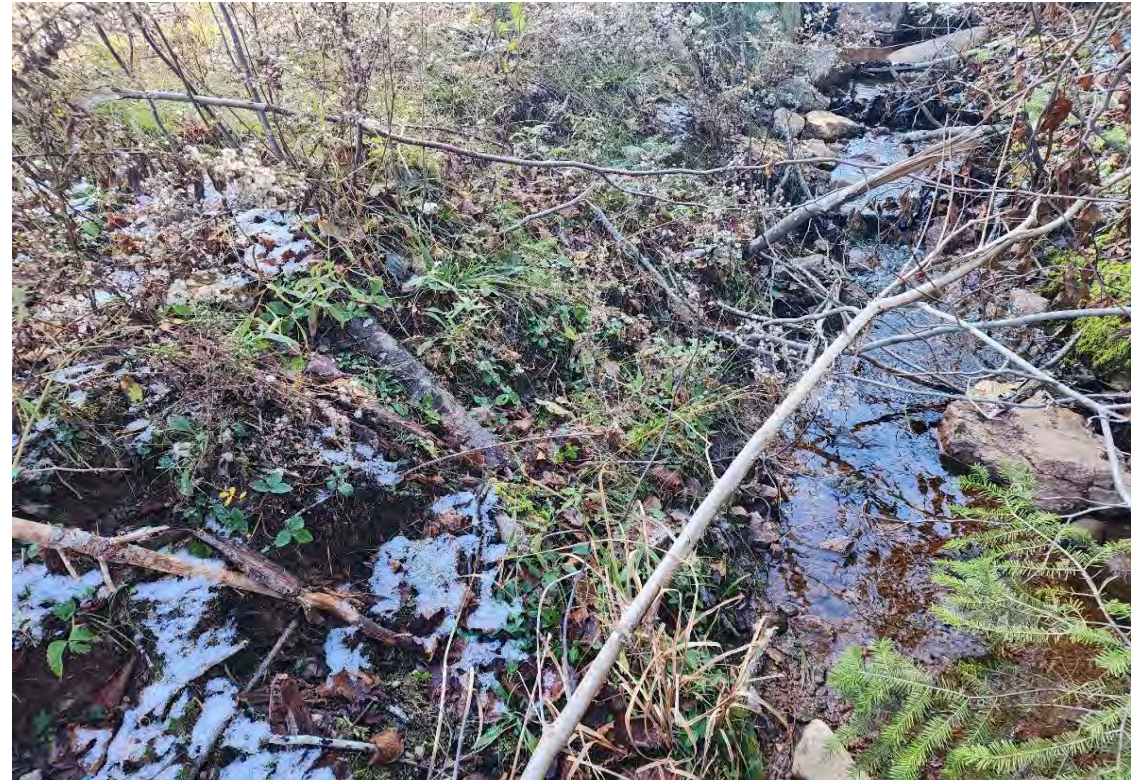
**Photo 2: Downstream at Crossing Location**

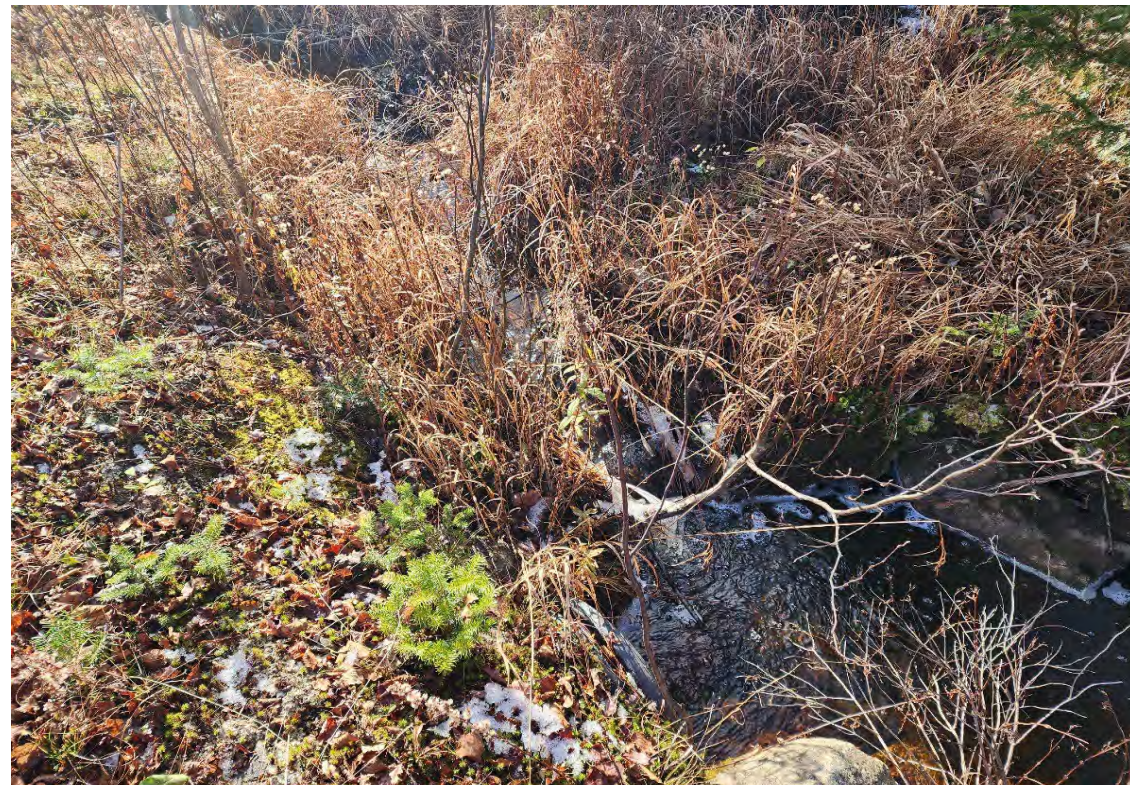
RIPARIAN VEGETATION SPECIES		
#	Common Name	Scientific Name
1	Red Maple	<i>Acer rubrum</i>
2	Speckled Alder	<i>Alnus incana</i>
3	Eastern Hemlock	<i>Tsuga canadensis</i>
4	Paper Birch	<i>Betula papyrifera</i>
5	Red Oak	#N/A
6	Cattail Sp.	#N/A
7		#N/A
8		#N/A
9		#N/A
10		#N/A
RIPARIAN INFORMATION		
Crown Closure %		
Bank Texture		
Bank Shape		
Bank Stability		Poor <50% Stable
Vegetation Stage		Young Forest
IMPORTANT FEATURES OBSERVED		
Spawning Area / REDD	<input type="checkbox"/>	
Beaver Dam	<input type="checkbox"/>	
Beaver Pond	<input type="checkbox"/>	
Underground Sections	<input type="checkbox"/>	
Waterfall or Cascade	<input type="checkbox"/>	
No Defined Channel	<input type="checkbox"/>	
Hanging Culvert	<input type="checkbox"/>	
Blocked or Damaged Culvert	<input checked="" type="checkbox"/>	
Bridge	<input type="checkbox"/>	
ADDITIONAL NOTES		
Wp. 1346 - PIWO holes in snag pic @12:51, Wp.1353- Culvert, WC joins area with Culvert, likely becoming WC 2. Sunked Culvert @ Wp. 1348

**Photo 3: Sunken Culvert D/S of crossing**

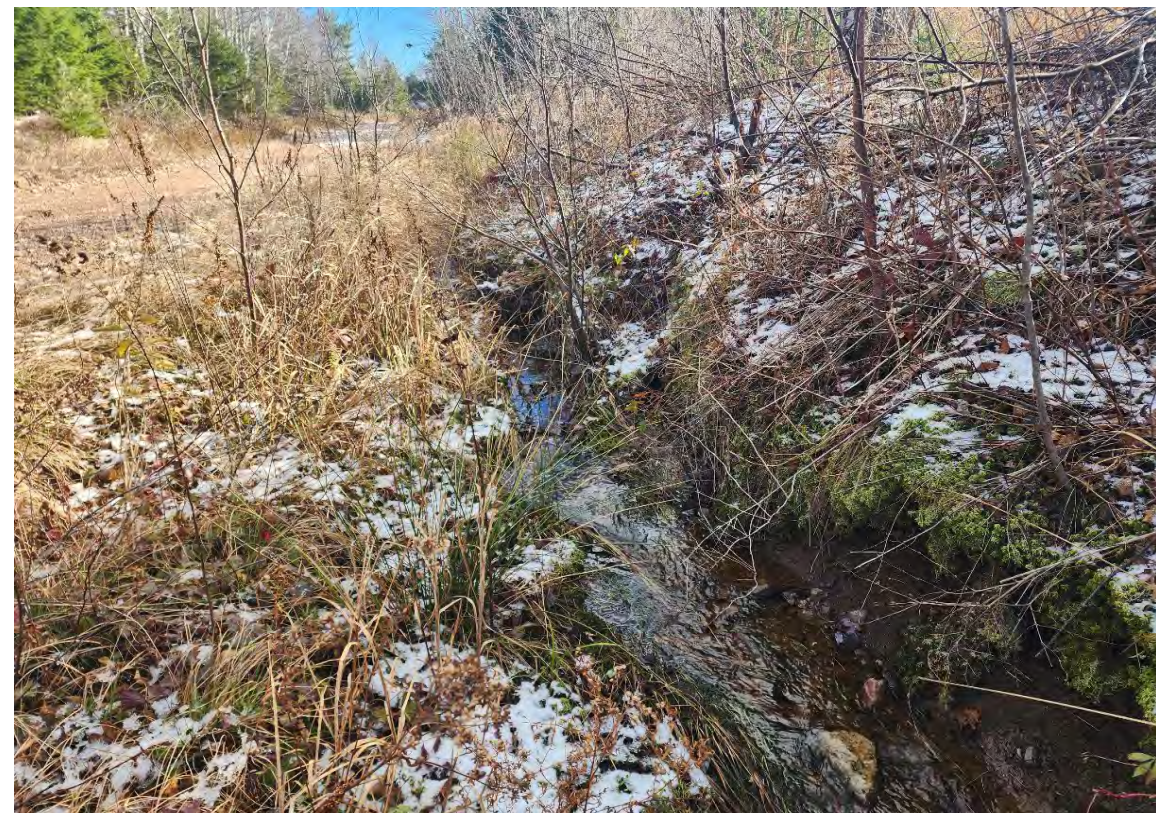
**Photo 4: U/S general habitat**

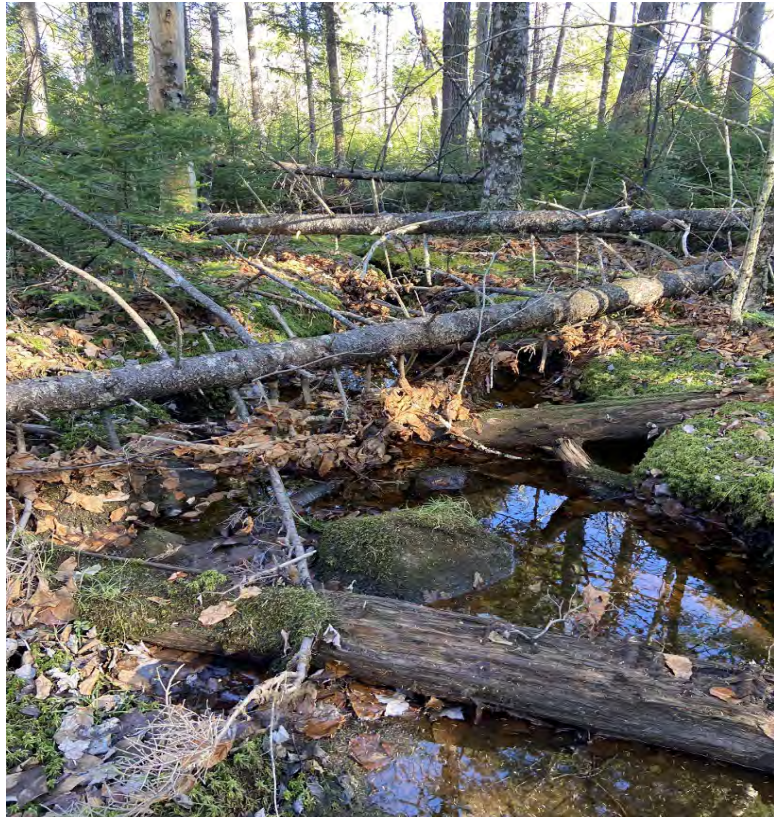
**Photo 1: Upstream habitat, example of large woody debris**

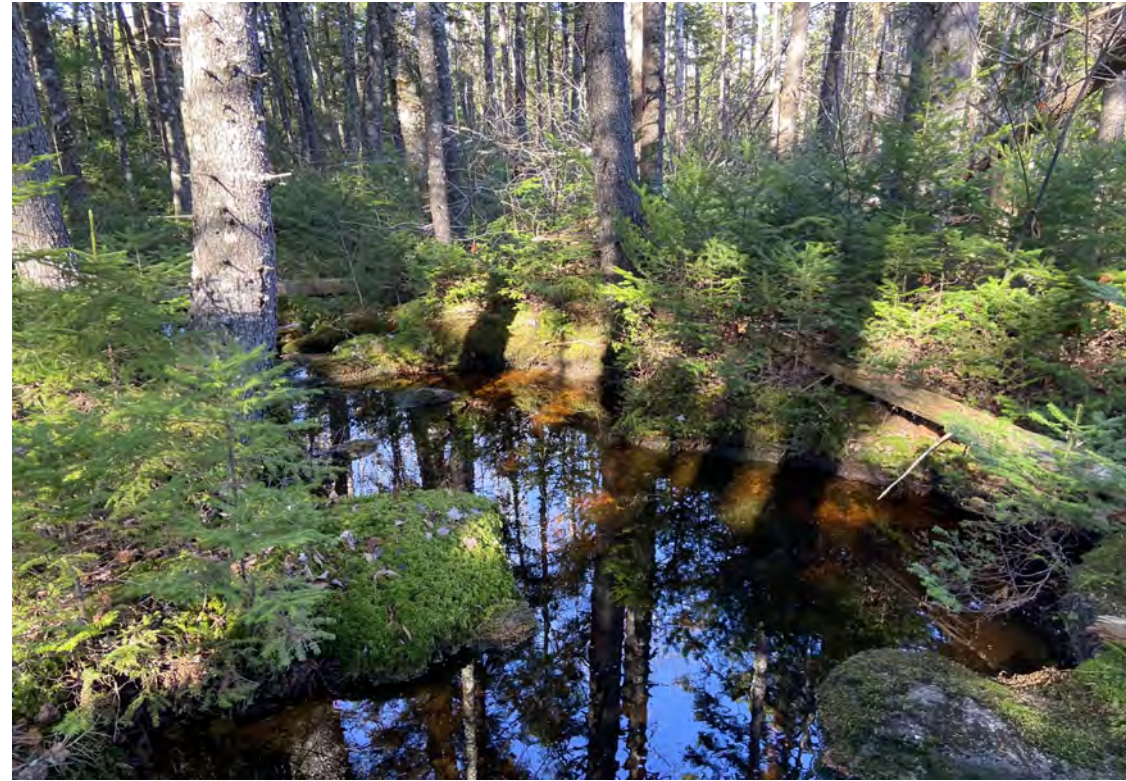
**Photo 2: Downstream habitat (Wp. 1913)**

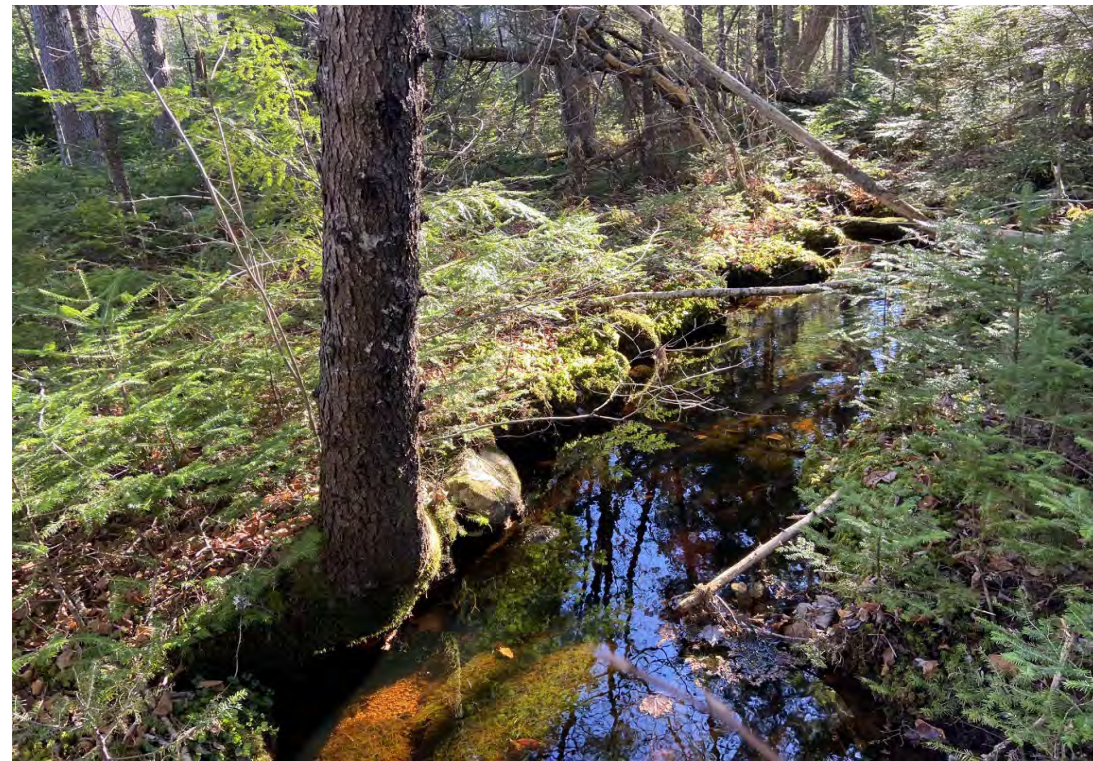
**Photo 3: Location where small Salmonid observed (Wp. 1913)**
