**An Assessment of the Sources and Magnitudes of Nutrient Inputs Responsible for Degradation of Water Quality in Seven Lakes Located Within the Carleton River Watershed Area of Digby and Yarmouth Counties, Nova Scotia**

Nova Scotia Environment

M. Brylinsky  
Acadia Center for Estuarine Research  
Acadia University  
Wolfville Nova Scotia

January 2012

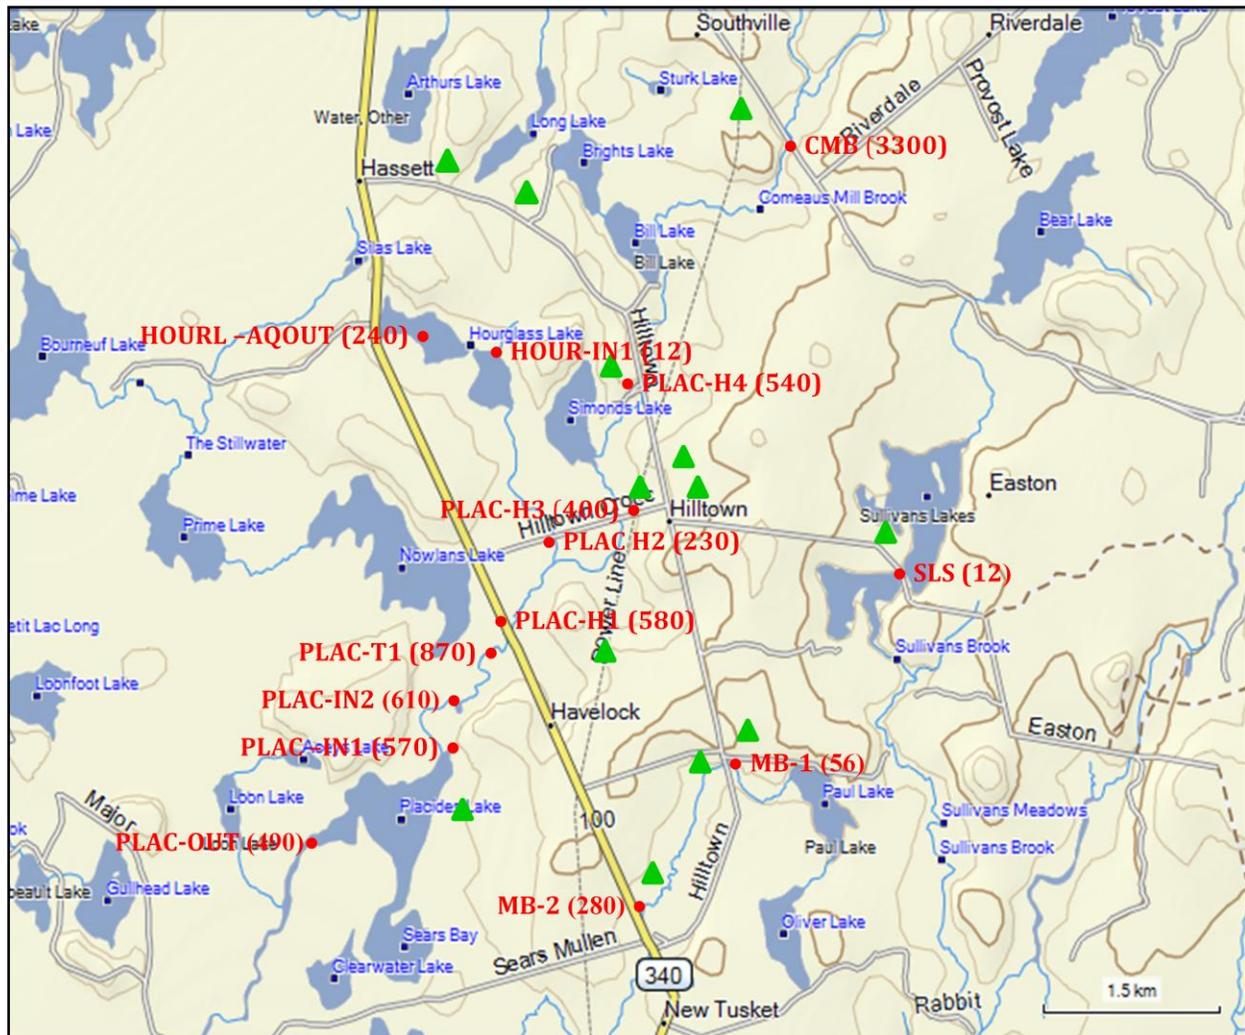
**Fig. 4.1.1.1** Location of sample stations (●) and approximate location of mink farms (▲) within the upper Carleton River watershed region (numbers in parenthesis indicate total phosphorus concentration in µg/L).

The upper Carleton River watershed region is a hydrologically complex area containing numerous lakes, streams and wetlands. The lakes and tributaries within this region (Fig.4.1.1.1 and Table 4.1.1.1) were found to have the highest levels of phosphorus within the Carleton watershed, most of which were well above 100  $\mu\text{g/L}$  and in one case exceeded 3,000  $\mu\text{g/L}$ . It also has the highest concentration of mink farms as well as a fish aquaculture operation located along the southwestern shoreline of Hourglass Lake.

The highest total phosphorus level of 3,300  $\mu\text{g/L}$  was measured at Station CMB where Comeaus Mill Brook crosses under Langford Road between Southville and Riverdale. This site was characterized by extensive growths of cattails and duckweeds, particularly along the southwesten

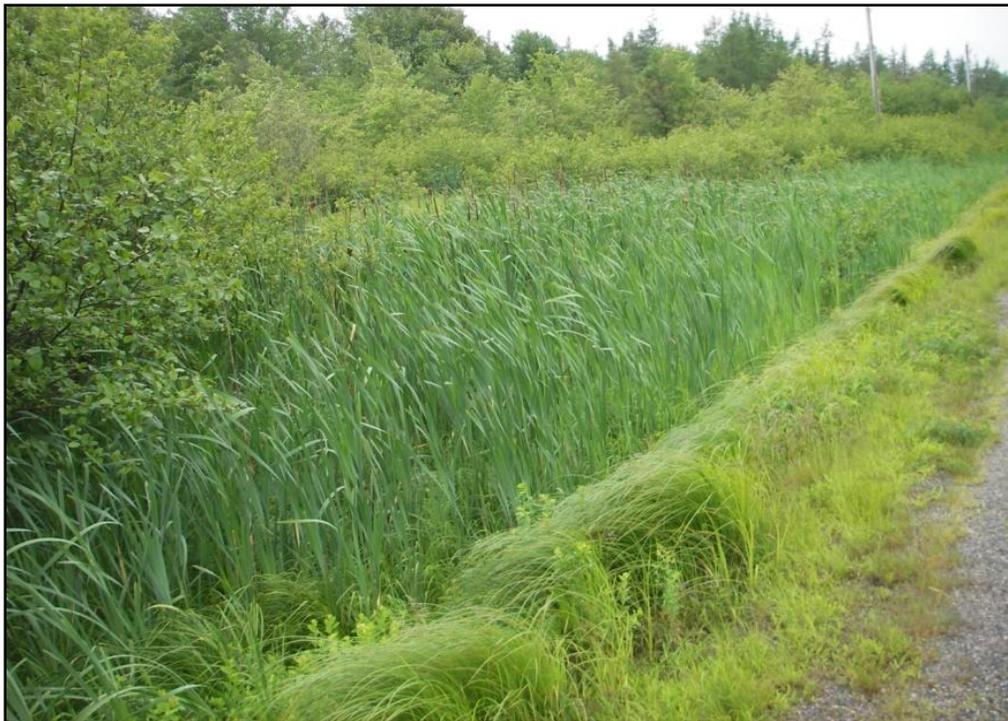
**Fig.4.1.1.2.** Cattail growth along Langford Road.

side of Langford Road (Fig. 4.1.1.2). Comeaus Mill Brook flows through a wetland area with extensive growth of cattails (Fig. 4.4.4.3) and then into Bill Lake. The outflow of Bill Lake, which passes under Hilltown Road (Station PLAC –H4), had a total phosphorus concentration of 540 µg/L. The much lower total phosphorus concentration relative to Station CMB is likely due to sequestering of phosphorus by the wetland and retention within Bill Lake. The outflow of Bill Lake in turn flows into Simonds Lake. Its outflow (Station PLAC-H3) had a total phosphorus level of 400 µg/L.

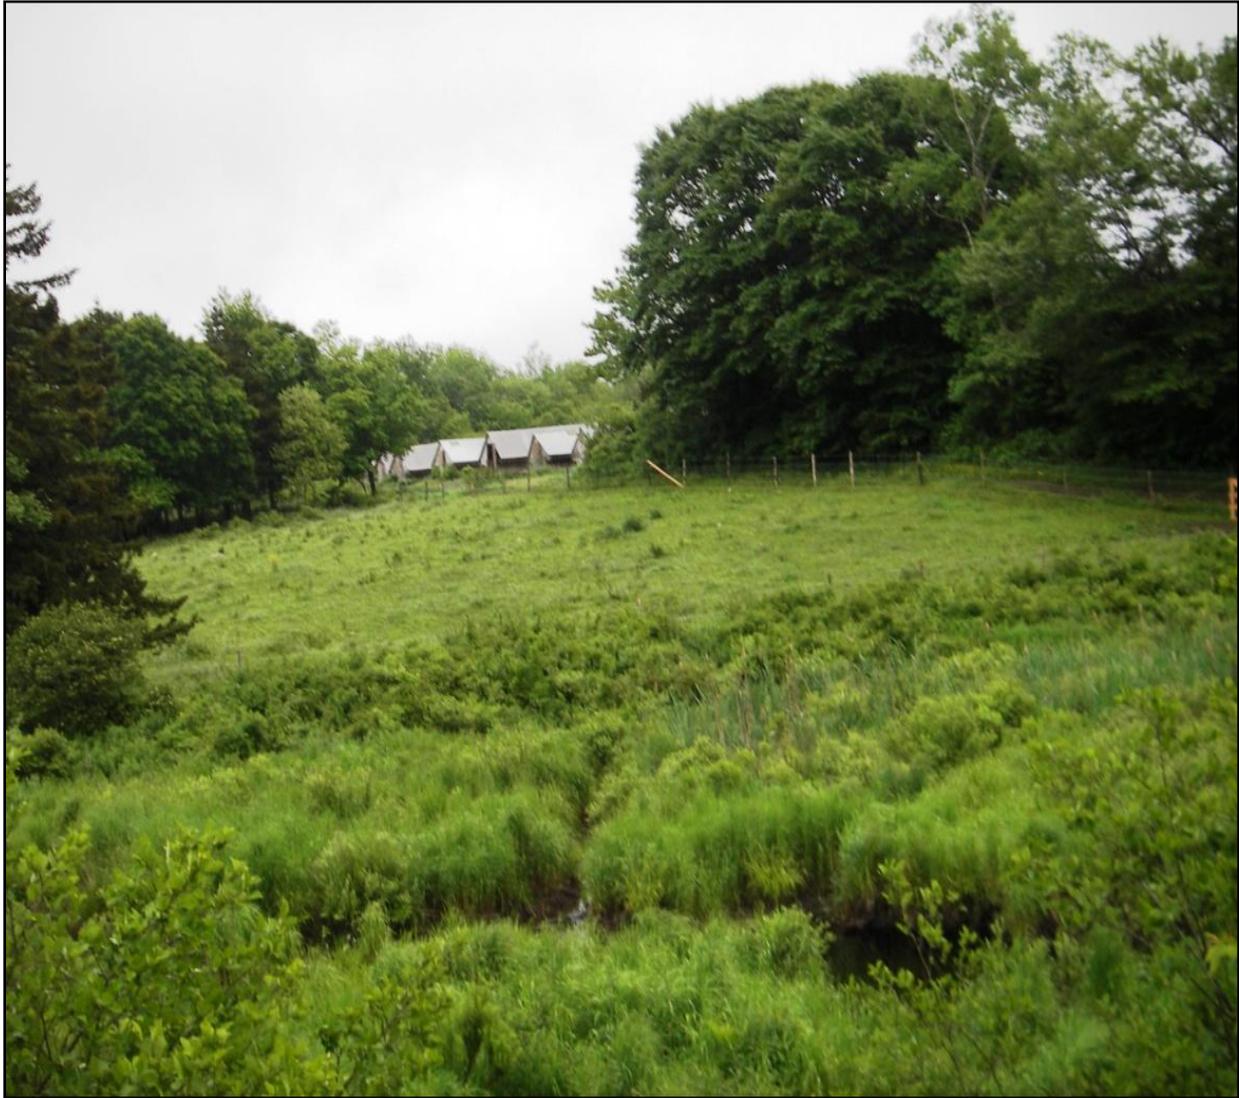
**Fig.4.1.1.3.** Wetland located along west side of Station CMB at Comeaus Mills Brook.

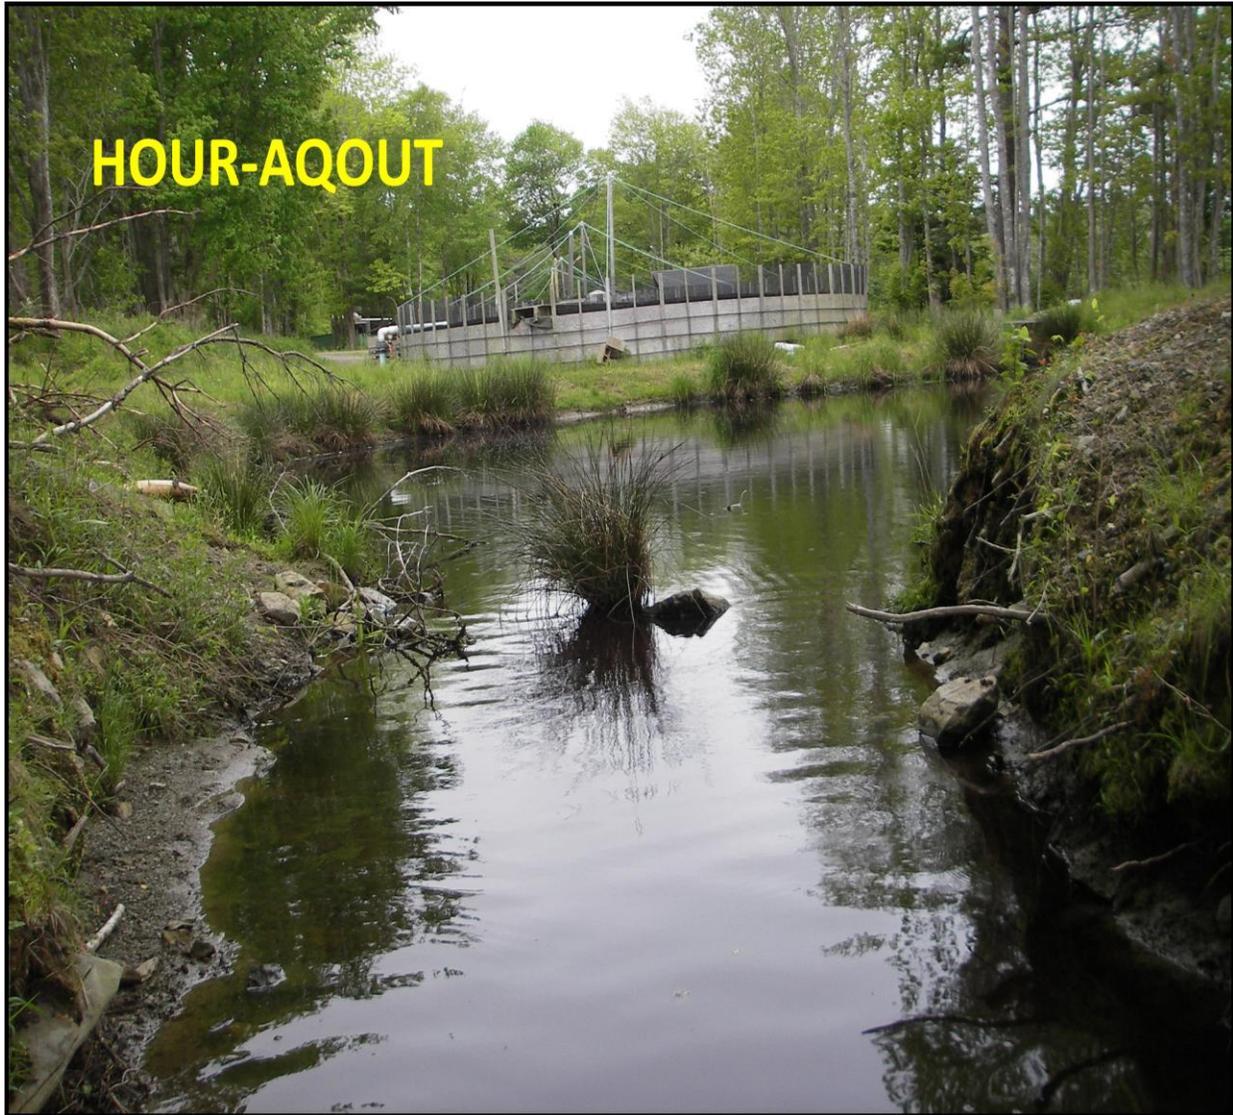
Another nutrient source that eventually enters Placides Lake is the outflow from a land-based smolt aquaculture operation located along the southwestern shoreline of Hourglass Lake (Fig 4.1.1.4). Although a significant outflow could not be measured at the time of the survey, water lying within the outflow channel had a total phosphorus concentration of 240  $\mu\text{g/L}$ . The outflow from Hourglass Lake eventually travels into Placides Lake after it passes under Hilltown Cross Road. The total phosphorus level at this point was 230  $\mu\text{g/L}$ , only slightly lower than the outflow from the aquaculture site. It is unlikely that this level of phosphorus is due entirely to the outflow of the aquaculture operation since it would be expected that some of the phosphorus would be retained within Hourglass Lake. It is more likely that an additional unidentified nutrient input exists within the area between the outflow of Hourglass Lake and Station PLAC-H2.

**Fig. 4.1.1.4** Outflow channel of the Hourglass Lake aquaculture facility.

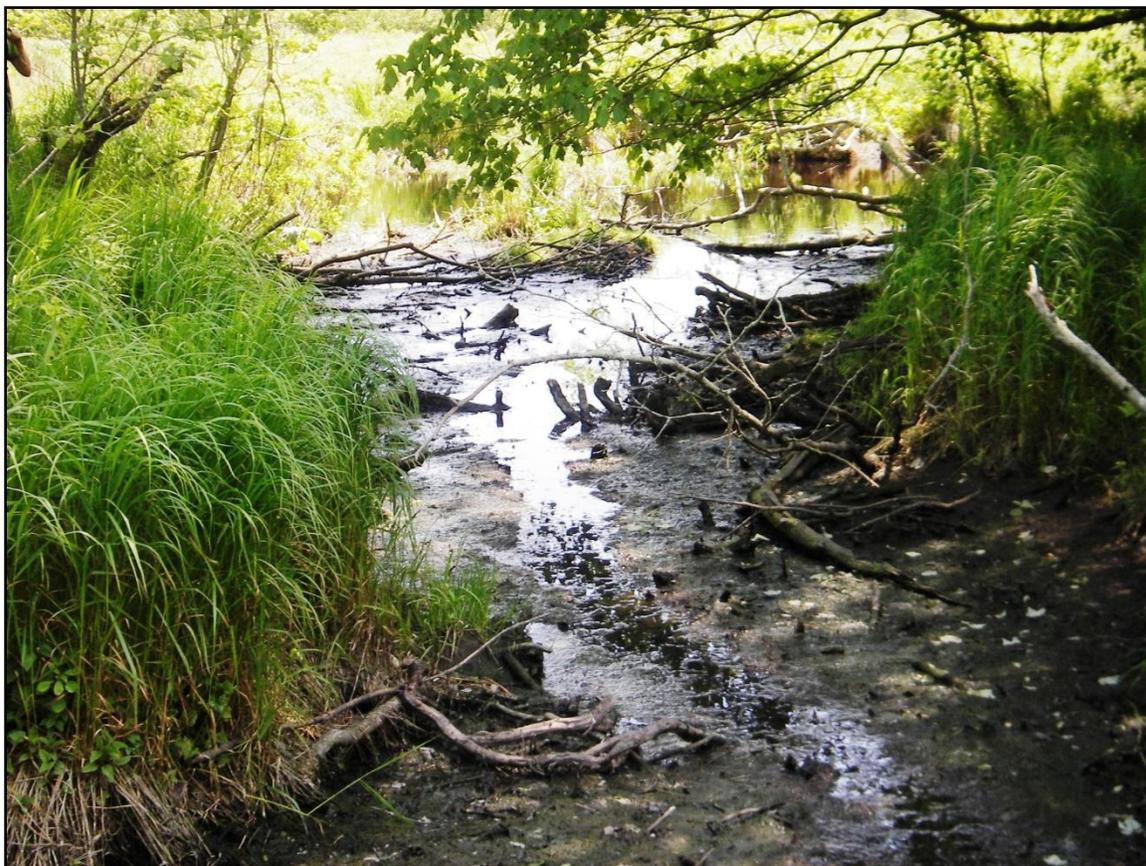
The outflow from Simmonds and Hourglass Lake join each other prior to the stream passing under Hwy 340. At Hwy 340 (Station PLAC-H1) the total phosphorus concentration was 580  $\mu\text{g/L}$ . Below this station total phosphorus levels again increased prior to the stream entering Placides Lake. This increase was due to an area of overland runoff located on the west side of the stream (Station PLAC-T1). This was an area of standing water surrounded by anoxic saturated soils, extensive cattail growth and a strong odour of hydrogen sulphide (Fig. 4.1.1.5). Total phosphorus concentration in the standing water was 870  $\mu\text{g/L}$ .

**Fig. 4.1.1.5** Area of overland runoff at Station PLAC-T1

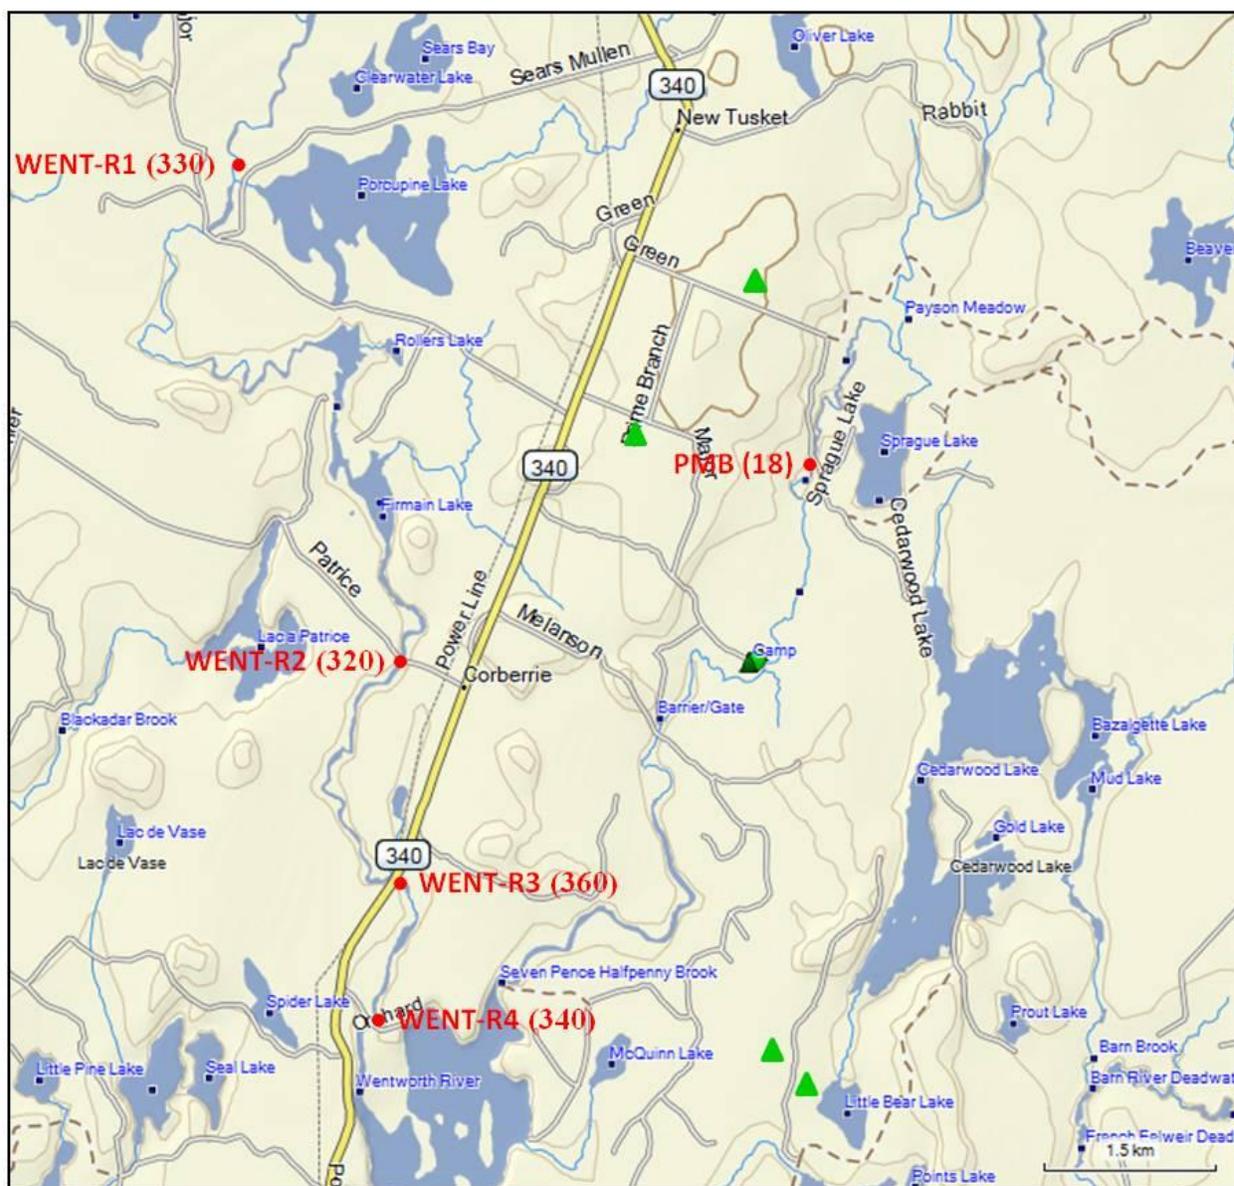
**Fig. 4.1.2.1** Location of sample stations (●) and approximate location of mink farms (▲) within the Wentworth River system (numbers in parenthesis indicate total phosphorus concentration in  $\mu\text{g/L}$ ).

The Wentworth River system begins at the outflow of Placides Lake and extends downstream approximately 14 km where it enters Wentworth Lake. Total phosphorus concentrations were high throughout the River ranging between 320 and 360  $\mu\text{g/L}$  (Fig.4.1.2.1 and Table 4.1.2.1), but lacked any significant variation within the River as it travels downstream indicating that it is

unlikely to have any major nutrient inputs, and that it has little ability to sequester the high nutrient load it receives from Placides Lake. Although there are four mink farms located in this area they do not appear to have a significant impact on nutrient levels within the Wentworth River system.

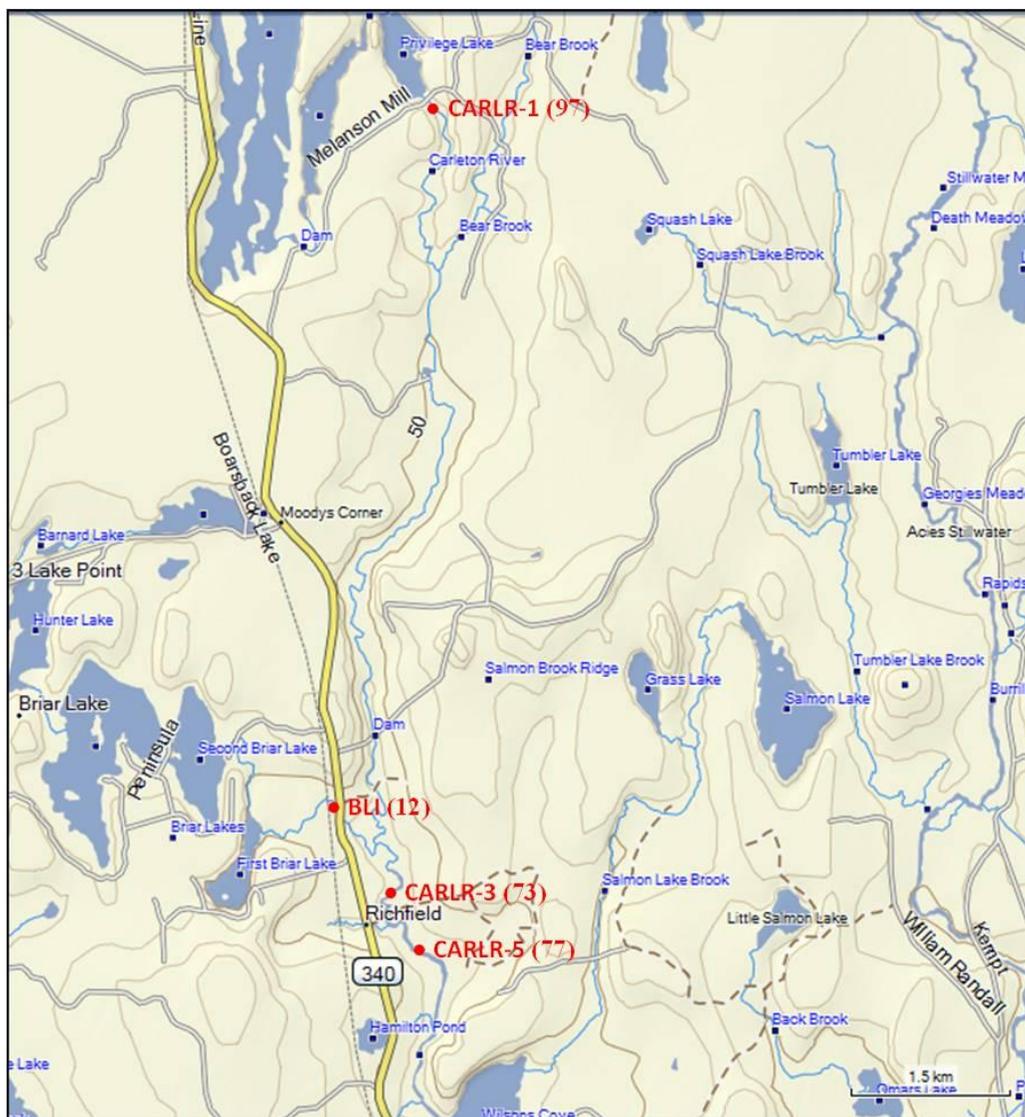
**Fig. 4.1.3.1** Location of sample stations (●) within the Upper Carleton River system (numbers in parenthesis indicate total phosphorus concentration in  $\mu\text{g/L}$ ).

The Carleton River system begins at the outflow of Privilege Lake, a small lake that receives the outflow of Wentworth Lake. The total phosphorus concentration at this point (CARLR-1) was 97 µg/L, about four times lower than the total phosphorus concentration at the inlet to Wentworth Lake. This decrease is most likely a result of phosphorus being retained within Wentworth Lake, which is one of the largest lakes in the area. From its origin, the Carleton River travels downstream approximately 11 km where it enters Parr Lake. Unlike the Wentworth River, there is only a small decrease of about 20 percent in total phosphorus by the time it enters Parr Lake (Fig. 4.1.3.1 and Table 4.1.3.1). There are no mink farms in this area and very few tributaries enter this stretch of River.

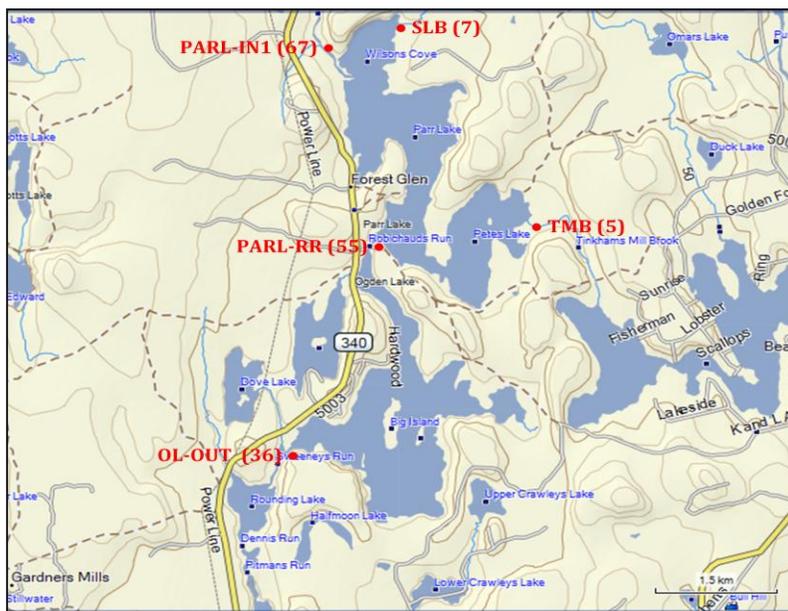
**Fig. 4.1.4.1** Location of sample stations (●) within the Parr and Ogden Lake area (numbers in parenthesis indicate total phosphorus concentrations in  $\mu\text{g/L}$ ).

The Carleton River flows into Parr Lake the outlet of which flows through Robichauds Run, a channel connecting Parr to Ogden Lake. Both Parr and Ogden are relatively large lakes. Parr Lake has three inputs, the Carleton River which flows into Parr Lake at Station PARL-IN1 (Fig. 4.1.4.1), and two small streams, Salmon Lake Brook and Tinkhams Mill Brook, both of which were found to have very low total phosphorus levels (Table 4.1.4.1). Ogden Lake, which has no other water inputs other than the input from Parr Lake, exits into the lower Carleton River. Between the inlet of Parr and the outlet of Ogden Lake, the total phosphorus concentration decreased about 50 percent, from 67 to 36  $\mu\text{g/L}$ . This decrease is also likely due to the retention of phosphorus within the lakes, and is indicative of there being no major nutrient inputs to either lake other than that received from the Carleton River.

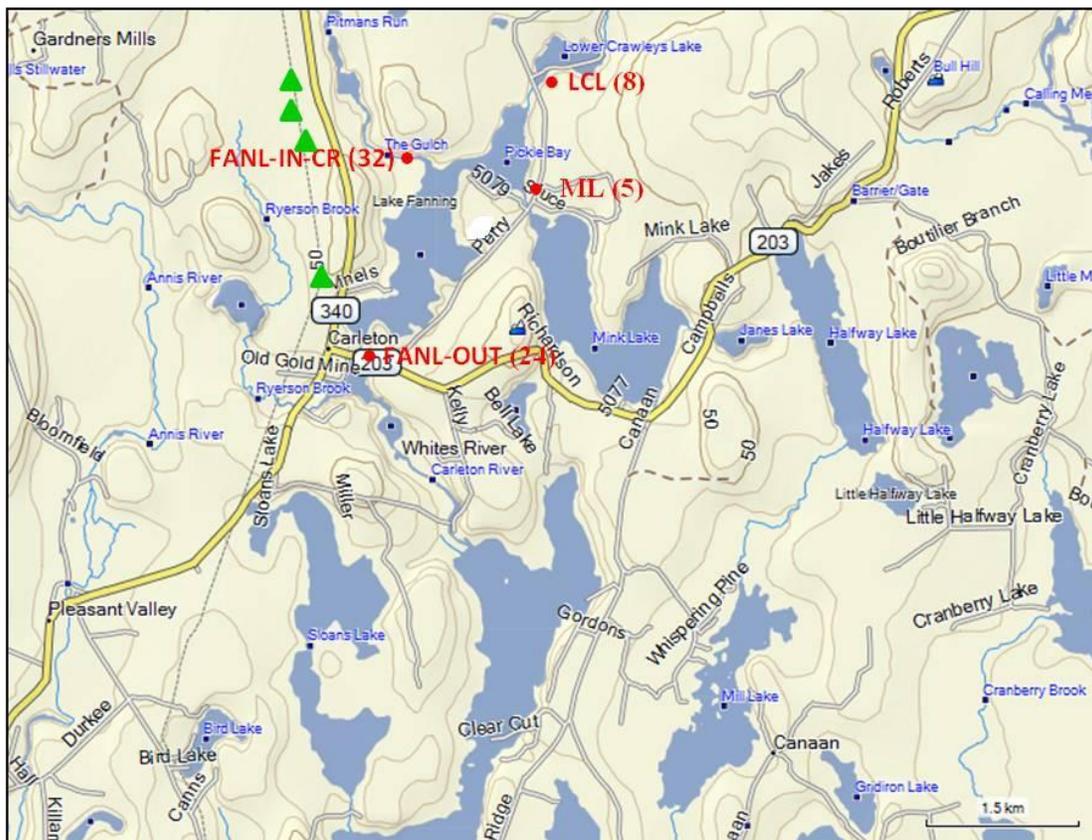
**Fig. 4.1.5.1** Location of sample stations (●) and approximate location of mink farms (▲) within the Fanning Lake area (numbers in parenthesis indicate total phosphorus concentrations in µg/L).

Fanning Lake receives its major input from the Carleton River. Two smaller inputs are the outflows of Lower Crawleys and Mink Lake, both of which have very low nutrient levels (Fig 4.1.5.1 and Table 4.1.5.1). There are four mink farms located near the lake’s western shoreline, but these do not appear to be associated with any tributary flows that may enter the lake. Nutrient levels at the input and output of Fanning Lake are relatively low.

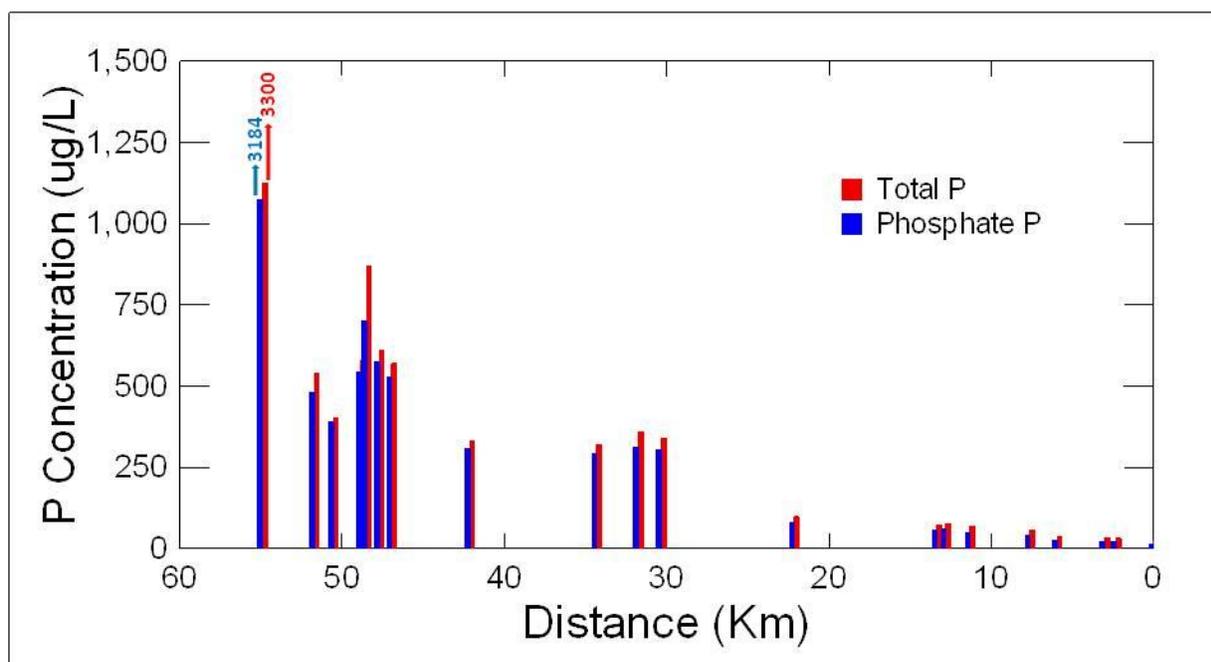
From the preceding description of nutrient levels within the Carleton River watershed it is obvious that there is a dramatic decrease in nutrient levels as the River flows downstream. This decrease is illustrated in Fig. 4.1.6.1 which shows the gradual decrease in both total phosphorus and phosphate at sample stations located within the main stem of the River beginning at Comeaus Mill Brook and ending at the outlet of Fanning Lake. Most of the phosphorus loading to this system originates within the upper region of the watershed in close proximity to the greatest concentration of mink farms. Most of the decrease occurs where the River enters and leaves lakes, the biggest decrease occurring at Wentworth Lake.

**Fig. 4.1.6.1** Variation in total phosphorus and phosphate levels with distance from Fanning Lake.

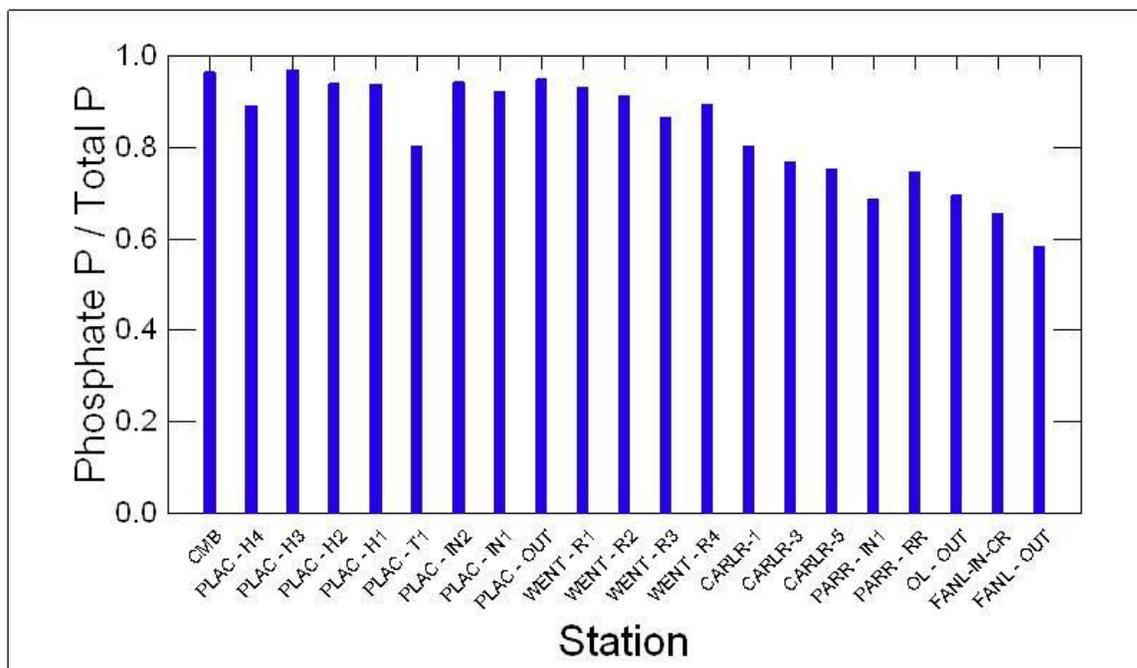
Also of note is that most of the phosphorus is present in the dissolved as opposed to the particulate form (Fig. 4.1.6.2). This is very unusual since in most natural aquatic ecosystems the level of phosphate is typically present at levels below the limit of analytical detection as a result of its rapid utilization by aquatic plants. The only likely source of dissolved phosphorus input to the Carleton River watershed region is superphosphate<sup>1</sup>, a widely utilized chemical among mink farmers that is used to increase the shelf life of mink food as well as reduce the occurrence of kidney stones in mink livestock (Leoschke 1996).

Also obvious is the gradual decrease in phosphate to total phosphorus ratio as water moves downstream, a result of waters low in phosphate entering the River in its lower reaches.

**Fig. 4.1.6.2** Ratio of phosphate to total phosphorus for sample stations located within the upper region and main stem of the Carleton River watershed.

Although it is expected that some of the phosphorus leading to the deterioration of water quality of the lakes is due to runoff associated with cleaning operations and/or the storage of mink manure, the high ratio of phosphate to total phosphorus suggests that the major source of phosphorus is more likely to be due to mink farm operations that utilize superphosphate. If this is the case, it is highly likely that a great reduction in phosphorus loading to the lakes could be accomplished by simply reducing, eliminating or better controlling this practice. It should be noted, however, that the typical remediation methodologies for reducing nutrient inputs to watercourses, such as diverting outflows into natural or constructed wetlands and settling ponds, may not work well if the nutrient concentrations are very high and largely in the dissolved as opposed to the particulate form. Although wetlands are considered to be nutrient sinks, they do have limits with respect to how much they can assimilate and unless quite extensive in area can easily become nutrient saturated under conditions of high nutrient loads. Settling ponds are only effective if the nutrients are in the particulate form and will not significantly reduce nutrient outputs if they are in the dissolved form.

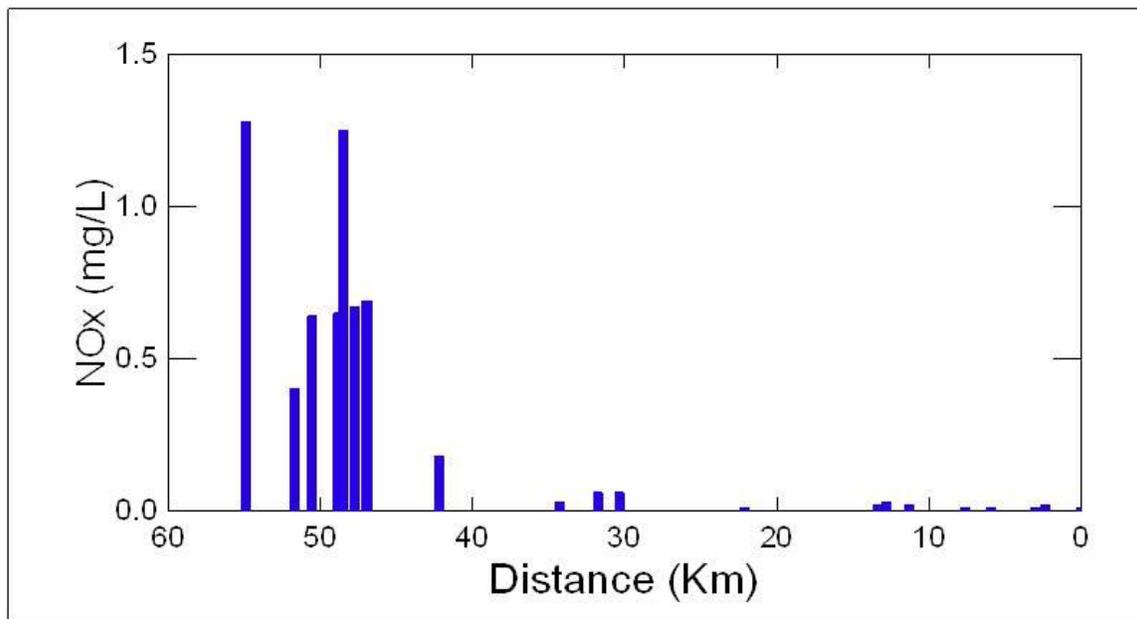
Inorganic nitrogen also shows a decreasing trend in concentration from upstream to downstream (Fig. 4.1.6.3). The greater levels within the upper region are most likely a result of the runoff of waste products originating from within milk farms.

**Fig. 4.1.6.3** Variation in inorganic nitrogen levels with distance from Fanning Lake.

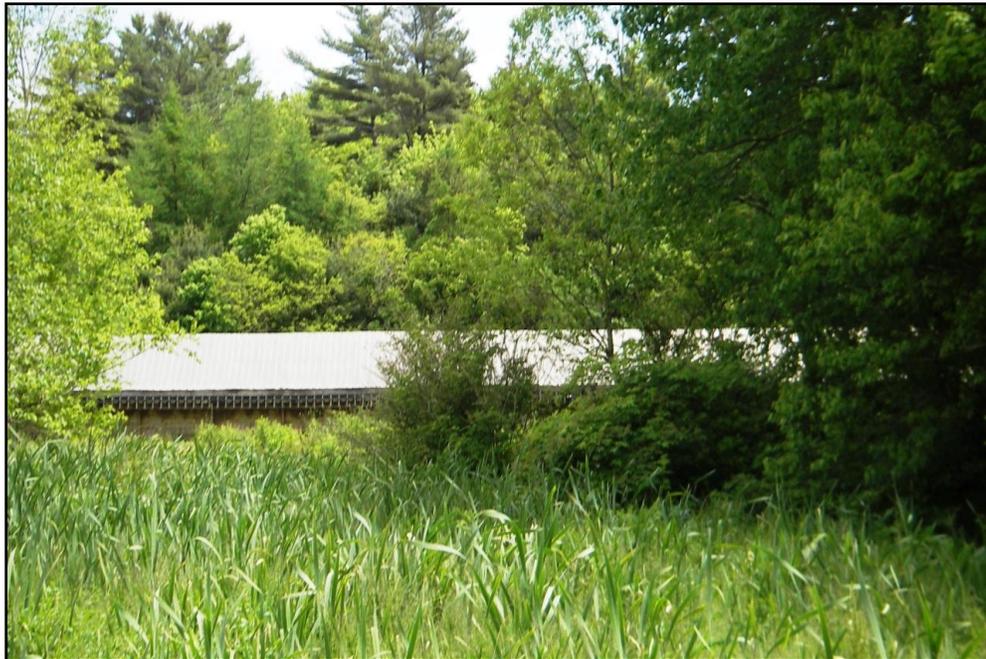
Nowlans Lake, a small headwater lake, is the only lake located within the Meteghan River watershed that was evaluated with respect to nutrient inputs. This lake exhibits the most highly degraded water quality of all the lakes surveyed. In addition to six mink farms, a fish meal processing plant is also located within its watershed. Although it is a headwater lake with no well defined stream inputs, flowage from a nearby boggy ravine located along its eastern shoreline enters the lake after flowing through a culvert located under Hwy 340. The ravine is saturated with water and has a heavy growth of cattails indicating that it receives an inflow of high nutrient water. Total phosphorus values measured in this area were among the highest observed during the survey and ranged between 7,100 and 32,000  $\mu\text{g/L}$  (Fig. 4.2.1 and Table 4.2.1). The nutrients appear to originate from a number of mink farms located just north of and above the ravine. At Station NOWL-IN5, a small stream located at the head of the ravine, it was possible to measure a flow rate into the bog of 5,424 L/day and a total phosphorus concentration of 32,000  $\mu\text{g/l}$  which results in a phosphorus loading of 173.5 kg/day. This stream appeared to originate from a mink farm building located approximately 150 metres above this outflow (Fig.4.2.2)

**Fig. 4.2.2** Mink farm building located above boggy ravine.

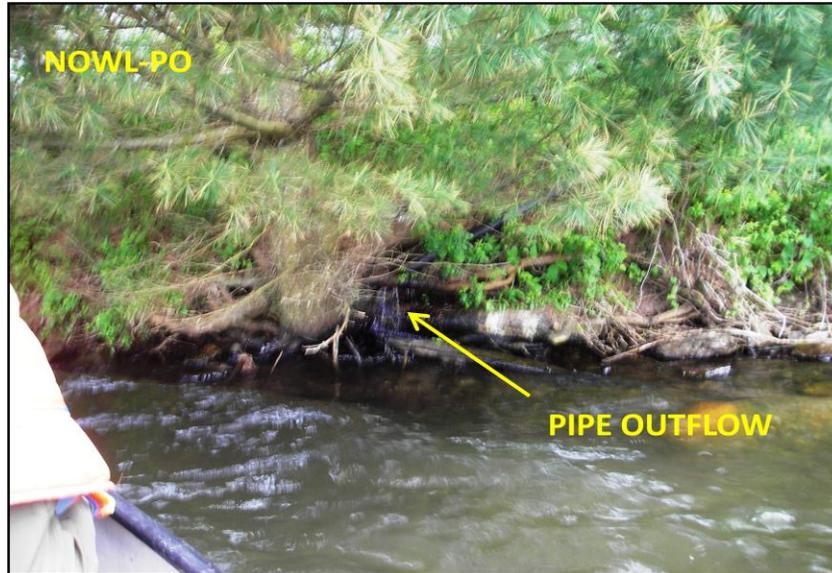
There was also an inflow to the lake from a plastic pipe observed at Station NOWL-PO (Fig.4.2.3). This inflow had a flow rate of 13,248 L/day and a total phosphorus concentration of 0.047 µg/l resulting in a phosphorus loading 0.622 kg/day. The discharge of the pipe appeared to originate from a mink farm operation located just above the lake’s shoreline.

**Fig. 4.2.3** Pipe outflow along the lower eastern shoreline of Nowlans Lake.

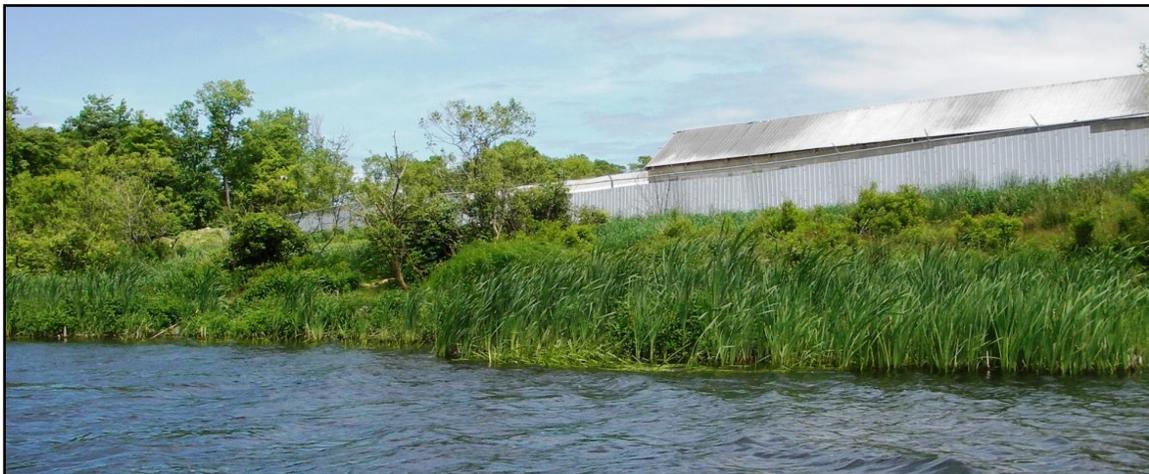
Also observed were two areas along the lake's shoreline that appear to be sites where overland flow periodically enters the lake, although at the time of the survey no flow was observed. In both cases extensive cattail growth was observed along the lake's shoreline. One was located along the lower western shoreline just north of where the pipe outflow was located and just below a mink farm building (Fig. 4.2.4). The other was located along the upper eastern shoreline just southwest of the fish meal processing plant (Fig. 4.2.5).

**Fig. 4.2.4** Area of overland flow along lower eastern shoreline of Nowlans Lake

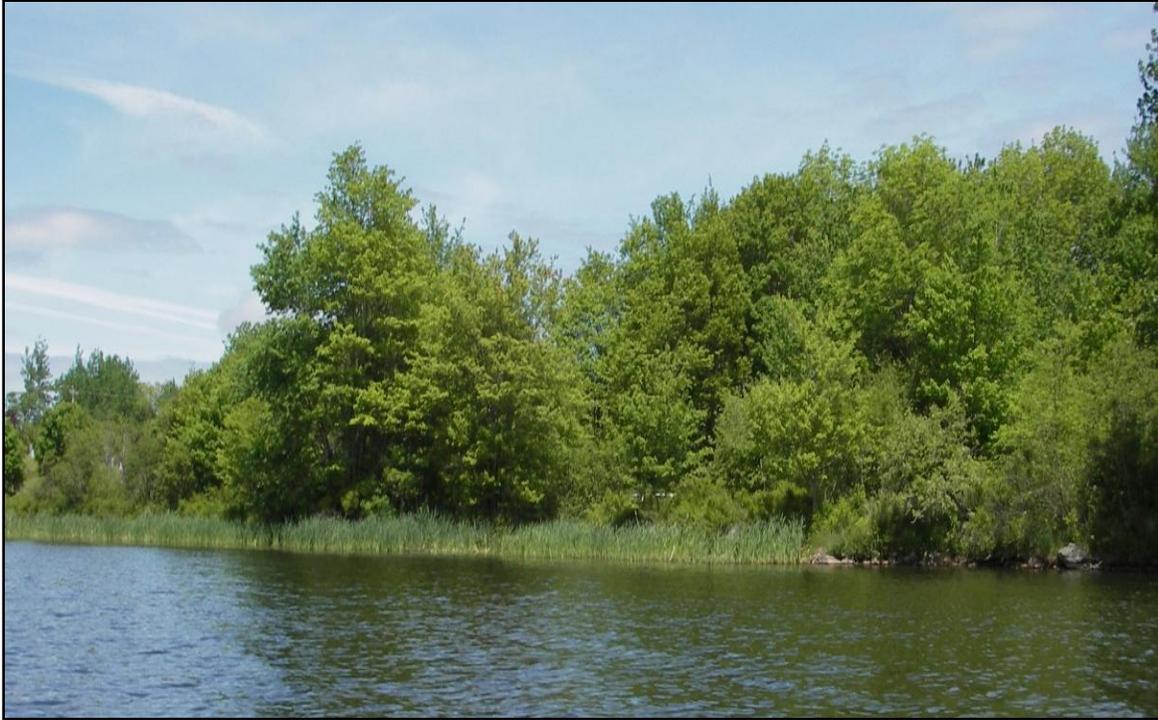
**Fig. 4.2.5** Area of overland flow along upper eastern shoreline of Nowlans Lake

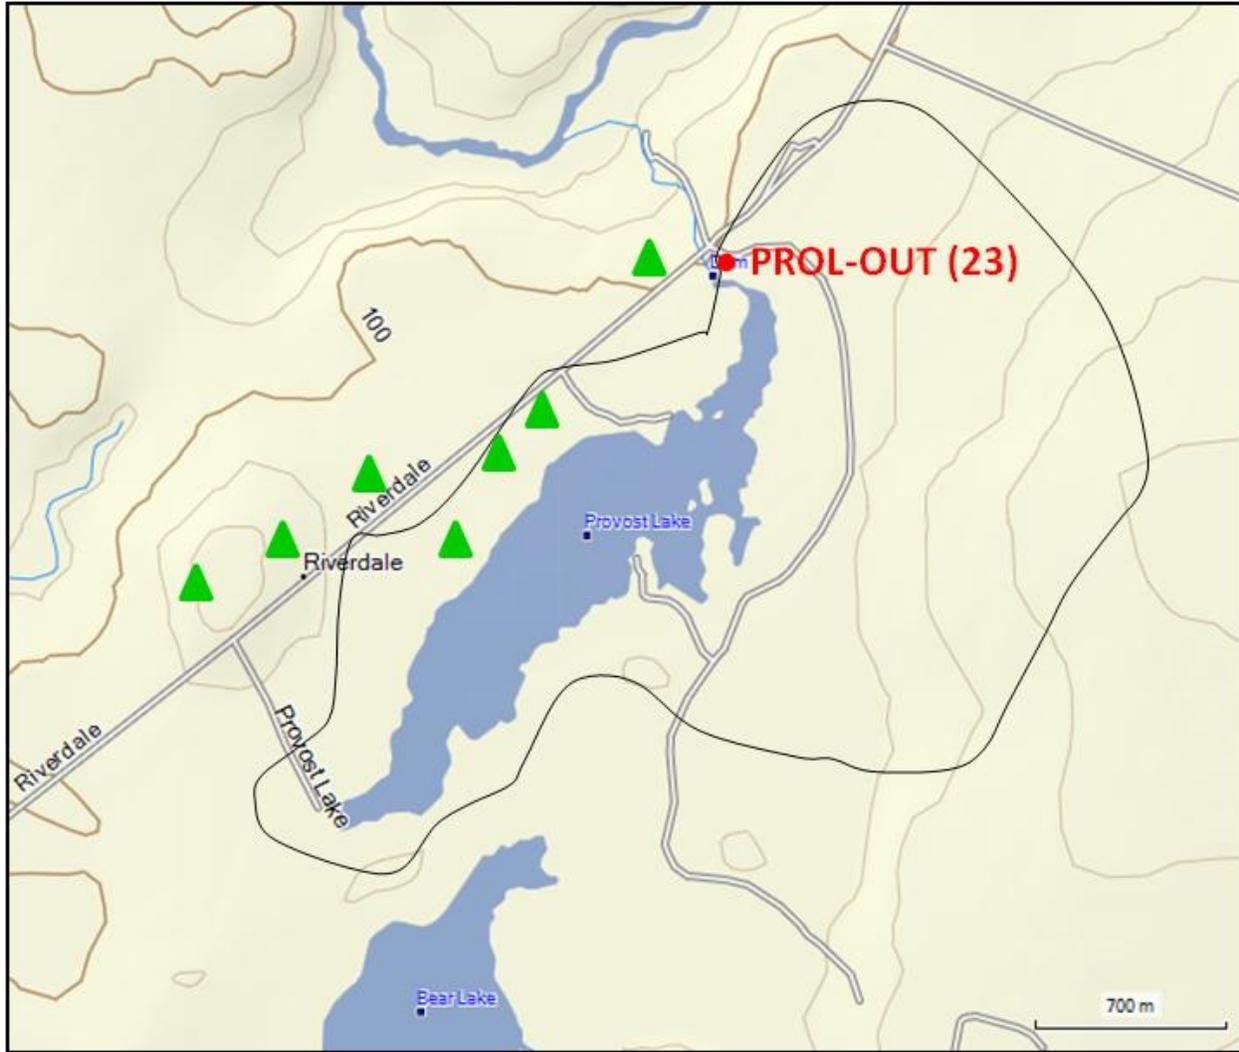
**Fig. 4.3.1** Location of sample stations (●) and approximate location of mink farms (▲) within the Provost Lake watershed (numbers in parenthesis indicate total phosphorus concentration in  $\mu\text{g/L}$ ).

Provost Lake, a small headwater lake, was the only lake surveyed within the Sissaboo River watershed. Its water quality is the least impacted of all the lakes surveyed. It has no significant surface water inputs and is most likely spring fed. The total phosphorus concentration at the lake's output was relatively low (Fig. 4.3.1). The only potential nutrient sources to the lake observed during the shoreline survey were a number of cottage properties having extensive lawn areas and the droppings of large numbers of roosting seagulls on the lake's water surface and along its shoreline. The latter may be due to the presence of several mink farms located nearby to the west of the Lake.

Although it has a number of mink farms located within its watershed, these do not appear to have any significant impact on the lake.
