NORTHERN PULP NOVA SCOTIA

Wetland Baseline Survey

Focus Report – Replacement Effluent Treatment Facility

Appendix Focus Report Item 5.1: Wetlands along the Re-aligned Pipeline Route

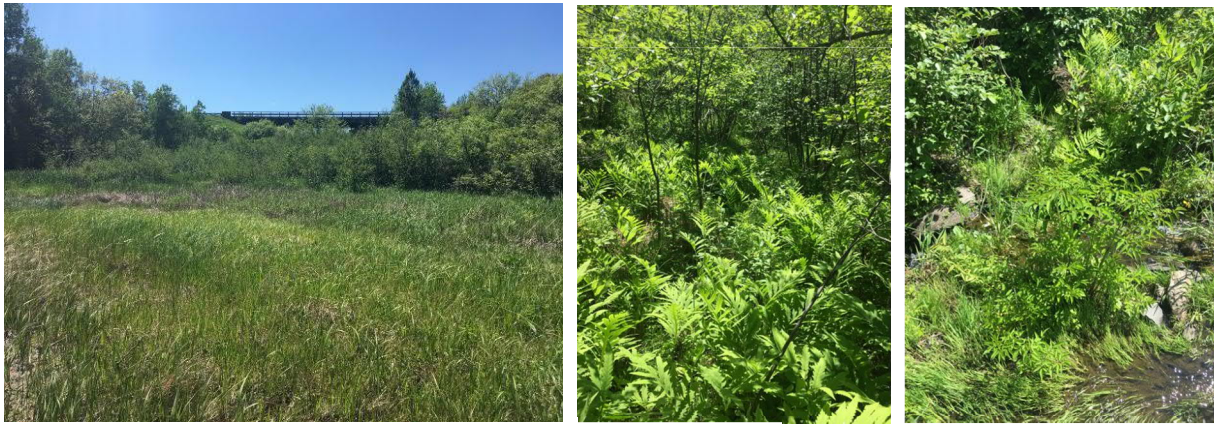
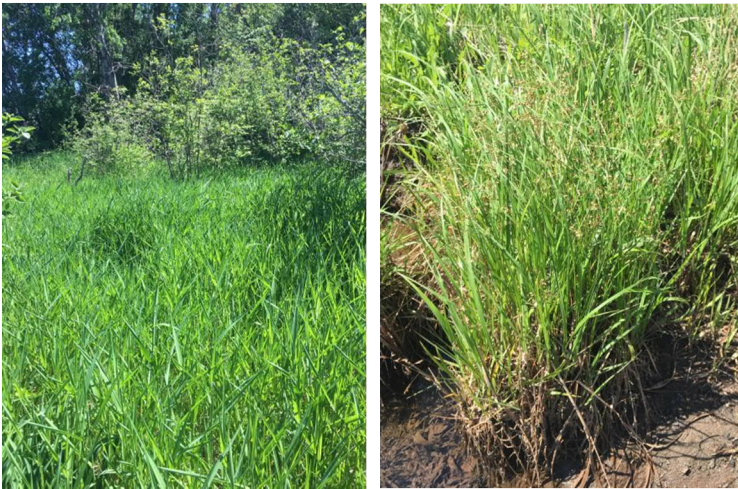
WL-3 – June 17, 2019

WL-3 appears to have been partially filled in from the past construction of adjacent roadways and the Pictou causeway. Most of the wetland area is tidally influenced and dominated by hardstem bulrush (*Schoenoplectus acutus*), reed canary grass (*Phalaris arundinacea*), and both broad-leaved and narrow-leaved cattail (*Typha latifolia* and *Typha angustifolia*, respectively). However, at the landward side of the wetland, furthest from a tidal influence, the land slopes steeply upwards and transitions into a dense thicket dominated by roses, hawthorn and speckled alder (*Alnus incana*). No federally or provincially listed priority species were identified in WL-3; however, two rare (according to the AC CDC) lichens were identified in June 2019. *Leptogium imbricatum* is ranked by the Atlantic Canada Conservation Data Centre (AC CDC) as S2? (rare within Nova Scotia with a degree of uncertainty), and *Leptogium tenuissimum* is ranked as S2S3 (rare to uncommon within Nova Scotia). More information on priority flora species is presented in **Annex 8.1 Section 8.1.3** of the Focus Report and in the EARD (Section 8.8).

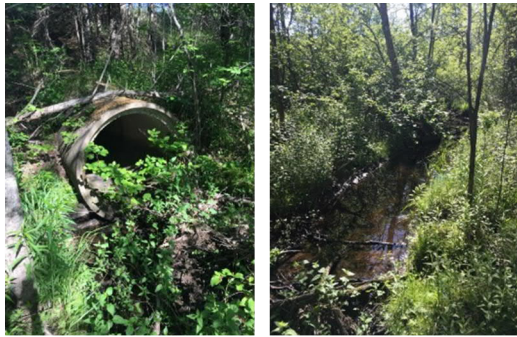
48 inch
outflow
culvert

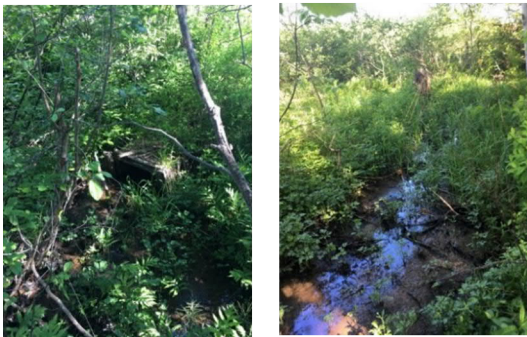
24 inch
wooden
culvert
input

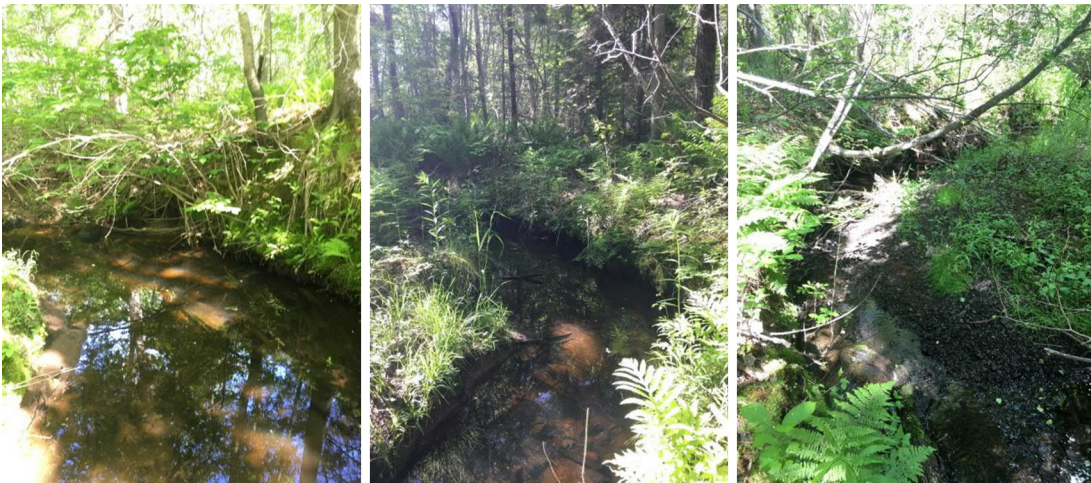
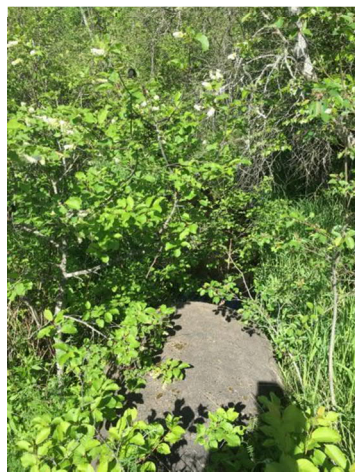
WC08 outflow:

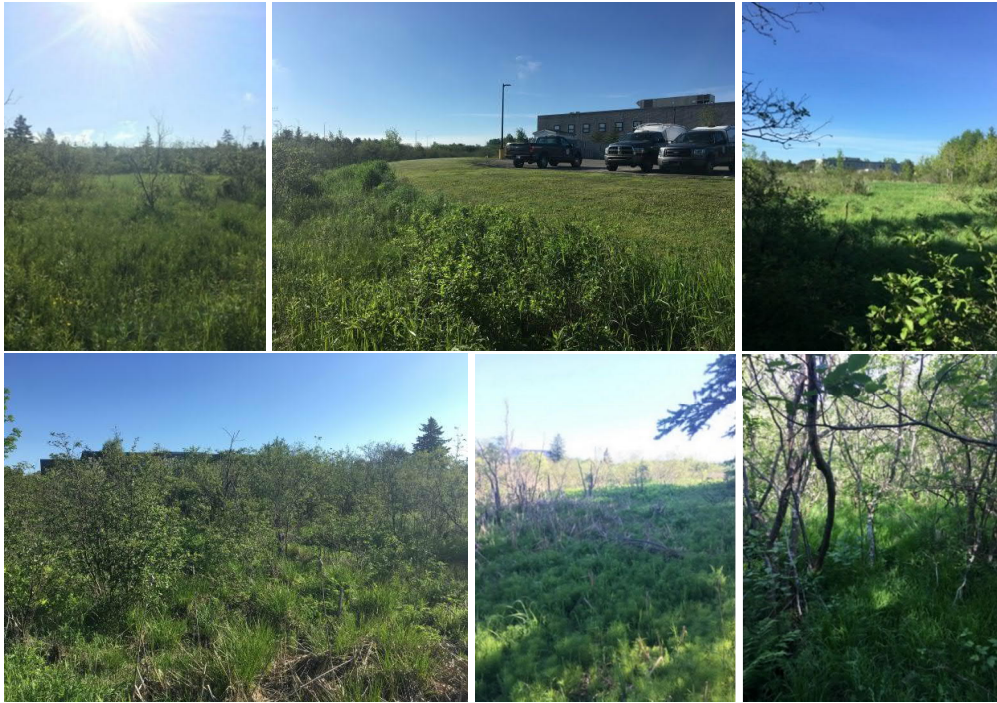
WL-5D – June 18, 2019

Watercourse 7 (WC07) is the wetland's only channelized inlet flow, but it also receives some amount of storm water runoff from adjacent roadways (i.e., Pictou Roundabout). Watercourse 7 (WC07) enters the wetland from the east via a concrete culvert under a section of the Pictou Roundabout between the Route 6 (Sunrise Trail) exit and the Highway 376 exit. Two outlet flows were noted for WL-5D: one is via a culvert under the drive to the Pictou Administration Building (Municipal Building); the other is a smaller, less channelized outflow located north of the aforementioned Pictou Administration Building. Both outflows continue flowing westward before joining Haliburton Brook near the tidal reach. No federally or provincially listed priority species were identified in WL-5D in 2019.

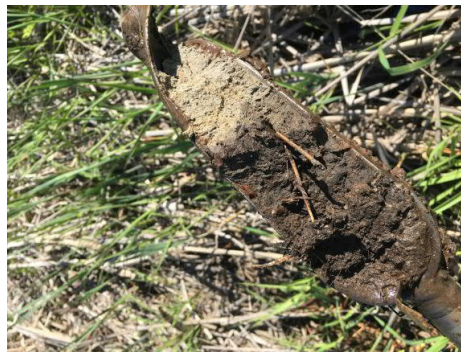
Soil pit

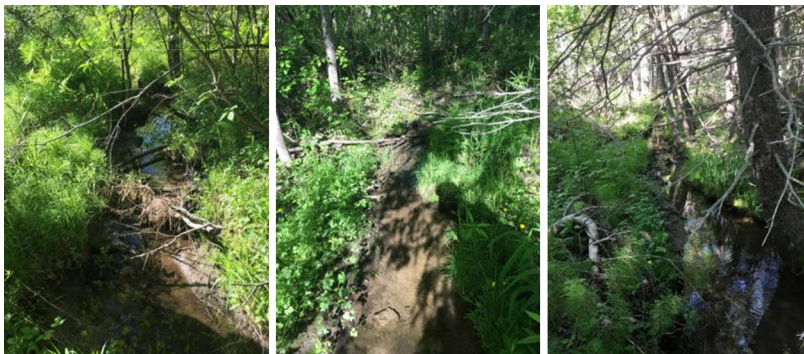
Small outlet stream

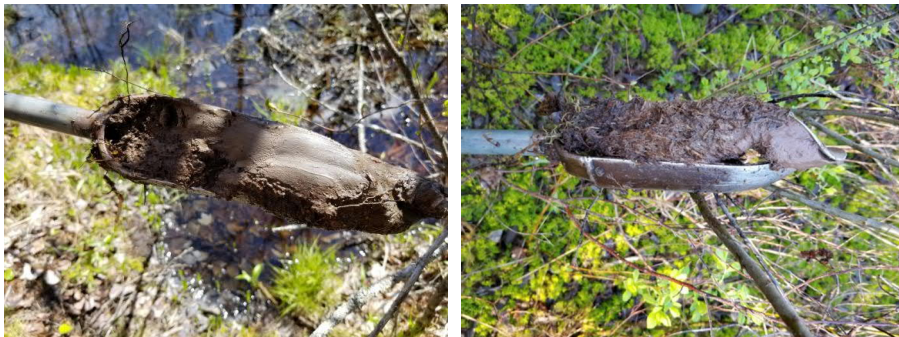
Soil pit in wetland:

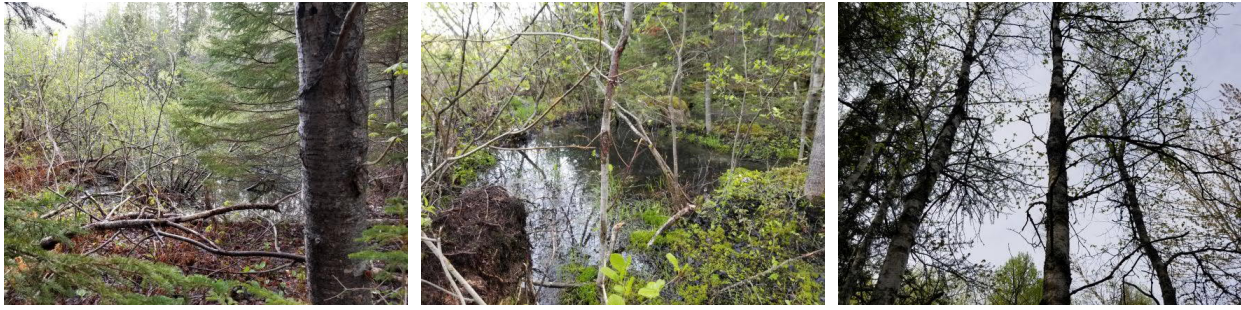
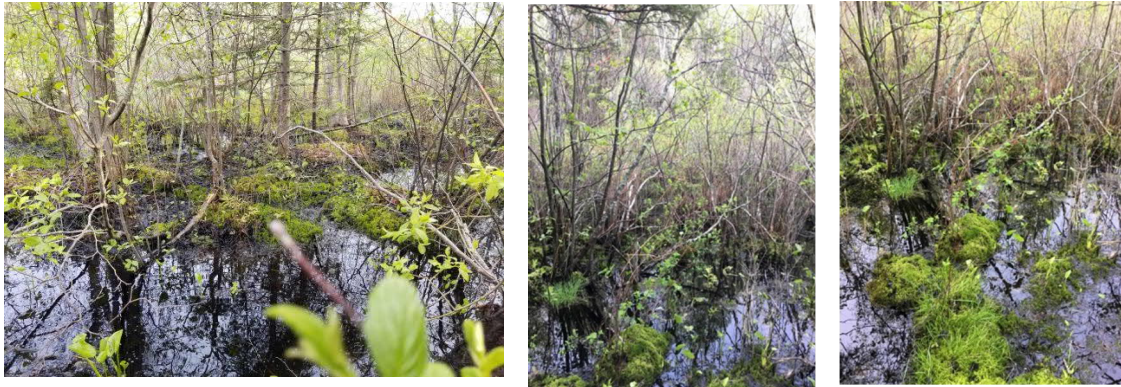
WL-11-2019 – June 4, 2019

The shrub swamp area is likely subject to seasonal flooding and exists along the upper edges of the shallow marsh and tended to become the dominant wetland condition with increasing distance from the impounding roadbed. These areas tended to be dominated by a shrub overstory of speckled alder and mountain holly (*Nemopanthus mucronatus*), however, some tree species do persist including American

larch, gray birch, and red maple. Dominant herbaceous species included sensitive fern, soft rush, and fowl manna-grass. This shrub swamp condition continues eastward and outside the pipeline route. No priority or sensitive species were identified in WL-11-2019 during the wetland assessment nor the plant surveys conducted within the wetland.

There were no channelized input flows observed flowing into the area of WL-11-2019 that was assessed, however, multi-branched internal channels were noted and suggest a channelized input likely exists off-site and to the east. This hydrological input from the east combined with ditch flows are the wetland's primary sources of hydrology. WL-11-2019 outflows via a concrete culvert flowing north-west and into a larger wetland area on the opposite side of Highway 106 (referred to as WL-12A in EARD).

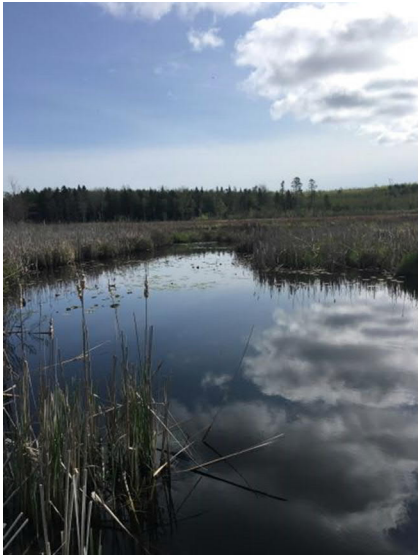
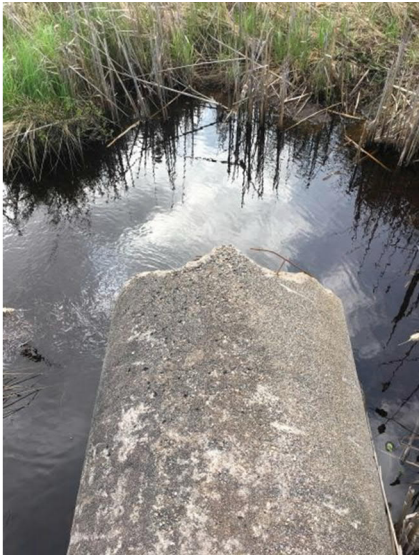
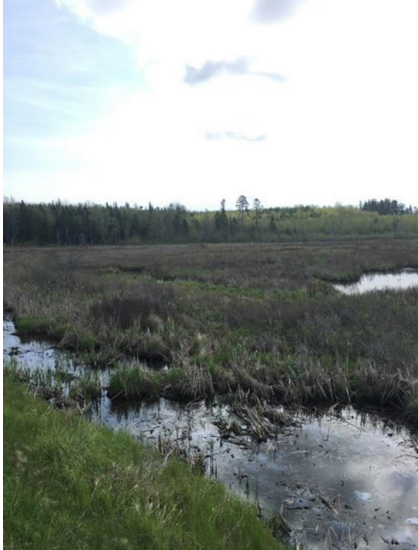
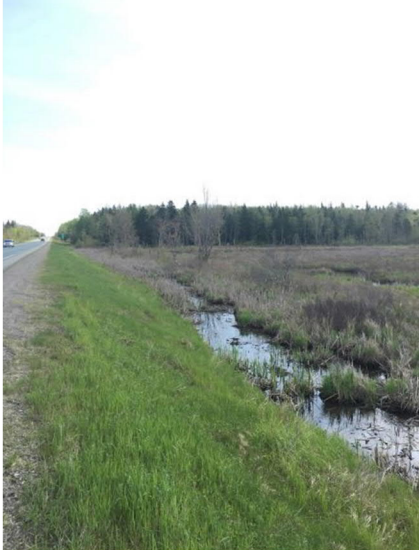
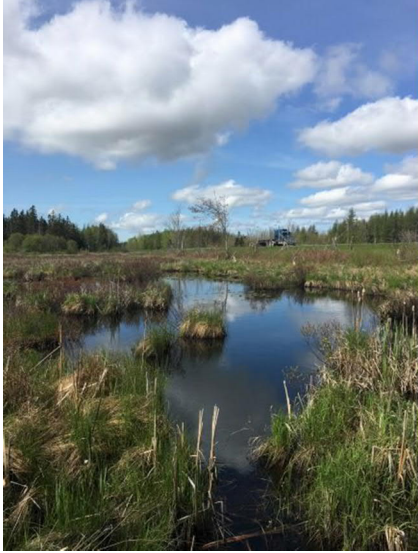
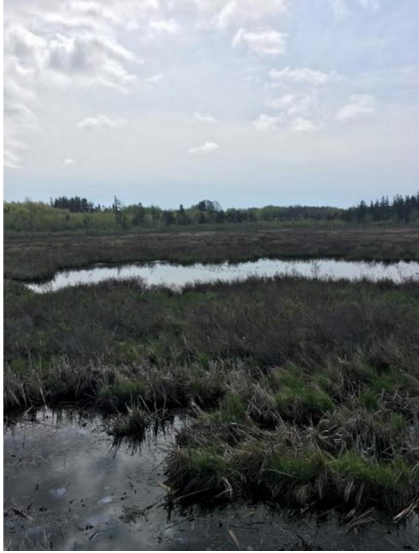
WL-13 – June 4, 2019 (WC13 passes through WL-13)

There were no channelized input flows observed flowing into the area of WL -13 that was assessed, however, the aforementioned multi-branched internal channel suggest a channelized input likely exists off-site and to the east. This hydrological input from the east, combined with overland runoff from the surrounding landscape, are the wetland's primary sources of hydrology. WL-13 outflows via a concrete culvert at its most southerly edge and flows westward under Highway 106 and into another large wetland area on the opposite side of Highway 106 (referred to as WL-12B in EARD), before the confluence with Mill Brook.

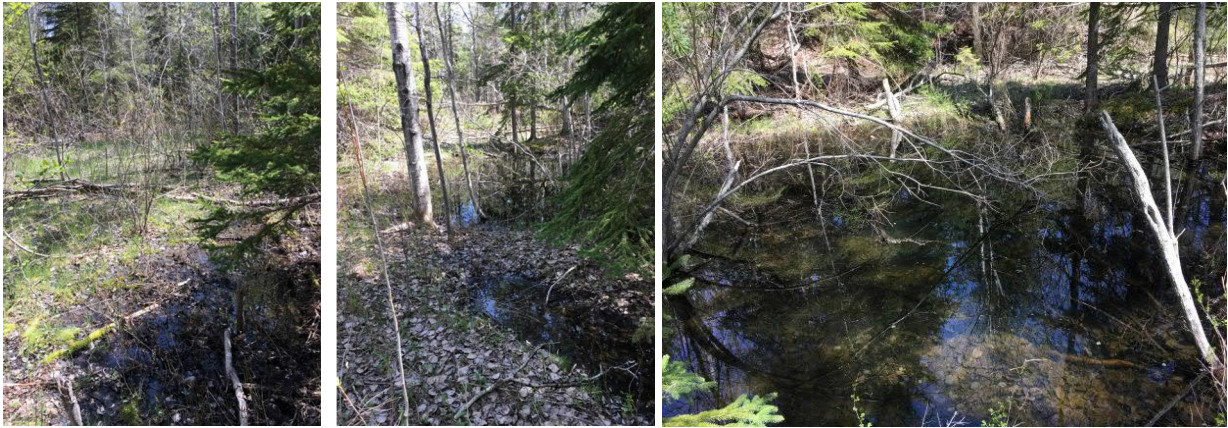
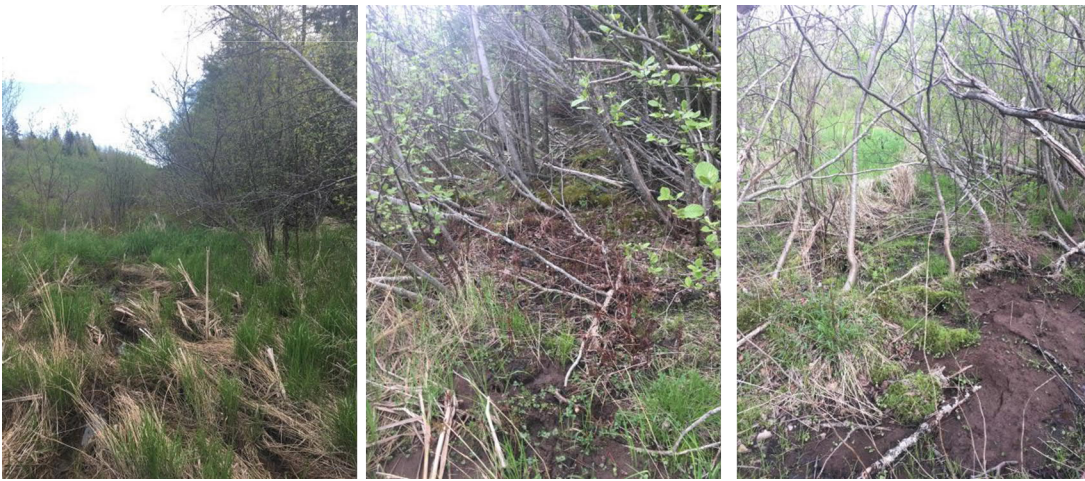
WL-13B – June 5, 2019

Ditch flow from the north combined with a loosely channelized input flow originating at the toe-of-slope of a nearby mowed agricultural field appear to be the primary sources of hydrology for WL-13B. The outflow location for WL-13B becomes channelized (Watercourse WC13B) and exits via a culvert flowing westward and under Highway 106 into a larger wetland (referred to as WL-12B in EARD) that eventually feeds Mill Brook.

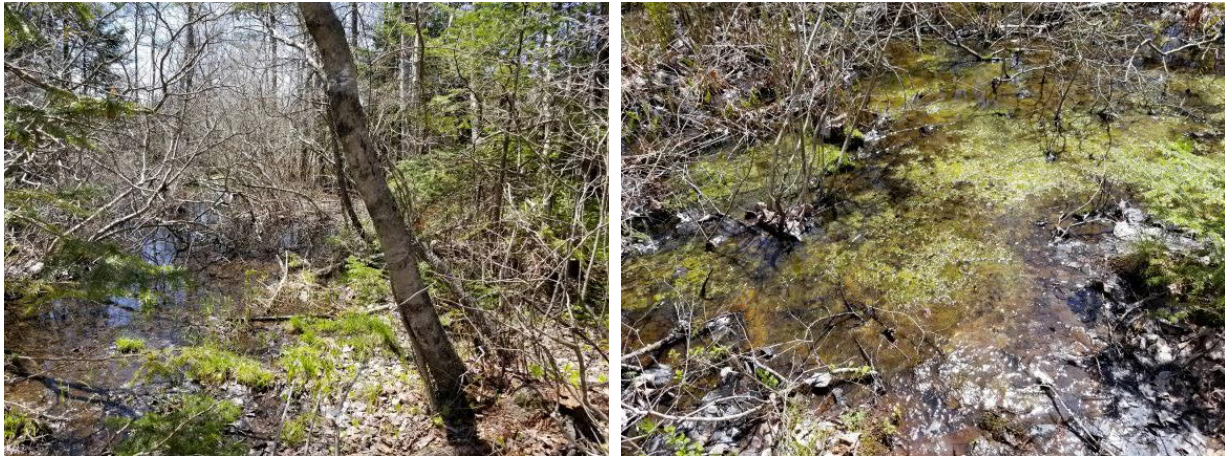
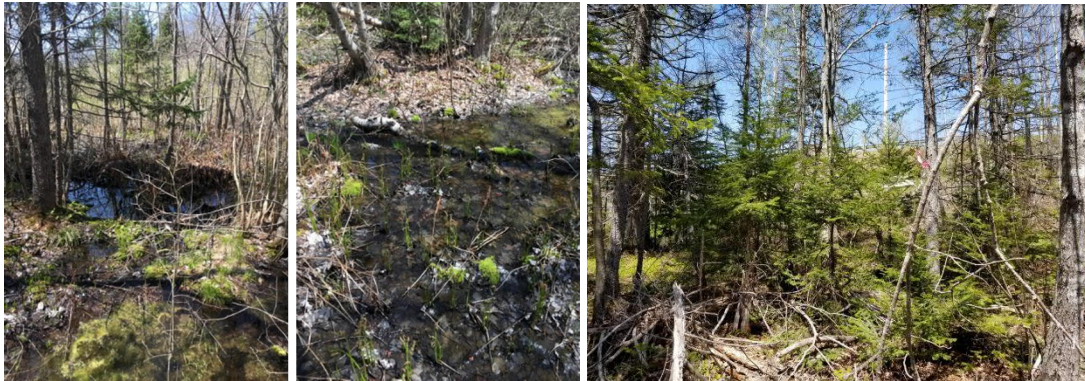
WL-19 – May 28, 2019

A loosely channelized input, originating from the ditch of the elevated section of Central Caribou Road, located to the east of WL-19, appears to be the primary source of hydrology for this wetland. The only apparent outflow location for WL-19 is the Highway 106 ditching flowing southward and joining WL-10, although this likely only occurs during high flow events.
