NORTHERN PULP NOVA SCOTIA

Fish Habitat Survey

Focus Report – Replacement Effluent Treatment Facility

Appendix Focus Report Item 7.1 Freshwater Fish and Fish Habitat

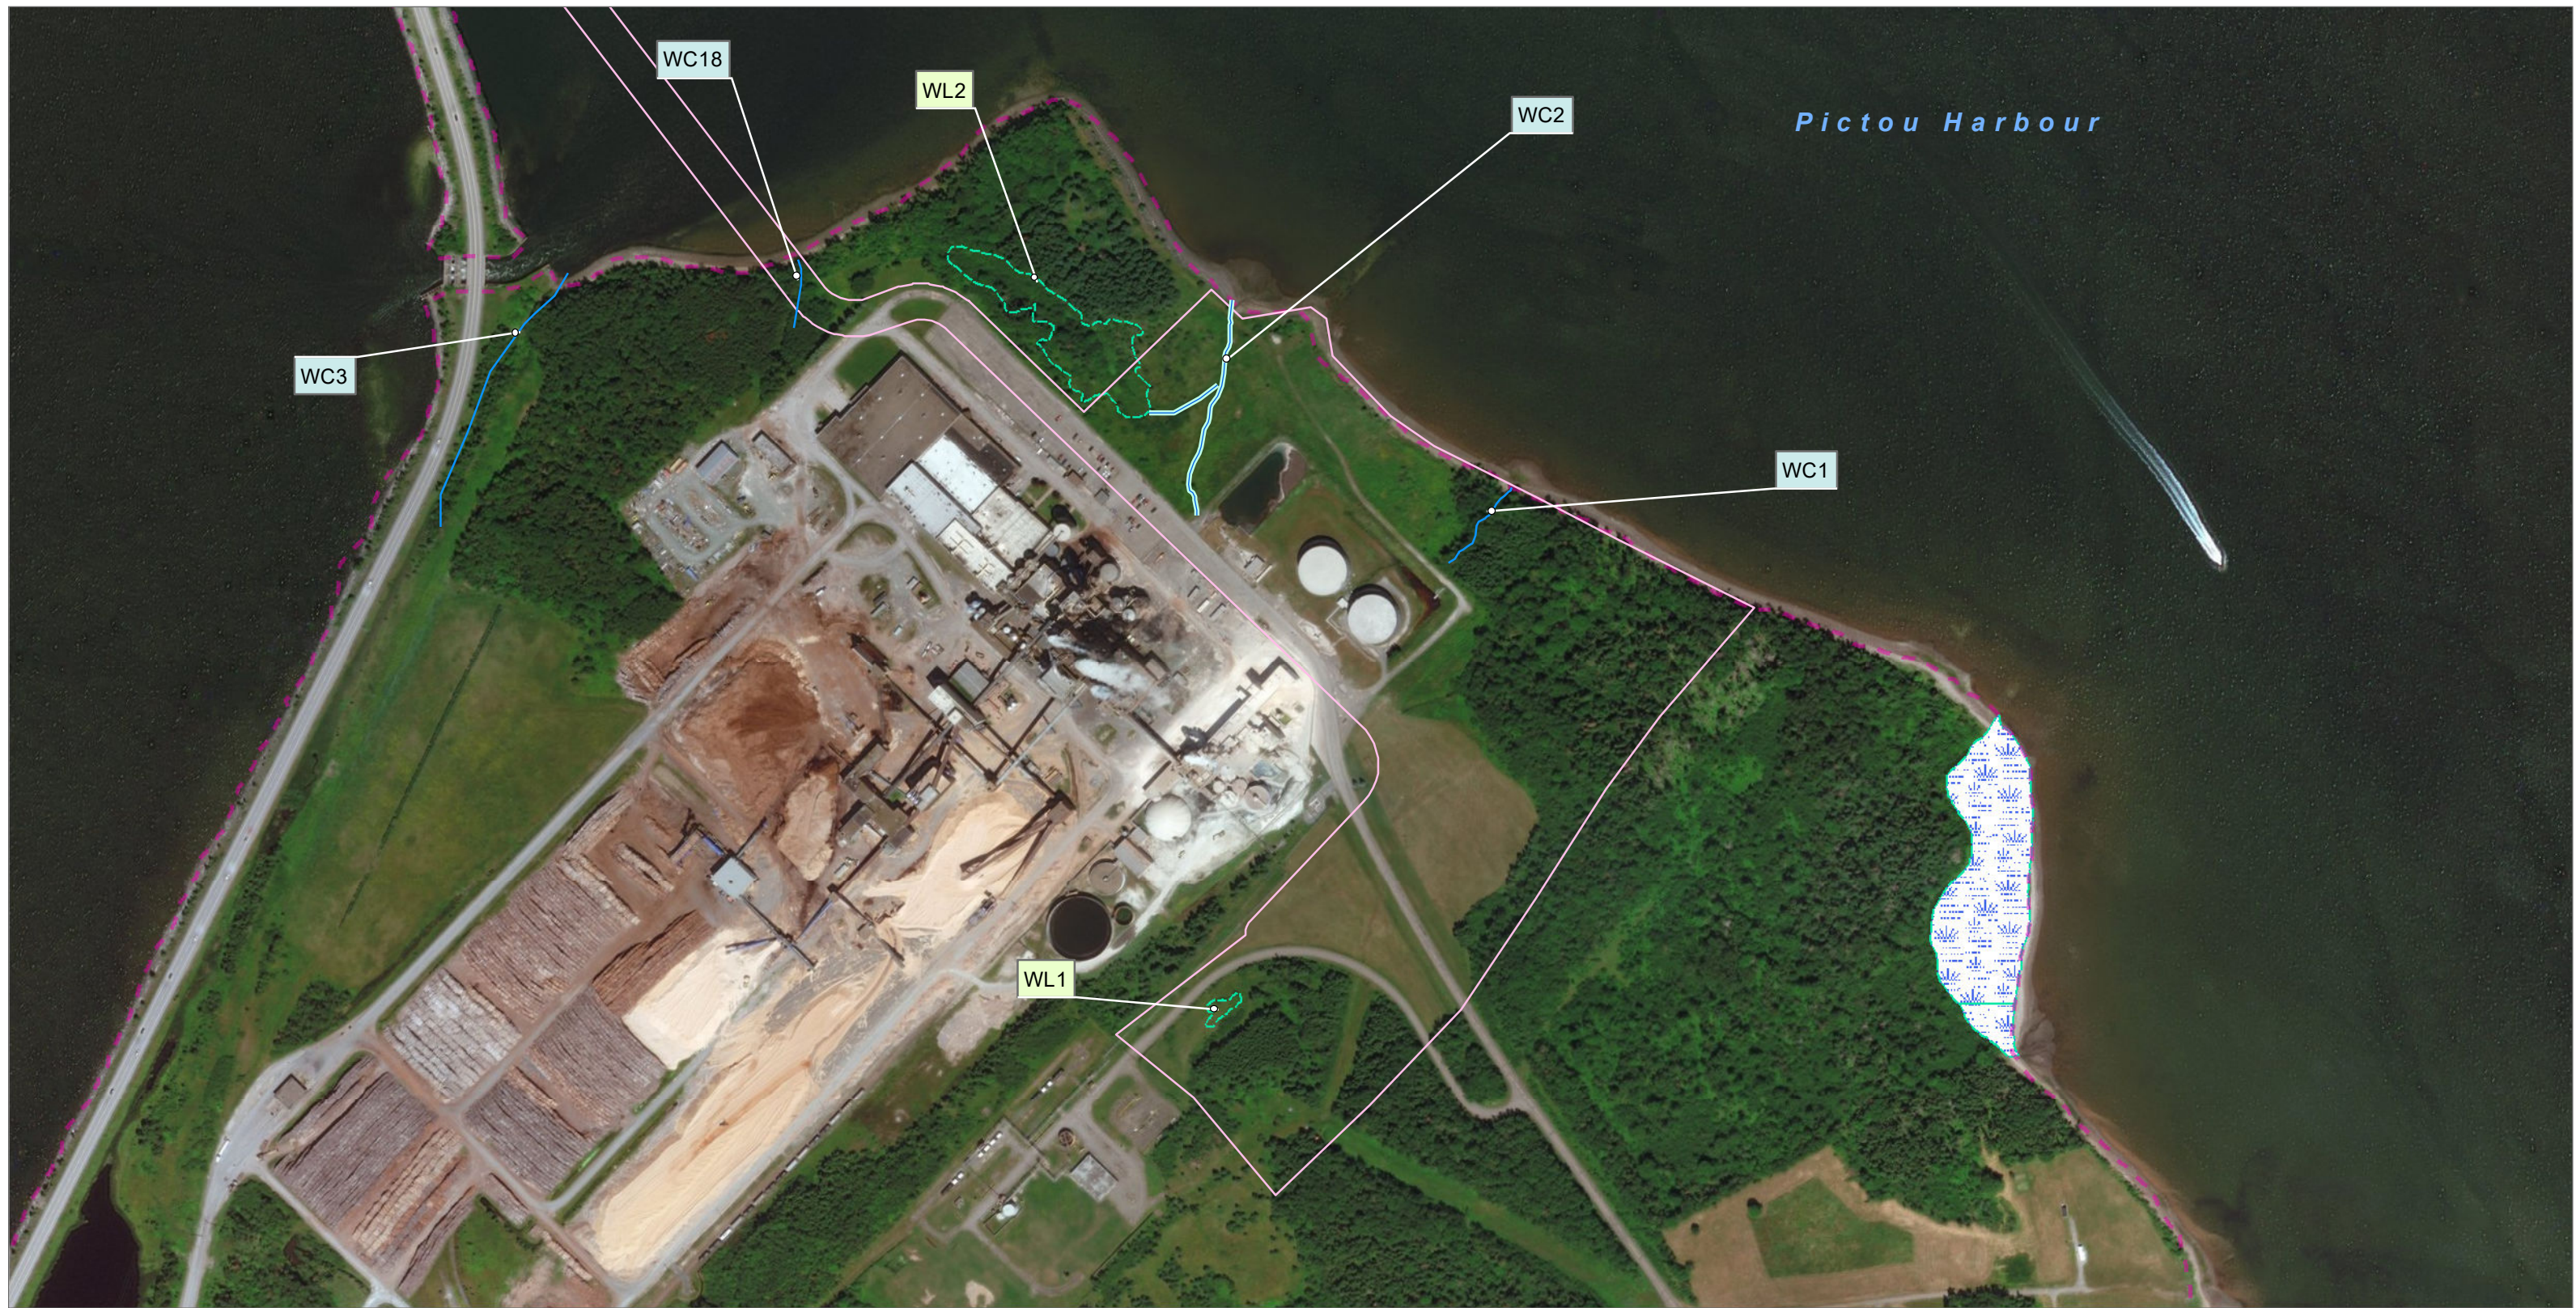
Watercourses in the Proposed ETF Area
 Figure A7.1-1A

Watercourses encountered at the proposed ETF property and along the proposed re-aligned pipeline route are shown in Figure A7.1-1. Freshwater watercourses encountered are small, intermittent to permanent drainages, ranging from less than a meter to over 10 m in width. Typical freshwater watercourse depths range from 0.05 m to over 1 m (the deeper watercourses were often in wetland areas). Many of the watercourses are associated with wetland habitat (Refer to Focus Report Section 5.1, and noted on Figures A7.1-1a and b).

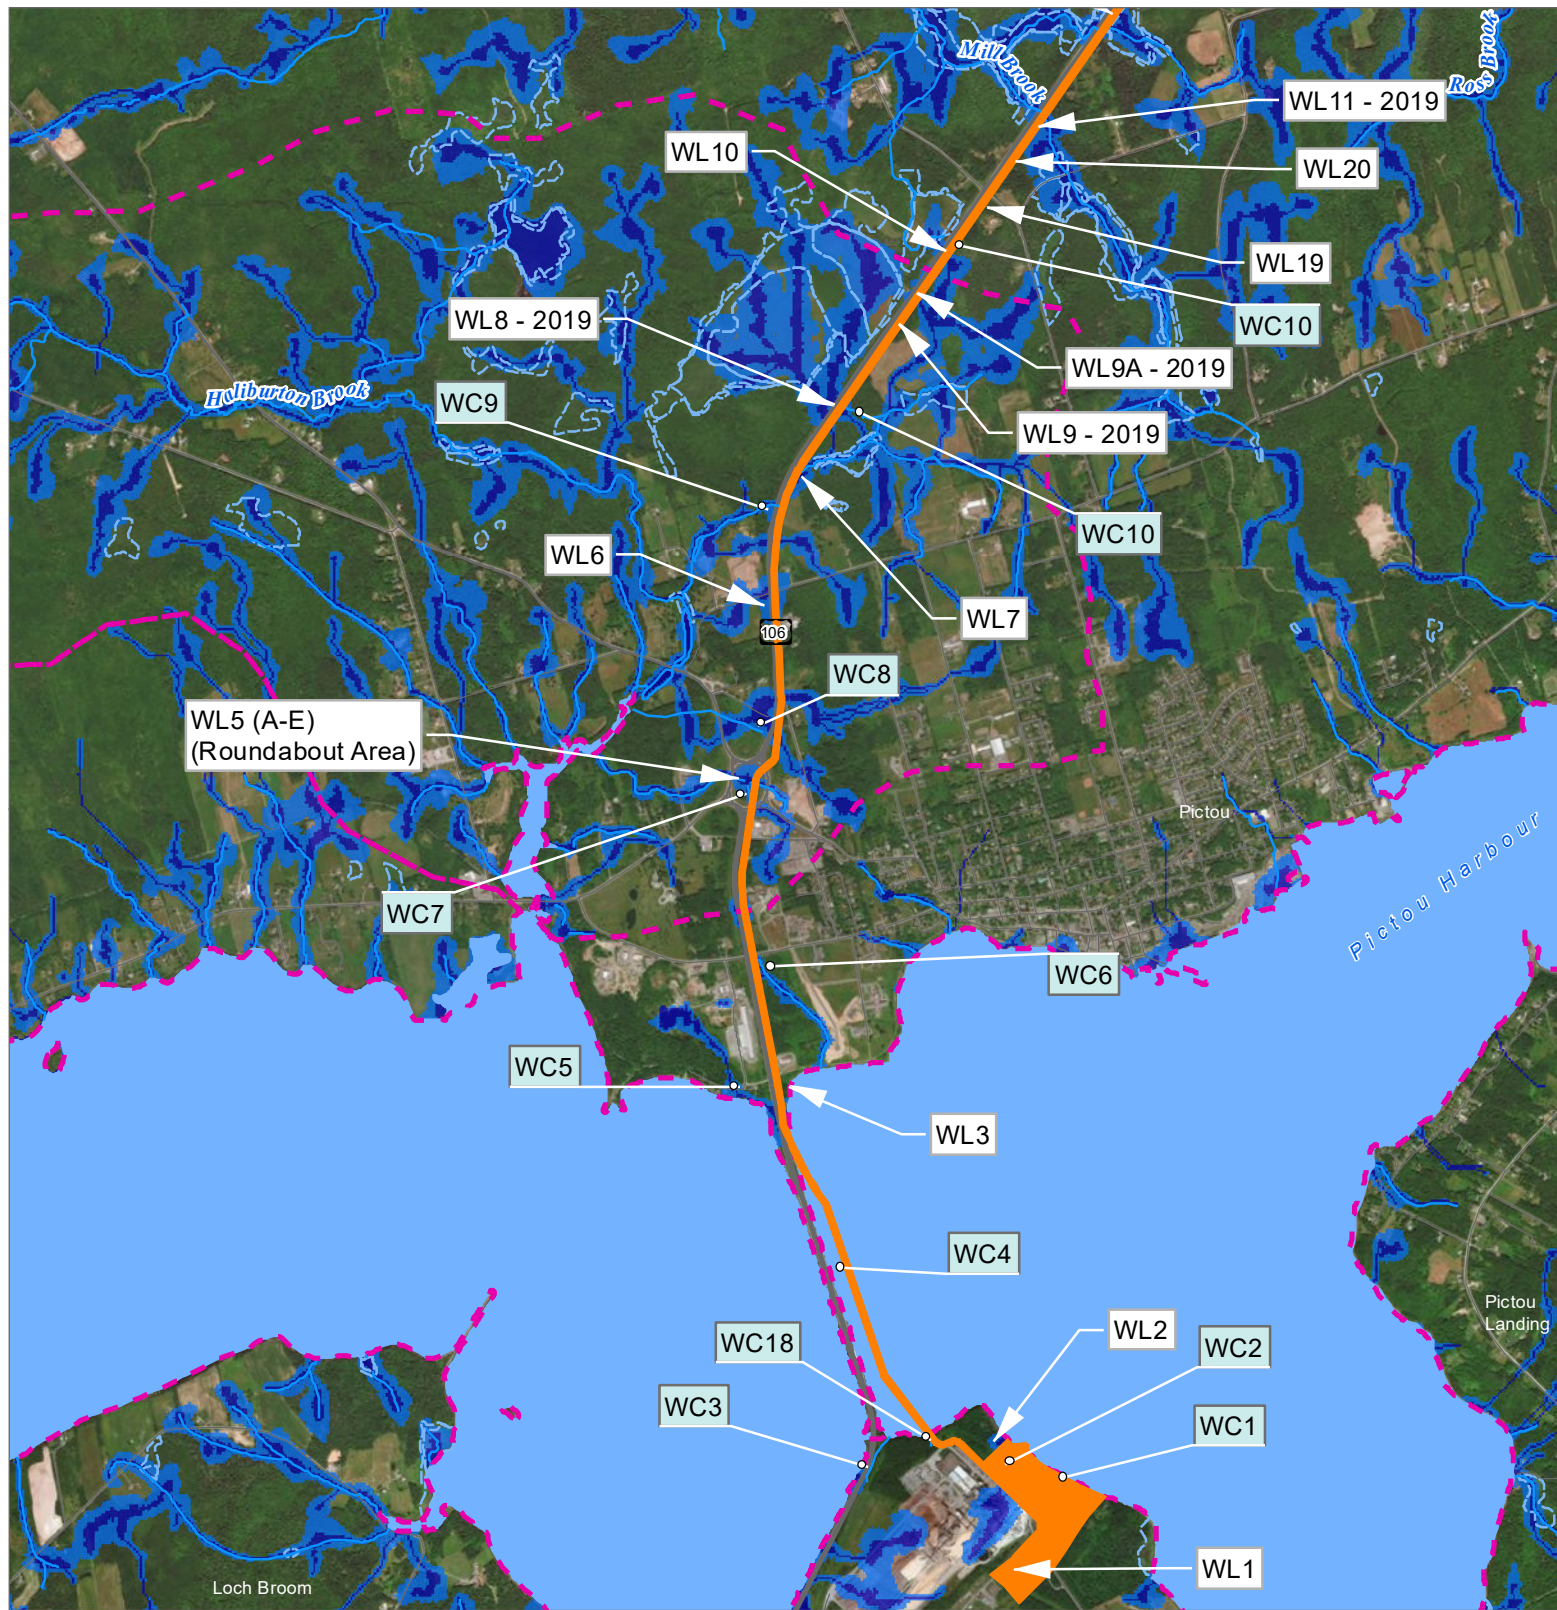
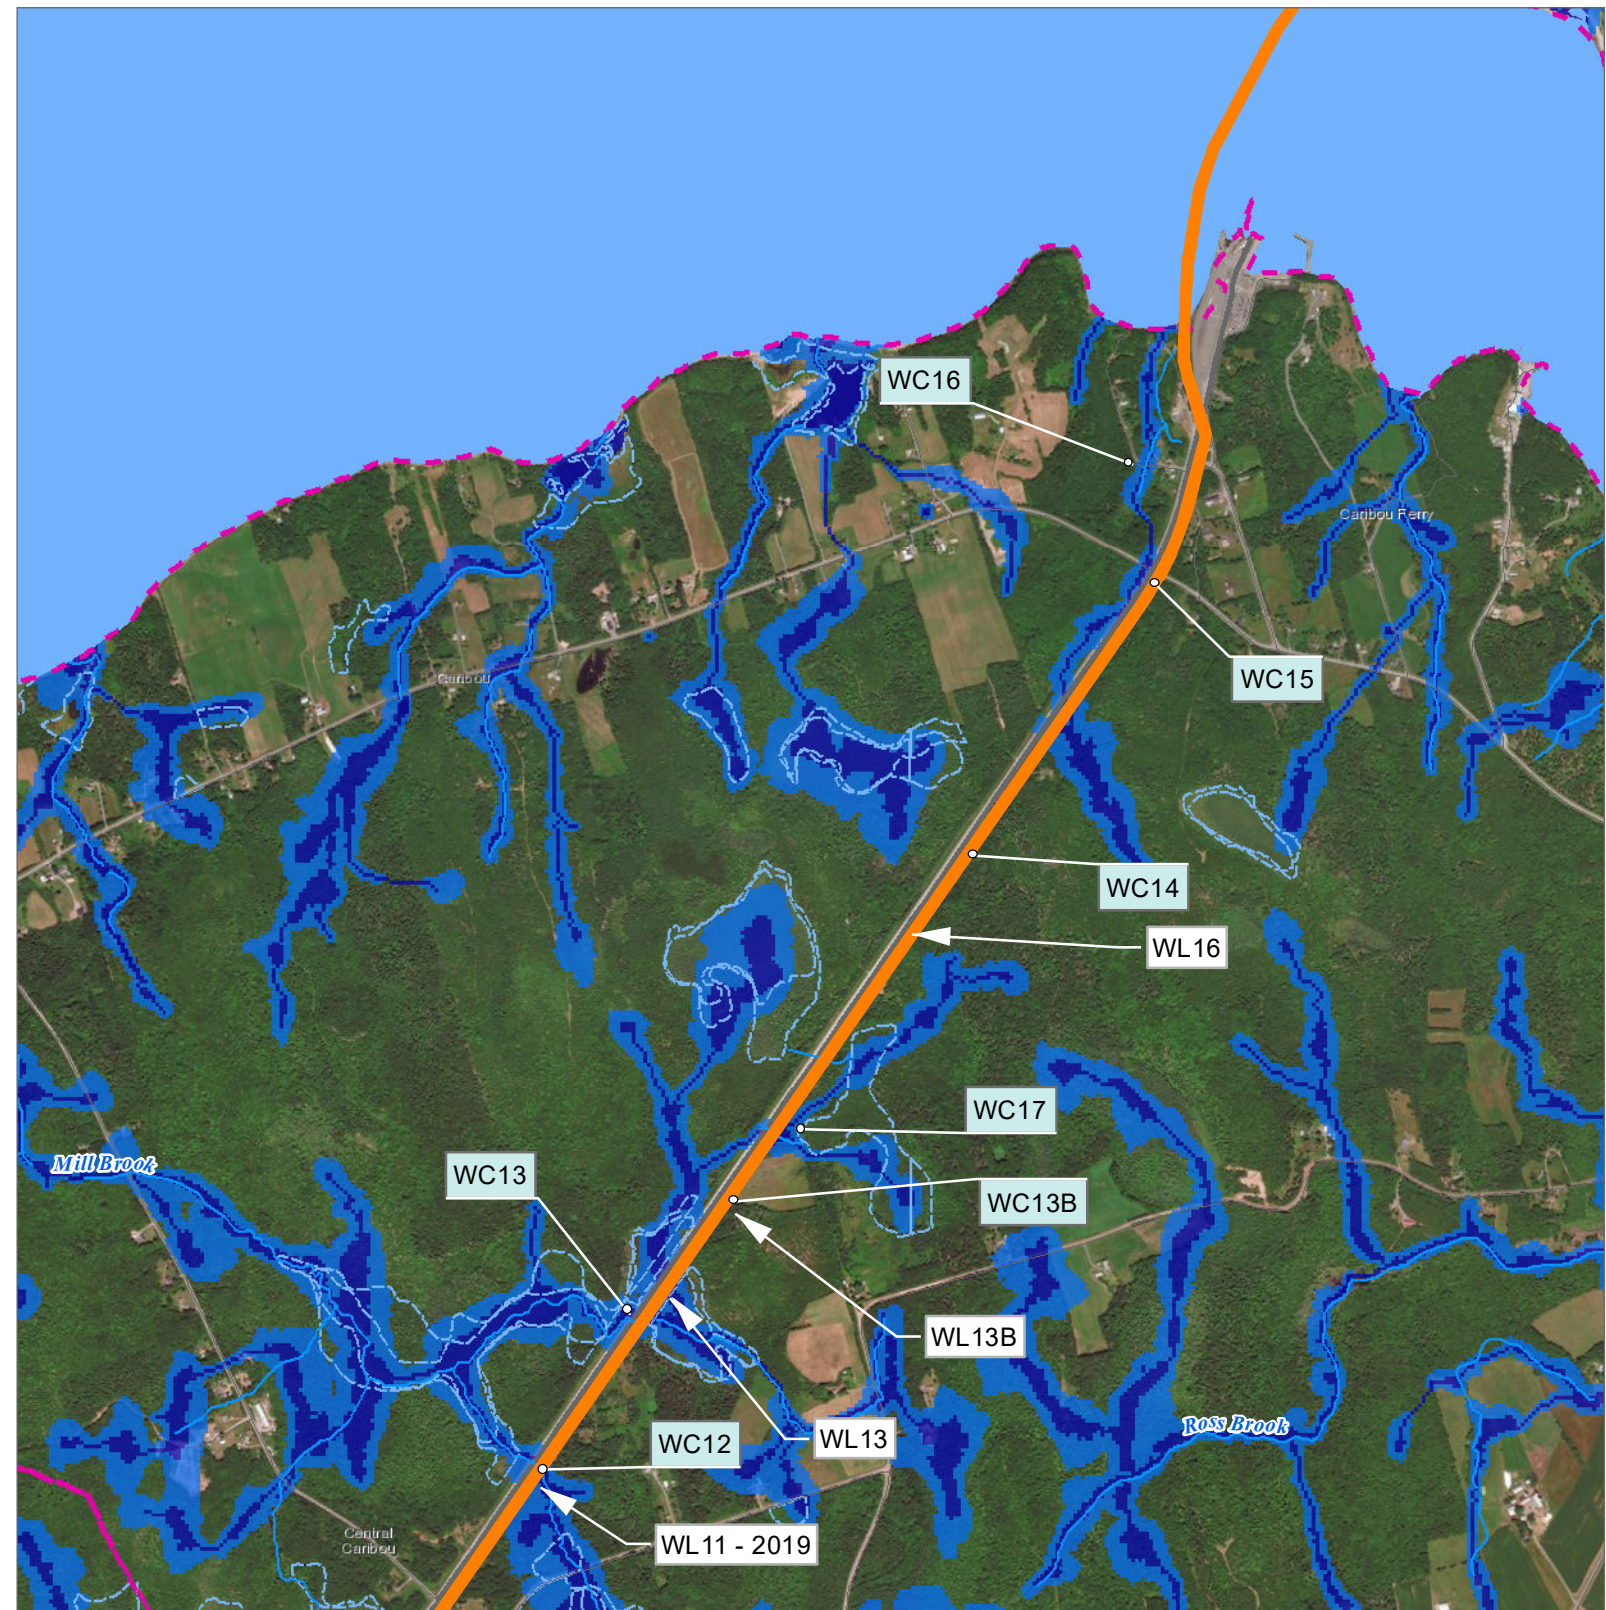
**Watersheds and Depth-to-Water-Table
 Derived Flow Paths
 Figure A7.1- 2**

Figure A7.1-2 illustrates the larger watersheds and potential flow paths as derived from Depth-to-Water Table mapping. Watercourses within the local assessment area near the ETF footprint area flow directly into Pictou Harbour. Watercourses along the approximate pipeline footprint area include those flowing directly to:

- The Pictou Harbour estuary (WC01 to WC03, WC05, WC06 and an additional small drainage WC18 observed in June 2019);
- The Caribou Harbour of the Northumberland Strait (WC15 and WC16);
- Freshwater sub-watershed Haliburton Brook flowing to the West River estuary portion of the Pictou Harbour (WC07 to WC11); and
- Freshwater sub-watershed Mill Brook flowing to the Northumberland Strait (WC12 to WC14, and WC17 flowing into WC13).

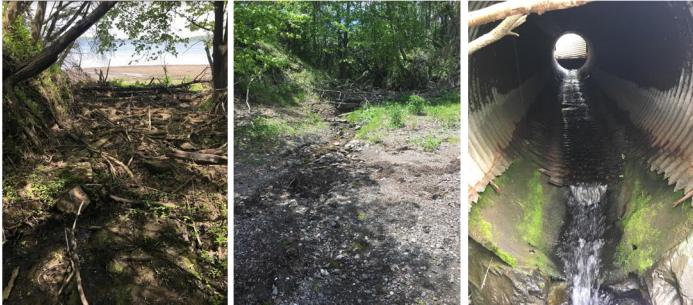
Reason Watercourse Deemed Not Fish Habitat at the Project Location	Photos
<p>WC01</p> <ul style="list-style-type: none"> • There is a pile of debris and at the mouth of WC01 prevents anadromous access. • A hanging culvert makes passage unlikely for fish. • The upstream areas of the watercourse are ditched for site drainage. • Upstream is dry seasonally.

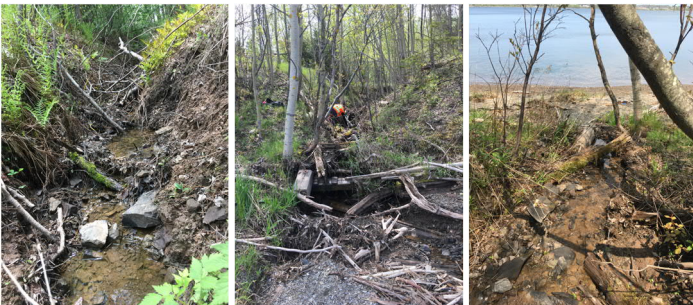
<p style="text-align: center;">June 12, 2018 June 3, 2019</p>
<p>WC18</p> <ul style="list-style-type: none"> • Steep, seepy drainage from the NPNS site. • Choked with wooden debris and very shallow • Photos: June 3, 2019

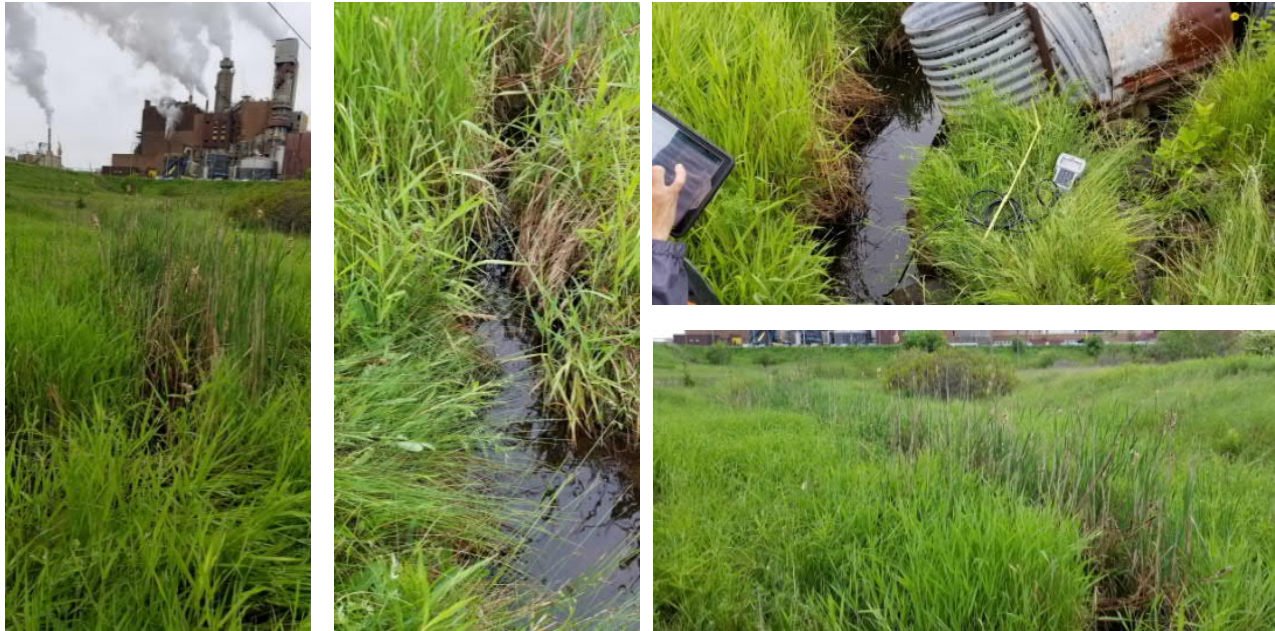
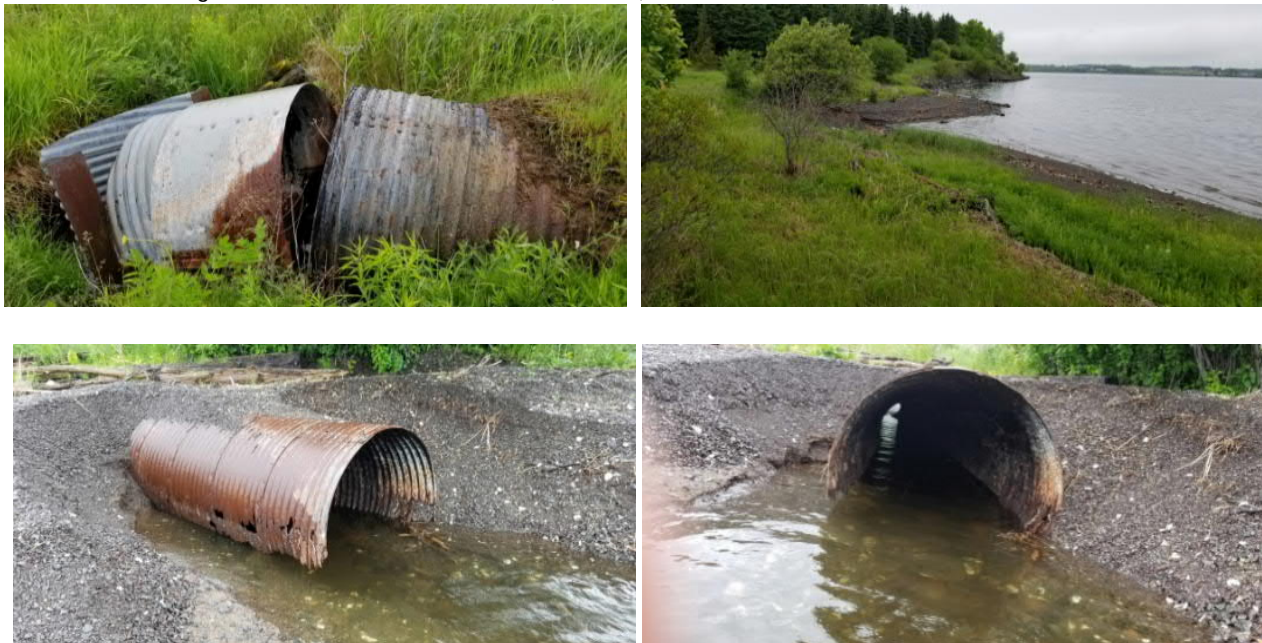
Fish Habitat Photo Plate 1 WC02 – June 2019

WC02 is a small, semi-permanent watercourse that originates in a wetland (WL-2), but also receives storm drainage from a concrete culvert that collects flow from the pressure relief drain on the raw water intake pipe to the mill. This flow is intermittent and occurs only about 5-6 times per year. Historically, this watercourse drained the NPNS car wash area. WC02 also receives a channelized drainage input and underdrain culverts from the parking area located on the north side of the NPNS facility. This narrow, incised channel was assessed as fish habitat (October 2017 and June 2018).

WC02 was at a mid-level water stage at the time of the June 2018 and June 2019 assessments. The channel pattern both within WL-2 and downstream of the storm water discharge from the NPNS facility was observed as sinuous. The morphology of this watercourse consists primarily of runs and small pools; however, much of the channel is encroached on by emergent vegetation such as cattails (*Typha* spp.), rushes (*Juncus* spp.), and blue flag iris (*Iris versicolor*). The substrate is dominated by gravels (70%) with some sand and fines. Patches of boulders and cobbles occur throughout and the amount of fines increase upstream as the watercourse approaches the storm water and wetland discharges. Both the left and right banks are composed primarily of fines and alternated from sloped to undercut (note: right and left bank designations are based on upstream facing perspective). In-stream cover is provided by abundant in-stream and over-hanging vegetation, as well as a moderate amount of bank-undercutting. The average channel and wetted widths in the storm water discharge area was generally less than 1 m. Average measured water depth was approximately 0.1 m; pool depth was 0.3 m in June 2018 and June 2019. WC02's immediate surroundings consist of open grassland with riparian vegetation consisting mostly of herbaceous species such as sedges (*Carex* spp.) and grasses, with cattails, soft rush (*Juncus effusus*), blue flag iris, and goldenrods (*Solidago* spp.) throughout. Nearby woody species are sparse, but speckled alder (*Alnus incana*), sweet gale (*Myrica gale*), willows (*Salix* spp.), and roses (*Rosa* spp.) are present in the area and increase in coverage within WL-2. Shade (cover) provided by both herbaceous and woody vegetation was estimated at approximately 50%.

The aquatic habitat of WC02 had limited potential for brook trout (*Salvelinus fontinalis*) spawning, with low but sufficient flow, access to upstream habitat and access to the marine environment. Although a corrugated metal culvert with a backwater detention feature is present, it does not currently prevent access to the watercourse from the marine environment at high tide. Within the upper reaches of WL-2, potential rearing habitat was present, owing to good cover and back eddies observed. Overwintering habitat was lacking due to insufficient depth. Storm water flow may reduce freezing conditions. Electrofishing in June 2019 captured ninespine stickleback (*Pungitius pungitius*). Stickleback habitat is anticipated throughout the watercourse.

Upstream of marine culvert, downstream of Wetland 2

Culvert entering Pictou Harbour and coastal (marine) area

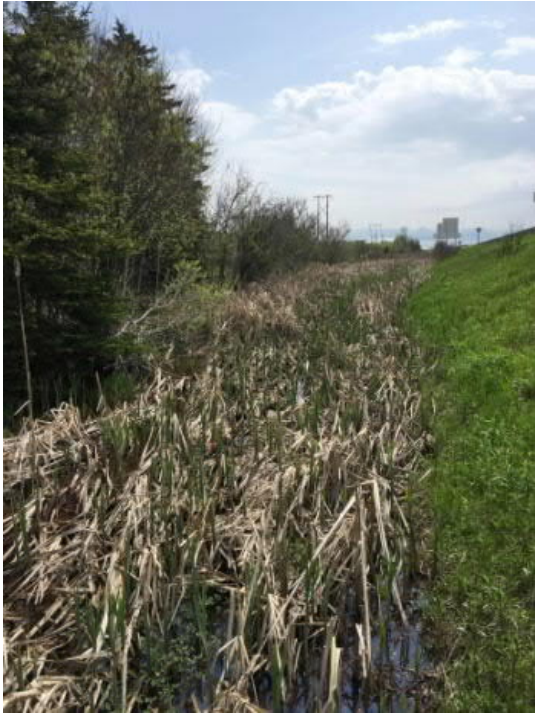
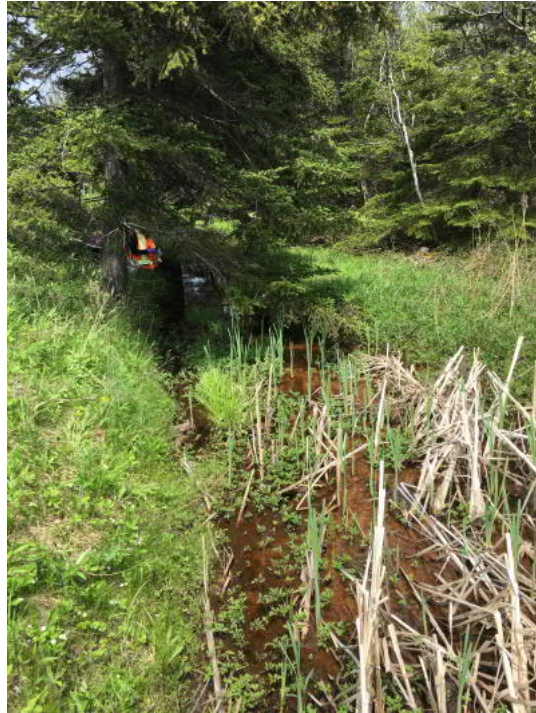
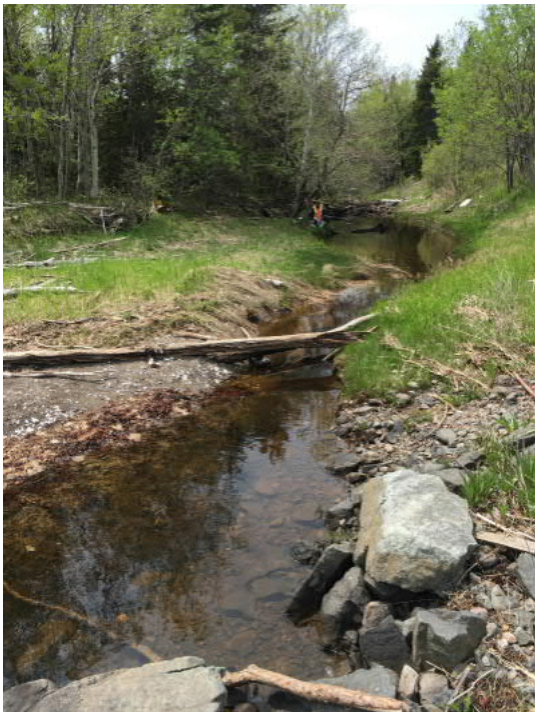
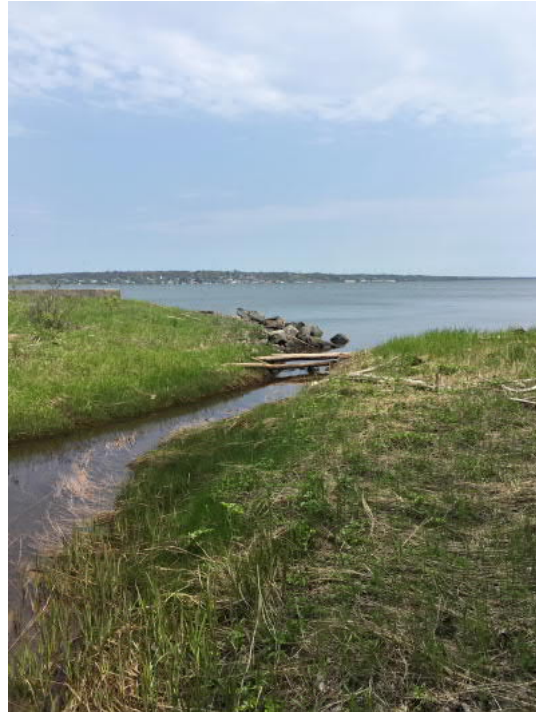
Fish Habitat Photo Plate 2 WC03 – June 2019

WC03 is an unnamed tributary to the Pictou Harbour. WC03 has a defined channel and is comprised of an ephemerally flowing ditch along the east side of Highway 106 draining an upstream ponded area and receiving drainage from the NPNS property, a short channel within the wooded area between the NPNS property and Highway 106, and a tidally influenced channel at East River/Pictou Harbour estuary. When flowing, water flows northeast along a steep channelled watercourse which runs down slope towards the Pictou Harbour collecting debris and suspended sediments. The upstream ponded area adjacent to Highway 106 has potential for fish habitat based on size and depth (over 300 m long and over 1 m deep). However, the long cattail-dominated ditch (over 500 m) along with the steep section within the wooded area limits fish passage. It is expected that fish access the lower portion of WC03 during high tides and/or periods of high flow.

WC03 was at a moderate-level water stage at the time of the June 2019 field visit. The morphology of this watercourse consisted primarily of small runs and riffles. Substrate appeared to be composed of small cobbles and fines with a high fines component. Iron flocculent was noted throughout the bottom of the freshwater portion of the watercourse. The banks were generally composed of fines (silts and sand) and are sloped upstream of the tidal section. The ditched portion is dominated by dense cattail development. As the watercourse enters the treed area, the cattail density decreases, but other herbaceous plants increase within shallow areas (e.g., horsetails – *Equisetum* sp., grasses)

Upstream – Ditch adjacent Highway 106 and transition to steep area

Watercourse as enters Pictou Harbour and coastal area (marine)

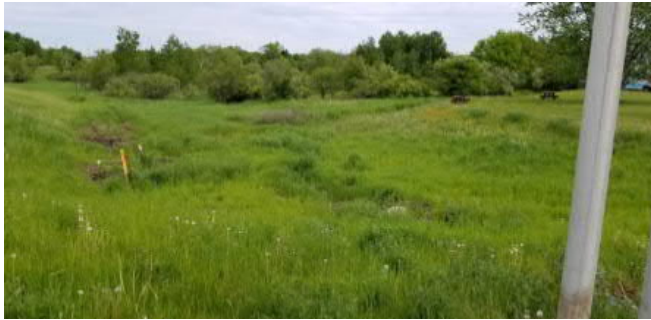
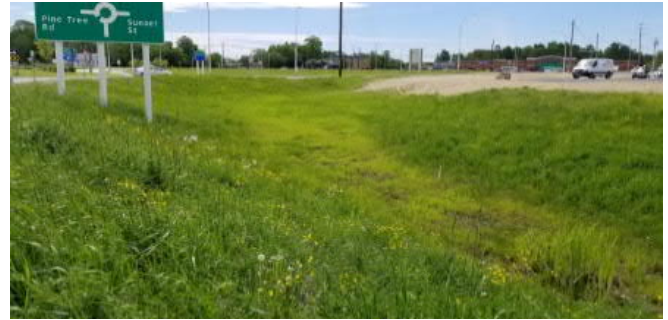
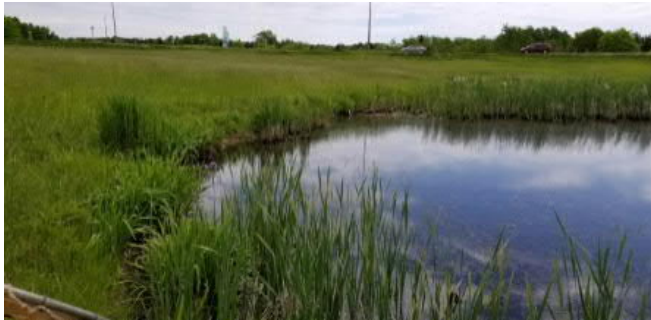
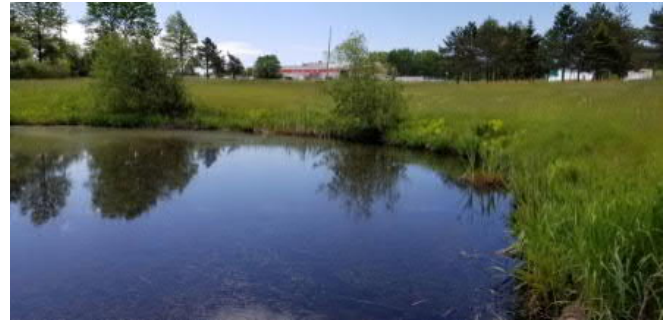
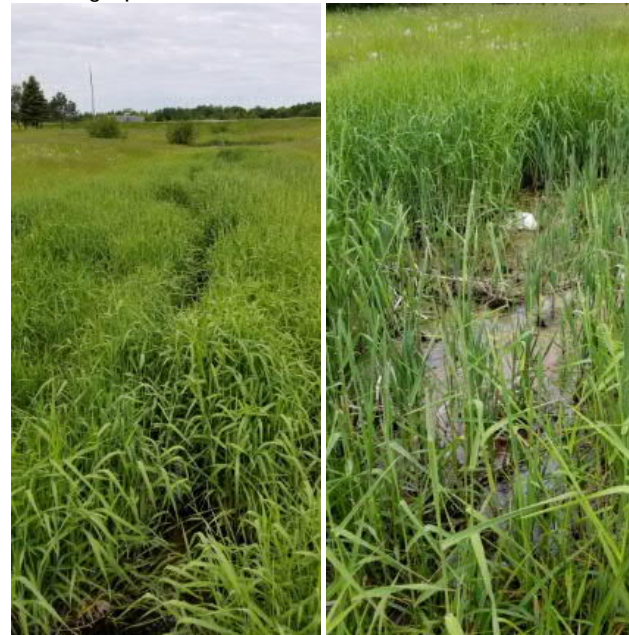
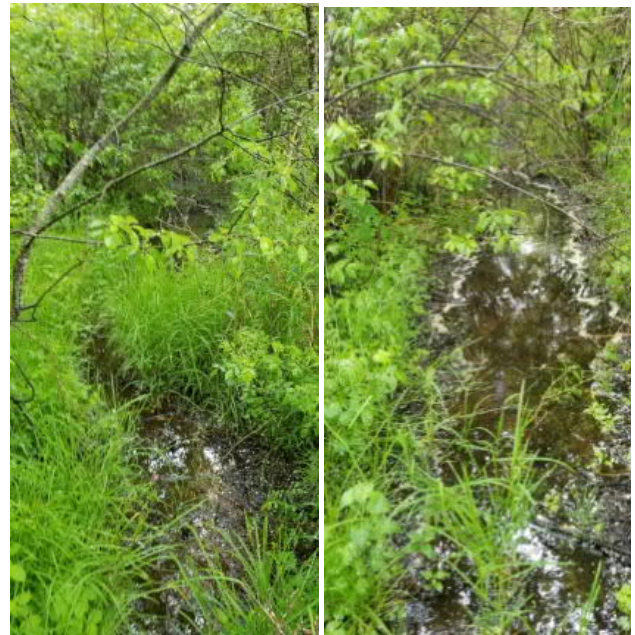
Fish Habitat Photo Plate 3 WC07 – June 2019

Ditching upstream of the roundabout

Roundabout "Pond"

Ditching upstream and downstream of "Pond"

Shrub wetland downstream of roundabout

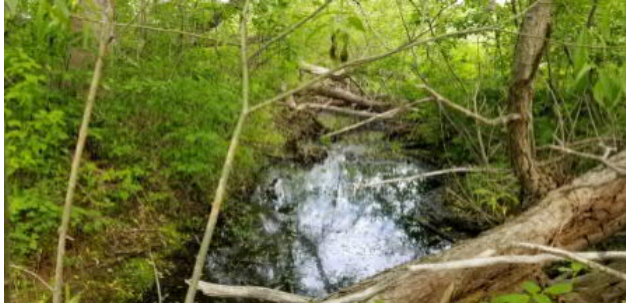
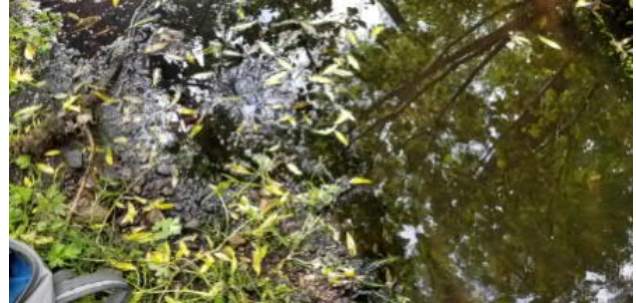
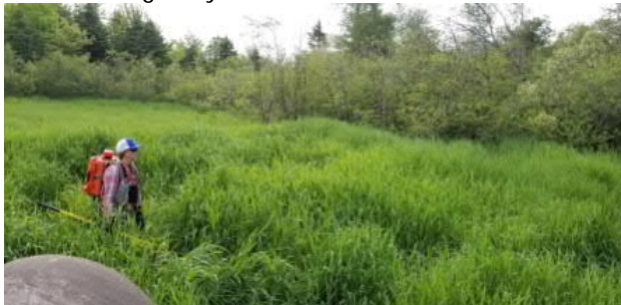
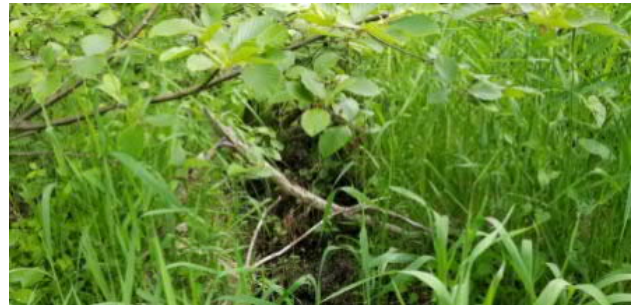
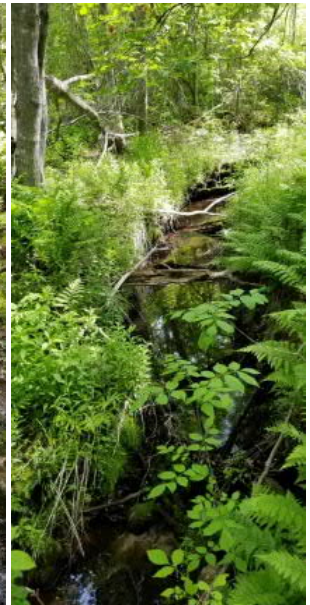
Fish Habitat Photo Plate 4 WC08 – June 2019

Downstream of Route 6, fish habitat characteristics improved and riffle habitat increased. The substrate included rock (20%), cobble (30%), gravel (20%), sand (20%), and fines (10%). Both banks were present and composed primarily of fines. Some bank-undercutting was observed. In-stream cover was abundant, consisting of small woody debris. Bank cover included herbaceous ferns and grass and overhead cover was up to 40% comprised of mixed wood forest.

Upstream of Highway 106

Between Highway 106 and Route 6

Downstream of Route 6

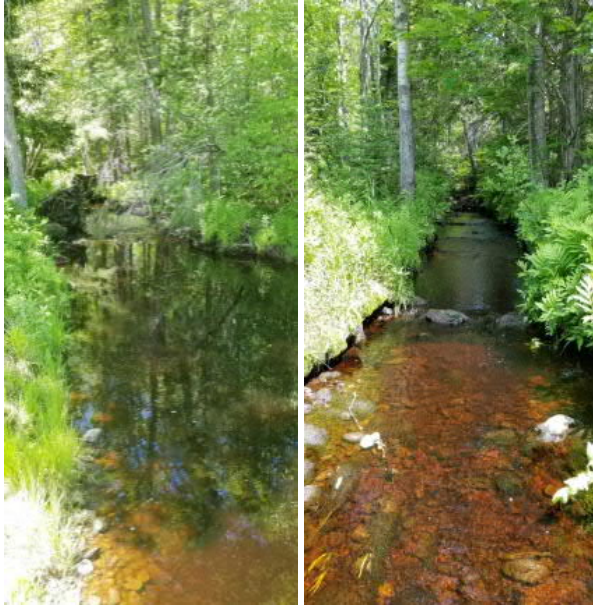
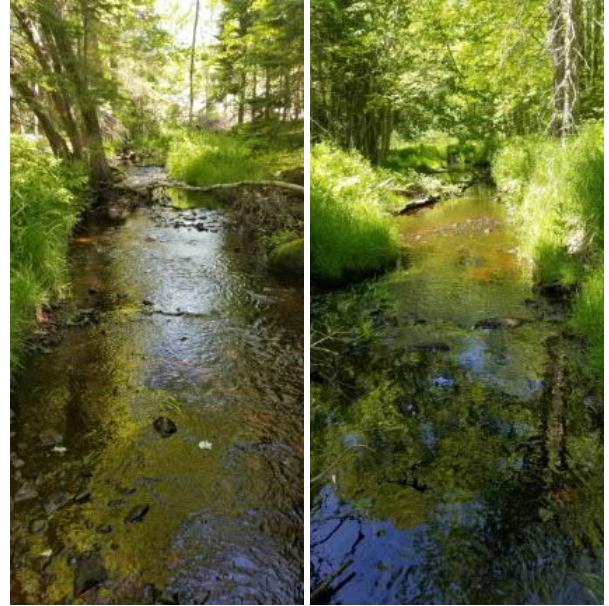
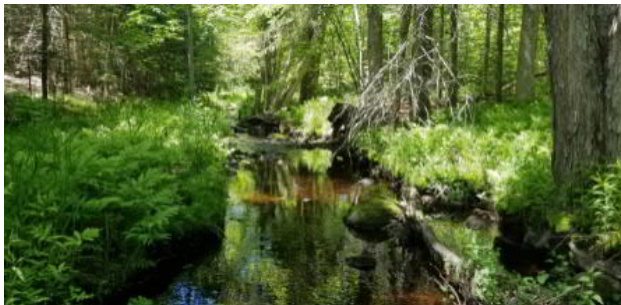
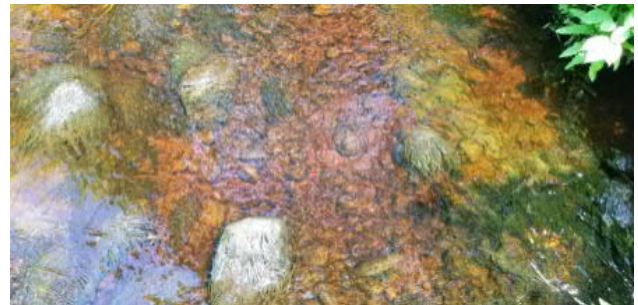
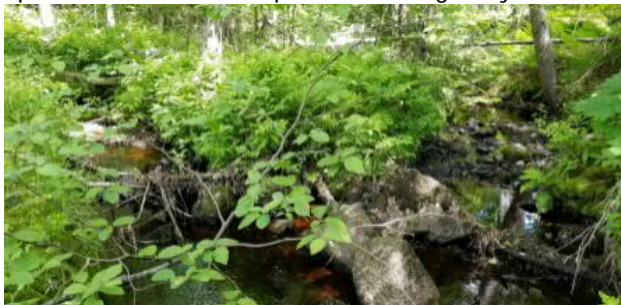
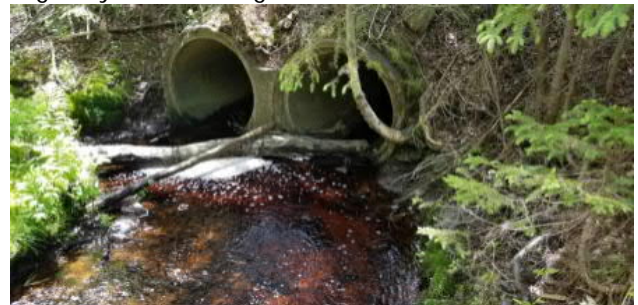
Fish Habitat Photo Plate 5 WC09 – June 2019

WC09 was at a moderate-level water stage at the time of the June 2019 field visit. The channel pattern observed was sinuous in sections and straight in other sections. Width varied from 1 to 5 m and depth ranged from 0.1 to 0.3 m. The morphology of this watercourse consisted primarily of riffle/run. Substrate in the riffle sections were dominated by cobble (35-40%), gravel (30%), and sand (15-25%), with some rock (5%) and fines (5-10%). Substrate in the run sections were also dominated by gravel

Electrofishing downstream of Highway 106 captured numerous fish: two brook trout, eight common sucker (*Catostomus commersoni*), and two minnow species (dace, *Couesius* sp. and shiner, *Notemigonus* sp.). Overall, habitat for brook trout was good and included rearing and spawning habitat, but no significant pools were observed. Atlantic salmon (*Salmo salar*) juvenile rearing habitat is unlikely but poor habitat is present within the Highway 106 ROW. Potential habitat for other fish species included American eel (*Anguilla rostrata*) adult foraging habitat. It is unknown if obstructions to anadromous fish passage are present downstream, but if passage is possible, potential fish that may travel up the watercourse could include gaspereau/blueback herring (*Alosa pseudoharengus* and *A. aestivalis*) and smelt (*Osmerus mordax*).

Typical riffle/run

Run Substrate

Split channel located upstream of Highway 106

Highway 106 crossing

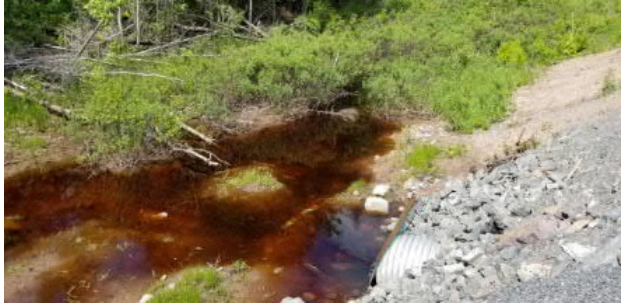
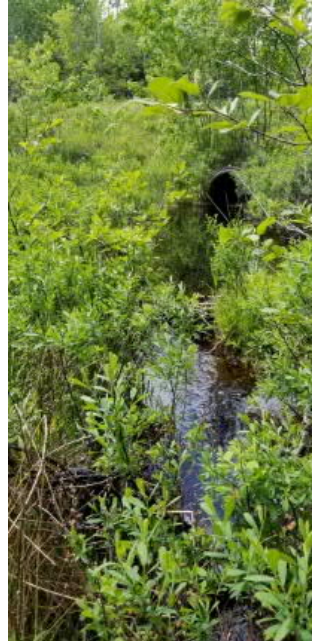
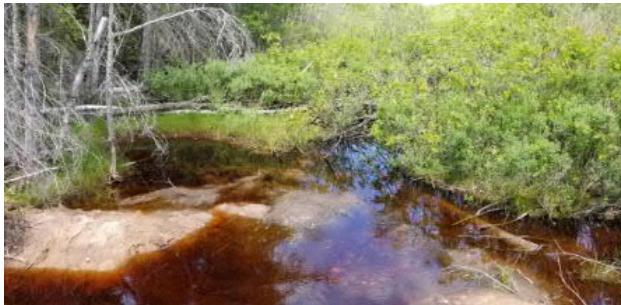
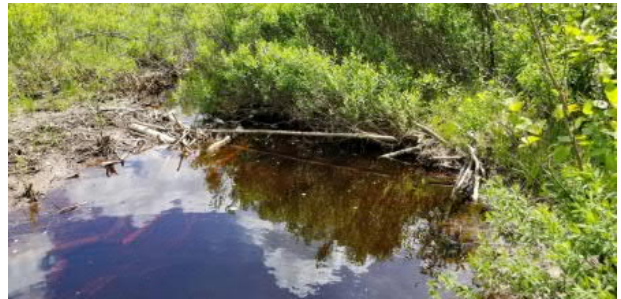
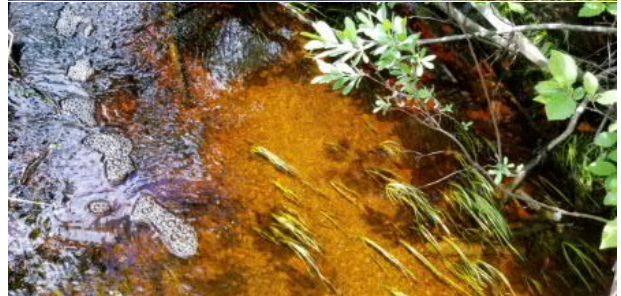
Fish Habitat Photo Plate 6 WC10 – June 2019

WC10 was at a moderate-level water stage at the time of the June 2019 field visit. Watercourse width varied from 2 m where channelized, to 10 m within wetland areas. Water depth varied from 0.1 m to 0.4 m. The channel pattern observed was sinuous. The morphology of this watercourse consisted primarily of run/flat associated with wetland and short runs and small pools. Substrate appeared to primarily consist of cobbles; however, due to the high water riffles (including as a result of beaver debris) visibility of substrate was limited. A large ponded area (i.e., pool) at the culvert outlet occurred downstream of the Highway 106 crossing. Substrate was dominated by sand (50%) and fines (30-40%), with a higher fines component in the culvert pool and minor boulder (<10%), rock (<10%) and cobble (<20%). Bank vegetation reflected the surrounding wetland shrub and grass/sedge cover type, providing up to 20% overhead cover. Minor amounts of in-stream vegetation was present.

Only tadpoles were observed during electrofishing and no fish were captured within the upstream or downstream portion of the Highway 106 ROW in June 2019. Poor potential for seasonal for habitat brook trout and for forage species, such as minnows, was present.

Upstream of Highway 106

Downstream of Highway 106

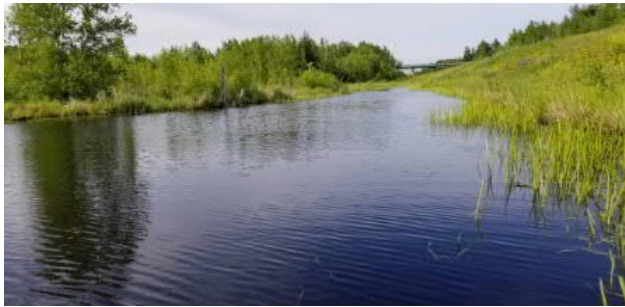
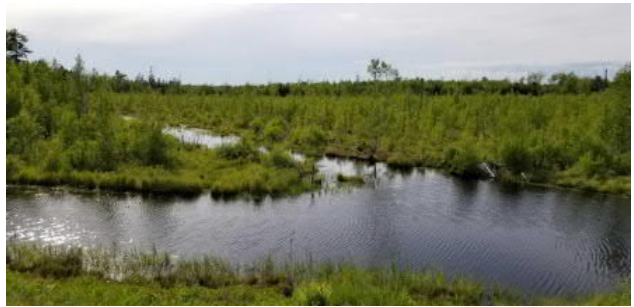
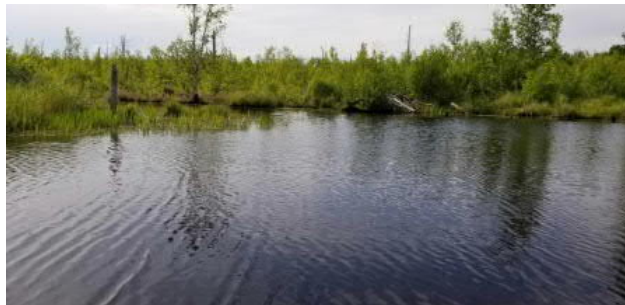
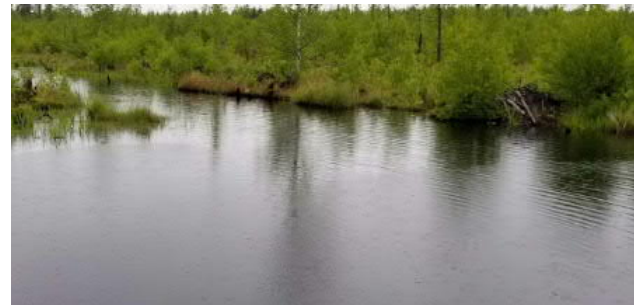
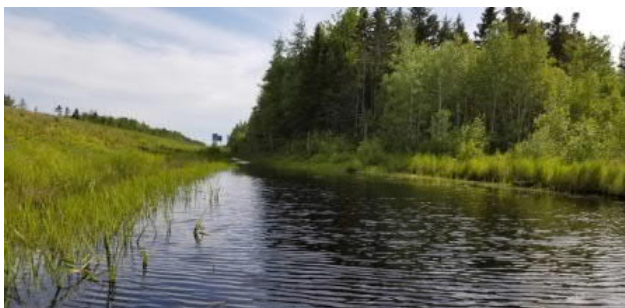
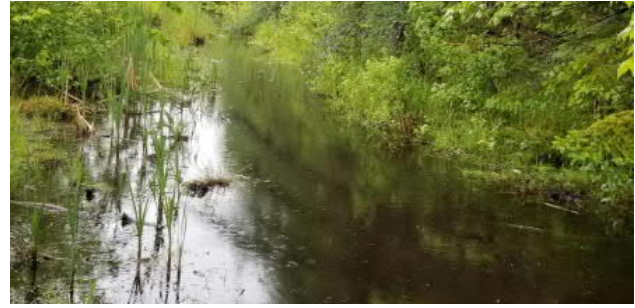
Fish Habitat Photo Plate 7 WC11 – June 2019

No fish were captured or observed in WC11 and only tadpoles were caught during an 8 hour minnow trap set in June 2019. Habitat present for brook trout is considered unlikely within the ROW, but may be seasonal. Access from downstream areas was poor due to the shallow, braided nature of wetland flow paths. Furthermore, both the pH and dissolved oxygen were low, reflecting the stagnant, bog-like wetland conditions. Lastly, a high sediment load was noted in the substrate. However, habitat within the ROW may be suitable for forage fish and eels.

West (Downstream) Highway 106

Looking across wetland habitat and WC11

East (upstream along Highway 106)

Downstream of Highway 106 crossing
