NORTHERN PULP NOVA SCOTIA

Fish Habitat Survey

Focus Report – Replacement Effluent Treatment Facility

Appendix Focus Report Item 7.1 Freshwater Fish and Fish Habitat

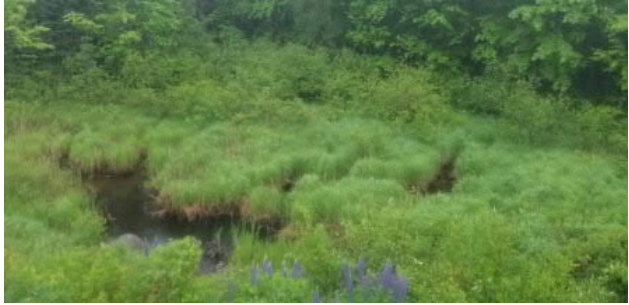
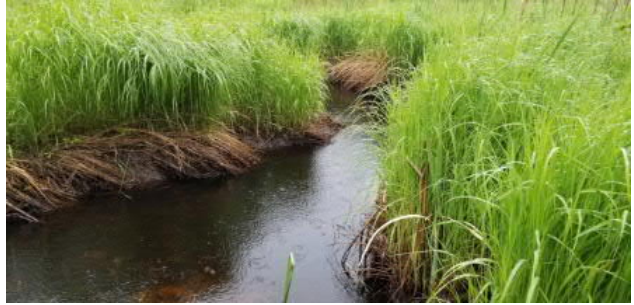
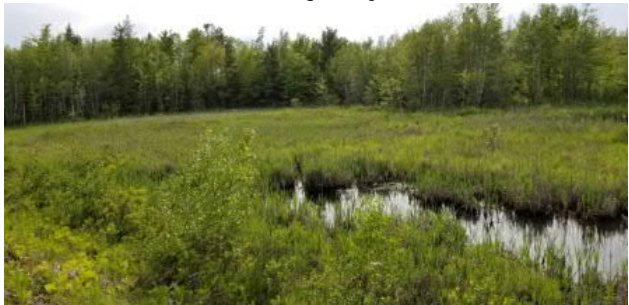
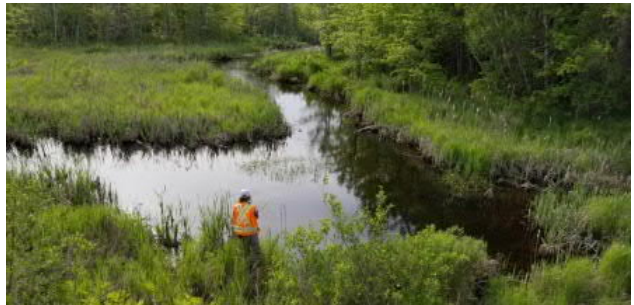
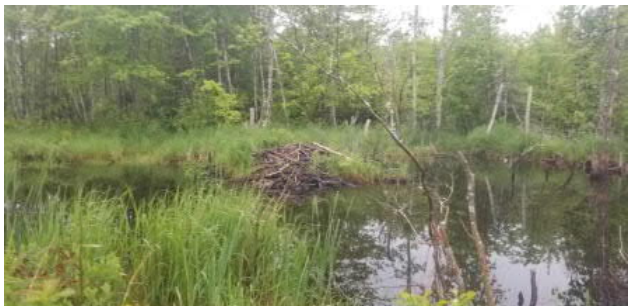
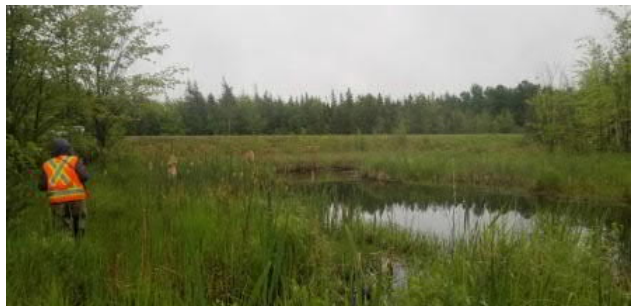
Fish Habitat Photo Plate 8 WC12 – June 2019

Mill Brook (WC12) runs from southeast to northwest and is permanent watercourse in the vicinity of Highway 106. Mill Brook receives drainage from wetlands, forests, and urban land, and eventually discharges to Caribou Harbour over 2 km to the northwest. Mill Brook receives drainage from a wetland to the south and the channel flows northwest and crosses Highway 106 via a concrete culvert and flows into a cattail marsh before confluence with WC13. A beaver dam historically occurred downstream of the highway which impounded that area historically. A beaver lodge was observed during the field survey.

WC12 was at a moderate-level water stage at the time of the June 2019 field visit. Channel pattern observed was sinuous. Watercourse width varied from 1 m to 5 m in the channel and up to 25 m within the floodplain. Watercourse depth also varied from 0.5 m to nearly 2 m within the ponded area west of the highway. The morphology of this watercourse consisted primarily of runs associated with wetlands, which in places was deep enough to constitute a pool. Substrate was dominated by fines throughout.

No fish were captured during a 13-hour minnow trap set in June 2019. Habitat for brook trout is unlikely, but may be seasonal. Access from downstream areas was poor due to the shallow, braided nature of wetland flow paths. Furthermore, the pH was low reflecting bog wetland conditions and substrate had a high sediment load. Habitat was suitable for forage fish and eels.

East (upstream) of Highway 106

West (downstream) of Highway 106

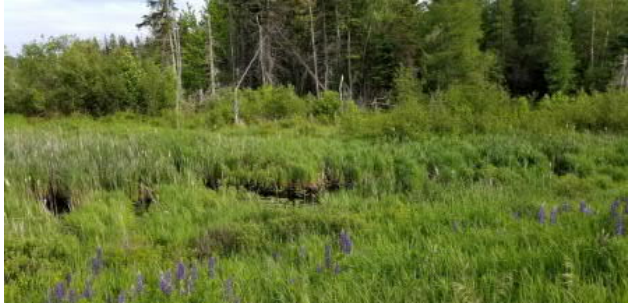
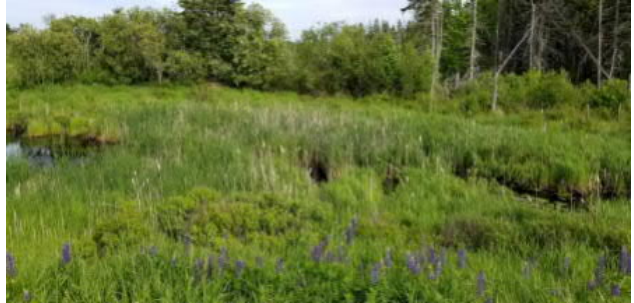
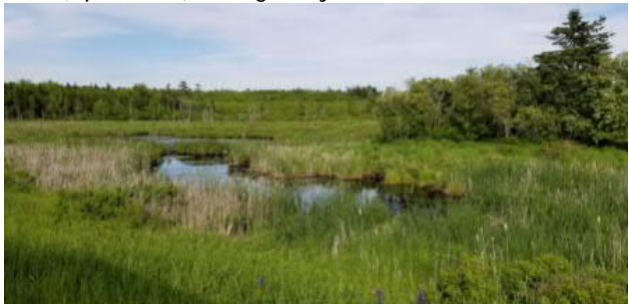
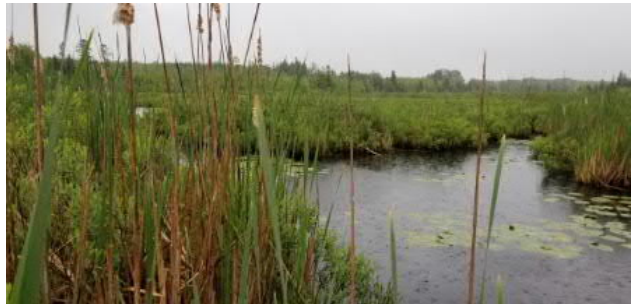
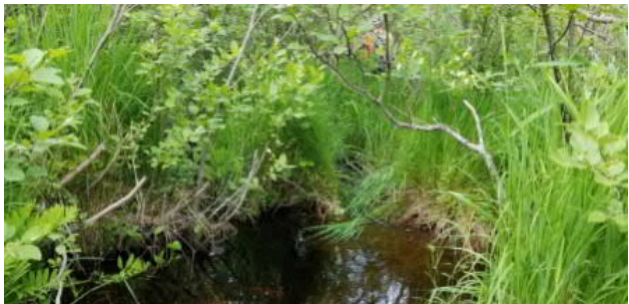
Fish Habitat Photo Plate 9 WC13 – June 2019

WC13 was at a moderate-level water stage at the time of the June 2019 field visit. No channel pattern was observed within the pond, but the downstream drainage was sinuous. The ponded area was over 150 m wide and generally less than 1 m deep in places. Substrate within the pond was dominated by fines. Extensive aquatic vegetation, predominantly lilies, was present within this shallow pond.

East (upstream) of Highway 106

Wetland outlet and west (downstream) of Highway 106

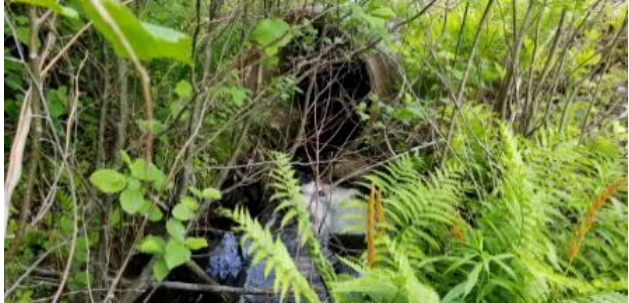
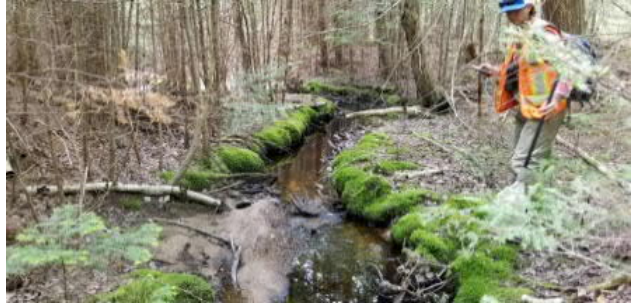
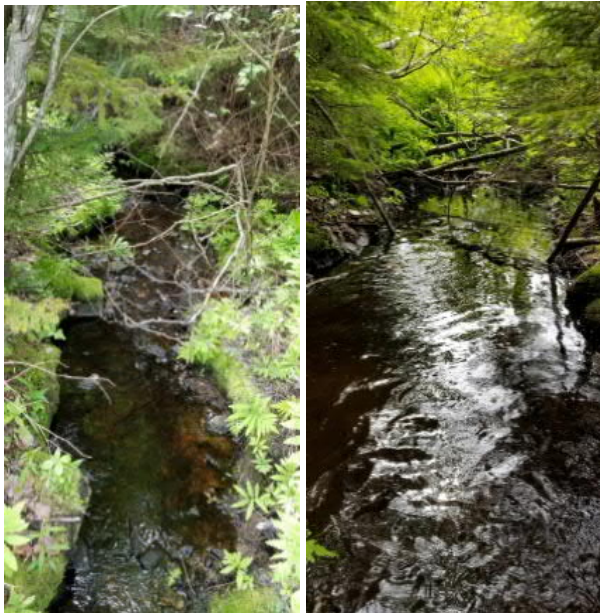
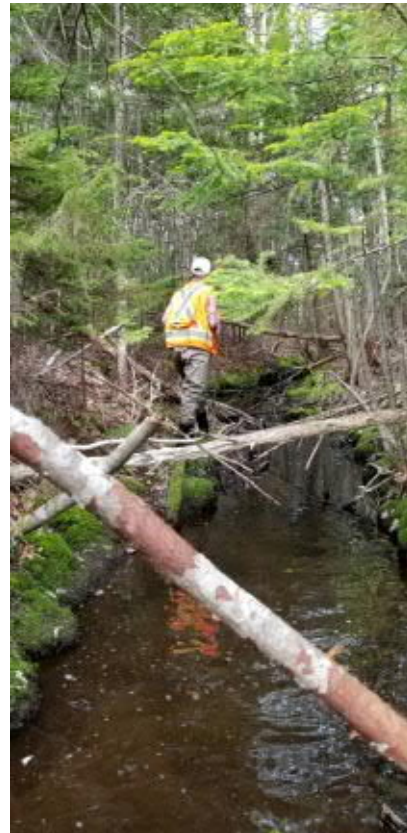
Fish Habitat Photo Plate 10 WC17 – June 2019

East (upstream) of Highway 106

West (downstream of Highway 106)

West (downstream) of Hwy 106

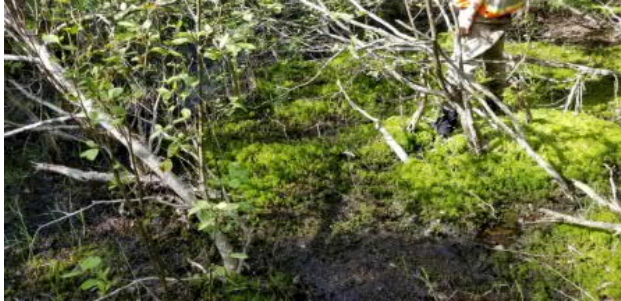
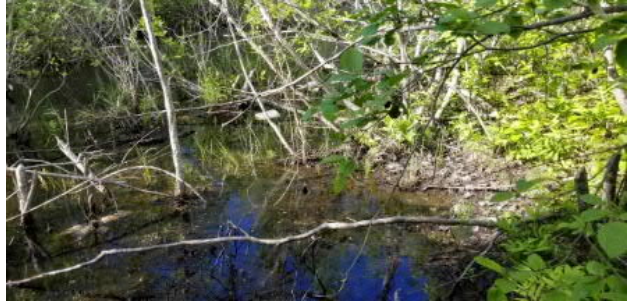
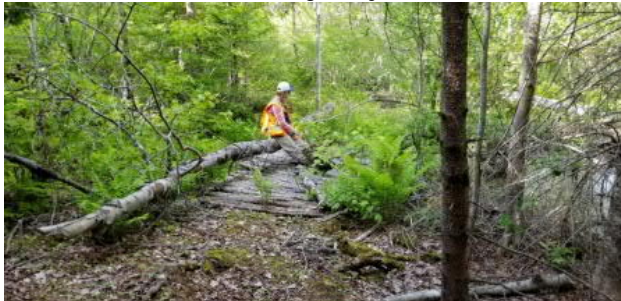
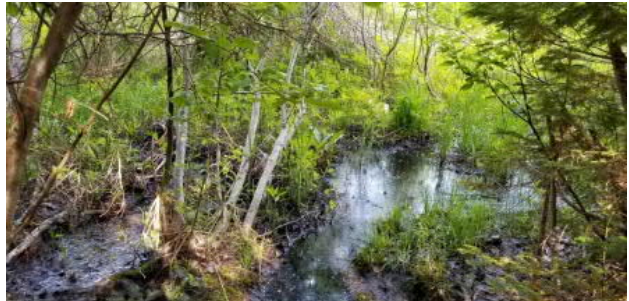
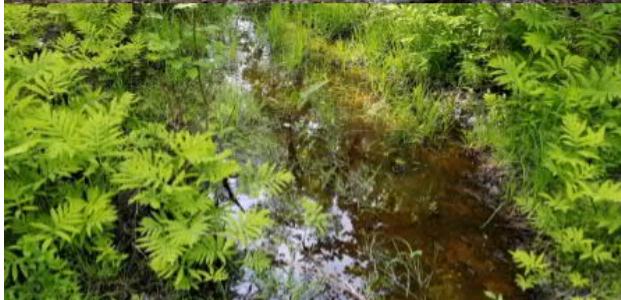
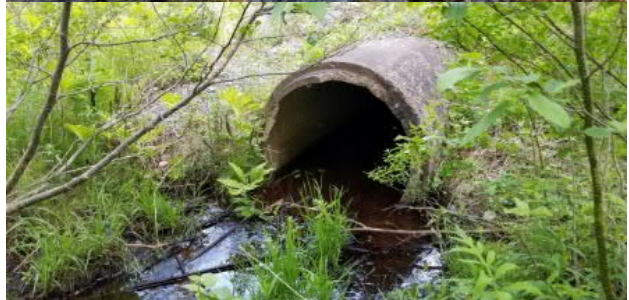
Fish Habitat Photo Plate 11 WC14 – June 2019

East (upstream) of Highway 106

Historical beaver activity

West (downstream) of Highway 106

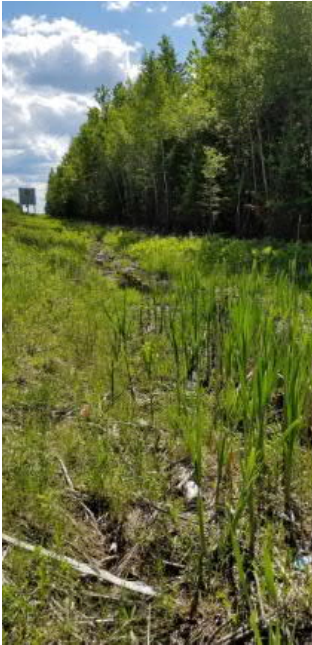
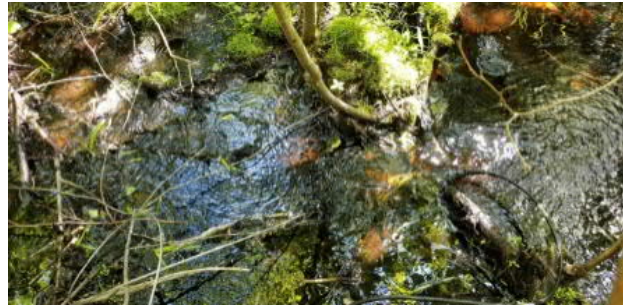
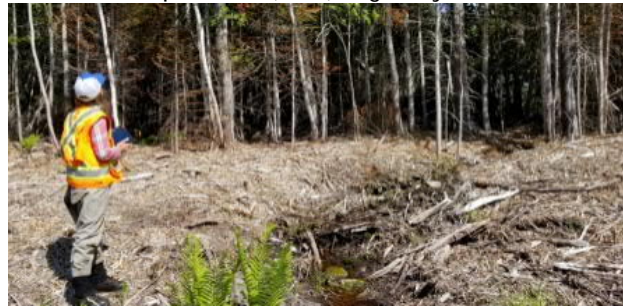
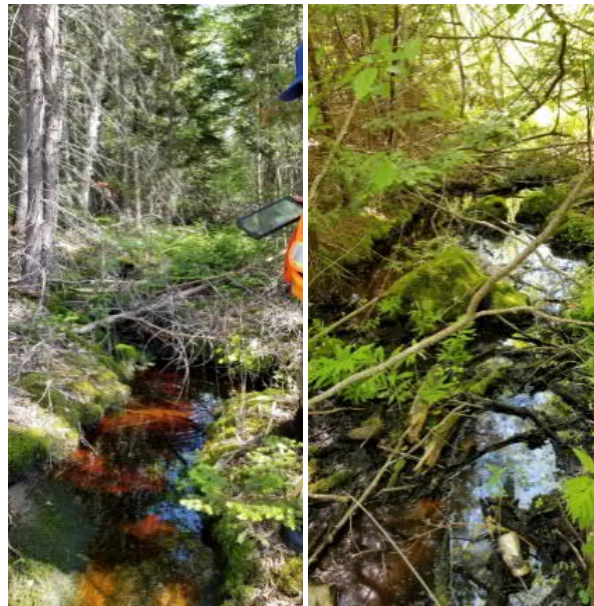
Fish Habitat Photo Plate 12 WC15

Upstream (west) of along Highway 106

Ditch on east side of Highway 106

Upstream (east) Highway 106

Downstream (west) Highway 106

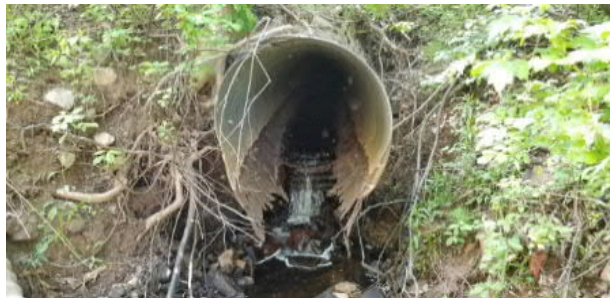
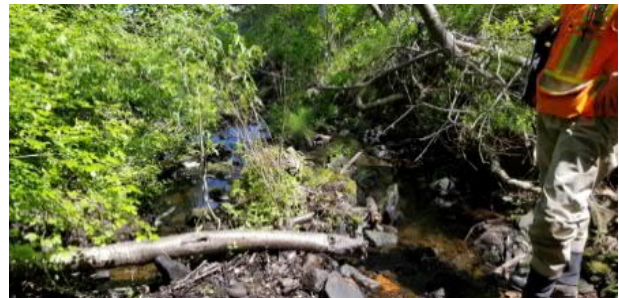
Fish Habitat Photo Plate 13 WC16

Caribou Harbour to approximately 100 m upstream
