# Sporting Mountain Quarry Expansion

EA SUPPLEMENTAL INFORMATION

Nova Construction Co. Ltd.

24 August 2022

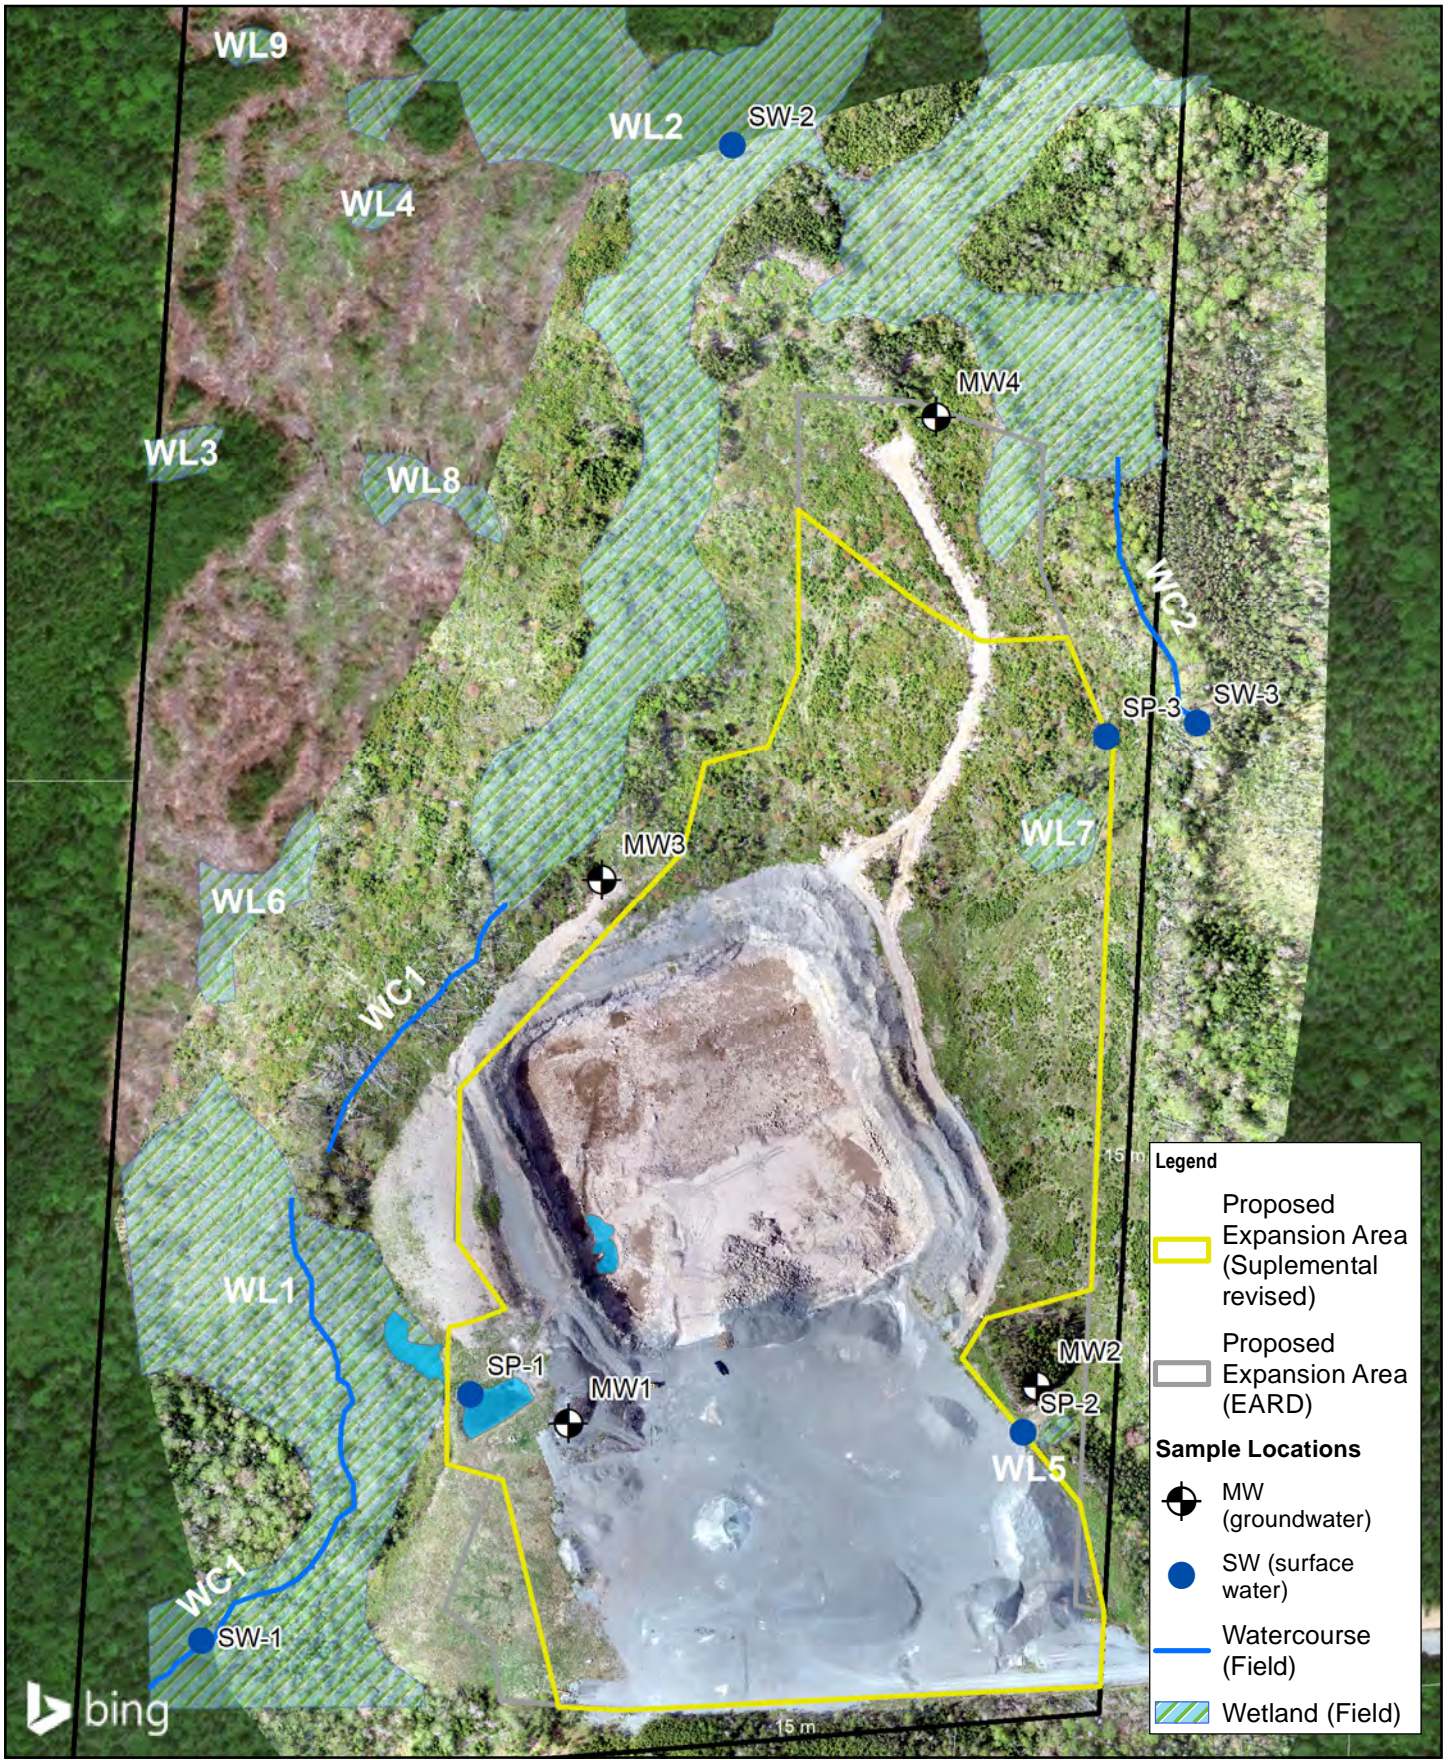
**FIGURE 2**

Nova had planned to expand to the quarry to 10.0 ha to continue meeting local demand for construction aggregate, however with efforts to reduce the footprint and potential effects to the environment with respect to wetlands and lynx, the proposed footprint has been reduced to less than 9 ha (Figure 2).

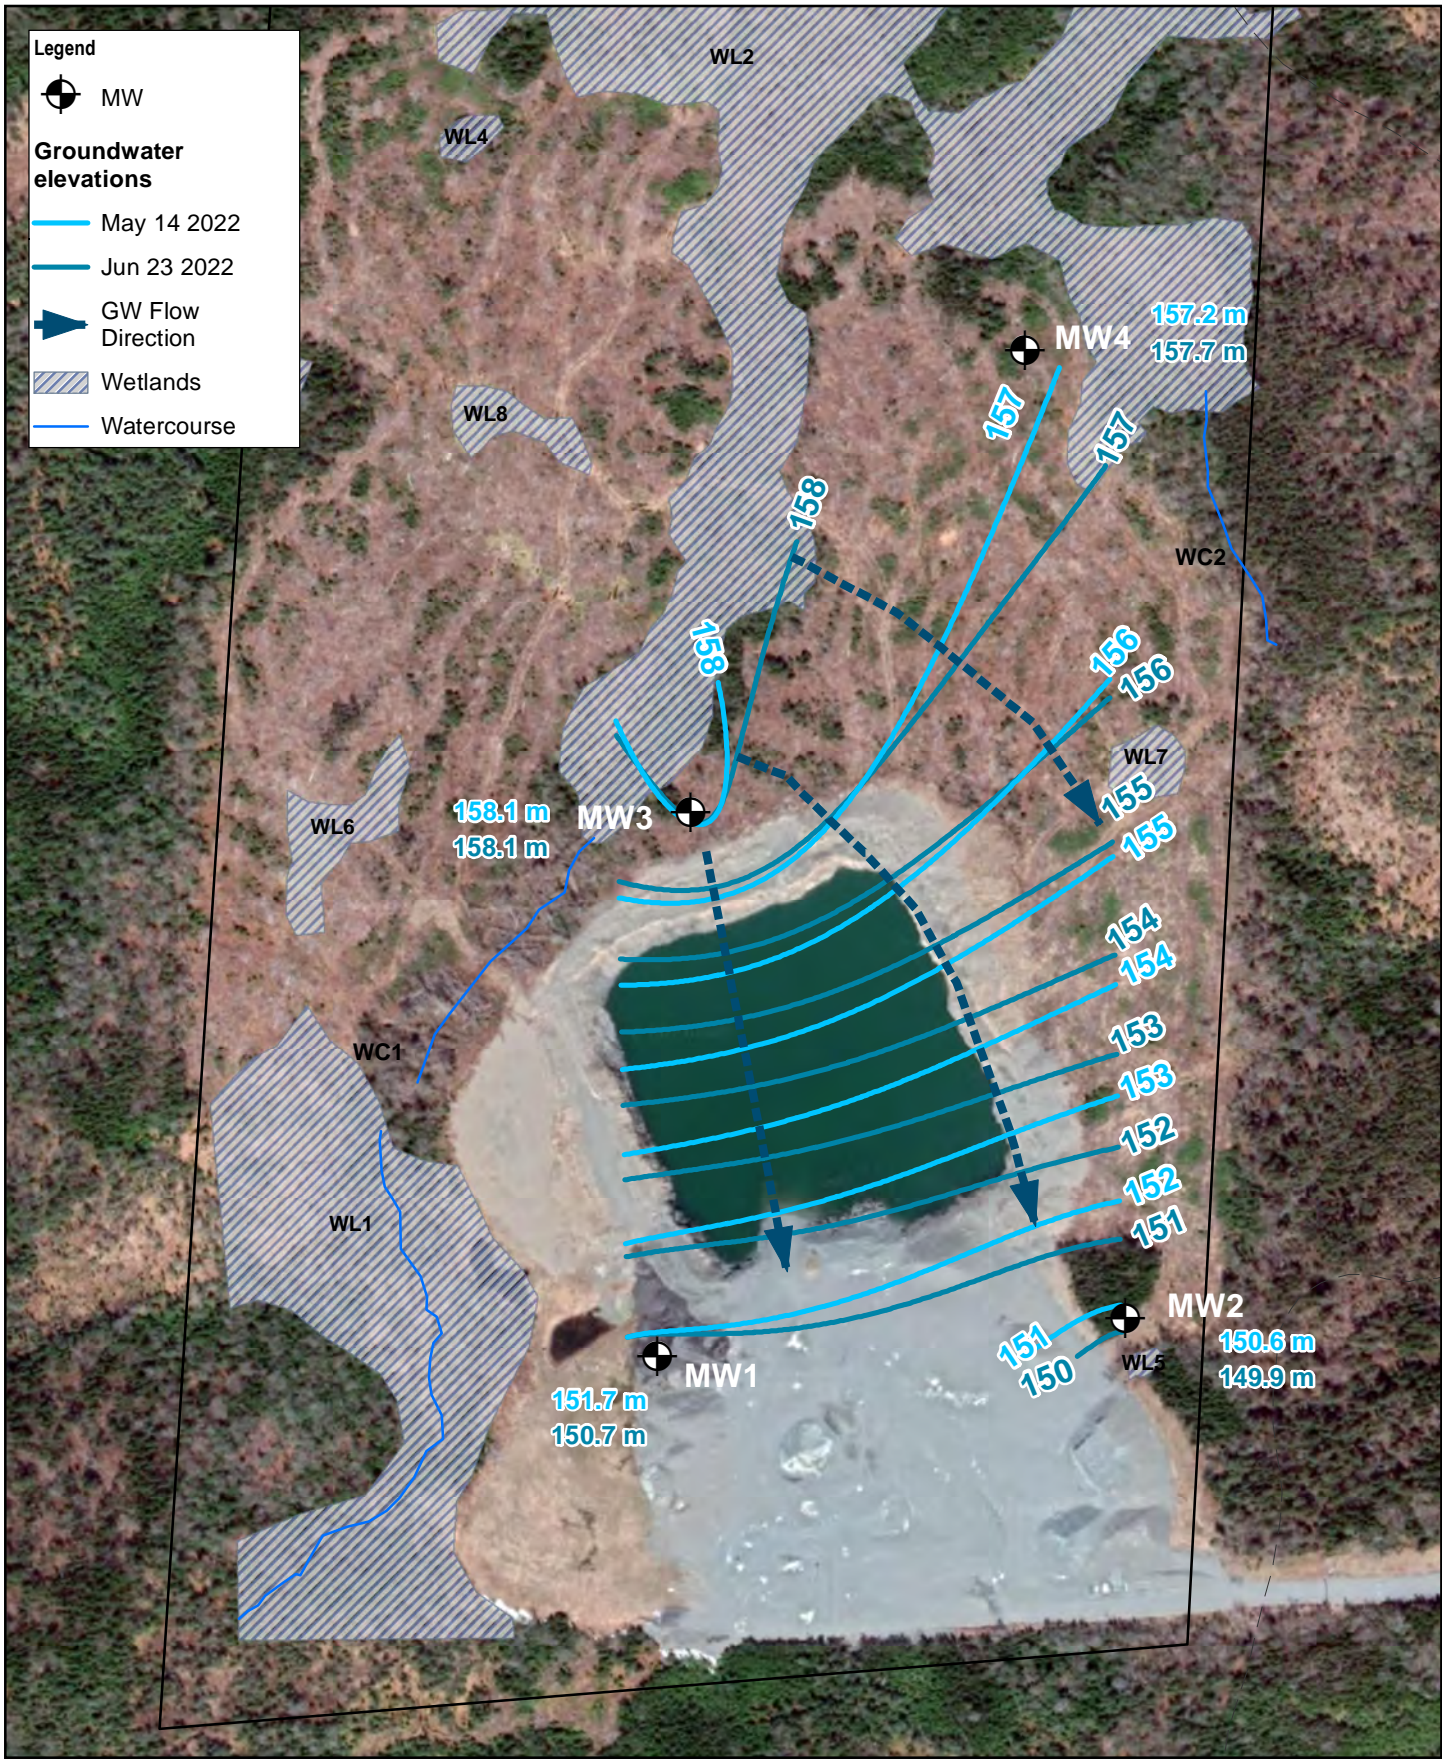
**FIGURE 3**

**GROUNDWATER ELEVATIONS**

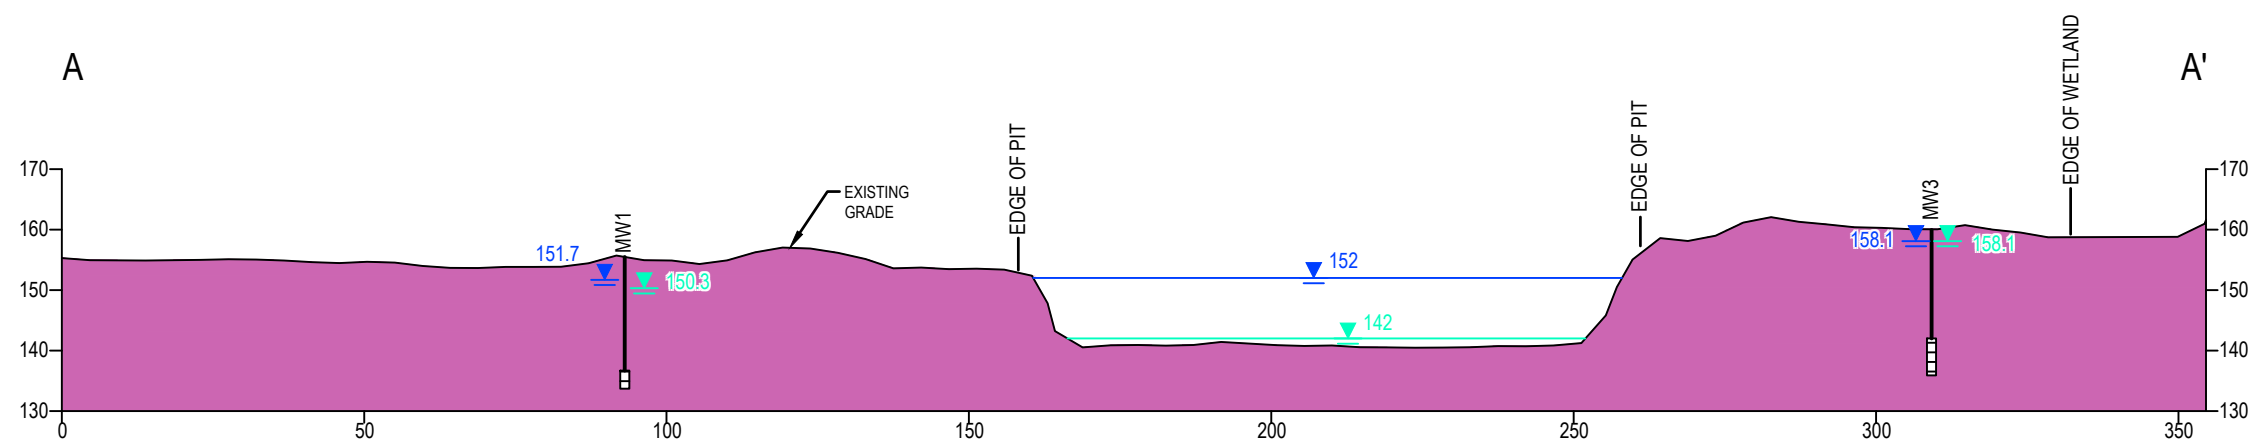
**FIGURE 4**

CROSS-SECTION A-A'

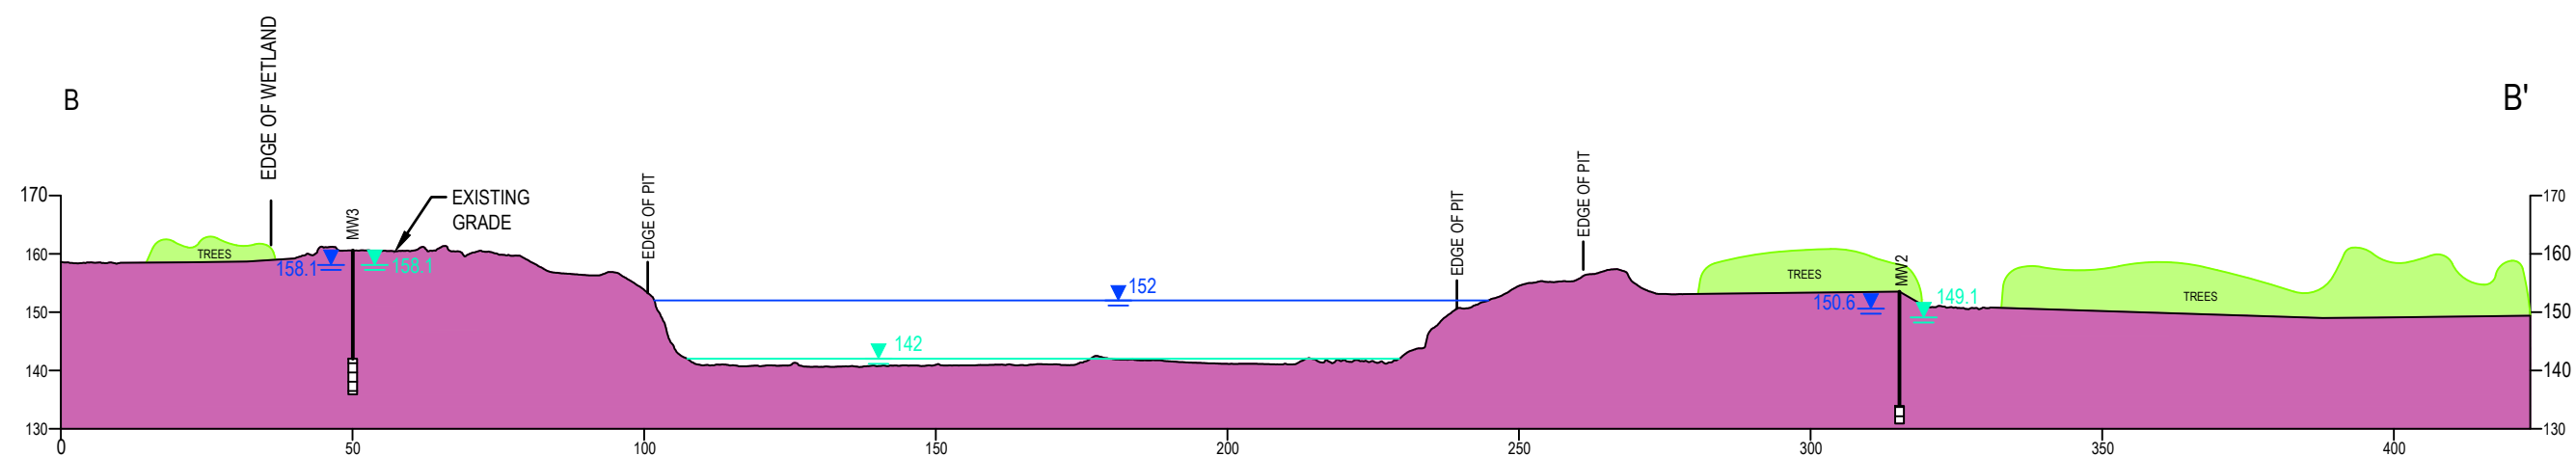
Figures 4 and 5 provide a cross section location map and two cross sections through the quarry. The groundwater elevations prior to dewatering the quarry (May 14, 2022) and after the quarry is dewatered (June 23, 2022) are shown as are the corresponding water levels in the quarry.

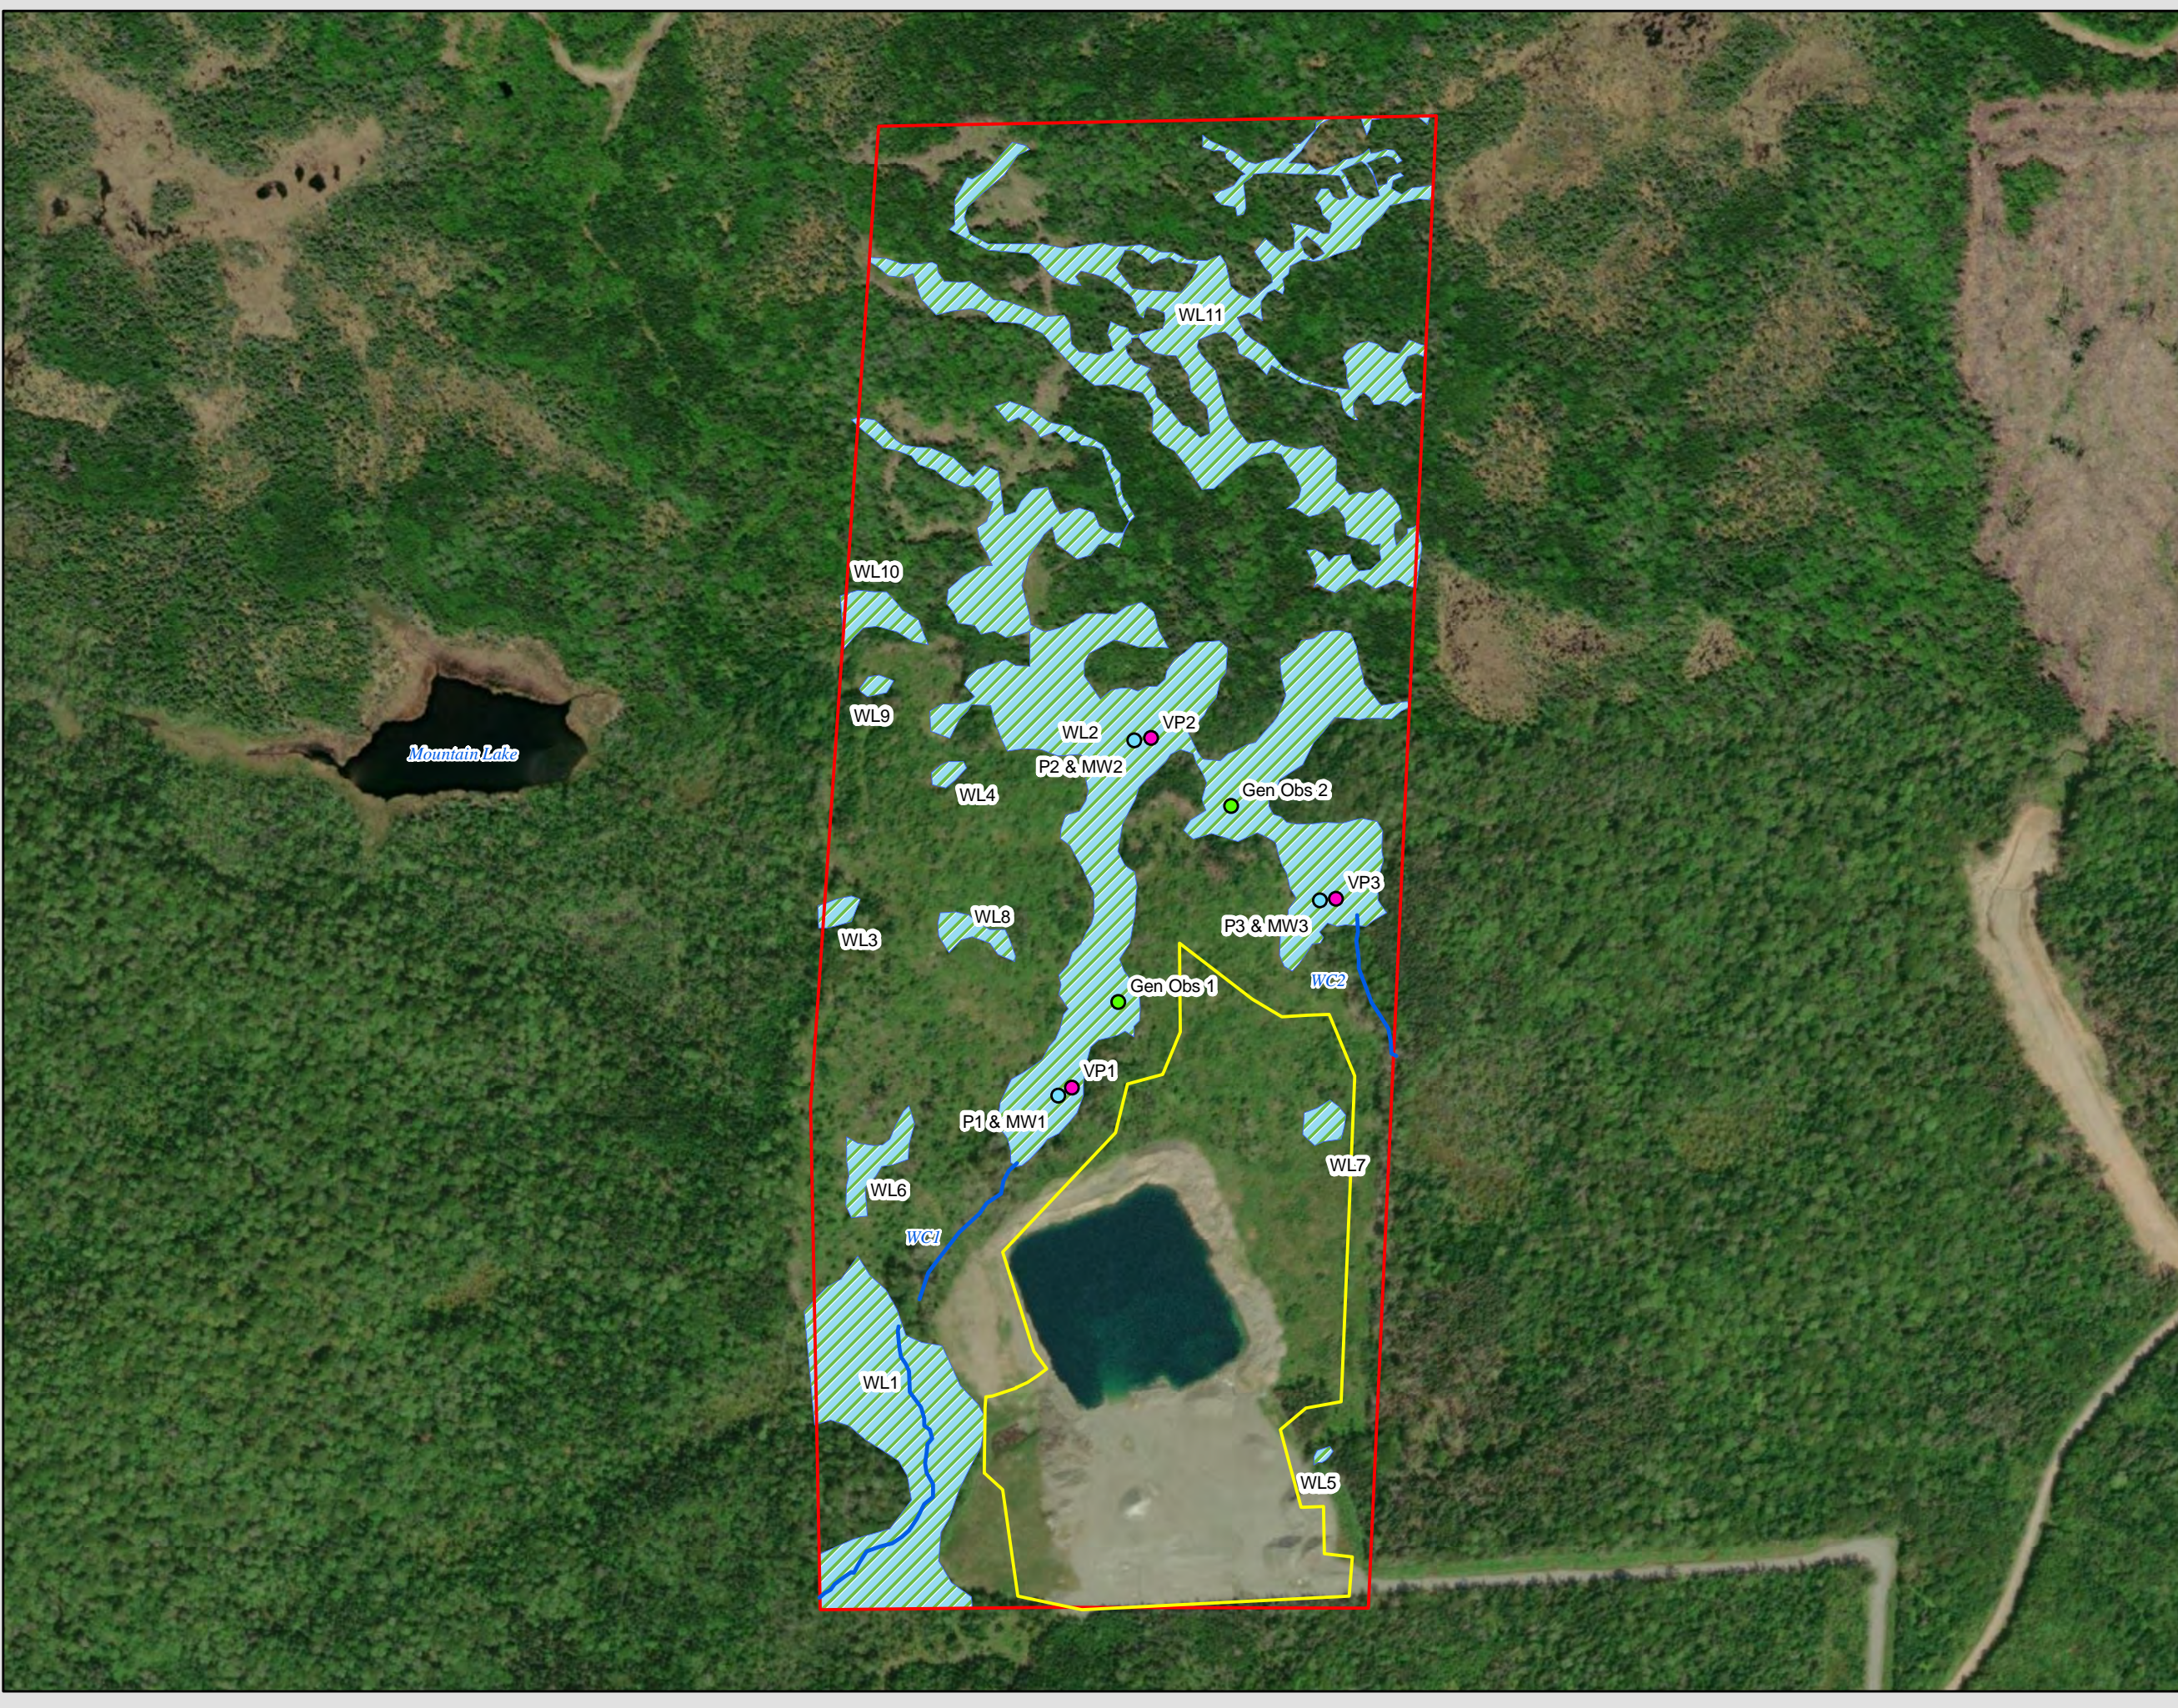
FIGURE 7

As previously noted, the channel of WC2 begins within the Study Area and shortly thereafter disperses into a swamp to the east of the Study Area. No watercourse channel was observed within this wetland, nor was any evidence of hydrological connectivity observed through the wetland. No fish were captured in WC2 as a result of electrofishing surveys. As such, the portion of WC2 within the Study Area is not considered to support fish. There is no NSECC mapped watercourse that drains out from this wetland – the closest mapped watercourse lies approximately 1.2 km southeast of the Study Area. No fish or fish habitat assessment was completed immediately downgradient of this swamp in what is expected to be a continuation of the first order stream, which is observable via aerial imagery (Figure 7).

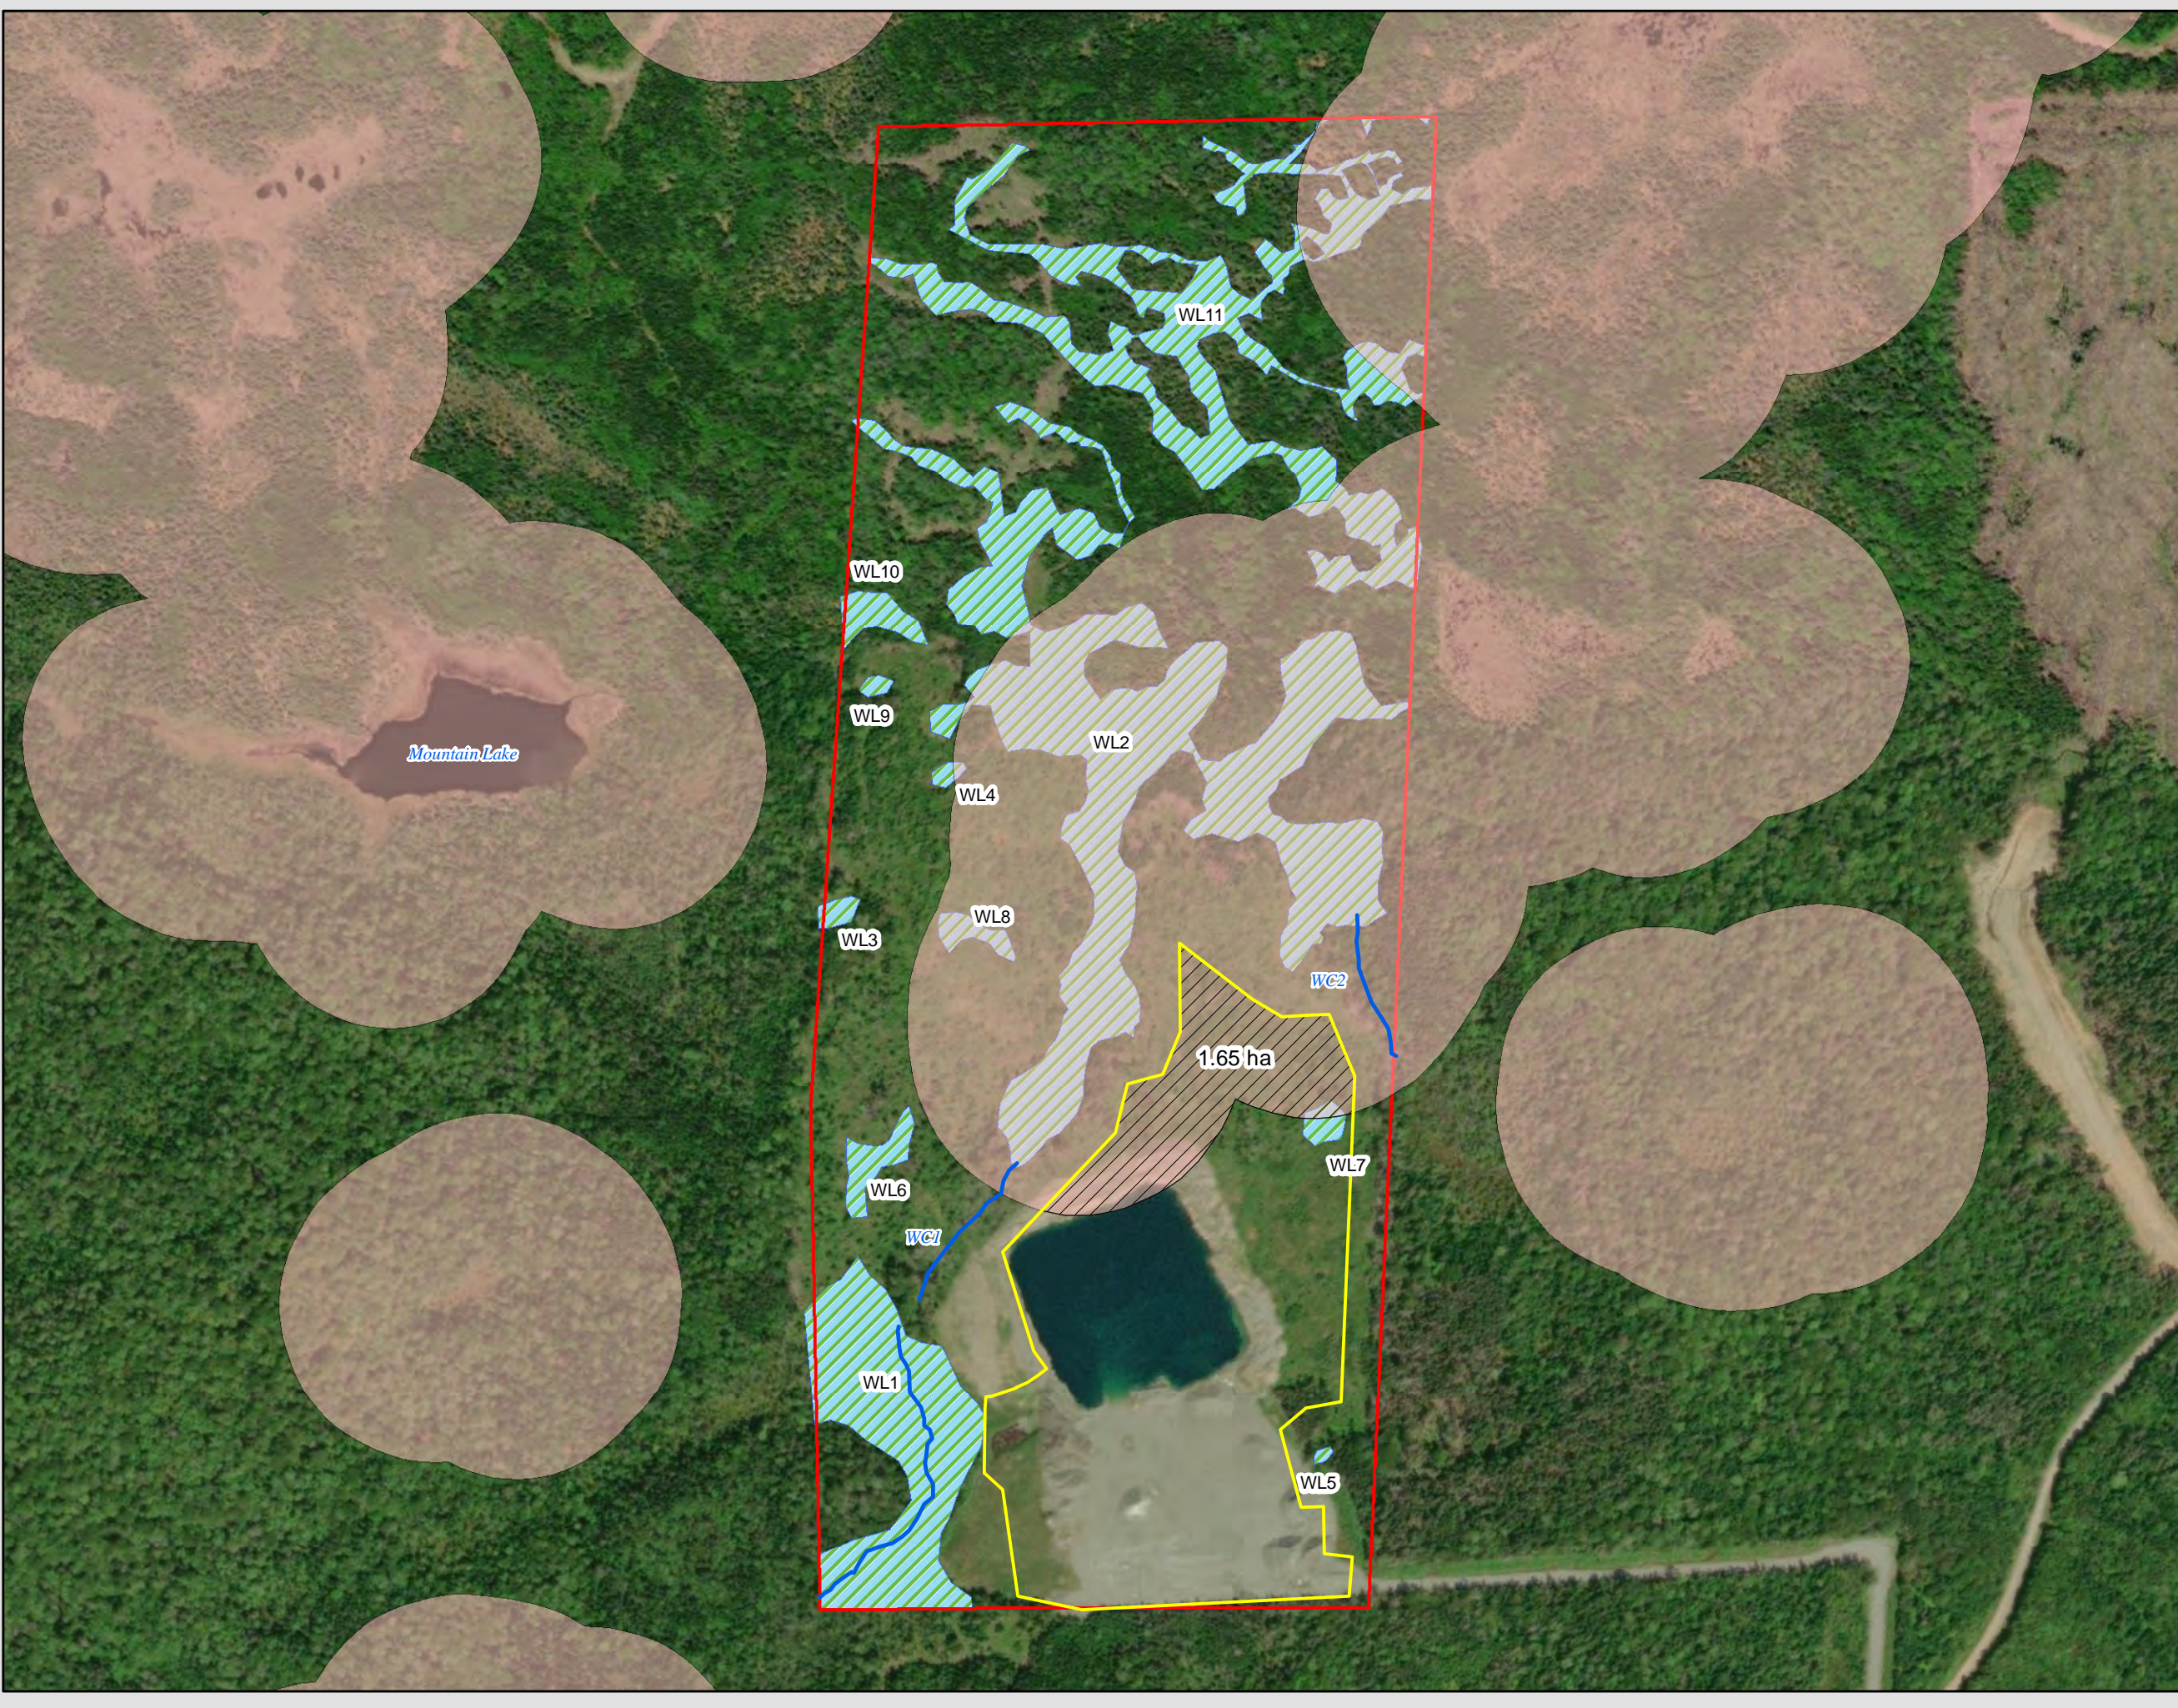
**FIGURE 10**

- Avian PC Locations
- Field Delineated Wetland
- Field Delineated Watercourse
- PC Separation (250 m)
- Revised Expansion Area
- Study Area

PC locations were placed prior to the boundaries of the expansion area (EARD) being finalized, therefore, only one PC (PC1) is present within the expansion area (EARD), at the southern extent of the existing quarry footprint. As shown on Figure 10, the location of point counts (and their 250 m separation from each other) encompassed all but 0.52 ha of the revised expansion area. The area not covered by the PCs 250 m separations is all cleared habitat and similar habitat exists within other areas covered by PCs. Given the size of the expansion area, and the close proximity and frequency of PCs, PC surveys were deemed to provide comprehensive coverage and be representative of all habitat types.

WL2, WL8, and WL10 have dense shrub layers that may provide suitable breeding habitat for Canada warblers. Furthermore, two Canada warbler were identified (probable breeding evidence) within WL2 (at point count location PC4 [Figure 10]). Due to the presence of suitable habitat and observations of Canada warbler in WL2, it is believed that NSECC will now classify WL2 as a WSS.

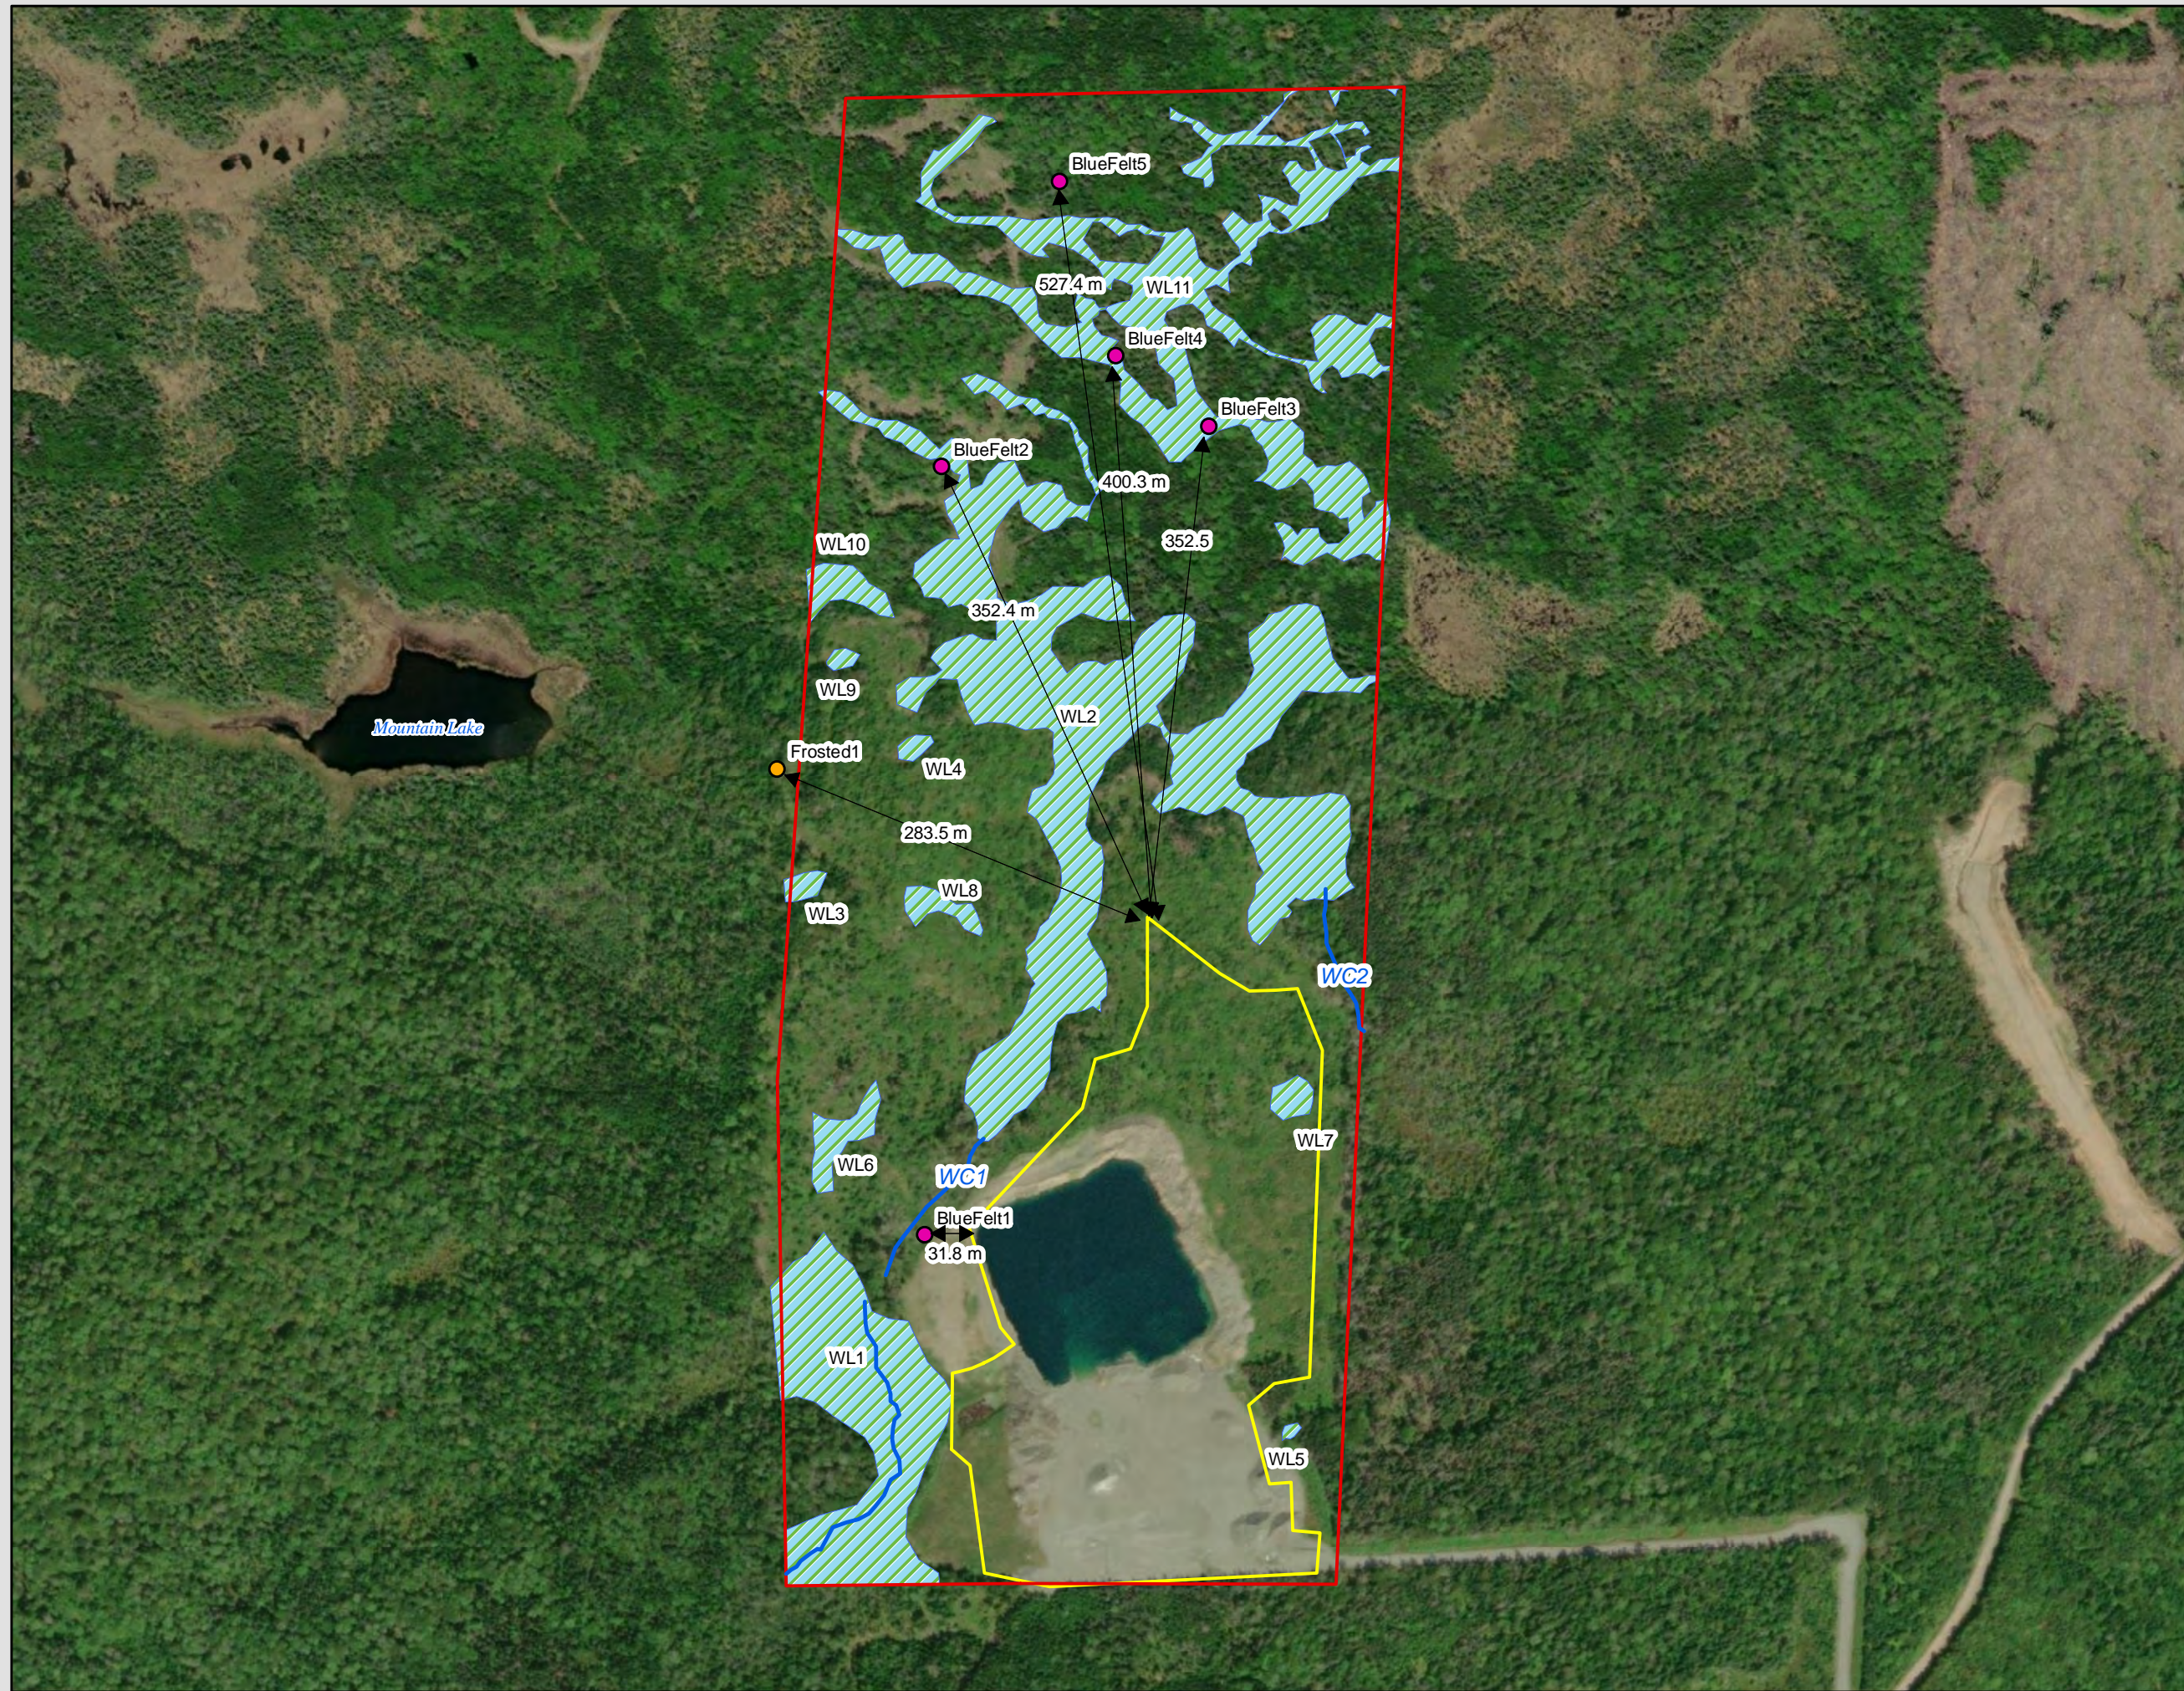
- Study Area
  - Revised Expansion Area
  - Field Delineated Watercourse
  - Field Delineated Wetland
- SAR Lichen**
- Blue Felt Lichen
  - Frosted Glass Whiskers Lichen

Thirteen thalli of blue felt lichen (SARA and COSEWIC Special Concern; NSESA Vulnerable; ACCDC S3) were observed in five separate locations across the EA Study Area. Four of these locations exist in the northern extent of the EA Study Area and the remaining observation (BlueFelt1) exists immediately west of the existing quarry along WC1 and between WL1 and WL2 (Figure 12). The habitats that this lichen was found in include upland, swamp (WL11), and on the edge of the existing quarry.

Nova has revised the expansion area which has reduced the footprint proposed for development (12.3% decrease) and redirected potential advancement of the quarry face away from the nearest observations of blue felt lichen (BlueFelt1). The revised expansion area maintains a setback of 100 m, as recommended within the *At-Risk Lichens – Special Management Practices* (NSDNR, 2018), from all but one observation of blue felt lichen, BlueFelt1 (Figure 12). BlueFelt1 is located within the existing Industrial Approval (IA) area and is situated 32 m west of the revised expansion area. These setbacks were deemed as acceptable by NSDNRR (M. McGarrigle, NSDNRR SAR Biologist, May 21, 2021).
