**APPENDIX E  
TECHNICAL REPORTS – TERRESTRIAL**

*APPENDIX E.1*  
*TOUQUOY GOLD MINE – STUDY AREA*  
*EXTENSION (SQUARE LAKE): WETLAND*  
*AND WATERCOURSE DELINEATION*

**Re: Touquoy Gold Mine – Study Area Extension (Square Lake): Wetland and Watercourse Delineation**

*APPENDIX E.2*  
*TOUQUOY MINE GOLD PROJECT, 2020*  
*ANNUAL WETLAND COMPENSATION*  
*REPORT*

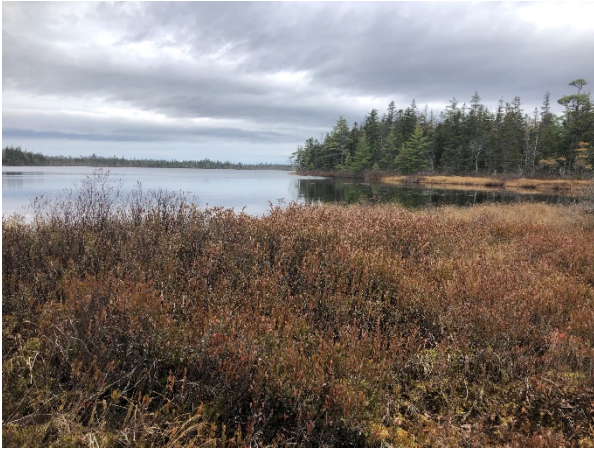
**Photo 1: Representative Fen Habitat in WL 53**

General observations within the fen portion of the wetlands indicate that the hydrological, soil and vegetation conditions are similar to those described in Wetland 53. A summary of the data point results and wetland characteristics for each wetland are provided in Table 1 and Table 2.

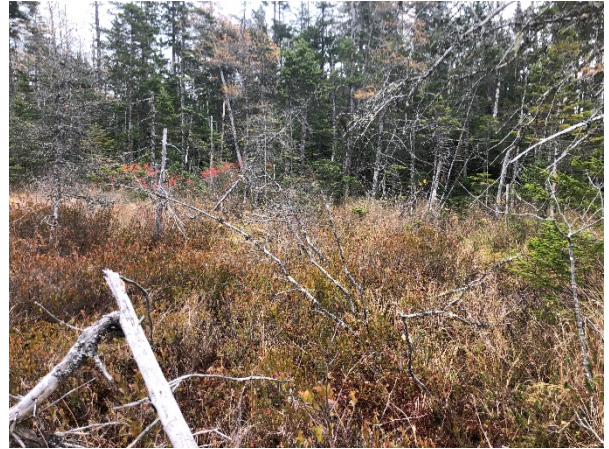
**Photo 2: Representative Fen Habitat in WL 53**

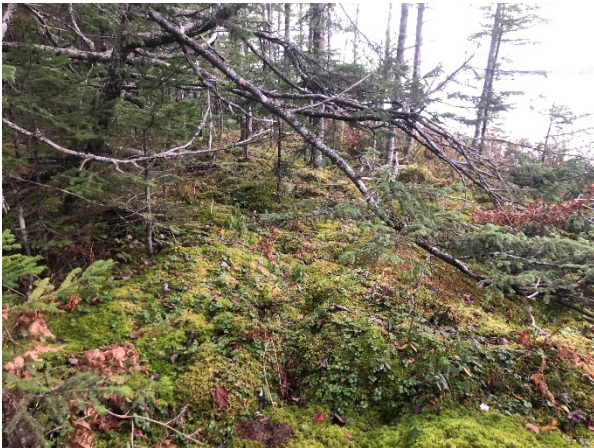
**Photo 3: Representative Swamp Habitat in WL 54**

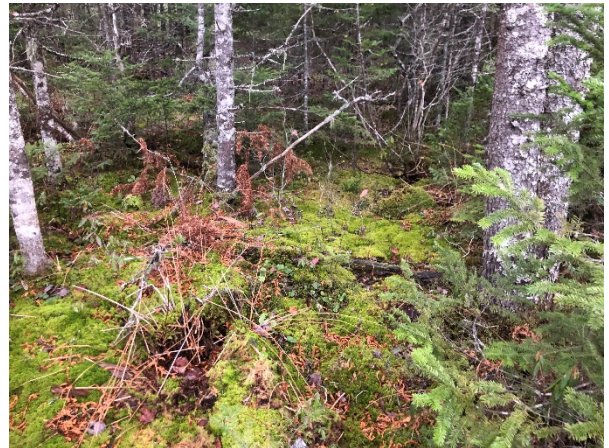
**Photo 4: Representative Swamp Habitat in WL 54**

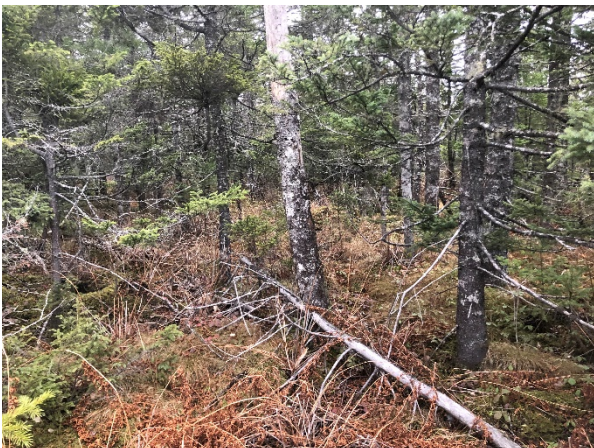
**Photo 5: Representative Swamp Habitat in WL 55**

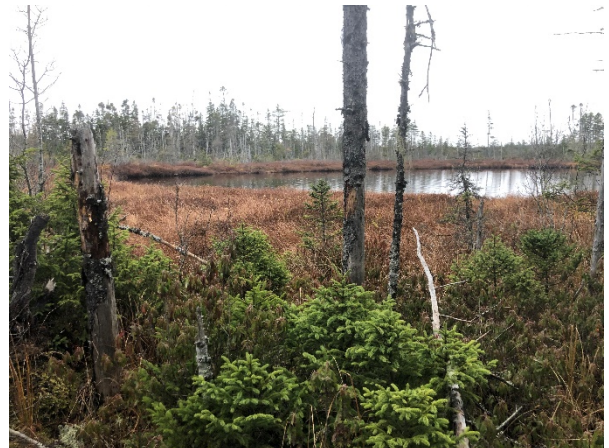
**Photo 6: Representative Fen Habitat in WL 55**

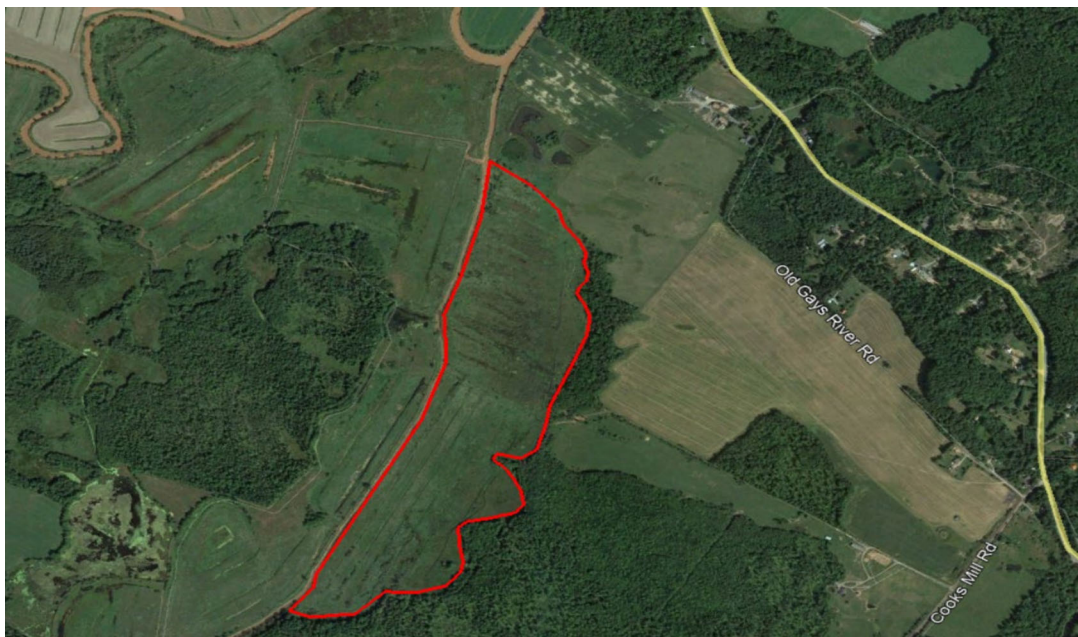
**Figure 2: Gays River Floodplain Restoration Project**

The potential restoration area includes the former agricultural land, where water has been re-directed through a series of multiple ditched drains and an old aboiteau at the northern outflow channel. Based on information provided from the landowner, and historical aerial photos the restoration area includes land that formerly comprised the natural channel of the Gays River prior to it being realigned into its straightened channel that we see today.

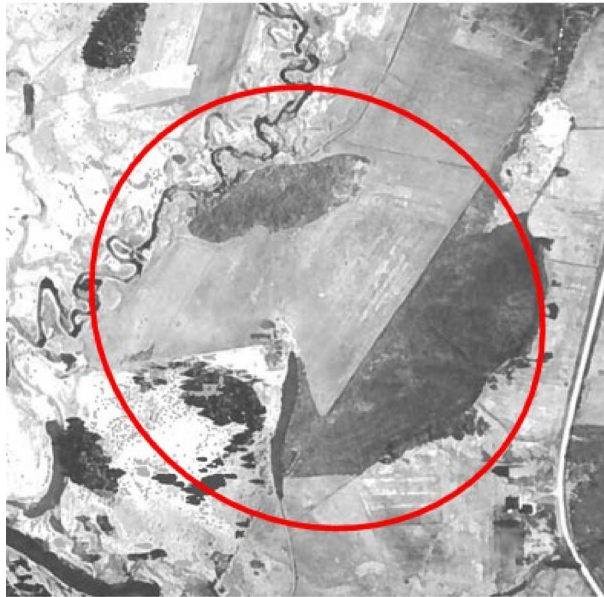
**Photo 1: Aerial photo of Project Site in 1938**

Up until as recent as 2018 the Project Site has been used for harvesting hay, however, in recent years has been left fallow. A review of aerial photos dating back to 1938 was completed to compare land use conditions within the Project Site. As can be seen on Photos 1 and 2 (below) the majority of the land had been cleared and ditched in 1938 and appeared to be in active agricultural use. One notable difference is identified in the eastern section of the Project Site where a dense vegetative cover appears to exist in 1938. Based on photo interpretation this cover type appears to of shrubby composition and is expected to have extended westward prior to historical draining and clearing taking place. Based on anecdotal information from the landowner, the installation of drainage ditches was employed as a method to drain the water from the land, especially during periods when the Stewiacke River and Otter Brook back-watered into the Project Site. It is anticipated that prior to the ditching and vegetation

clearing, the land existed as a shrub swamp which likely experienced very wet conditions during the spring and intermittently throughout the year during high flow conditions and backwatering from the downstream aquatic features. The linear ditching, which are concentrated in central and eastern portions of the Project Site, have been used to drain the land, reduce surface water detention post backwatering events and encourage the establishment of suitable vegetation for hay making practices. Additional information regarding hydrological conditions is provided in Section 3.3.

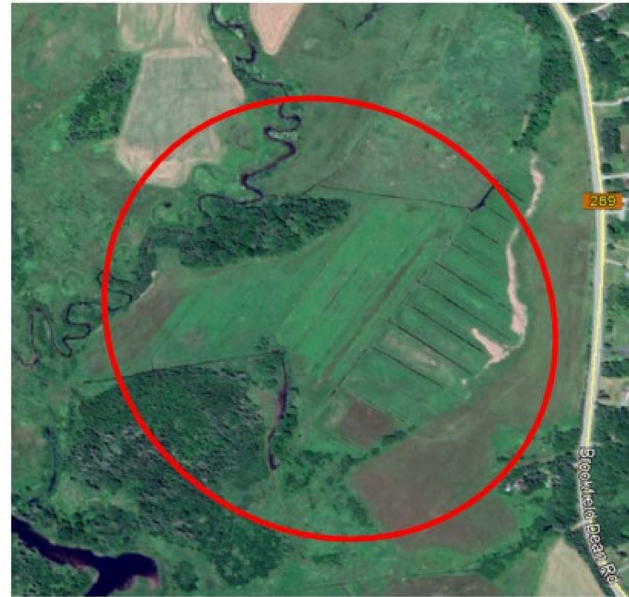
**Photo 2: Aerial photo of Project Site in 2019**

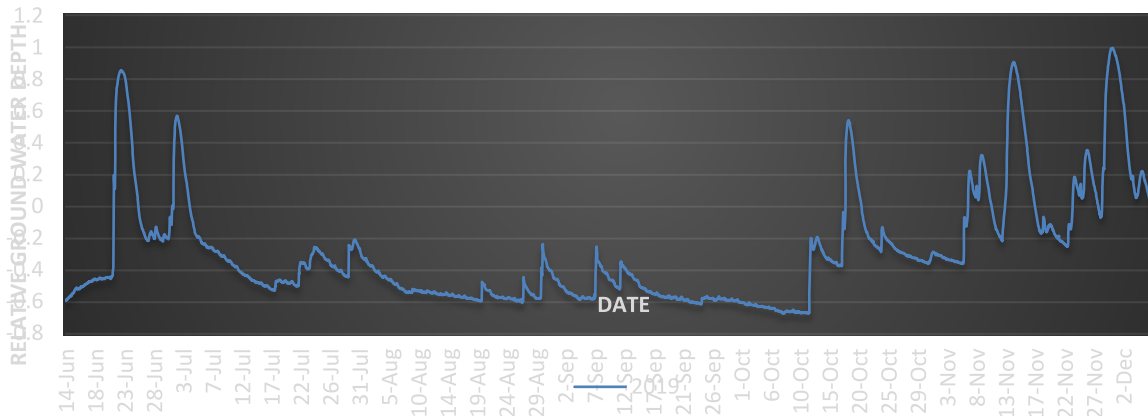
**Figure 1: 2019 Monitoring Well Data**

topography with localized high and low areas around the perimeter. Based on interviews with the landowner and site visits during the investigation period, the site experiences high water levels up to 800mm above existing ground during the spring freshet and periodic flood events through the remainder of the year. Flood depths and groundwater response were monitored between June 14, 2019 and December 6, 2019, which confirmed this anecdotal information. Because of the excavated drainage channels, surface water subsides immediately following the flood events, while groundwater levels subside over a period of thirty to eighty hours following a flood event. The presence of the drainage channels ensures that during the summer months, high groundwater on site is limited to a one- or two-day period during Otter Brook floods. Figure 1 (below) shows the monitoring well data at MW3 for the 2019 growing season.

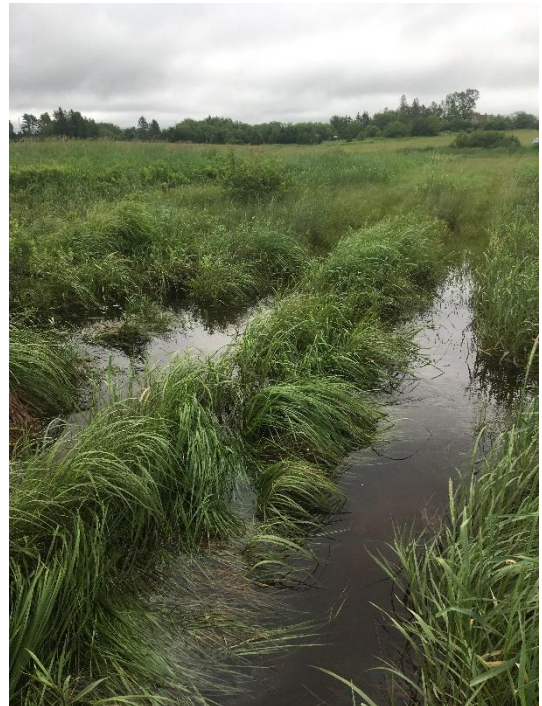
Photo 4: Trail crossing D2 (flooded, July 3, 2019).

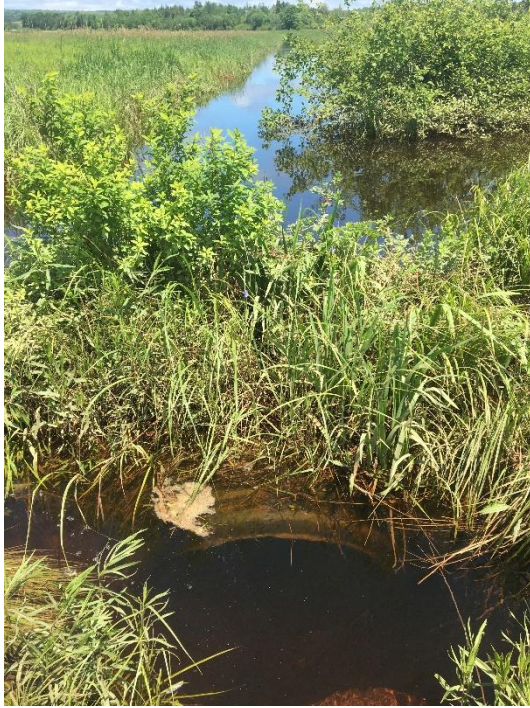
Photo 5: Culvert beneath D2 trail crossing (July 3, 2019).

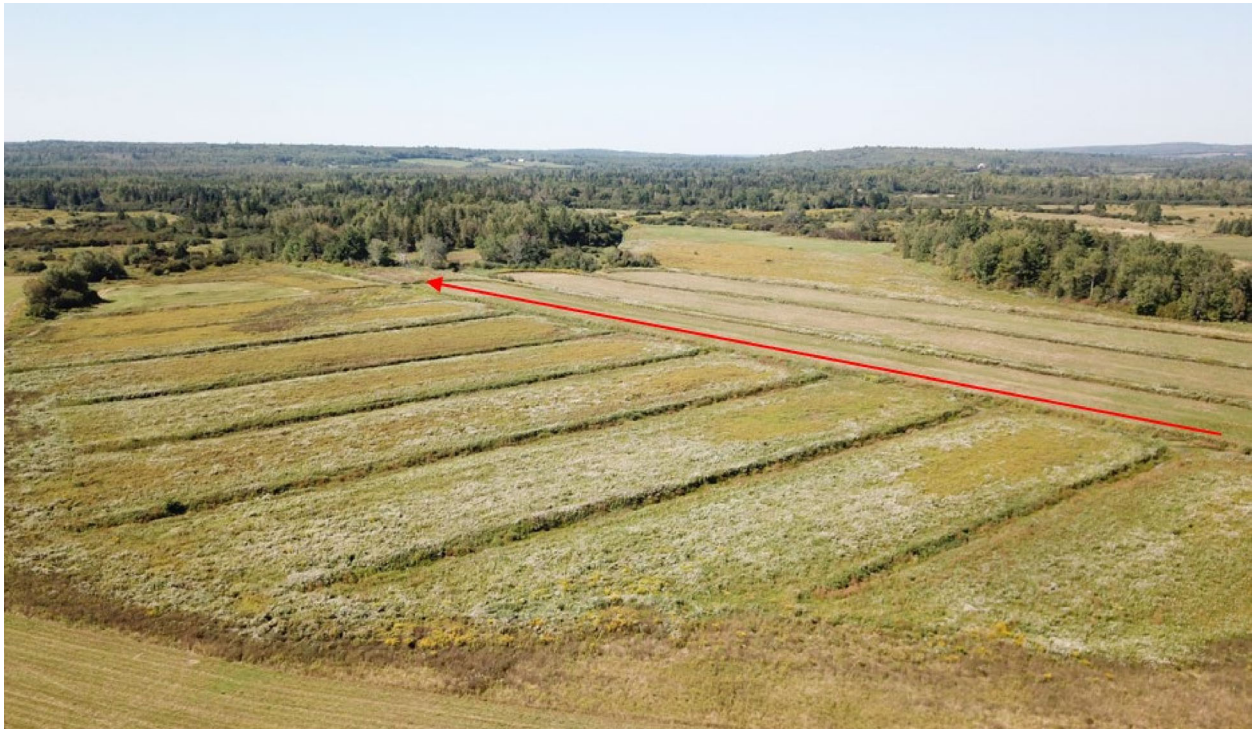
Photo 11: Wetland Restoration Project Site Looking Southwest – D2 indicated with arrow
