**Assessment of Wetlands 6 and 15
and Watercourse 4, Touquoy
Mine, Nova Scotia**

Watercourse and Wetland Assessment
to fulfill the requirements of Nova Scotia
Environment Directives #12628894 and
#12776418

December 19, 2019

Stantec Consulting Ltd.
845 Prospect Street
Fredericton NB E3B 2T7

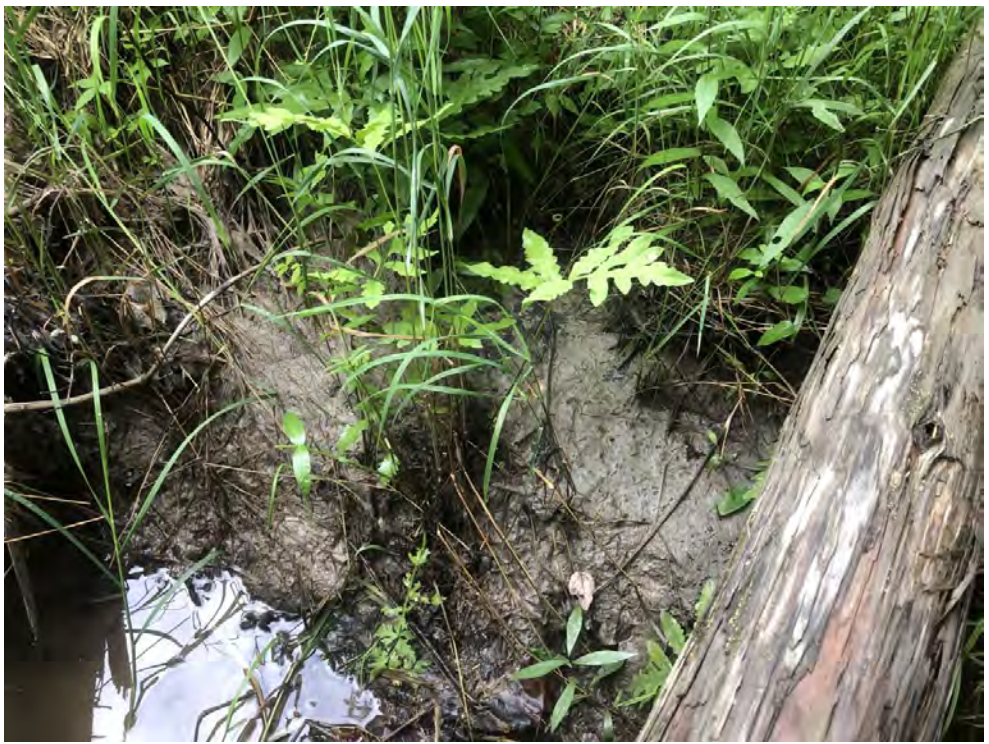
Client:	Atlantic Mining NS Corporation	Project:	Assessment of Watercourse WC4 and Associated Wetlands
Site Name:	Touquoy Mine	Site Location:	Moose River, Nova Scotia
Photograph ID: 1

Photo Location: Wetland 6			
Survey Date: 8/1/2019			
Comments: Fine grey sediment deposits near edge of inlet stream in Wetland 6.			
Photograph ID: 2

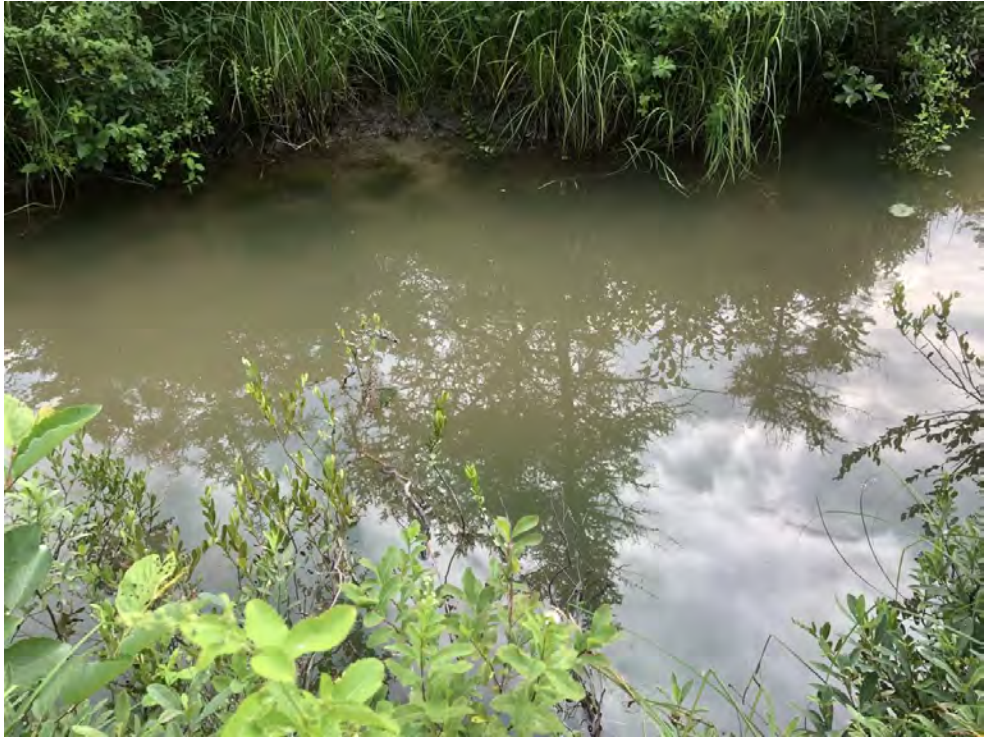
During the site visit to Wetland 6, exposed deposits of silt were observed at the northern tip of the wetland. The area where these silt deposits were found was approximately 0.02 ha in size. These silt deposits were up to 5 cm thick and occurred in depressions adjacent to the inlet stream (WC4) (Appendix A, Photo 1) and occupied approximately 10% of the wetland surface. The deposits extended approximately 20 m downstream from the northern inlet of the wetland.

Photo Location: Wetland 6			
Survey Date: 7/31/2019			
Comments: Poorly vegetated still water in northern half of Wetland 6.

Plant communities in most of Wetland 6 are in good condition. If further silt inputs are eliminated, it is expected that new sphagnum moss will colonize the areas where mortality has occurred, and aquatic plants will colonize the bare substrate in the northern half of the still water.

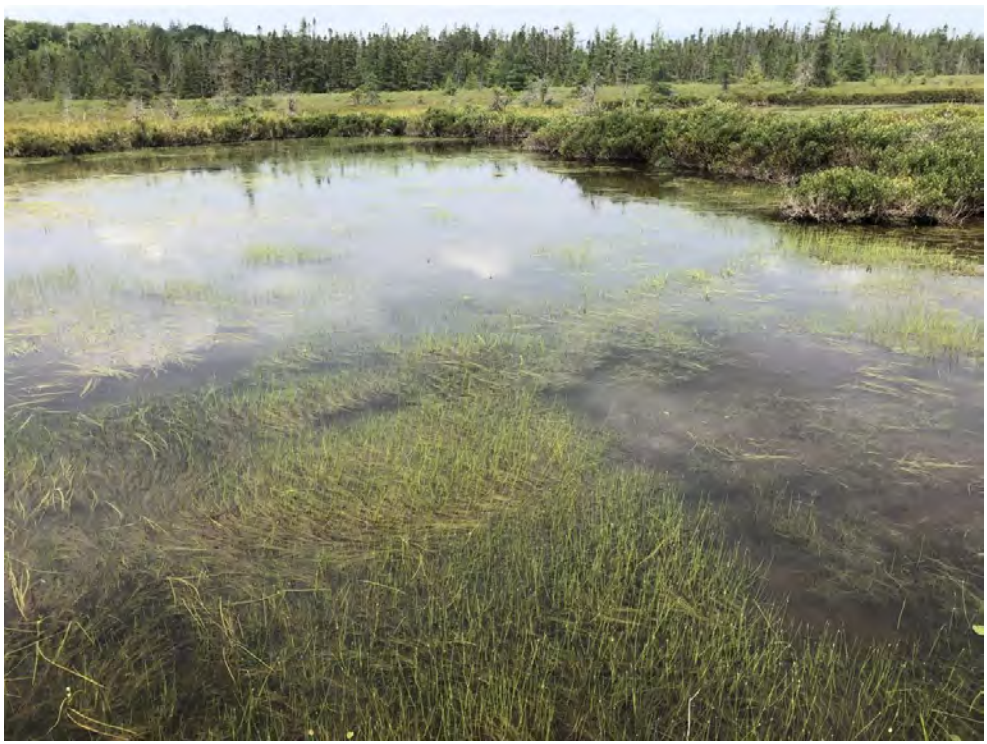
Client:	Atlantic Mining NS Corporation	Project:	Assessment of Watercourse WC4 and Associated Wetlands
Site Name:	Touquoy Mine	Site Location:	Moose River, Nova Scotia
Photograph ID: 3

Photo Location: Wetland 6			
Survey Date: 7/31/2019			
Comments: Well vegetated still water in southern half of Wetland 6.			
Photograph ID: 4

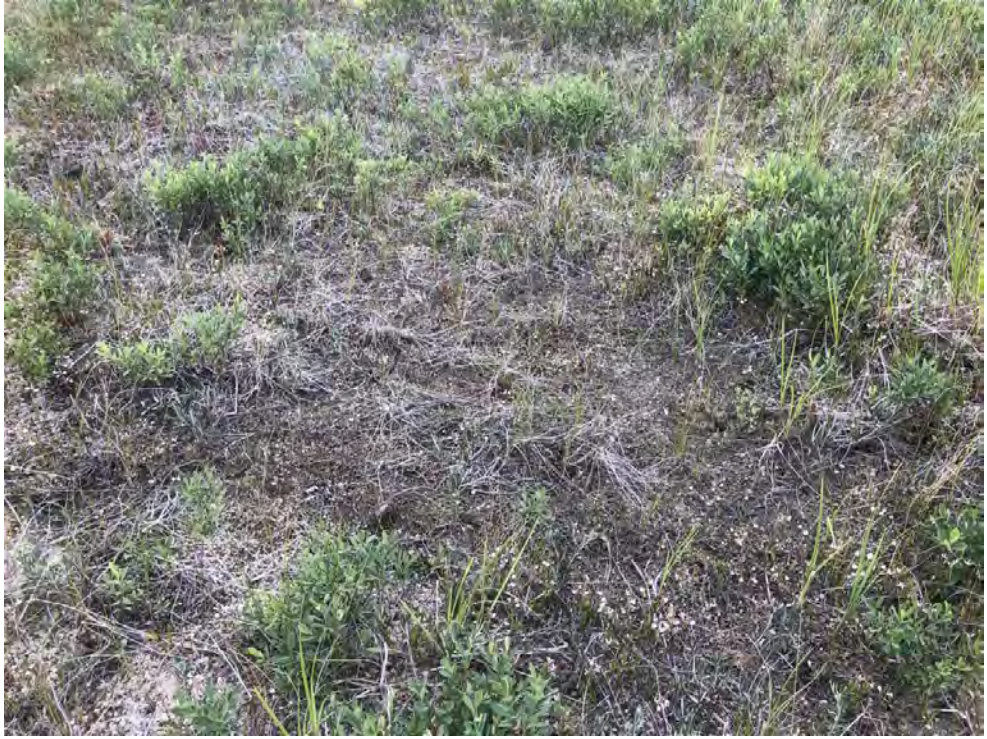
Client:	Atlantic Mining NS Corporation	Project:	Assessment of Watercourse WC4 and Associated Wetlands
Site Name:	Touquoy Mine	Site Location:	Moose River, Nova Scotia
Photograph ID: 5

Photo Location: Wetland 6			
Survey Date: 7/31/2019			
Comments: Area of high sphagnum moss and graminoid mortality in Wetland 6.

- a. Wetland 6: monitoring quadrats placed at representative locations of sphagnum moss staining and bleaching would be used to document recovery based on colonization by healthy plants over time.

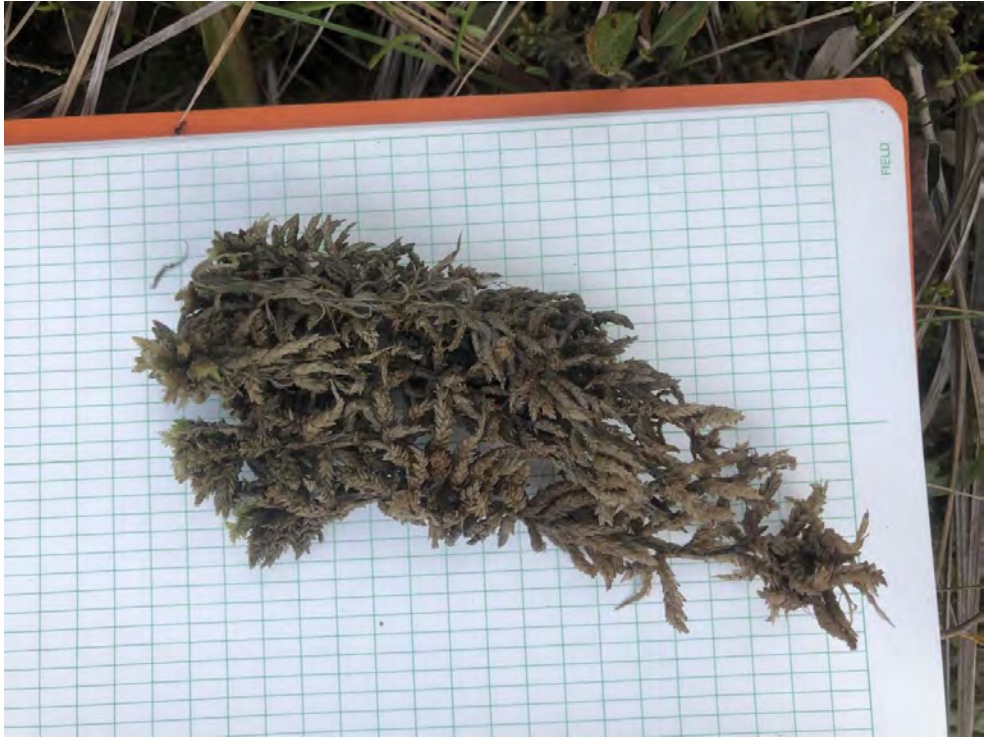
Dead and stressed plants were observed within parts of the open bog plant community. In low lying areas, there was heavy mortality of sphagnum moss and moderate mortality of graminoids (Appendix A, Photo 4). Moss in the affected areas was typically stained grey (Appendix A, Photo 5) or bleached white (Appendix A, Photo 6) and the living portions of surviving plants were restricted to the tips of the plants. Initially, it was thought that the mortality and stress might be attributable to dry growing conditions, however after a heavy rain event puddles of grey turbid water were observed in fresh footprints in these patches (Appendix A, Photo 7). When samples of wetted sphagnum moss were squeezed, grey turbid water was discharged, whereas under normal conditions, the water would typically be amber colored or stained black by fine organic matter.

Photo Location: Wetland 6			
Survey Date: 7/31/2019			
Comments: Staining of sphagnum moss.			
Photograph ID: 6

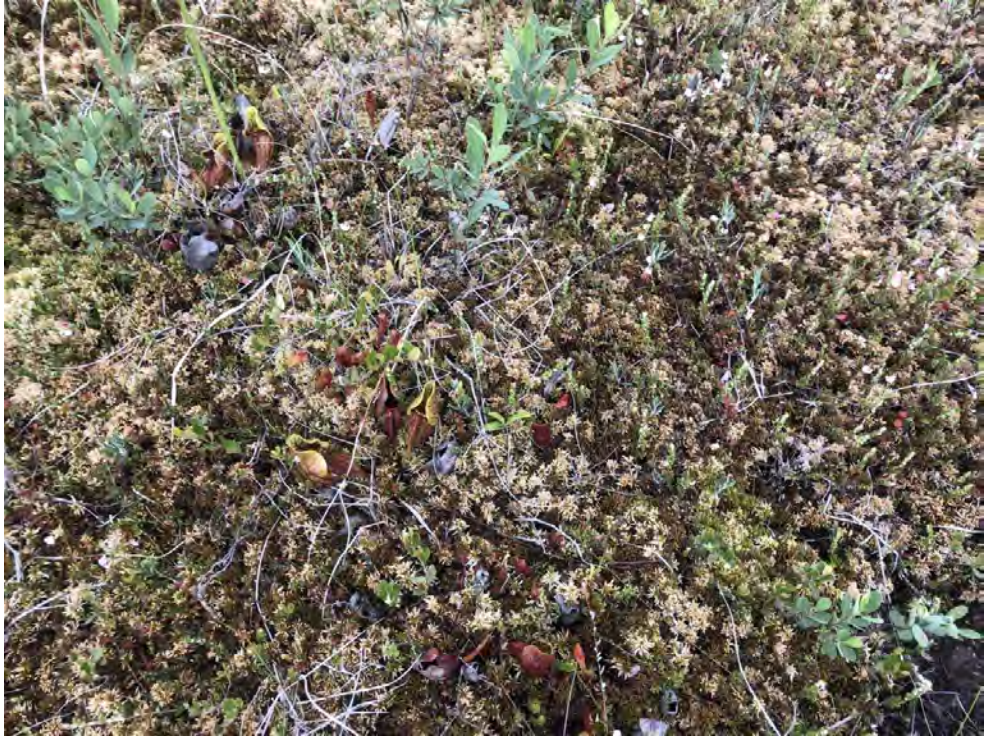
Photo Location: Wetland 6			
Survey Date: 7/31/2019			
Comments: Bleaching of sphagnum moss.

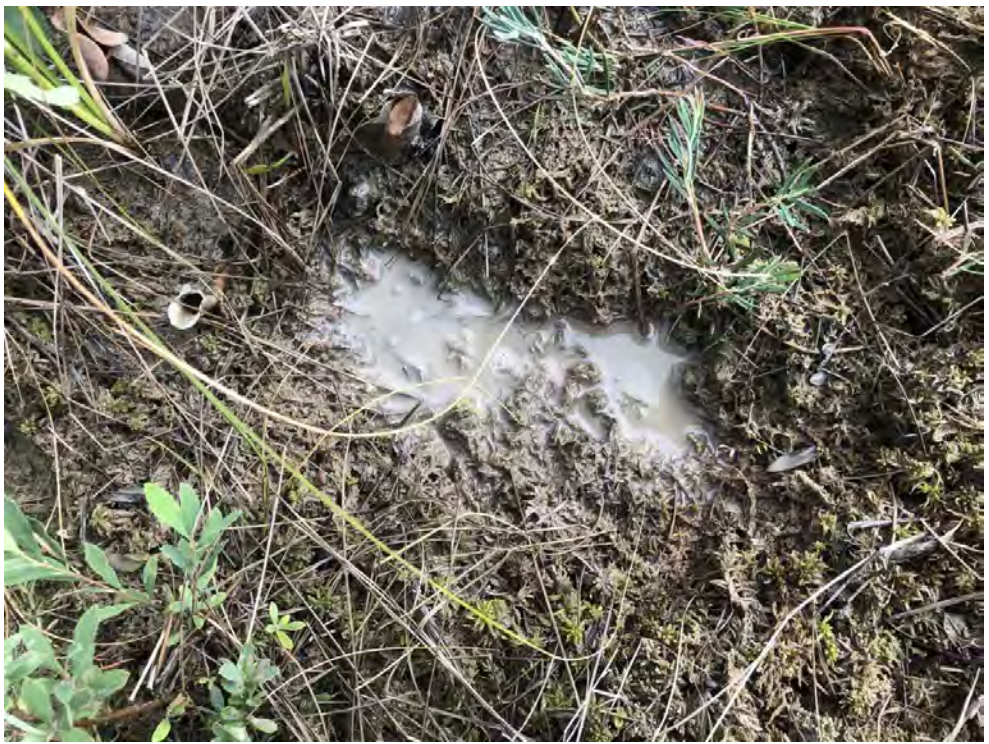
Client:	Atlantic Mining NS Corporation	Project:	Assessment of Watercourse WC4 and Associated Wetlands
Site Name:	Touquoy Mine	Site Location:	Moose River, Nova Scotia
Photograph ID: 7

Photo Location: Wetland 6			
Survey Date: 7/31/2019			
Comments: Turbid water in footprint in Wetland 6.			
Photograph ID: 8

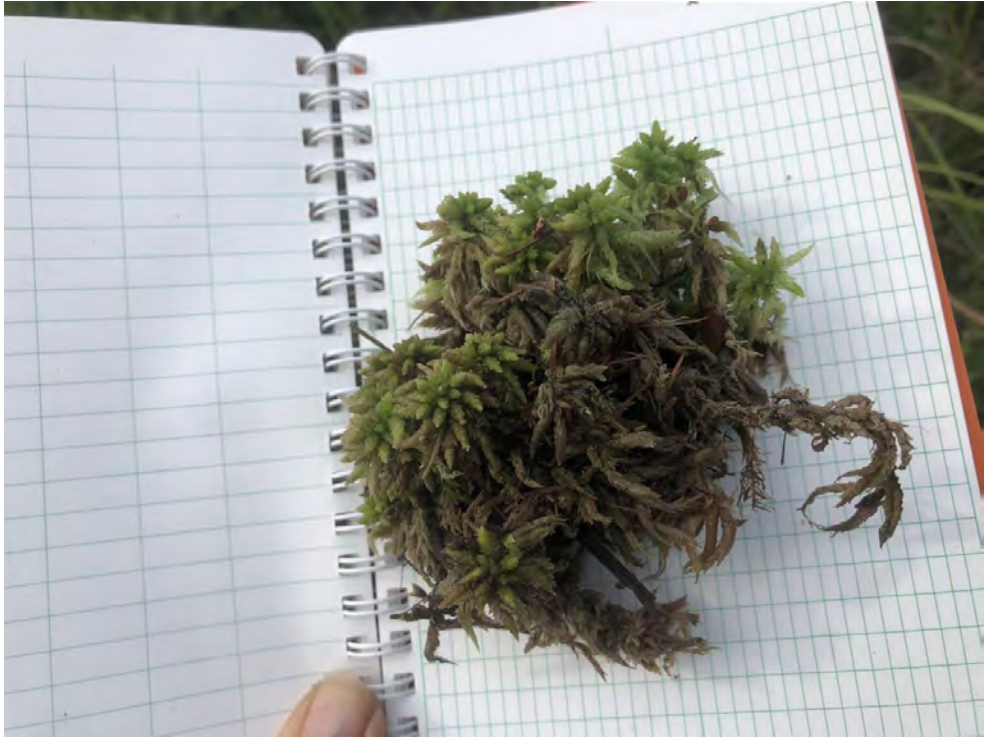
Sphagnum moss growing at higher elevations in the wetland appeared to be in good health with no grey staining or bleaching. When sphagnum moss from these areas was removed from the moss mat, the portions of the moss below the surface were stained grey and grey turbid water could be squeezed from the clumps of moss (Appendix A, Photo 8). Vascular plant species in higher elevation areas were in good health (Appendix A, Photo 9). No evidence of adverse effects to sphagnum moss or vascular plant species was observed in either the treed bog or the mixedwood treed swamp plant communities.

Photo Location: Wetland 6			
Survey Date: 7/31/2019			
Comments: Staining of sphagnum moss below peat surface in Wetland 6.

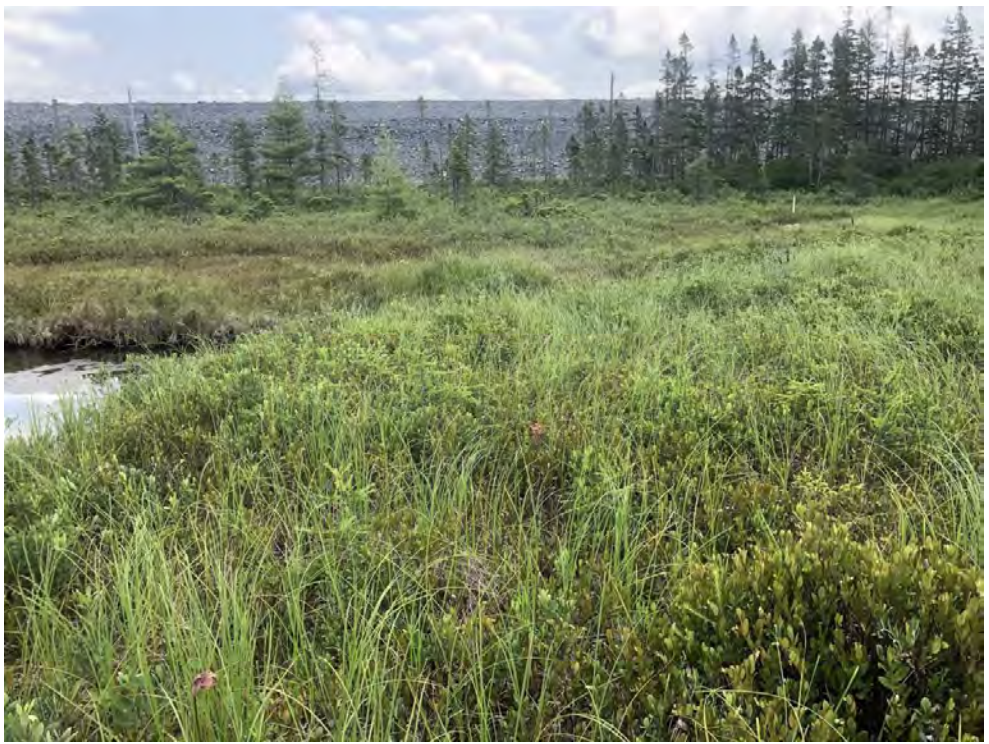
Photo Location: Wetland 6			
Survey Date: 7/31/2019			
Comments: Typical condition of wetland vegetation in Wetland 6.			
Photograph ID: 10

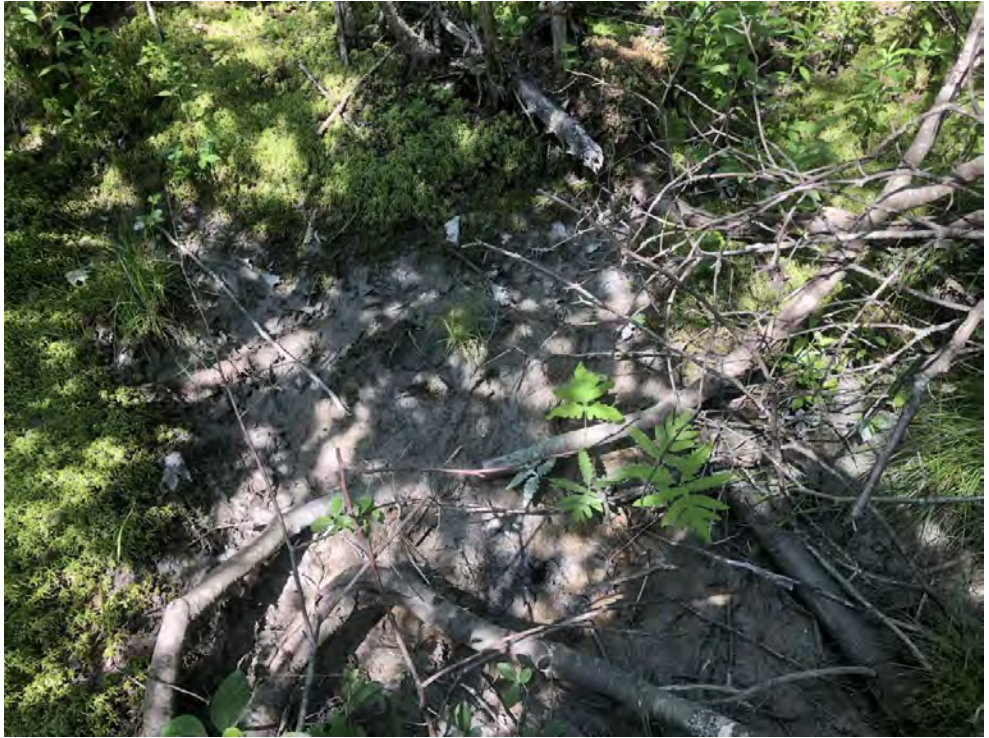
In Wetland 15, silt deposits were observed in areas of the wetland adjacent to the Admin Road. The silt consisted of grey deposits of silt. Areas of silt deposition based on the presence of grey silt were evident within the wetland approximately 90 m downgradient of the road.

Photo Location: Wetland 15			
Survey Date: 7/31/2019			
Comments: Typical sediment deposit in depressional areas in Wetland 15.

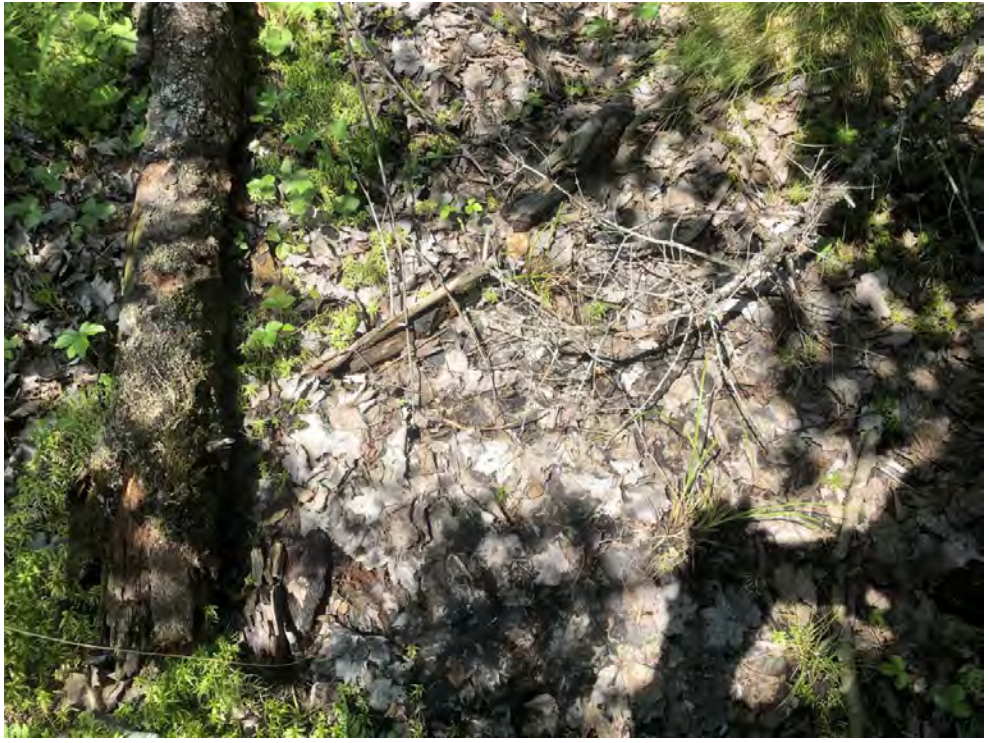
Although the depressions that contained silt had few plants, similar depressions without silt were also poorly vegetated (Appendix A, Photo 11), so this may reflect natural conditions rather than an effect of siltation. As such, the amount of wetland vegetation lost to silt deposition does not appear to be high. Furthermore, vegetation adjacent to the areas of silt deposition appeared healthy and dense.

Photo Location: Wetland 15			
Survey Date: 7/31/2019			
Comments: Depressional area in Wetland 15 unaffected by sediment deposition.

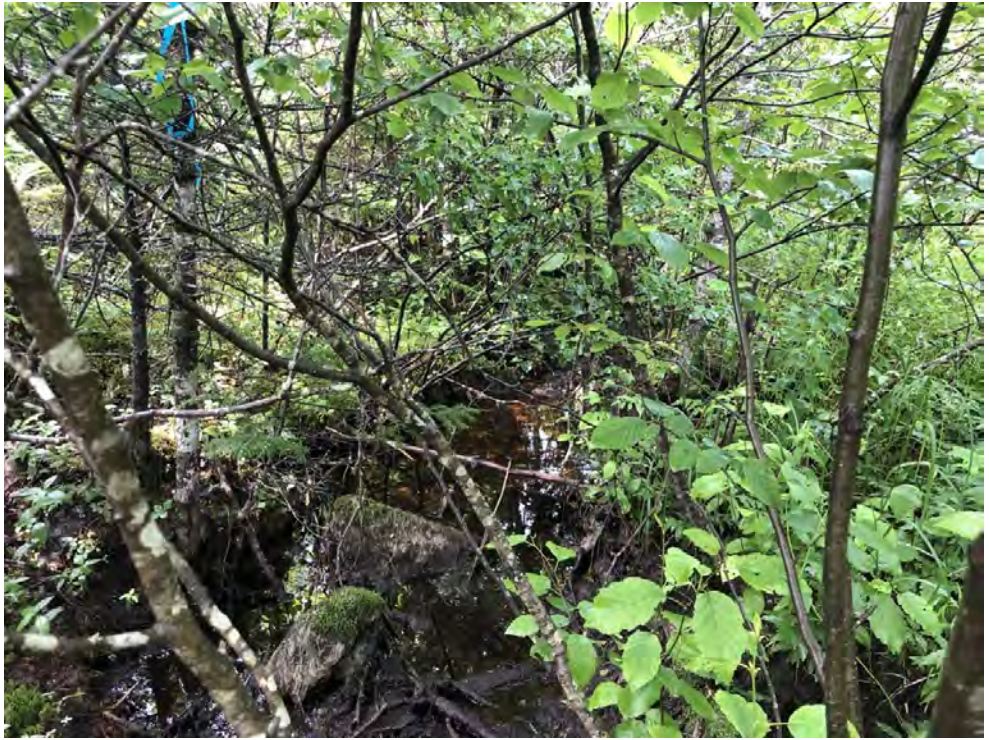
Client:	Atlantic Mining NS Corporation	Project:	Assessment of Watercourse WC4
Site Name:	Touquoy Mine	Site Location:	Moose River, Nova Scotia
Photograph ID: 1

Photo Location: Watercourse 4, Reach 1			
Direction: Upstream			
Survey Date: 8/1/2019			
Comments: Illustrating reference conditions of fish habitat, upstream of the Admin Road.			
Photograph ID: 2

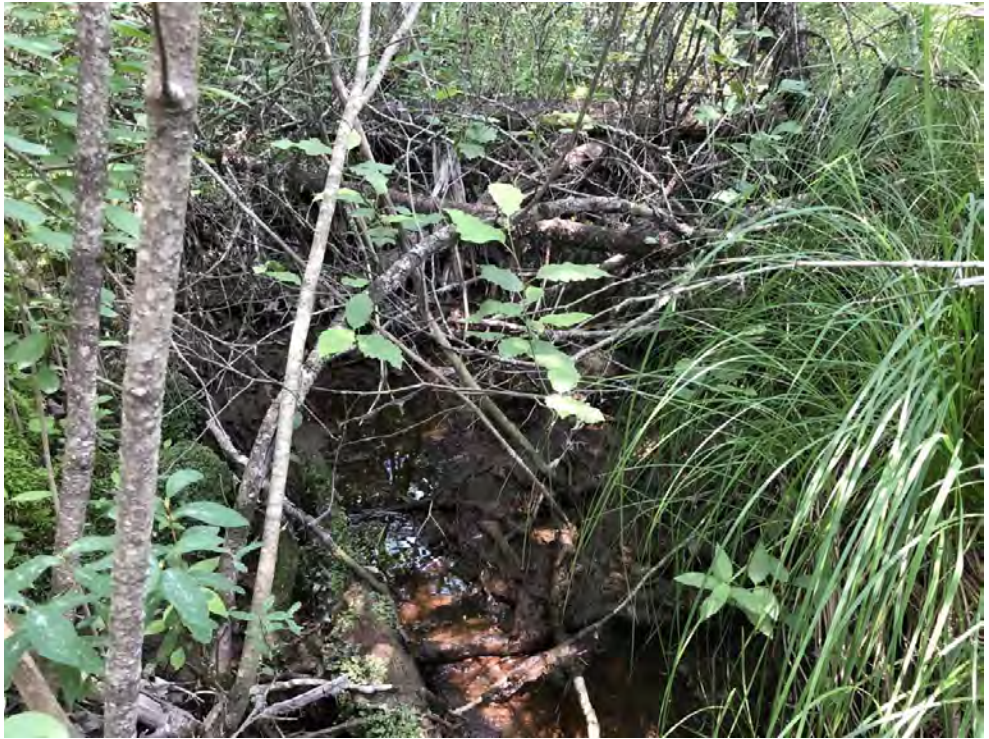
Photo Location: Watercourse 4, Reach 2			
Direction:			
Survey Date: 7/31/2019			
Comments: Representative intermittent stream fish habitat within 200 m of Admin Road Culvert. Negligible flow was observed.

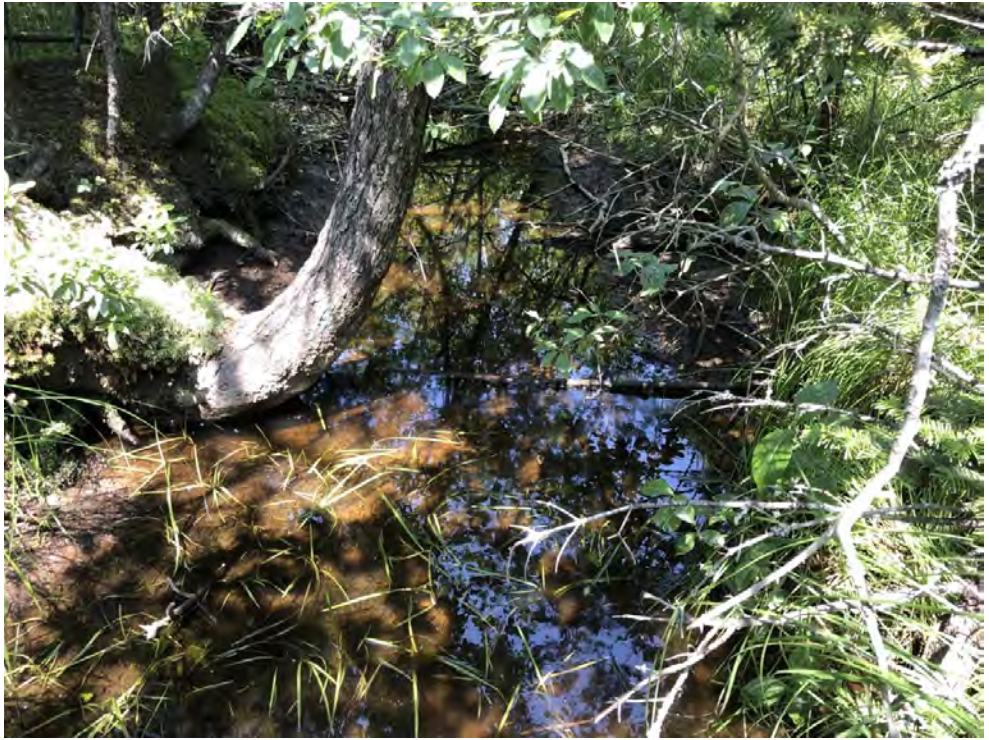
Client:	Atlantic Mining NS Corporation	Project:	Assessment of Watercourse WC4
Site Name:	Touquoy Mine	Site Location:	Moose River, Nova Scotia
Photograph ID: 3

Photo Location: Watercourse 4, Reach 2			
Direction:			
Survey Date: 7/31/2019			
Comments: Representative fish habitat within area of WC4 with permanent flow.			
Photograph ID: 4

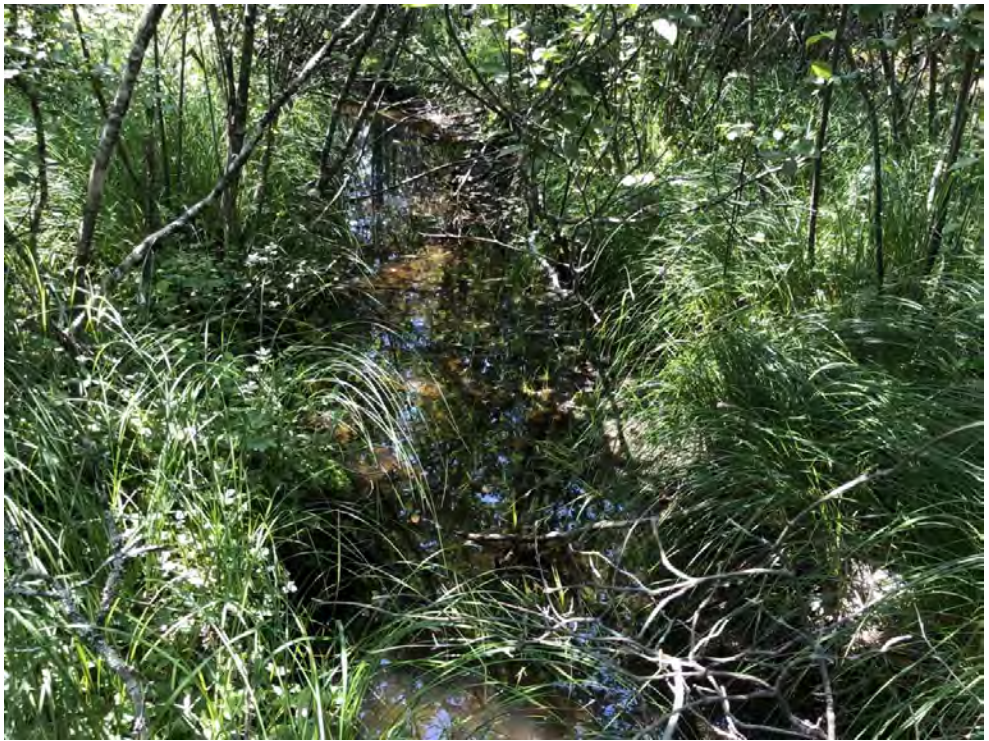
Photo Location: Watercourse 4, Reach 2			
Direction:			
Survey Date: 7/31/2019			
Comments: Representative fish habitat within area of WC4 with permanent flow.

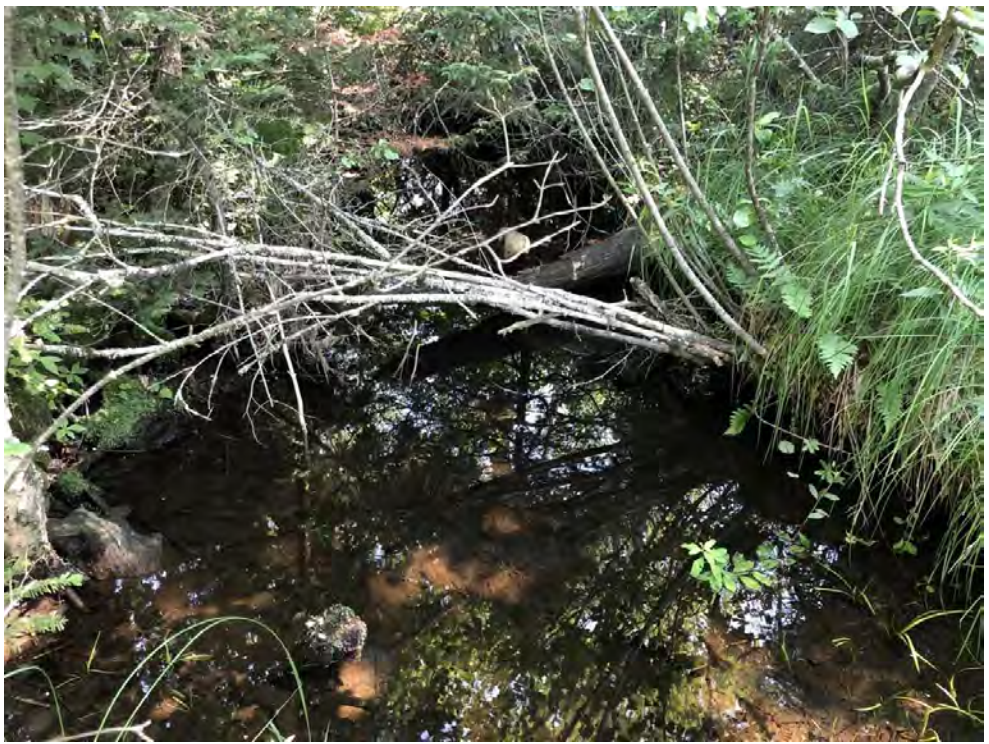
Client:	Atlantic Mining NS Corporation	Project:	Assessment of Watercourse WC4
Site Name:	Touquoy Mine	Site Location:	Moose River, Nova Scotia
Photograph ID: 5

Photo Location: Watercourse 4, Reach 2			
Direction: Downstream			
Survey Date: 7/31/2019			
Comments: Illustrating heavily vegetated riparian zones.			
Photograph ID: 6

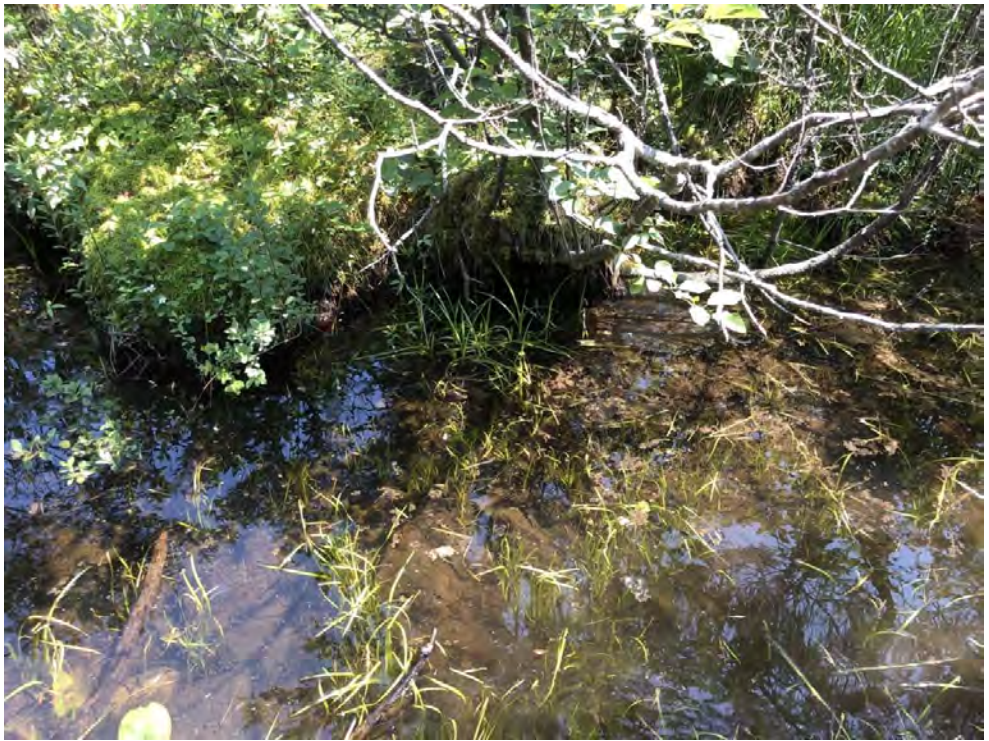
Photo Location: Watercourse 4, Reach 2			
Direction: Left Bank			
Survey Date: 7/31/2019			
Comments: Illustrating aquatic vegetation and substrates.

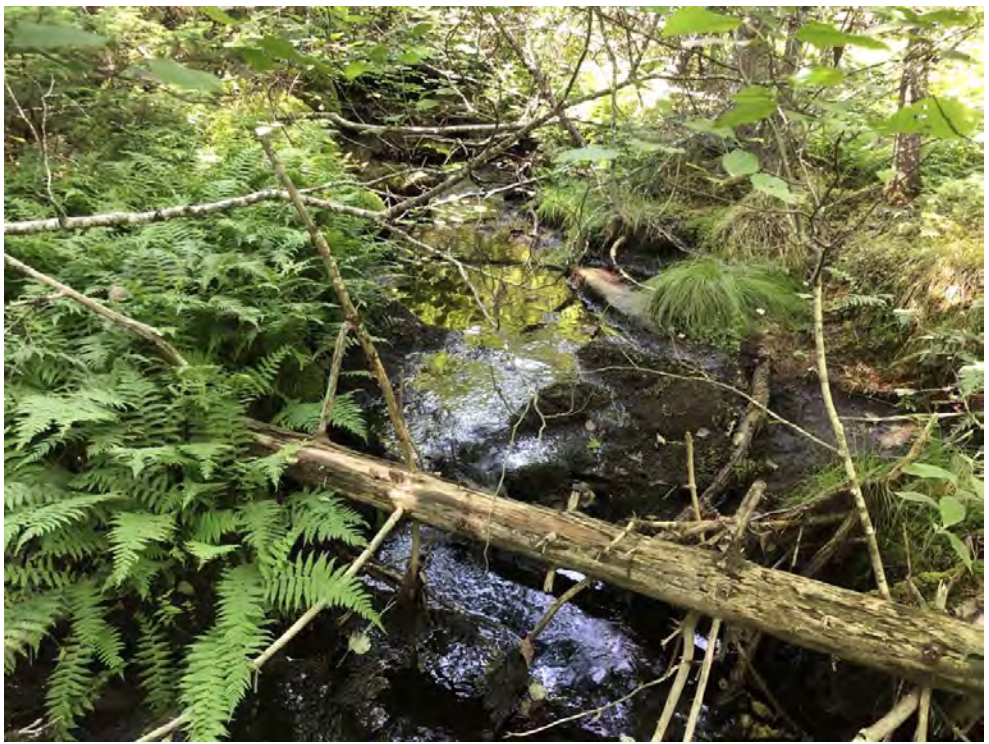
Client:	Atlantic Mining NS Corporation	Project:	Assessment of Watercourse WC4
Site Name:	Touquoy Mine	Site Location:	Moose River, Nova Scotia
Photograph ID: 9

Photo Location: Watercourse 4, Reach 2			
Direction: Upstream			
Survey Date: 7/31/2019			
Comments: Representative flowing habitat.			
Photograph ID: 10

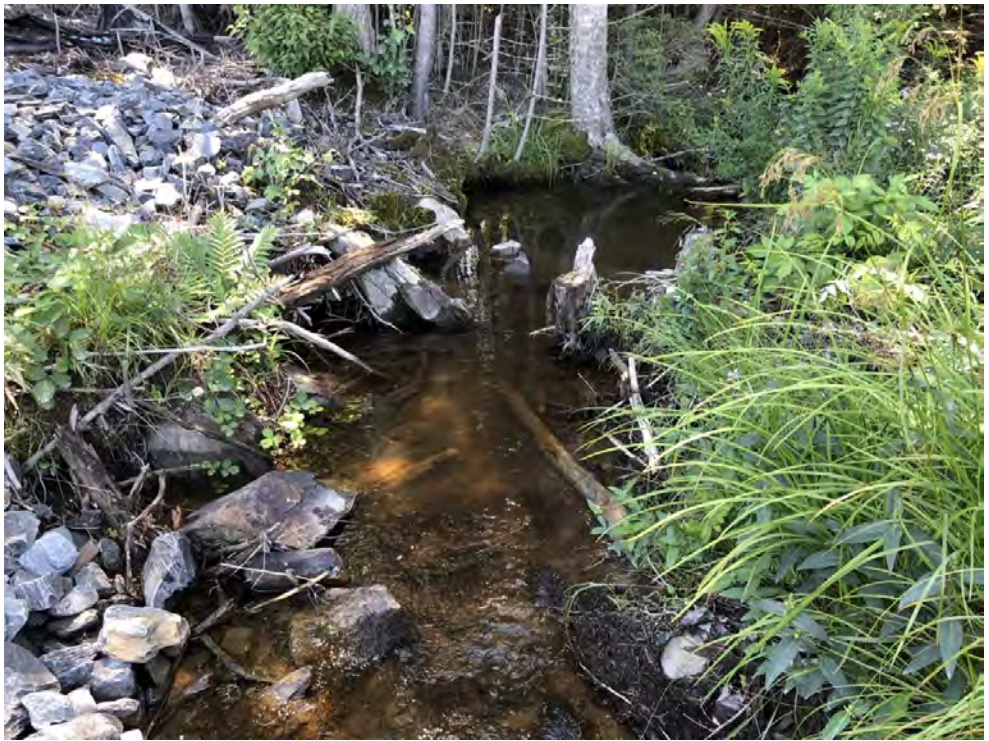
Photo Location: Watercourse 4, Reach 2			
Direction: Left Bank			
Survey Date: 7/31/2019			
Comments: Representative swift-flowing fish habitat, downstream of Culvert 4A.

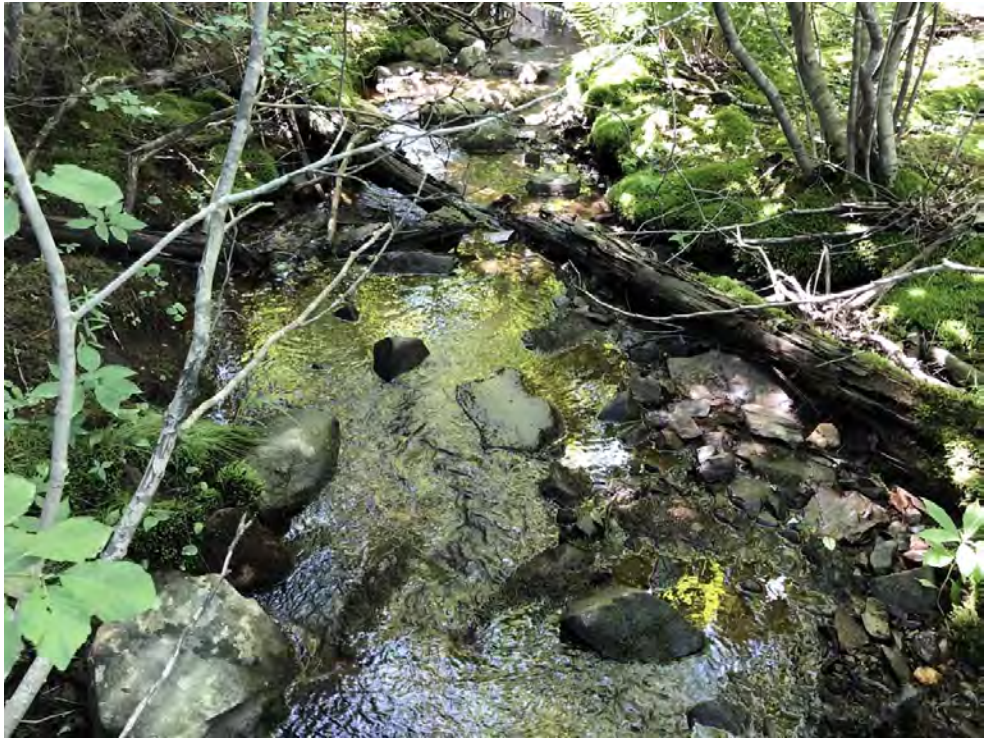
Client:	Atlantic Mining NS Corporation	Project:	Assessment of Watercourse WC4
Site Name:	Touquoy Mine	Site Location:	Moose River, Nova Scotia
Photograph ID: 11

Photo Location: Watercourse 4, Reach 2			
Direction: Downstream			
Survey Date: 8/14/2019			
Comments: Representative fish habitat, downstream of Mooseland Road.			
Photograph ID: 12

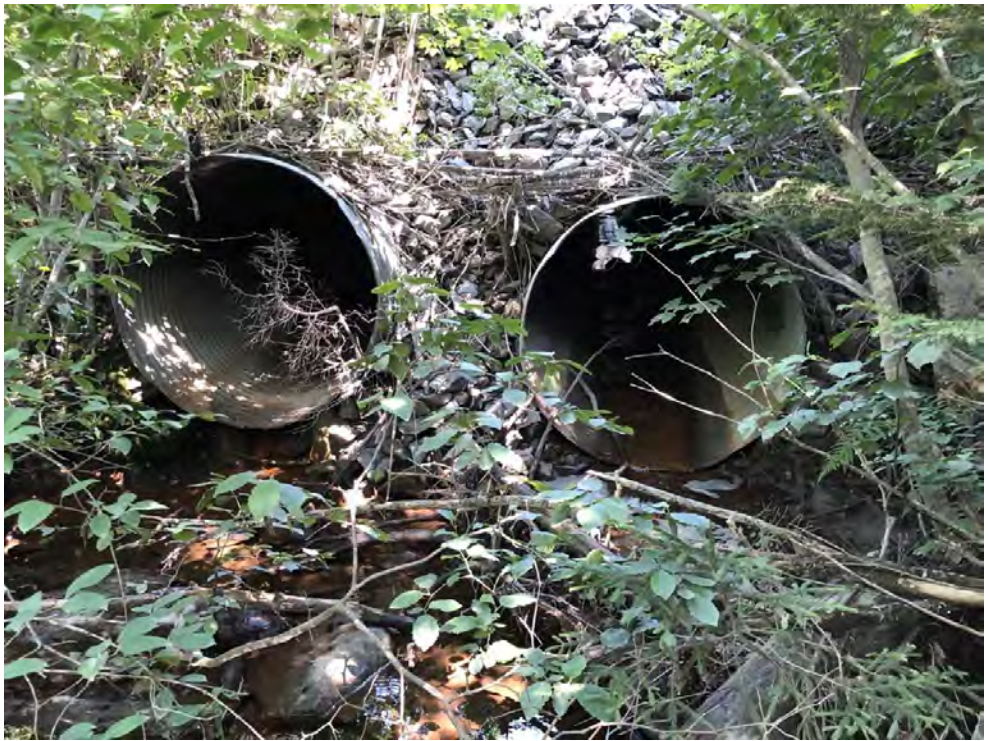
Photo Location: Watercourse 4, Reach 2			
Direction: Upstream			
Survey Date: 8/14/2019			
Comments: Illustrating perched outlets of twin corrugated steel culverts running under Mooseland Road.

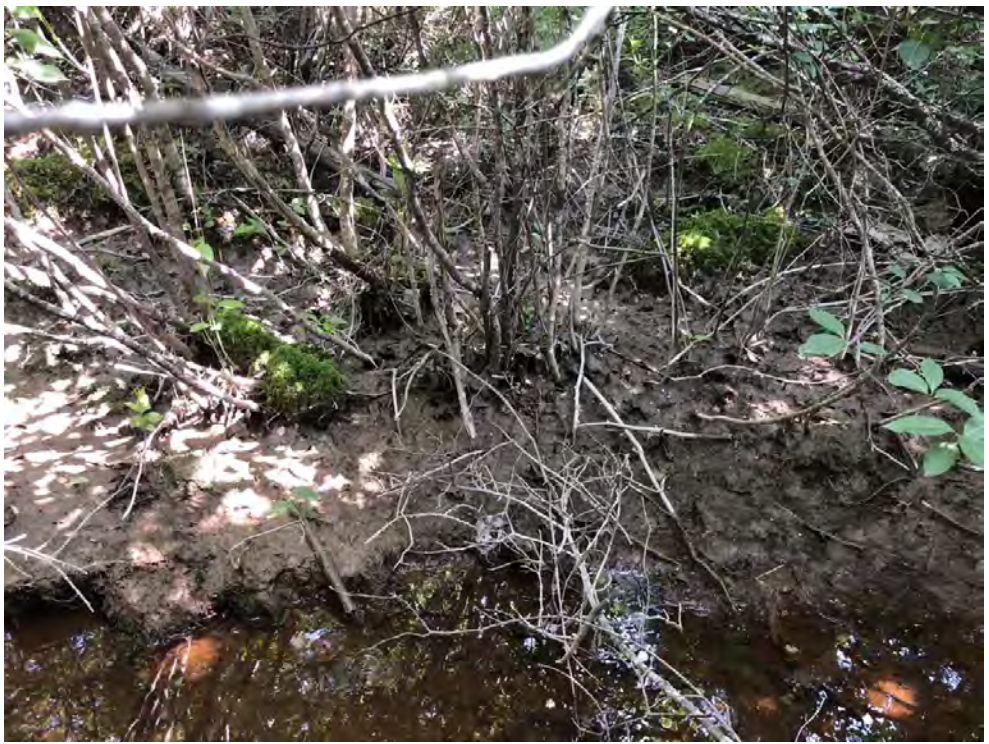
Brown silt was observed within Reach 2 downstream of the Admin Road within the intermittent portion of WC4 along the stream banks (Appendix B, Photo 13). This silt did not appear to be the same material as the silt that was observed on the mine roads, which was grey in colour. Approximately 80 m downstream a root mass plugged with debris accumulated the brown sediment (Appendix B, Photo 14). At 100 m downstream the brown sediment was no longer apparent within the riparian area and was apparent within the edges of the wetted channel (Appendix B, Photo 15). Small quantities of grey silt were apparent along the stream edges and depositional areas within Reach 2 (Photo 16, 18, and 19). Downstream of culvert 4A grey silt was visible within the pool and along the edges of the pool (Appendix B, Photo 17).

Photo Location: Watercourse 4, Reach 2			
Direction: Left Bank			
Survey Date: 7/31/2019			
Comments: Fine sediment observed along edges of watercourse and within the riparian area above existing bankfull level.			
Photograph ID: 14

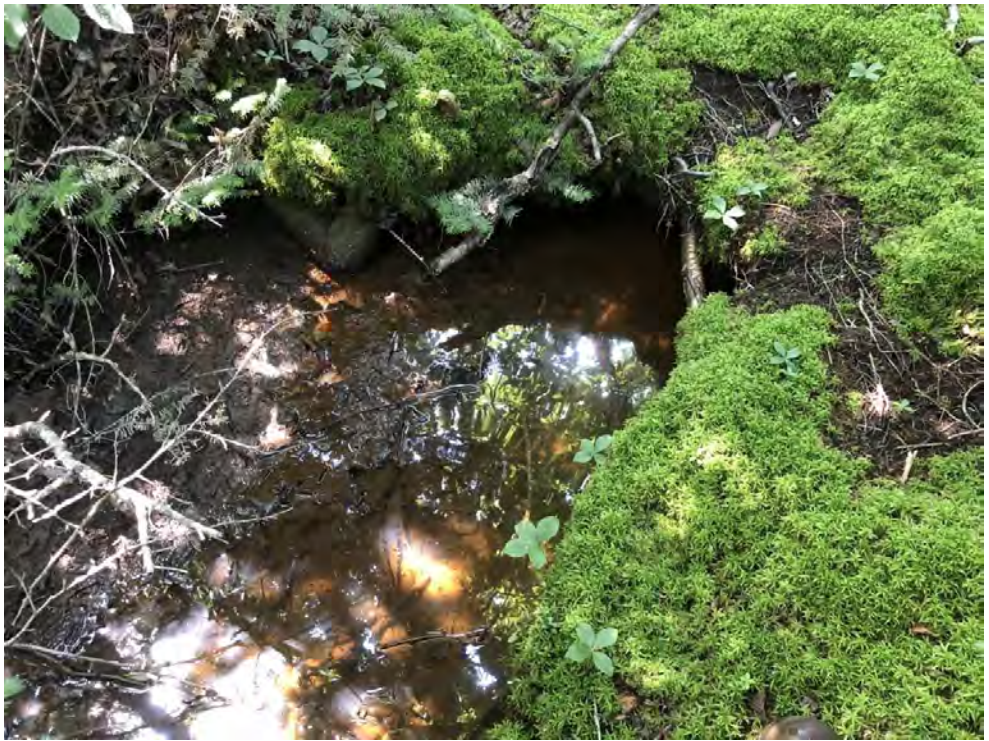
Photo Location: Watercourse 4, Reach 2			
Direction: Upstream			
Survey Date: 7/31/2019			
Comments: Illustrating a sediment plugged root mass through which the watercourse filters.

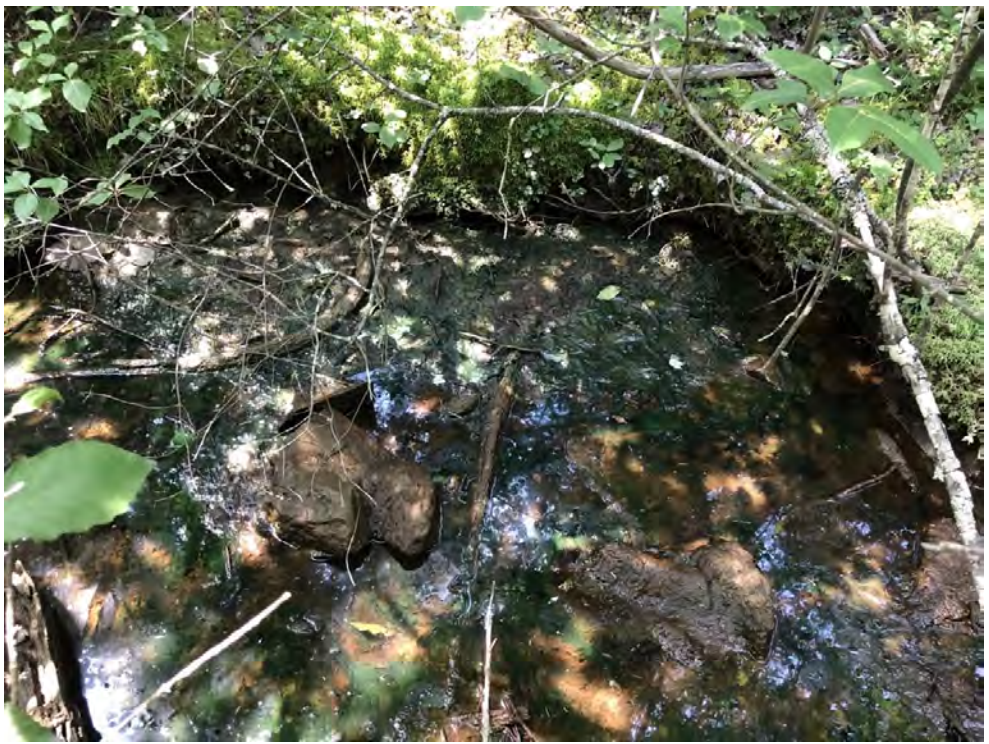
Photo Location: Watercourse 4, Reach 2			
Direction: Left Bank			
Survey Date: 7/31/2019			
Comments: Brown sediment deposited along banks within wetted channel, however no longer apparent within riparian area.			
Photograph ID: 16

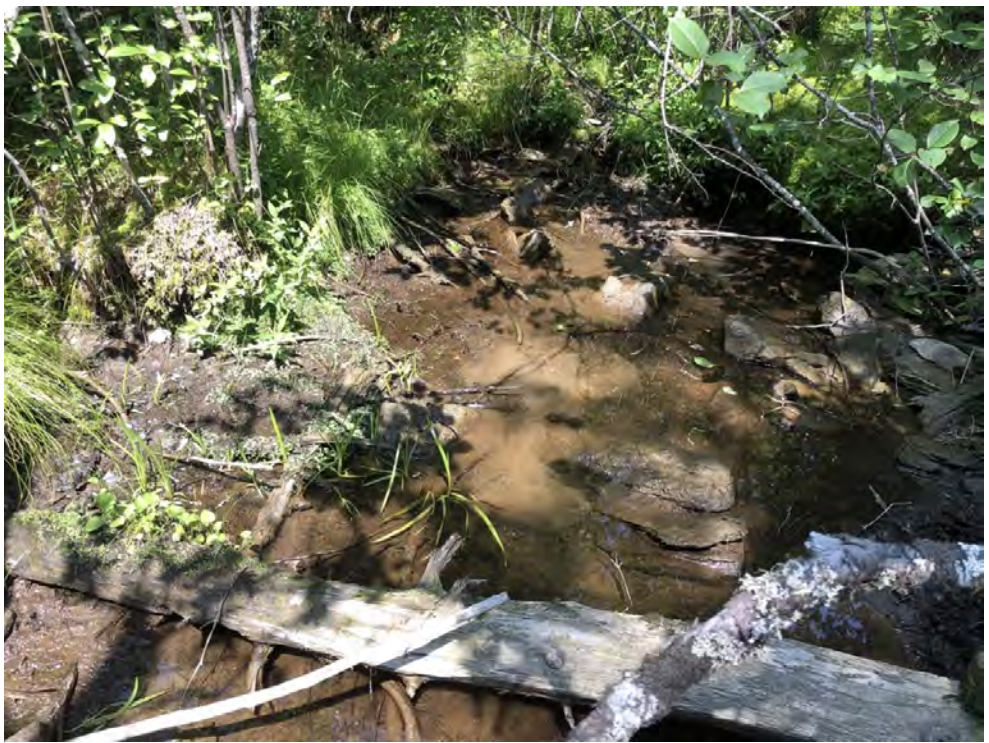
Photo Location: Watercourse 4, Reach 2			
Direction: Upstream			
Survey Date: 7/31/2019			
Comments: Illustrating areas of deposition along banks.

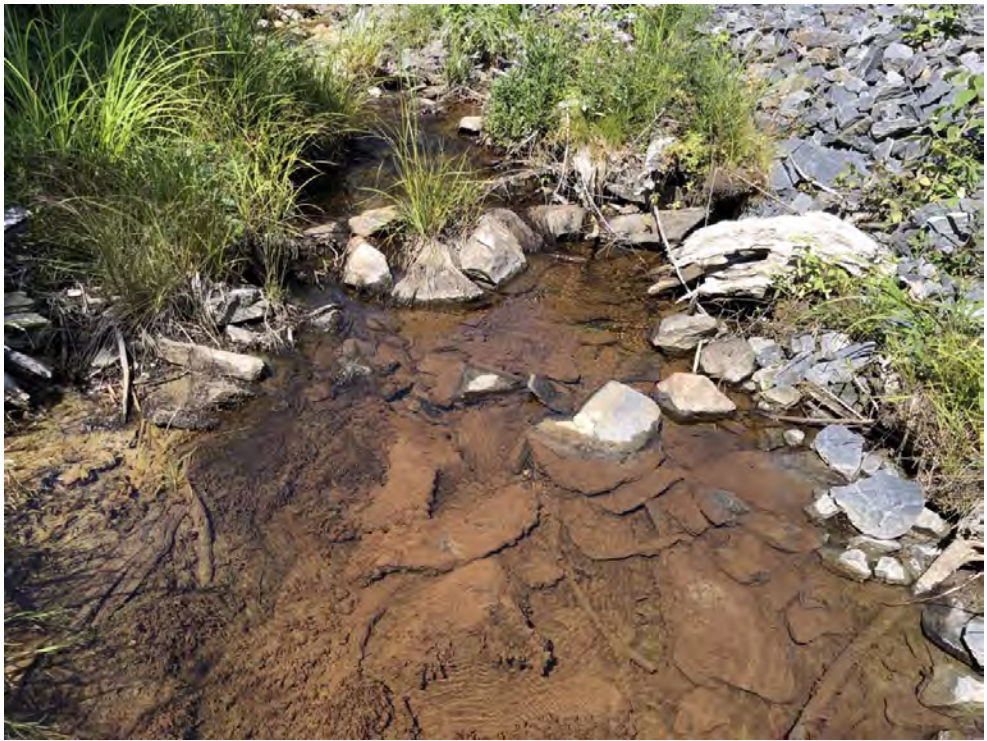
Photo Location: Watercourse 4, Reach 2			
Direction: Upstream			
Survey Date: 8/14/2019			
Comments: Illustrating deposition of grey silt, riparian vegetation and substrate. Downstream of Waste Rock Haul Road at Culvert 4A.

Siltation is evident in WC4 within the surveyed area and the silt observed appears consistent with the grey silt that accumulates on the mine roads. Siltation is most evident in areas immediately downstream of the Waste Rock Haul Road at Culvert 4A and TMF Haul Road at Culvert 4B and within the slow-moving sections of WC 4 (Reach 3), where it flows through Wetland 6.

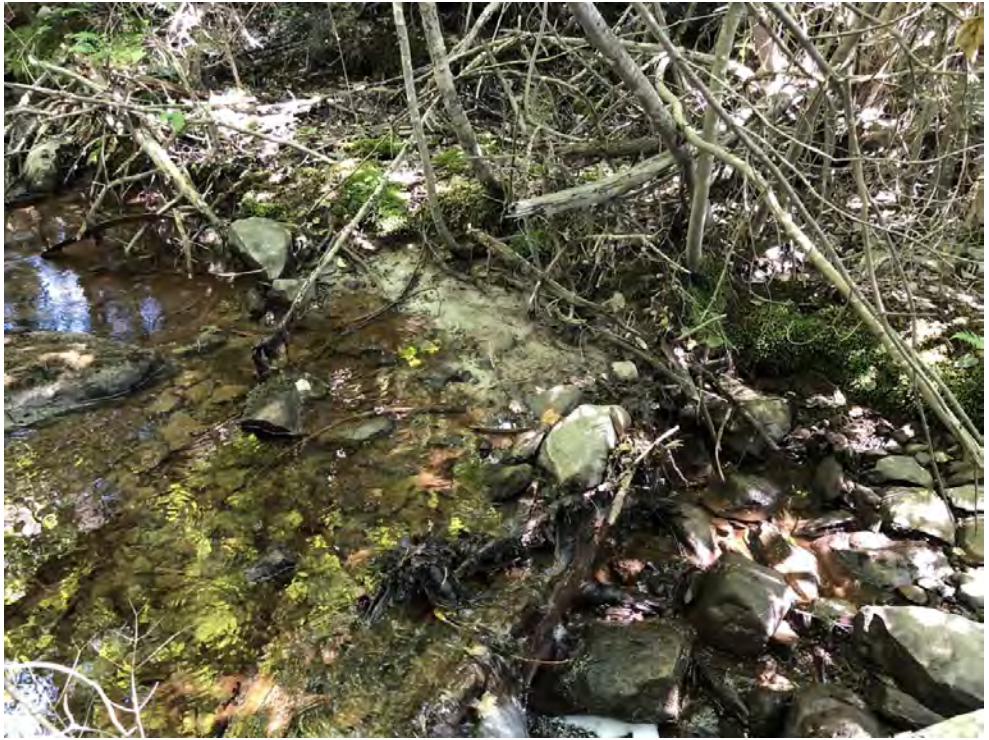
Photo Location: Watercourse 4, Reach 2			
Direction: Left Bank			
Survey Date: 8/14/2019			
Comments: Illustrating deposition of grey silt localized to one area near the bank. Downstream of the culvert on Mooseland Road.			
Photograph ID: 20
