**Assessment of Wetlands 6 and 15
and Watercourse 4, Touquoy
Mine, Nova Scotia**

Watercourse and Wetland Assessment
to fulfill the requirements of Nova Scotia
Environment Directives #12628894 and
#12776418

December 19, 2019

Stantec Consulting Ltd.
845 Prospect Street
Fredericton NB E3B 2T7

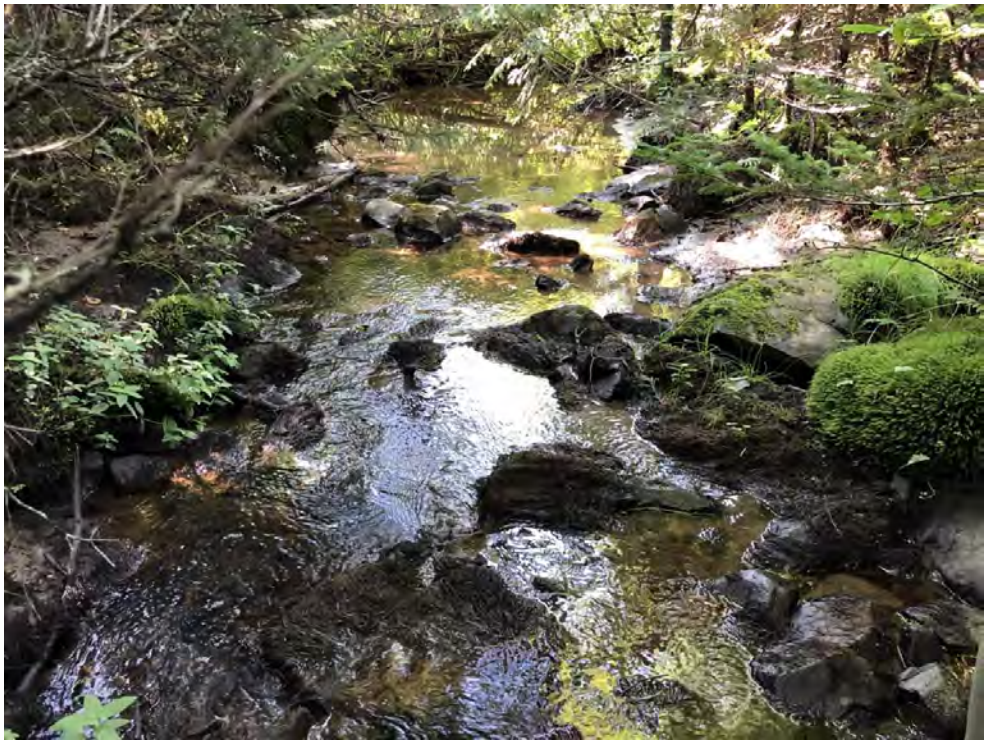
Photo Location: Watercourse 4, Reach 3			
Direction: Downstream			
Survey Date: 8/14/2019			
Comments: Representative swift-moving fish habitat.

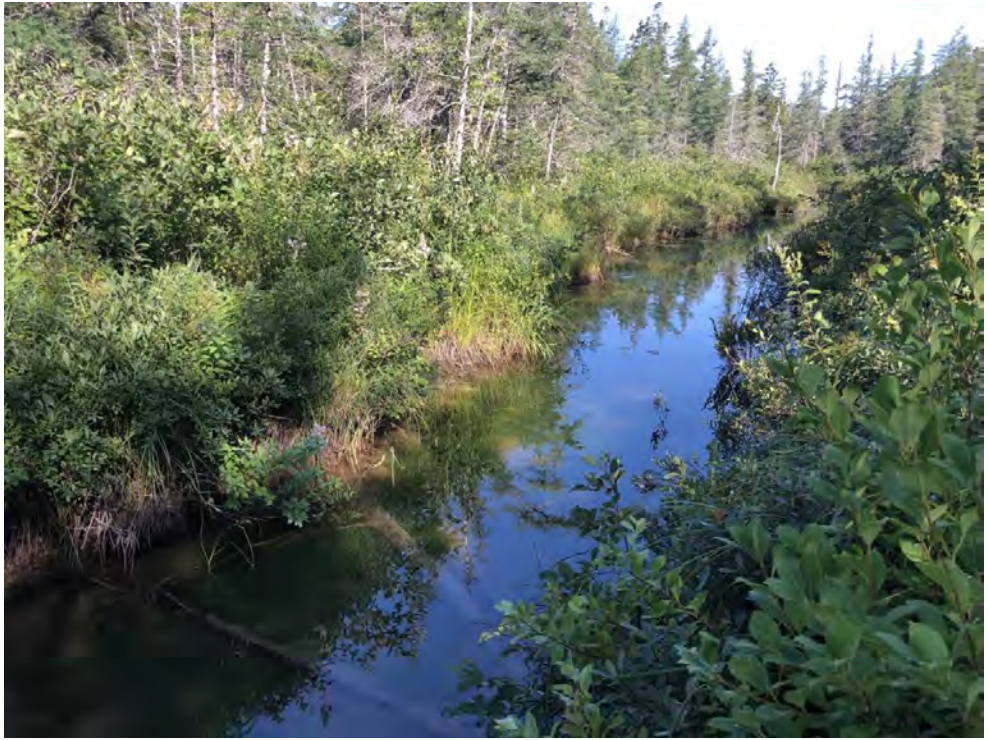
Client:	Atlantic Mining NS Corporation	Project:	Assessment of Watercourse WC4
Site Name:	Touquoy Mine	Site Location:	Moose River, Nova Scotia
Photograph ID: 21

Photo Location: Watercourse 4, Reach 3			
Direction: Downstream			
Survey Date: 8/1/2019			
Comments: Representative swift-moving fish habitat.			
Photograph ID: 22

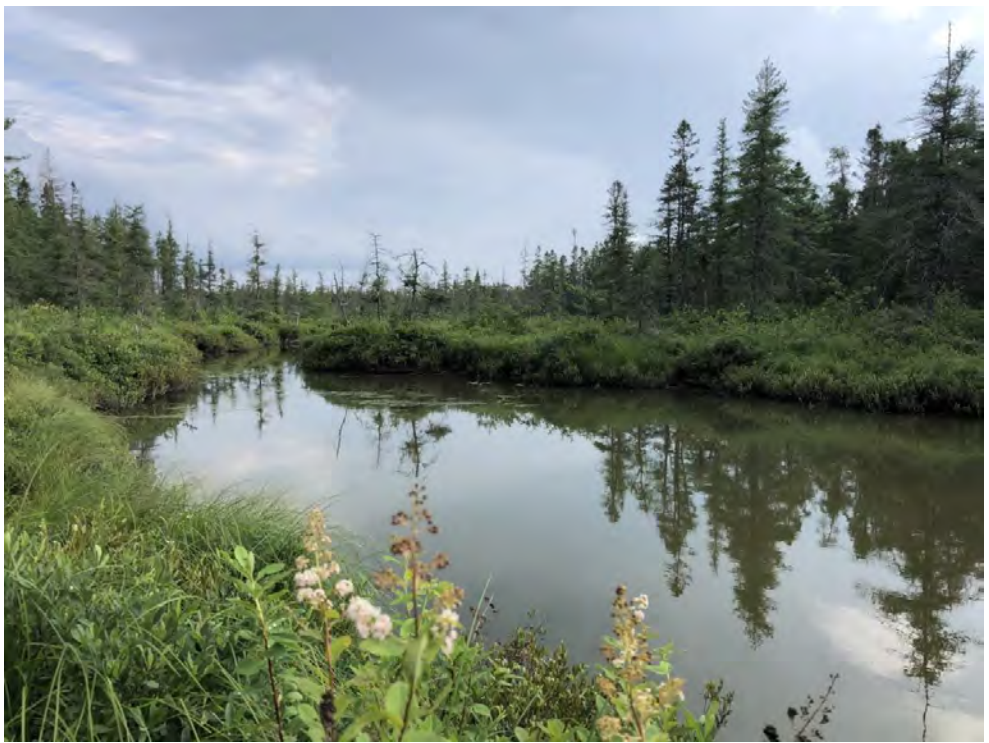
Photo Location: Watercourse 4, Reach 3			
Direction: Upstream			
Survey Date: 8/1/2019			
Comments: Visual signs of turbidity within slow-moving section.

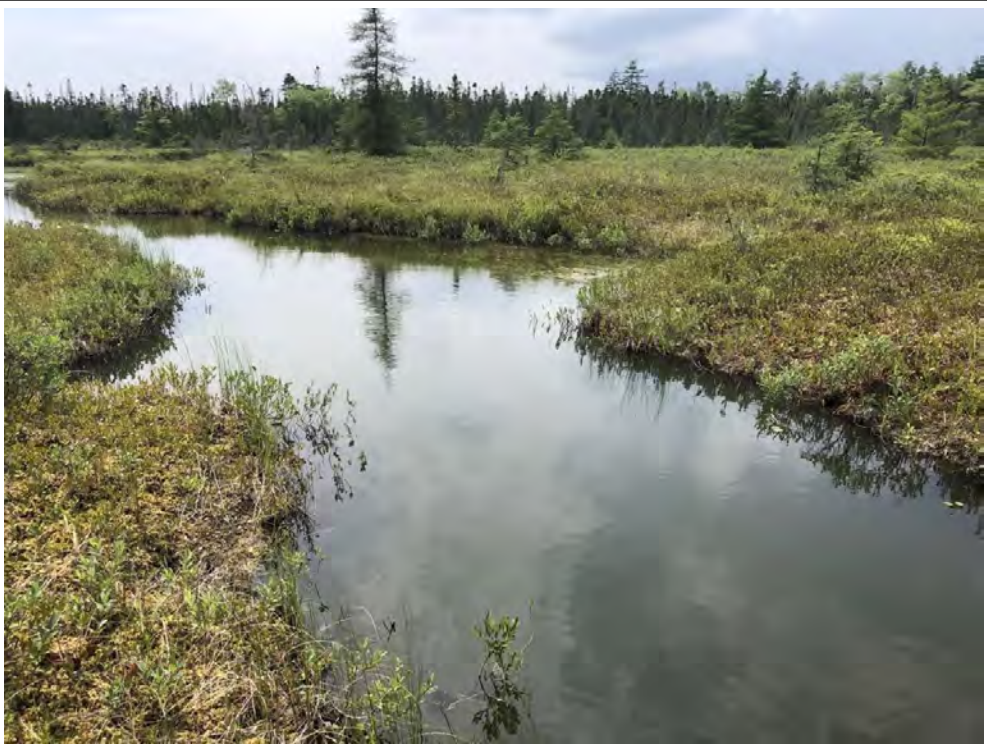
Client:	Atlantic Mining NS Corporation	Project:	Assessment of Watercourse WC4
Site Name:	Touquoy Mine	Site Location:	Moose River, Nova Scotia
Photograph ID: 23

Photo Location: Watercourse 4, Reach 3			
Direction: Downstream			
Survey Date: 8/1/2019			
Comments: Representative slow-moving habitat, within Wetland 6.			
Photograph ID: 24

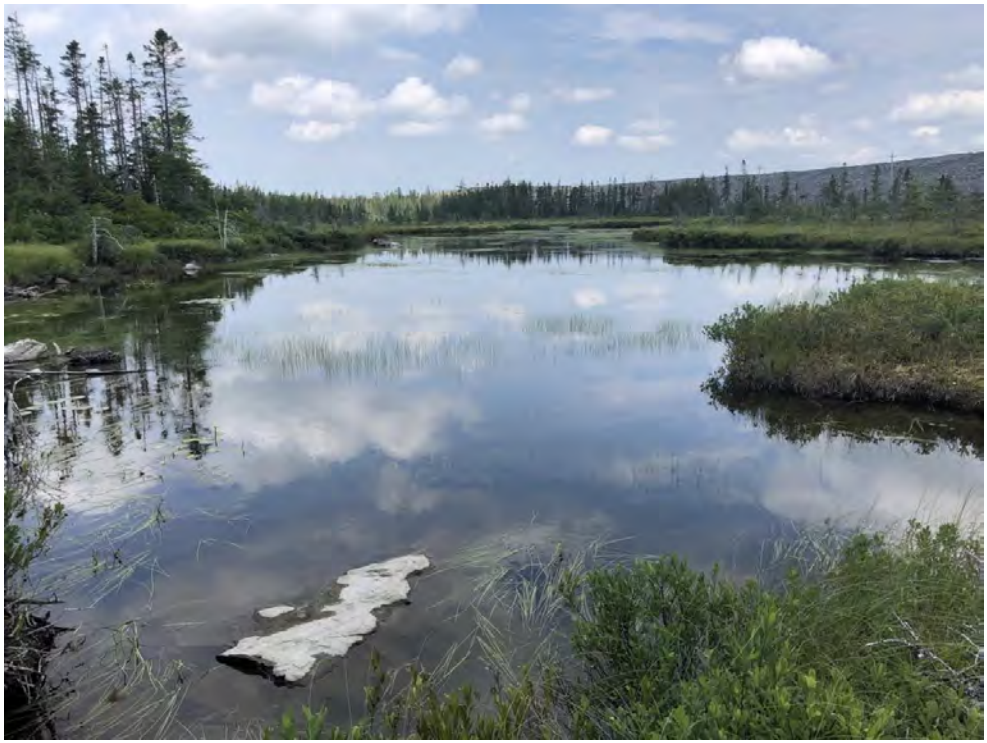
Photo Location: Watercourse 4, Reach 3			
Direction: Upstream			
Survey Date: 8/1/2019			
Comments: Representative slow-moving habitat, within Wetland 6.

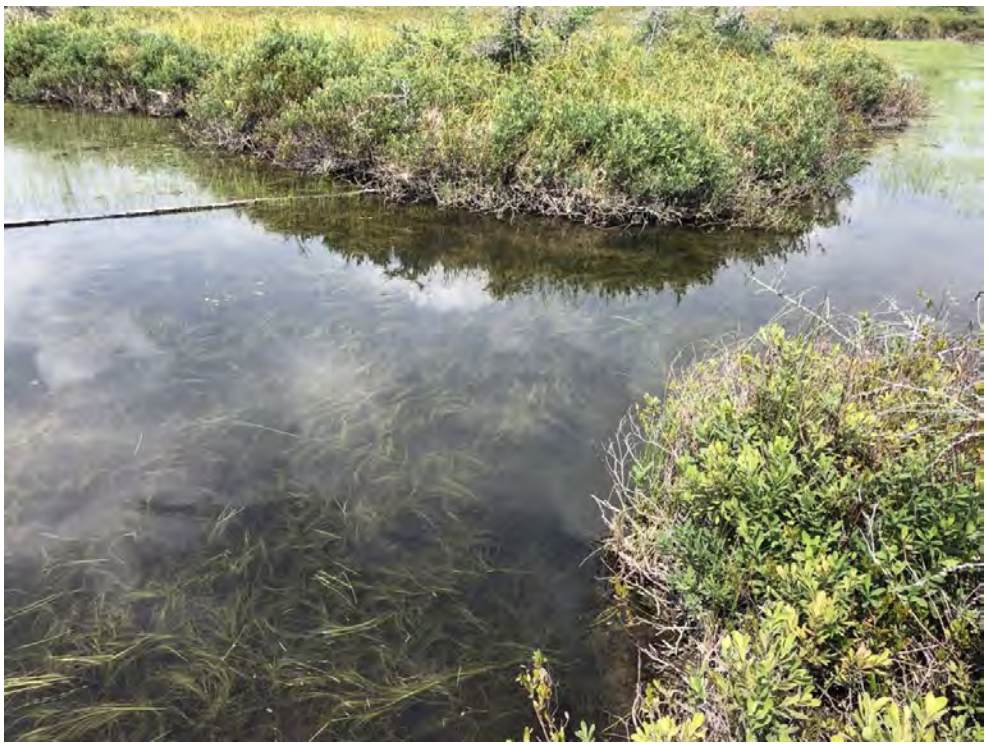
Client:	Atlantic Mining NS Corporation	Project:	Assessment of Watercourse WC4
Site Name:	Touquoy Mine	Site Location:	Moose River, Nova Scotia
Photograph ID: 25

Photo Location: Watercourse 4, Reach 3			
Direction:			
Survey Date: 8/1/2019			
Comments: Representative fish habitat. Aquatic vegetation is abundant.			
Photograph ID: 26

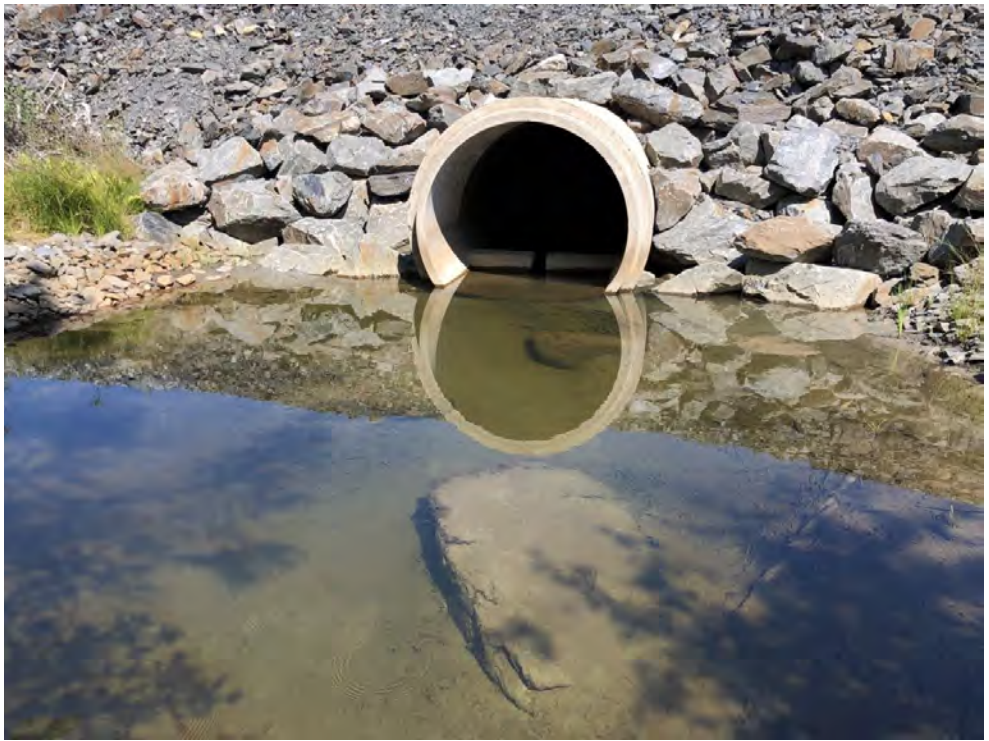
Grey silt was most prevalent within Reach 3. Grey silt was observed downstream of the TMF Haul road in the pool below culvert 4B (Appendix B, Photo 26). Fine grey silt was also observed along the bank edges within the swift-flowing sections, riparian areas and interstitial spaces between rocks (Appendix B, Photo 27-30). Water within the upstream end of this reach was generally clear and there were a few areas where increased turbidity was apparent (Appendix B, Photo 31). The substrate within the slow-moving fish habitat consisted of fine grey silt and this silt was also apparent within the riparian area of the watercourse (Appendix B, Photo 32-33).

Photo Location: Watercourse 4, Reach 3			
Direction: Upstream			
Survey Date: 8/14/2019			
Comments: Illustrating baffled concrete Culvert 4B at the TMF Haul Road, and the downstream pool laden with mine sediment.

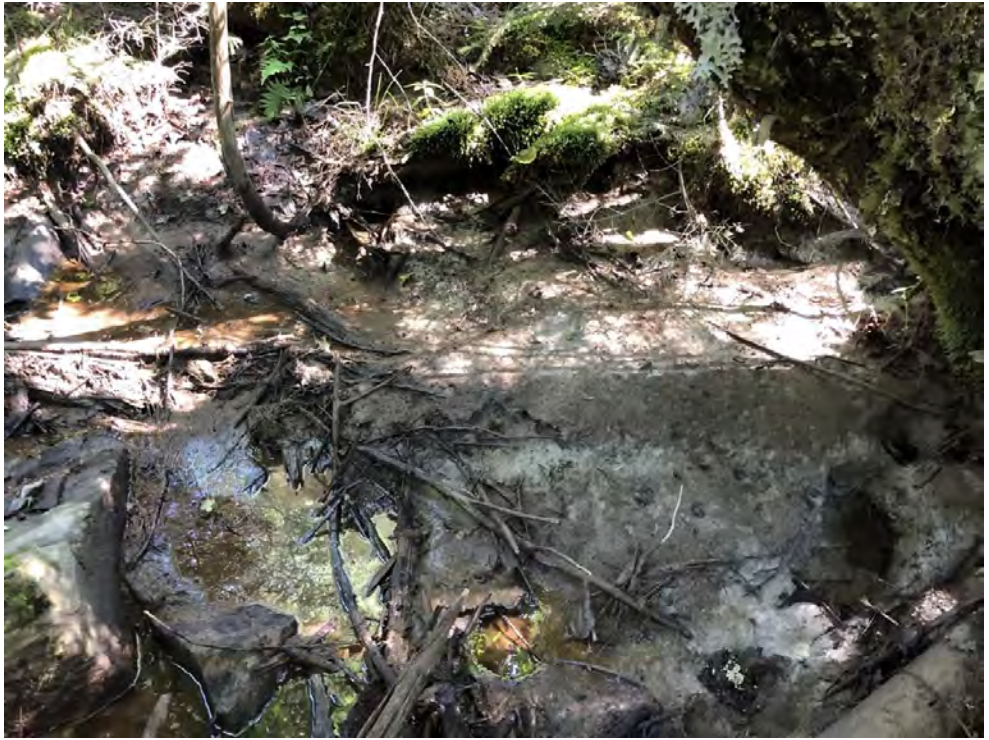
Photo Location: Watercourse 4, Reach 3			
Direction: Left Bank			
Survey Date: 8/14/2019			
Comments: Grey silt deposition along left bank, downstream of Culver 4B.			
Photograph ID: 28

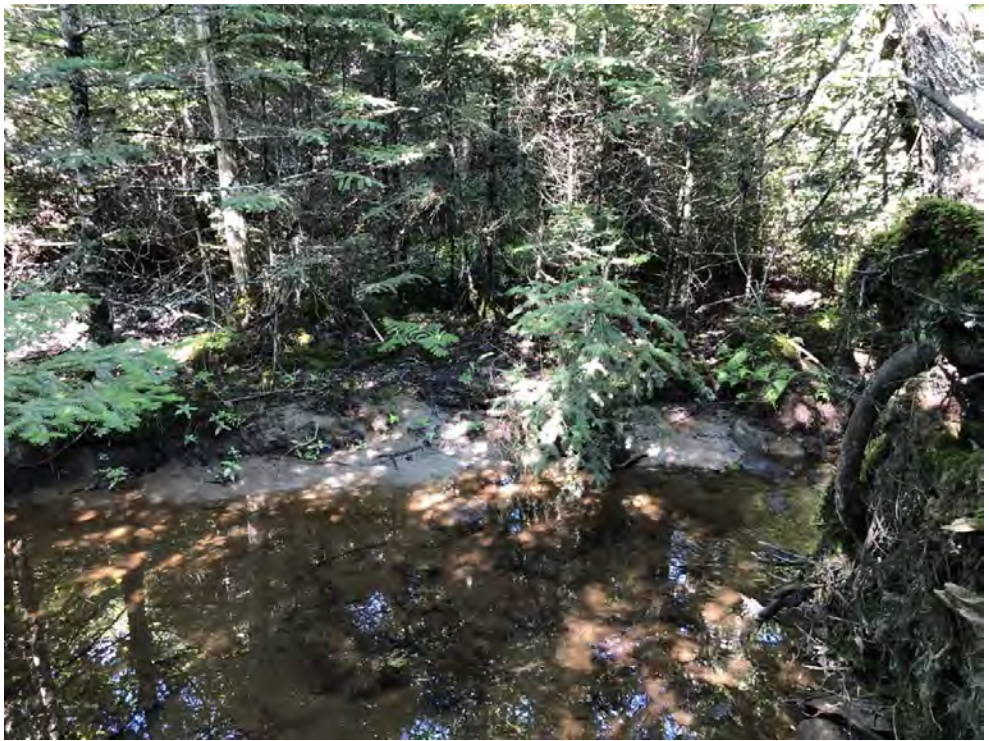
Photo Location: Watercourse 4, Reach 3			
Direction: Right Bank			
Survey Date: 8/14/2019			
Comments: Illustrating deposition of grey silt along the banks and throughout the watercourse.

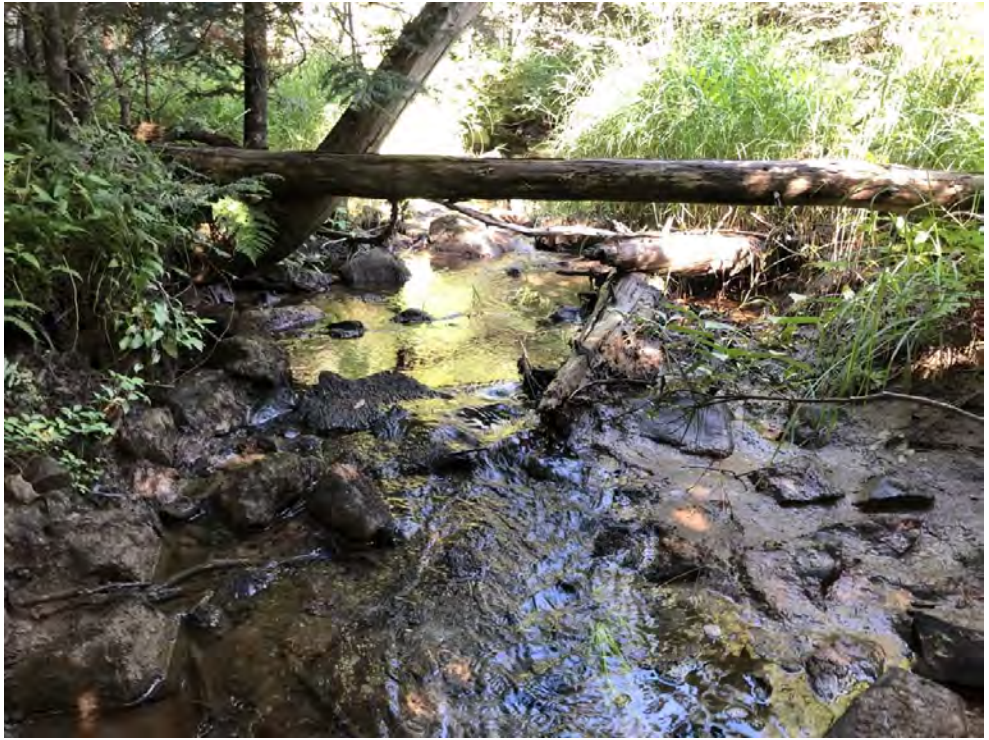
Photo Location: Watercourse 4, Reach 3			
Direction: Upstream			
Survey Date: 8/14/2019			
Comments: Grey silt observed within depositional areas near the banks and within rock crevices.			
Photograph ID: 30

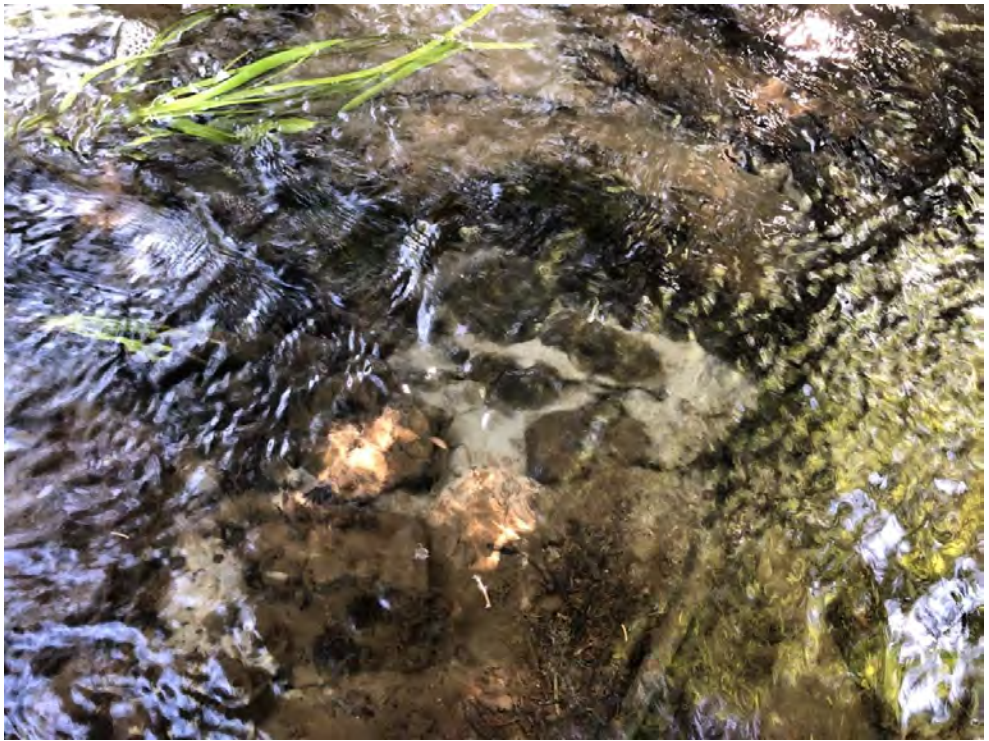
Photo Location: Watercourse 4, Reach 3			
Direction: Right Bank			
Survey Date: 8/14/2019			
Comments: Fine grey silt within spaces of coarse substrates within flowing water sections.

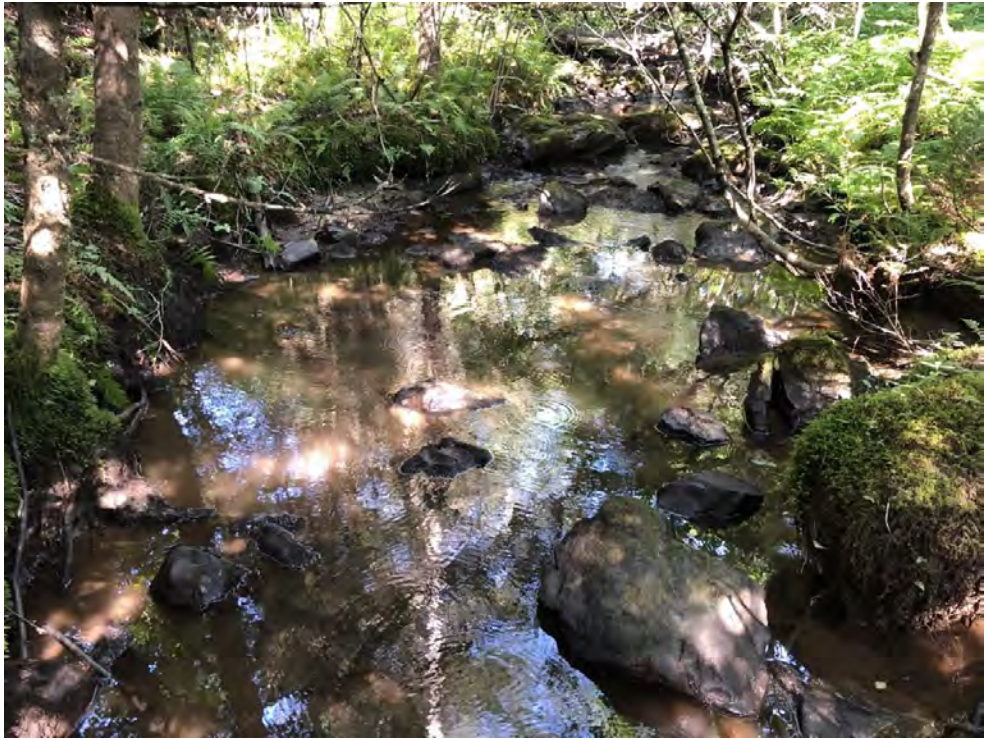
Photo Location: Watercourse 4, Reach 3			
Direction: Downstream			
Survey Date: 8/14/2019			
Comments: Grey silt along Watercourse 4 banks and turbid water.			
Photograph ID: 32

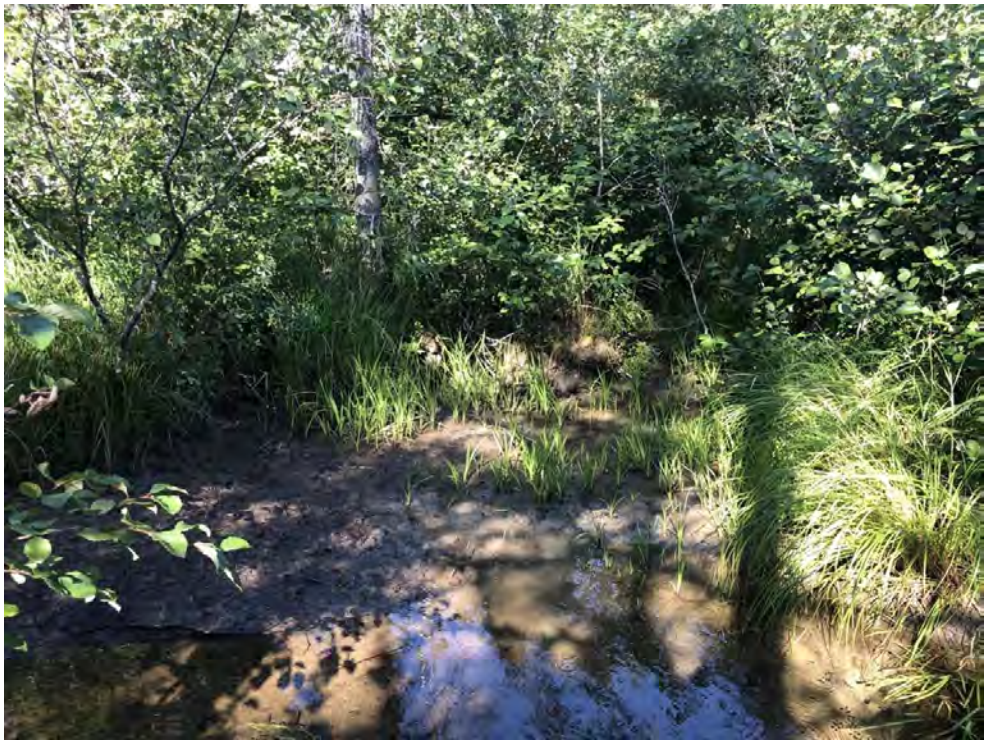
Photo Location: Watercourse 4, Reach 3			
Direction: Left Bank			
Survey Date: 8/14/2019			
Comments: Illustrating deposition of grey silt along the banks.

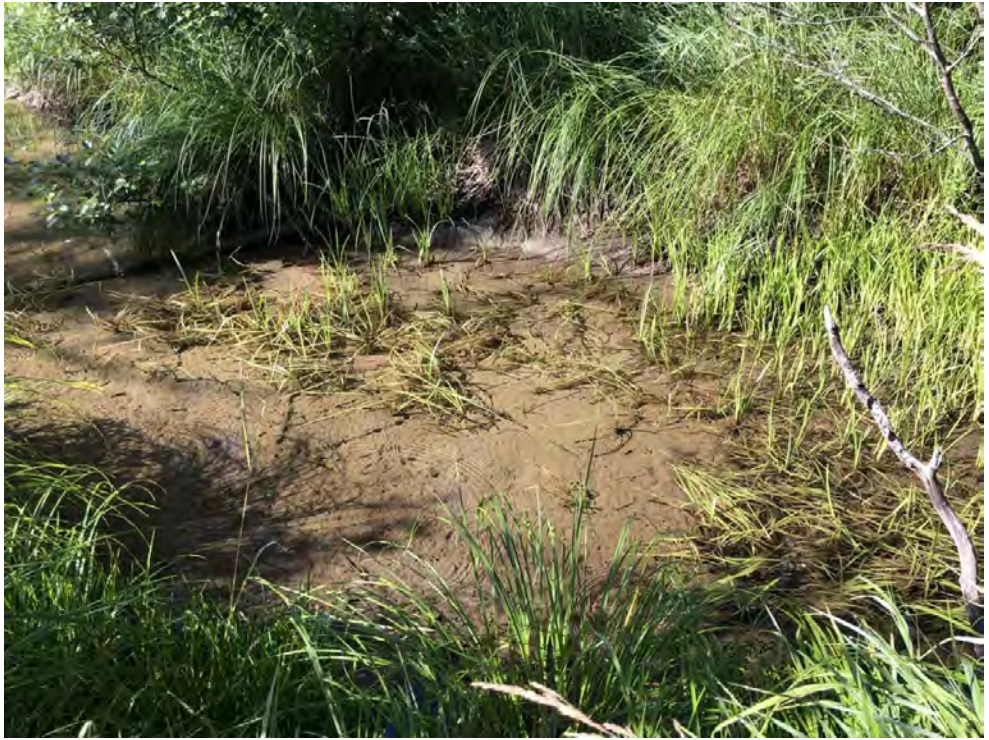
Photo Location: Watercourse 4, Reach 3			
Direction: Right Bank			
Survey Date: 8/14/2019			
Comments: Fish habitat heavliy affected by grey silt.			
Photograph ID: 34

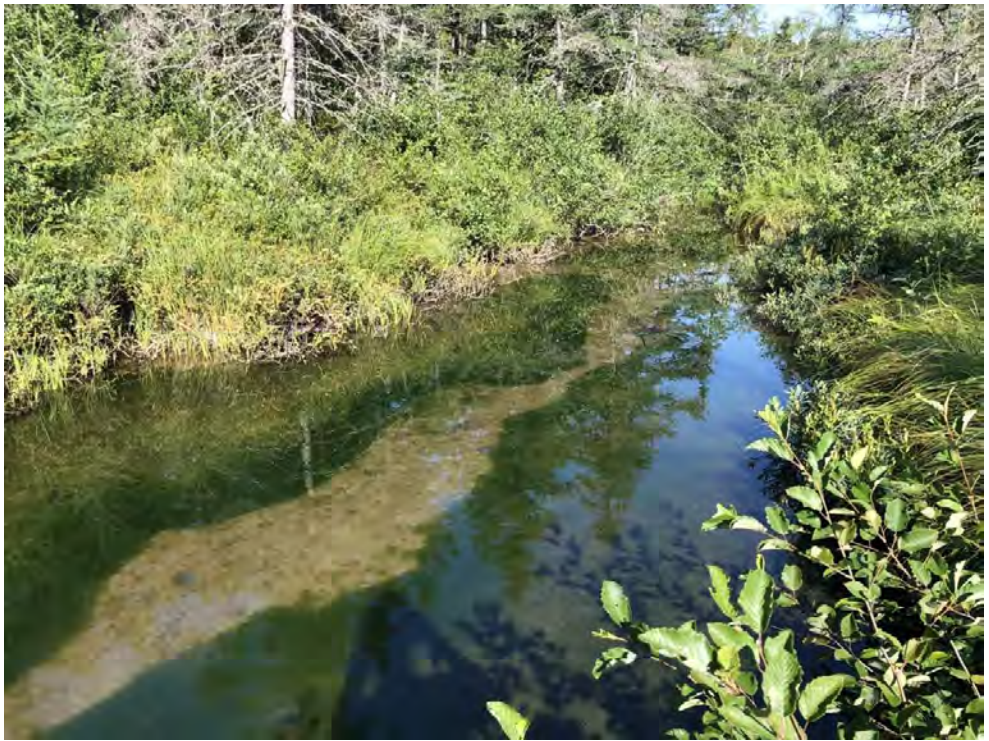
Photo Location: Watercourse 4, Reach 3			
Direction: Upstream			
Survey Date: 8/14/2019			
Comments: Water appears clear, with substrate composed of fines.

Within the slow-moving section of Reach 3 the water appeared clear and further downstream the water showed signs of increased turbidity (Appendix B, Photos 34-36). Grey silt was observed within areas of some, but not all, areas of submergent aquatic vegetation and was not apparent in others (Appendix B, Photo 37-38). Similarly, grey silt was observed in some but not all areas of substrate (Appendix B, Photo 39-40). At the downstream end of Reach 3 fine grey silt was dried on the exposed rocks, which suggests that silt had been carried downstream in a previous high-water event (Appendix B, Photo 41).

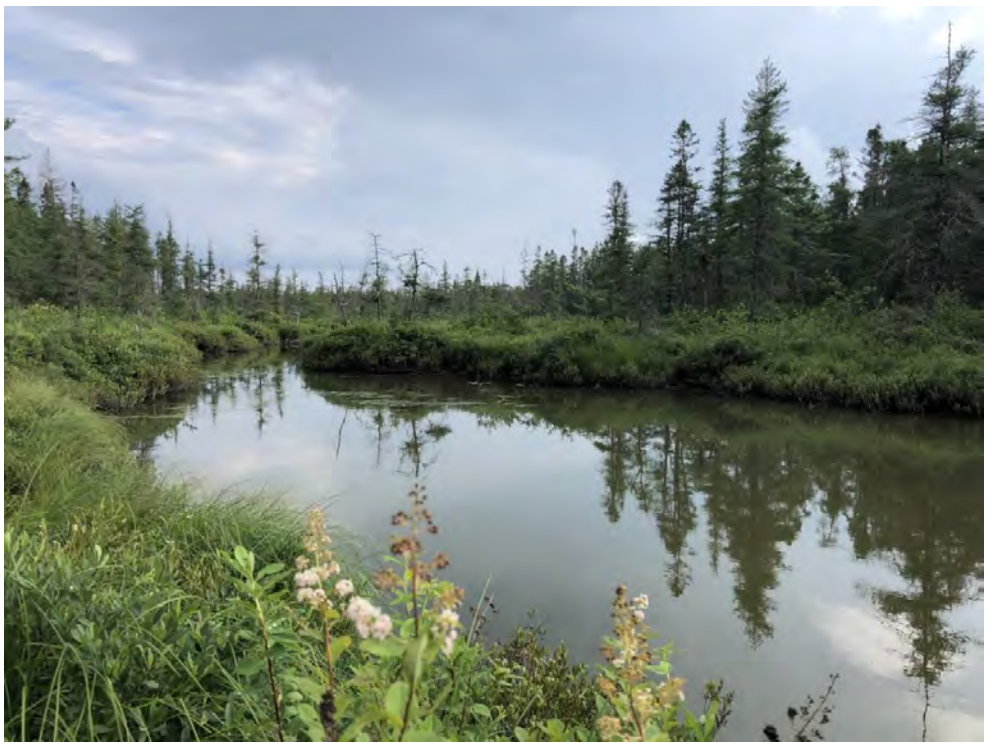
Photo Location: Watercourse 4, Reach 3			
Direction: Upstream			
Survey Date: 8/1/2019			
Comments: Visual signs of turbidity within slow-moving section.			
Photograph ID: 36

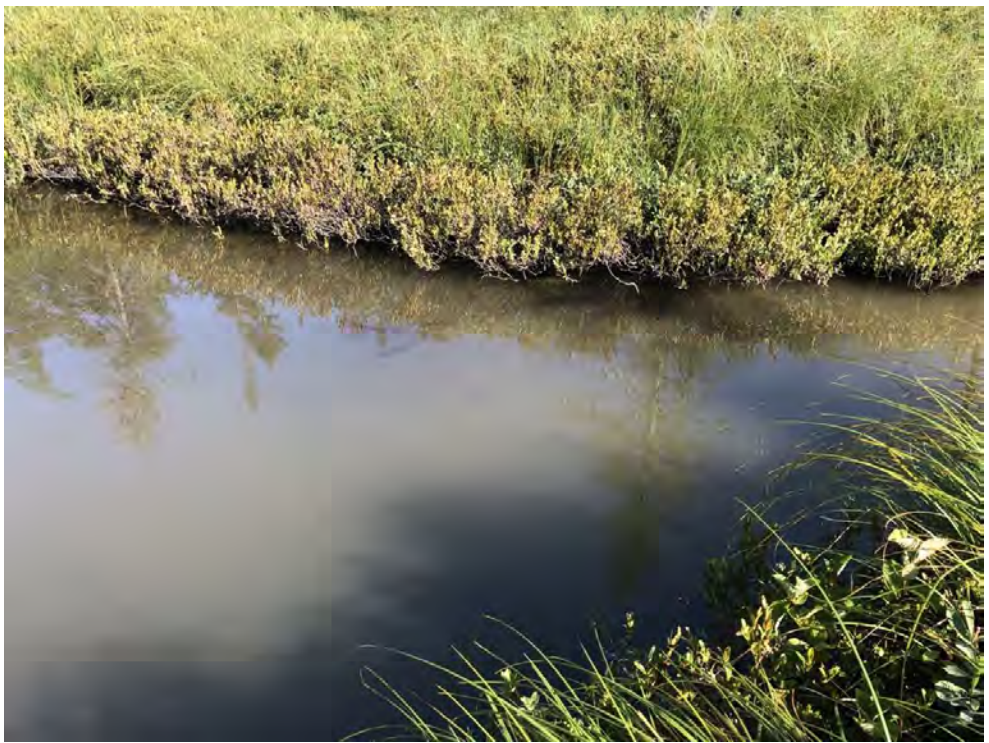
Photo Location: Watercourse 4, Reach 3			
Direction: Left Bank			
Survey Date: 8/14/2019			
Comments: Visual signs of turbidity within slow-moving section.

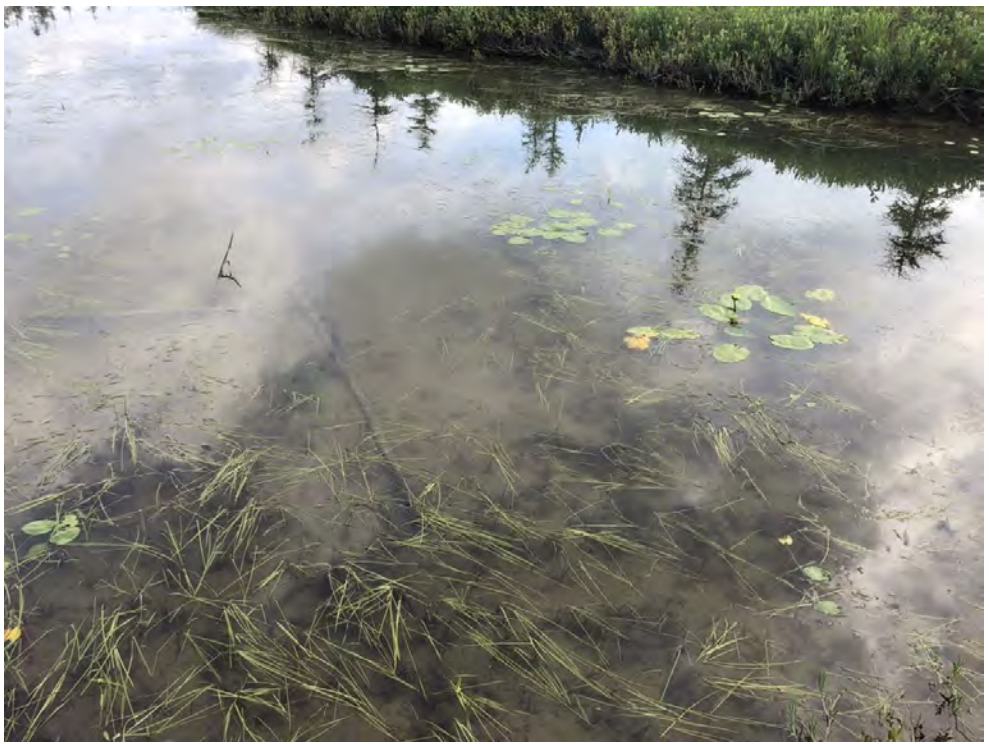
Photo Location: Watercourse 4, Reach 3			
Direction: Right Bank			
Survey Date: 8/1/2019			
Comments: Grey silt observed within areas with submergent aquatic vegetation within Wetland 6.			
Photograph ID: 38

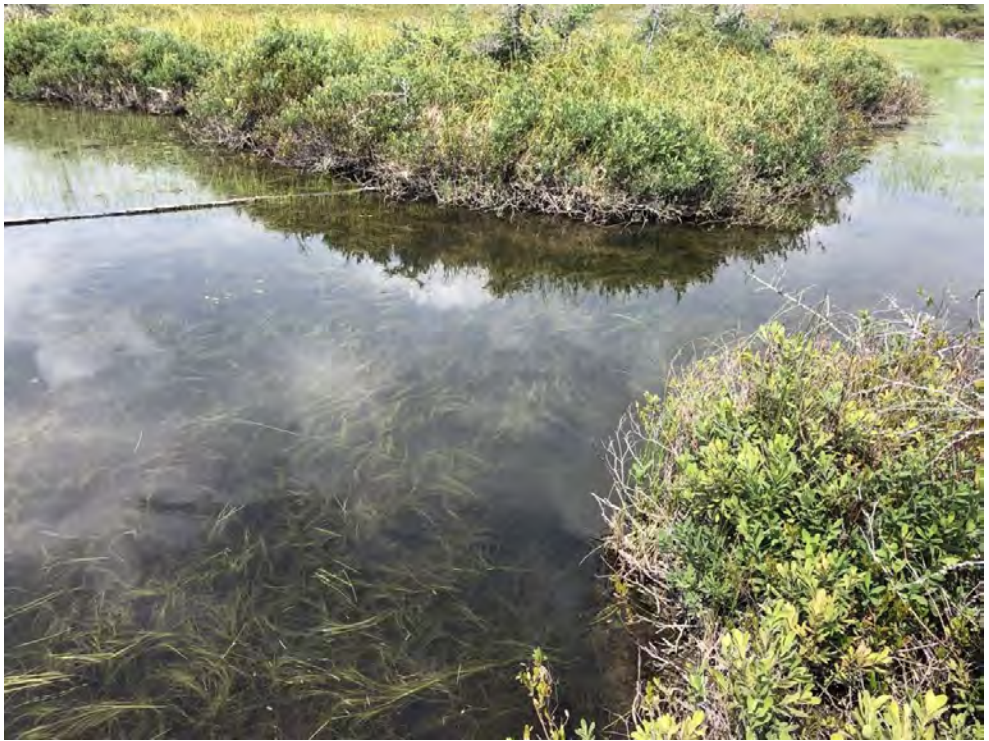
Photo Location: Watercourse 4, Reach 3			
Direction: Right Bank			
Survey Date: 8/1/2019			
Comments: Representative slow-moving fish habitat. Aquatic vegetation is abundant.

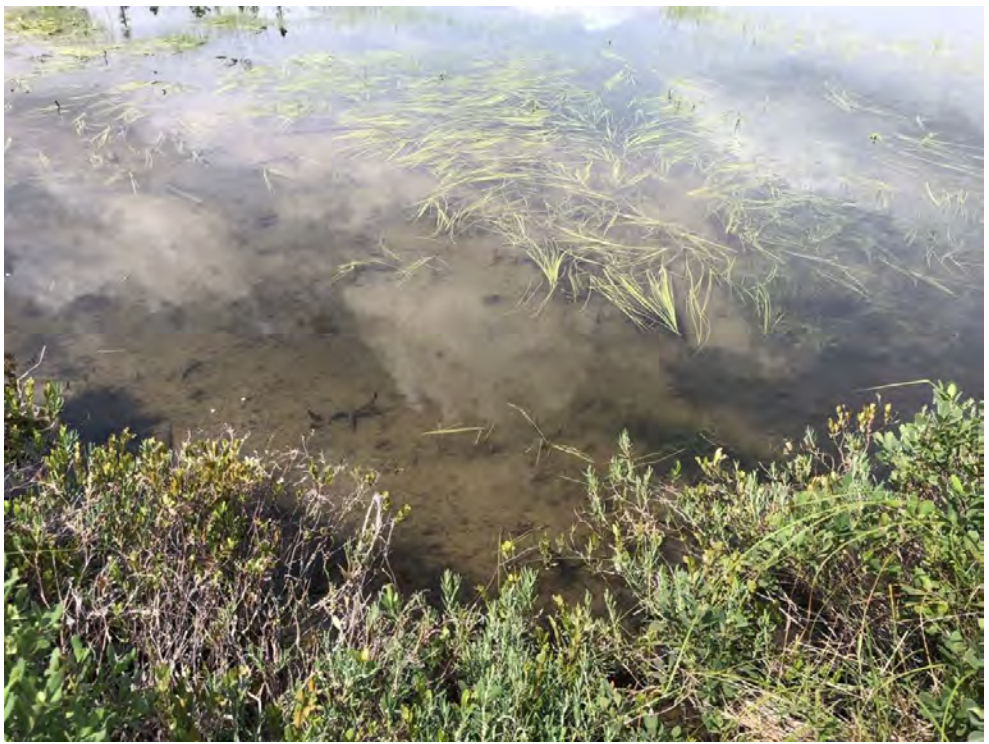
Photo Location: Watercourse 4, Reach 3			
Direction: Left Bank			
Survey Date: 8/1/2019			
Comments: Grey silt within slow-moving section.			
Photograph ID: 40

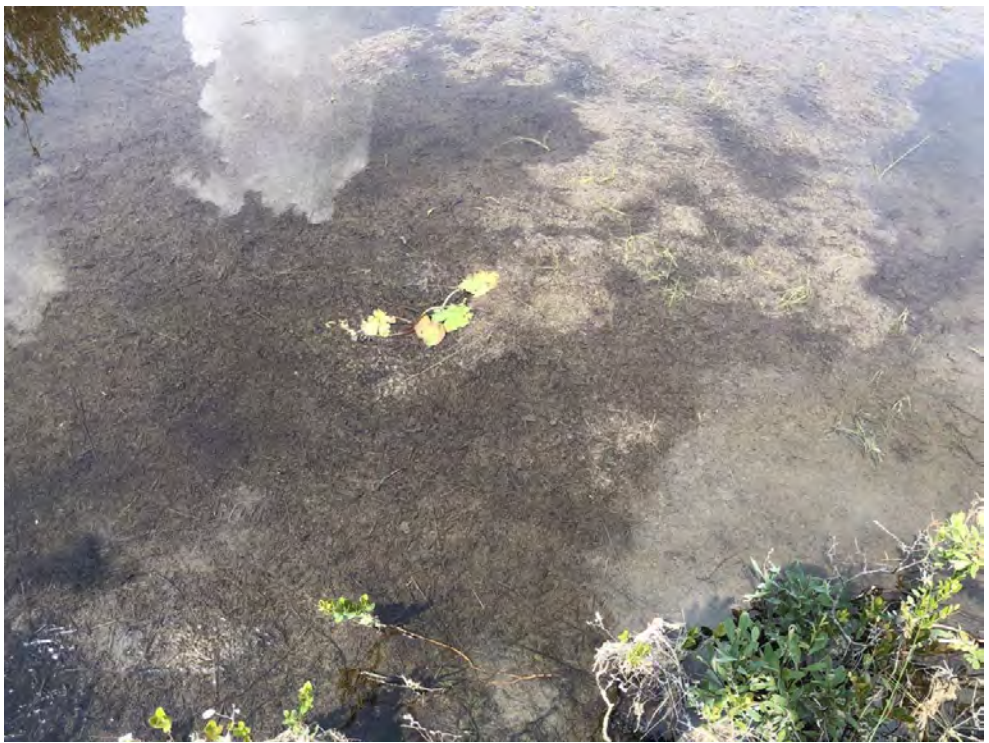
Photo Location: Watercourse 4, Reach 3			
Direction: Substrate			
Survey Date: 8/1/2019			
Comments: Organic soils within the downstream most section of Reach 3. Appear to be unaffected by the siltation.

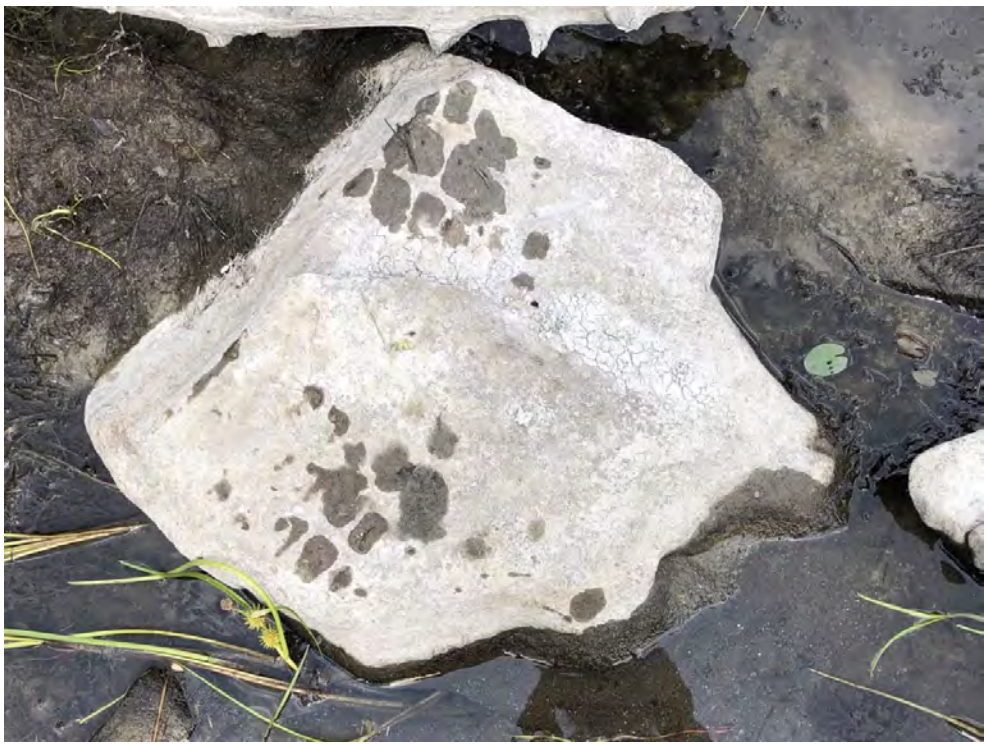
Photo Location: Watercourse 4, Reach 3			
Direction: Substrate			
Survey Date: 8/1/2019			
Comments: Grey silt dried on a rock at the downstream end of Reach 3.			
Photograph ID: 42

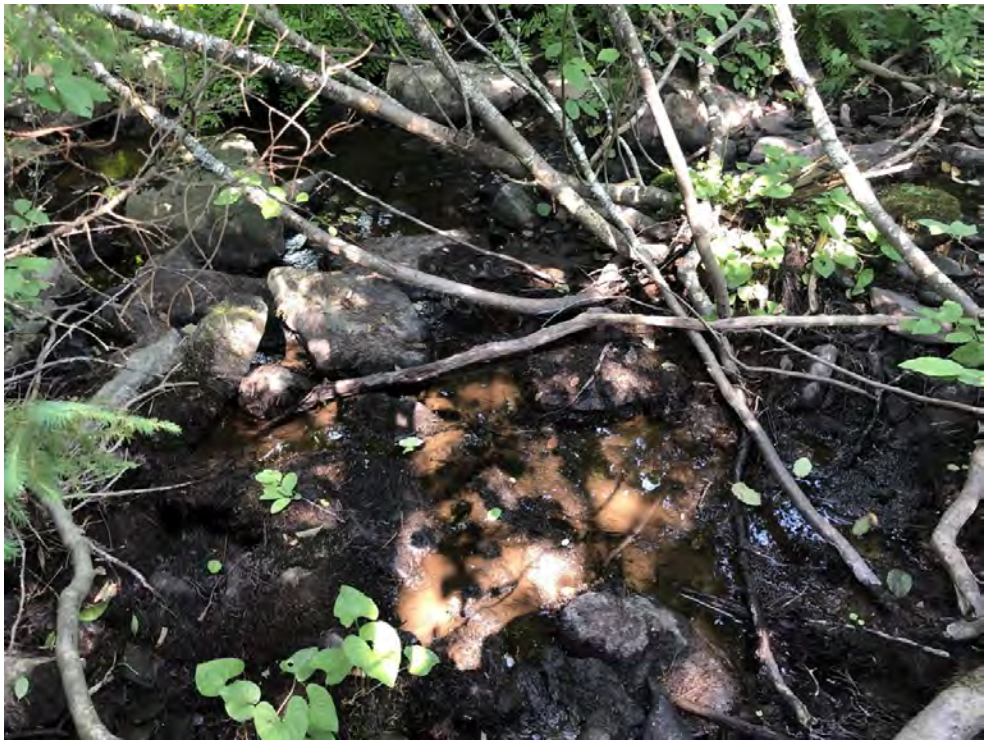
Photo Location: Watercourse 4, Reach 4			
Direction: Upstream			
Survey Date: 8/1/2019			
Comments: Representative fish habitat, showing aquatic vegetation and substrate.

Reach 4 consists of both swift-moving and slow-moving sections ranging in width from 2.7 to 5.8 m. At the time of the fish habitat surveys the average wetted width was 3.74 m and average channel width was 4.16 m. Banks were generally stable and riparian vegetation was dominated by conifer forest (~40%) and grass/shrubs (~30% each). Substrate was dominated by fines (~40%) and small boulder (~40%). Average total cover was ~30% and was primarily made up of instream aquatic vegetation (~15%). Representative photos of fish habitat in Reach 4 can be found in Appendix B (Appendix B, Photos 42 to 44).

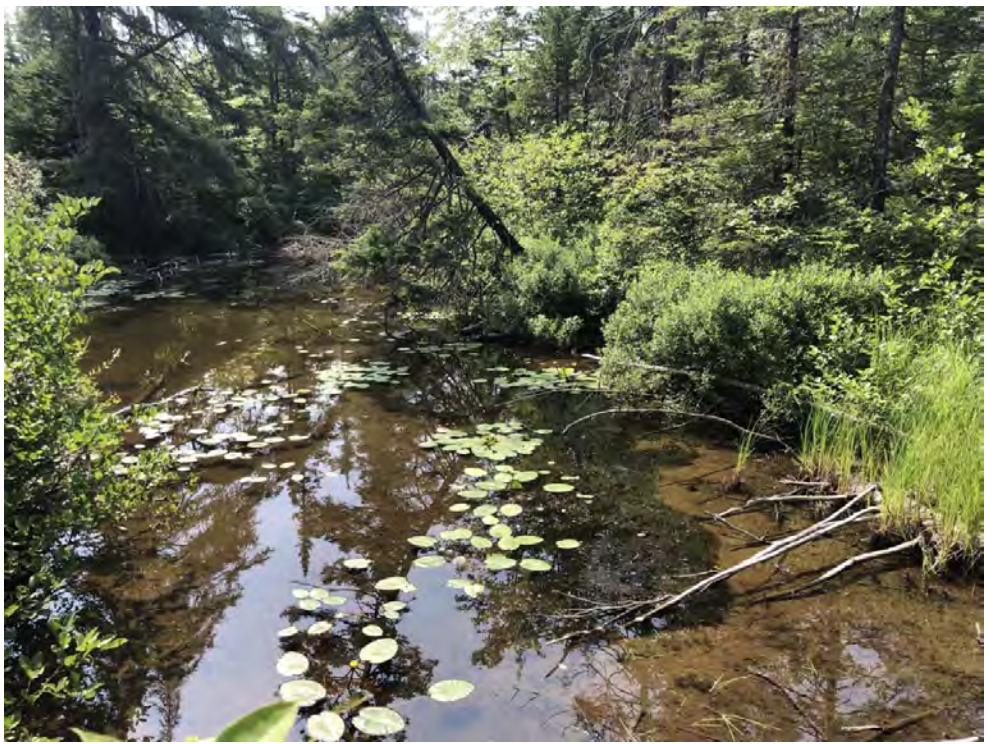
Client:	Atlantic Mining NS Corporation	Project:	Assessment of Watercourse WC4
Site Name:	Touquoy Mine	Site Location:	Moose River, Nova Scotia
Photograph ID: 43

Photo Location: Watercourse 4, Reach 4			
Direction: Downstream			
Survey Date: 8/1/2019			
Comments: Representative fish habitat within slow-moving sections.			
Photograph ID: 44

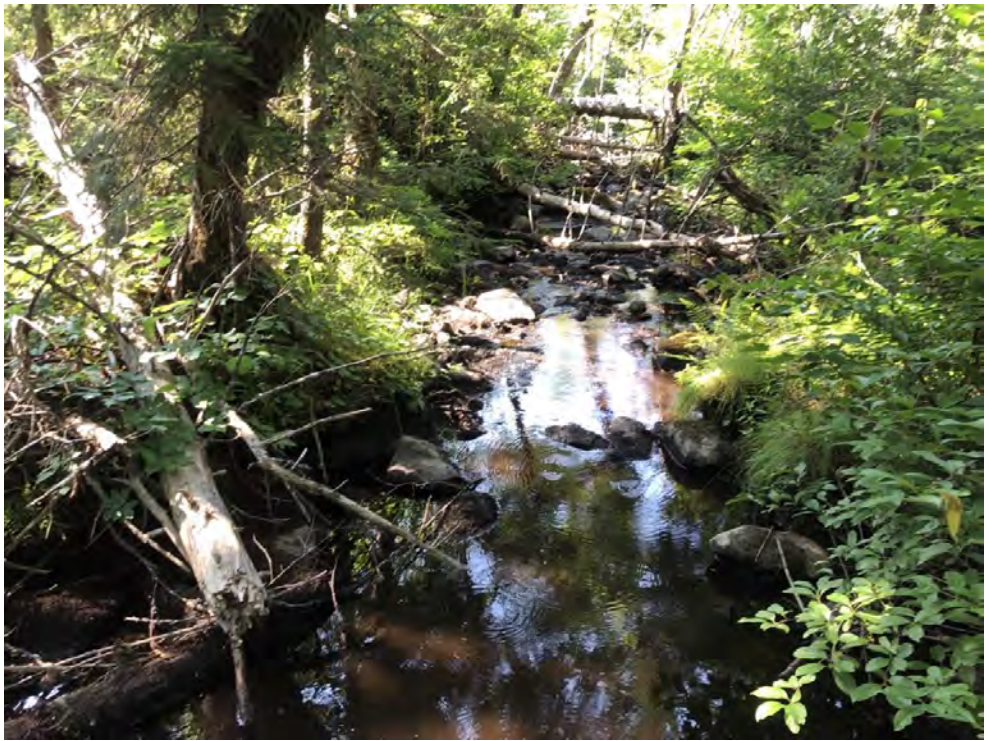
Photo Location: Watercourse 4, Reach 4			
Direction: Downstream			
Survey Date: 8/1/2019			
Comments: Representative swift-moving fish habitat.

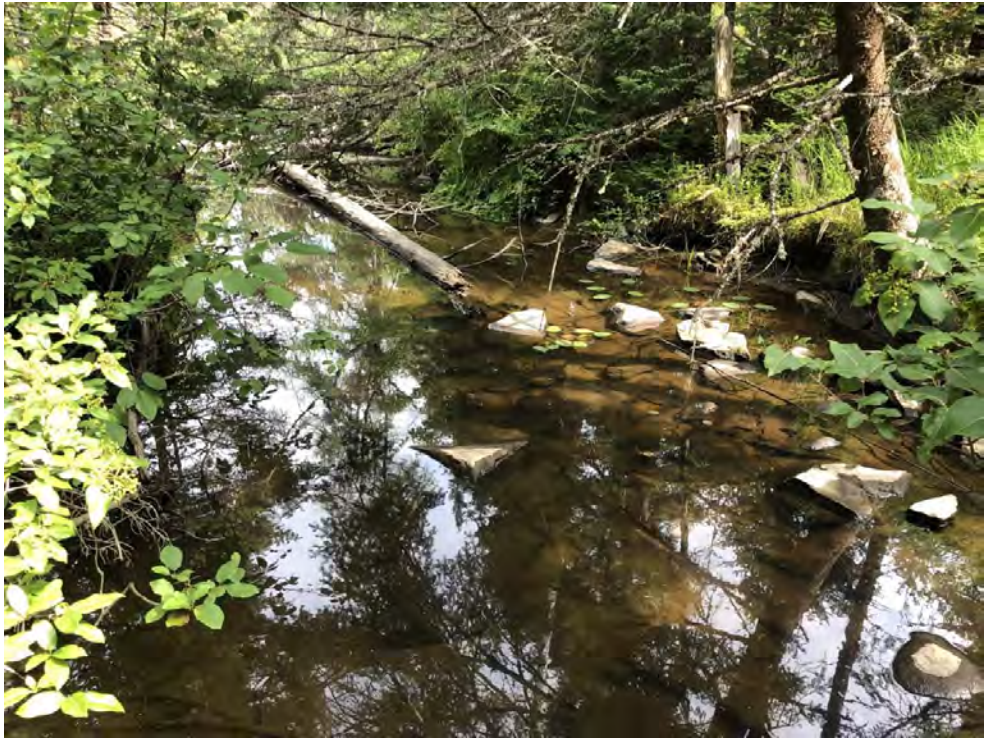
Grey silt was observed within Reach 4. Fine grey silt was observed between rocks as well as in depositional areas of the watercourse (Appendix B, Photos 45-47). An old forestry road bridge is present at the downstream end of Reach 4 (Appendix B, Photo 48). Grey silt was also observed in the area of private property downstream of Reach 4; silt was visible within the interstitial spaces of rocks and within depositional areas (Appendix B, Photo 49).

Photo Location: Watercourse 4, Reach 4			
Direction: Downstream			
Survey Date: 8/1/2019			
Comments: Grey silt observed between rocks.			
Photograph ID: 46

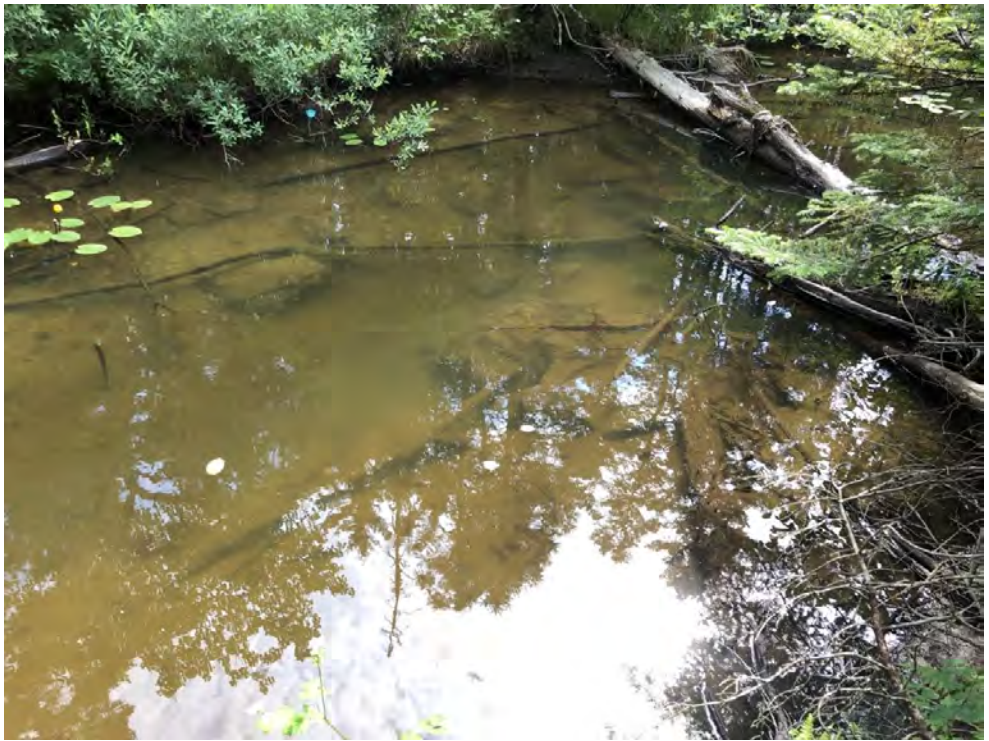
Photo Location: Watercourse 4, Reach 4			
Direction: Downstream			
Survey Date: 8/1/2019			
Comments: Illustrating turbid water and deposition of fine sediments.

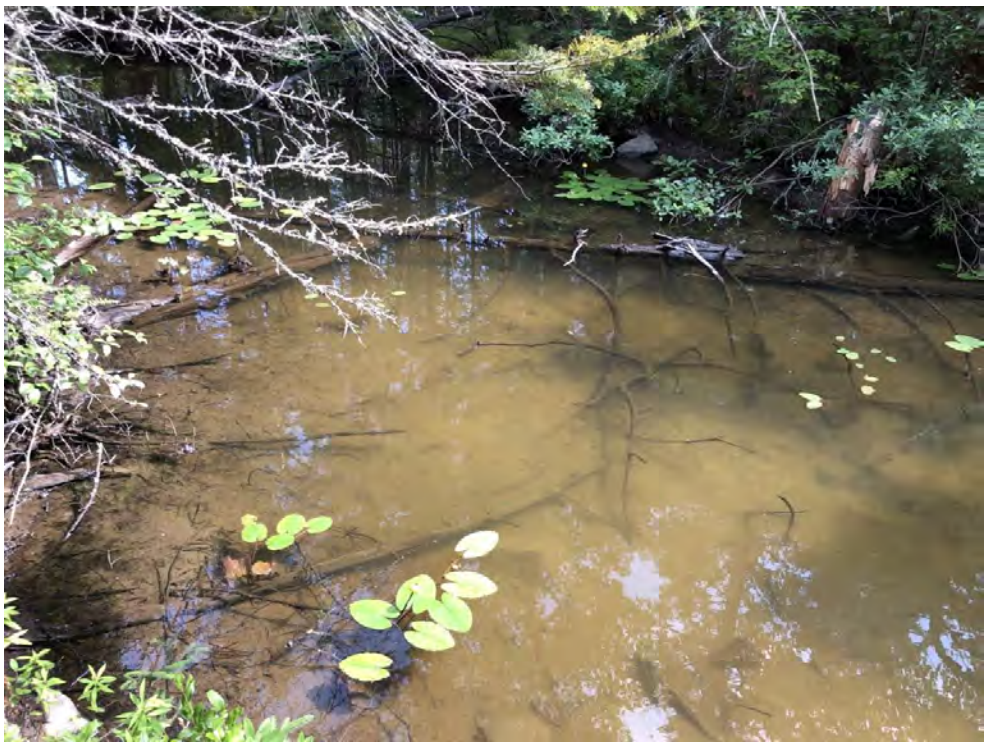
Photo Location: Watercourse 4, Reach 4			
Direction: Right Bank			
Survey Date: 8/1/2019			
Comments: Grey silt within slow-moving sections.			
Photograph ID: 48
