**Assessment of Wetlands 6 and 15
and Watercourse 4, Touquoy
Mine, Nova Scotia**

Watercourse and Wetland Assessment
to fulfill the requirements of Nova Scotia
Environment Directives #12628894 and
#12776418

December 19, 2019

Stantec Consulting Ltd.
845 Prospect Street
Fredericton NB E3B 2T7

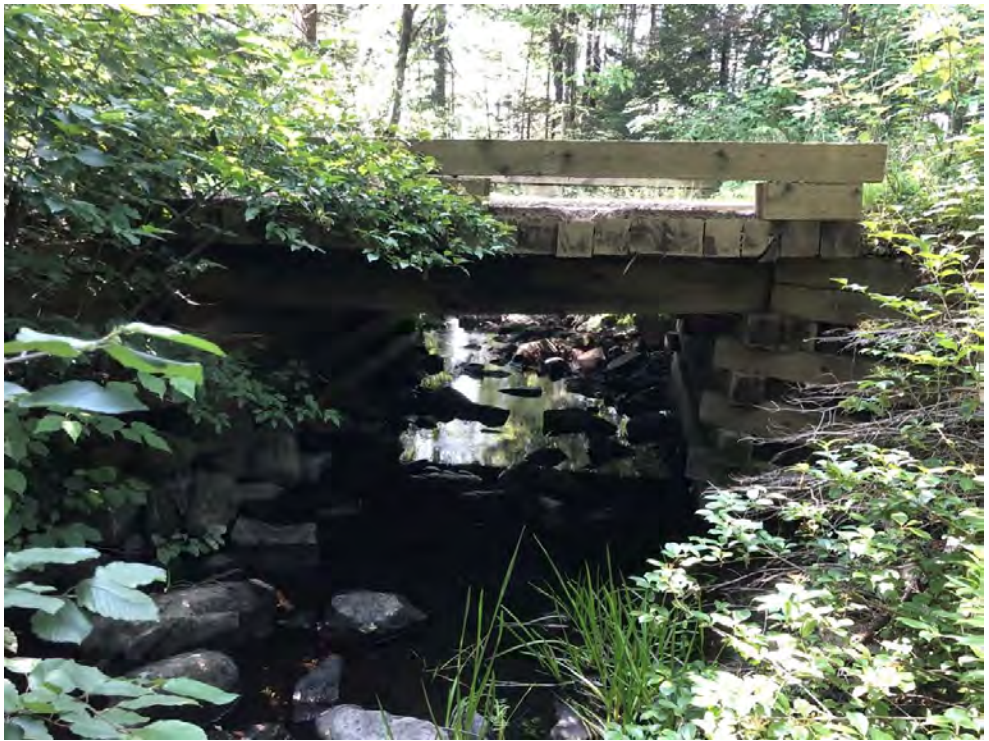
Photo Location: Watercourse 4, Reach 4			
Direction: Downstream			
Survey Date: 8/1/2019			
Comments: Illustrating bridge crossing at old forestry road.

Grey silt was observed within Reach 4. Fine grey silt was observed between rocks as well as in depositional areas of the watercourse (Appendix B, Photos 45-47). An old forestry road bridge is present at the downstream end of Reach 4 (Appendix B, Photo 48). Grey silt was also observed in the area of private property downstream of Reach 4; silt was visible within the interstitial spaces of rocks and within depositional areas (Appendix B, Photo 49).

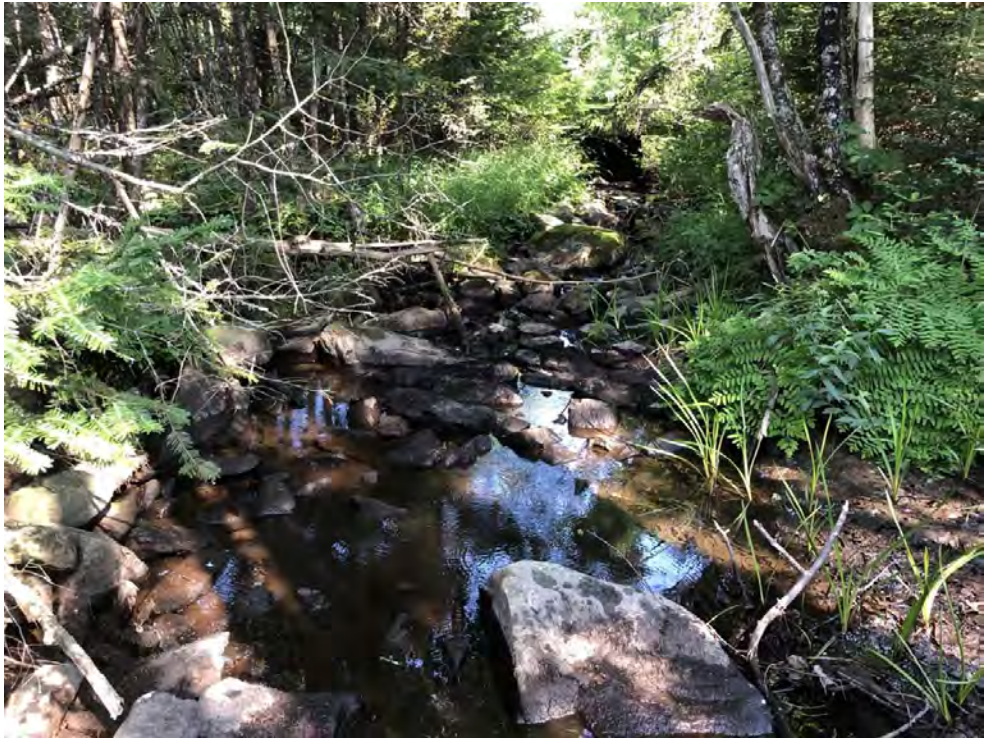
Photo Location: Watercourse 4, Reach 4			
Direction: Upstream			
Survey Date: 8/1/2019			
Comments: Fish habitat downstream of old forestry road. Small amounts of grey silt were apparent between cobble and boulder substrates and depositional areas.			
Photograph ID: 50	 		
Photo Location: Watercourse 4, Reach 1			
Direction:			
Survey Date: 8/1/2019			
Comments: Pooled water adjacent to Admin Road.

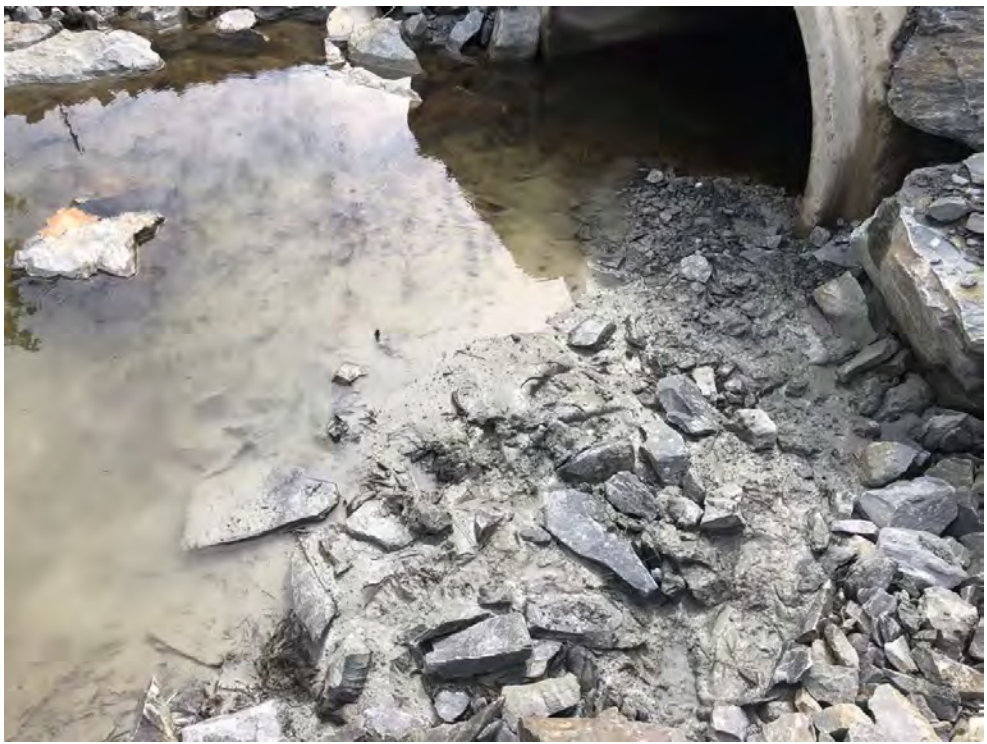
Client:	Atlantic Mining NS Corporation	Project:	Assessment of Watercourse WC4
Site Name:	Touquoy Mine	Site Location:	Moose River, Nova Scotia
Photograph ID: 51

Photo Location: Watercourse 4, Reach 2			
Direction:			
Survey Date: 8/1/2019			
Comments: WC4-14 Sediment Sample.			
Photograph ID: 52

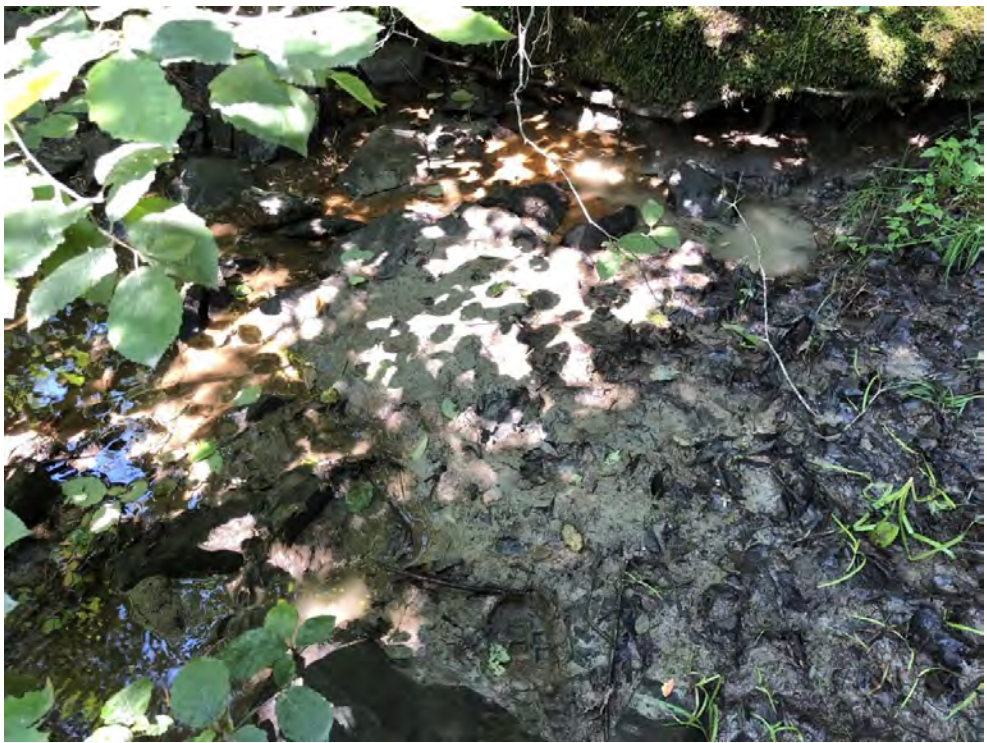
Photo Location: Watercourse 4, Reach 3			
Direction:			
Survey Date: 8/14/2019			
Comments: WC4-15, Sediment Sample from depositional area.

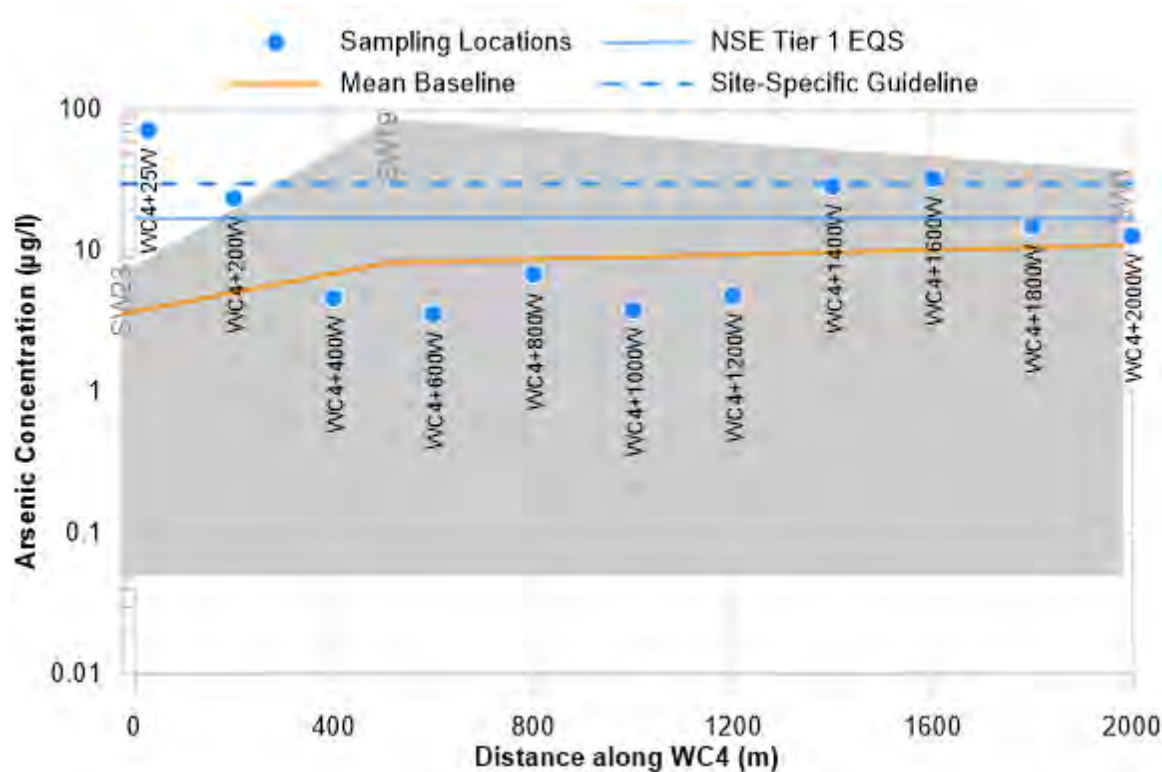
Figure D.5. Concentrations of Total Arsenic in WC4 Surface Water (Range of Baseline IA Shaded in Grey Derived from Stantec 2019b and Summarized in Table D.1)

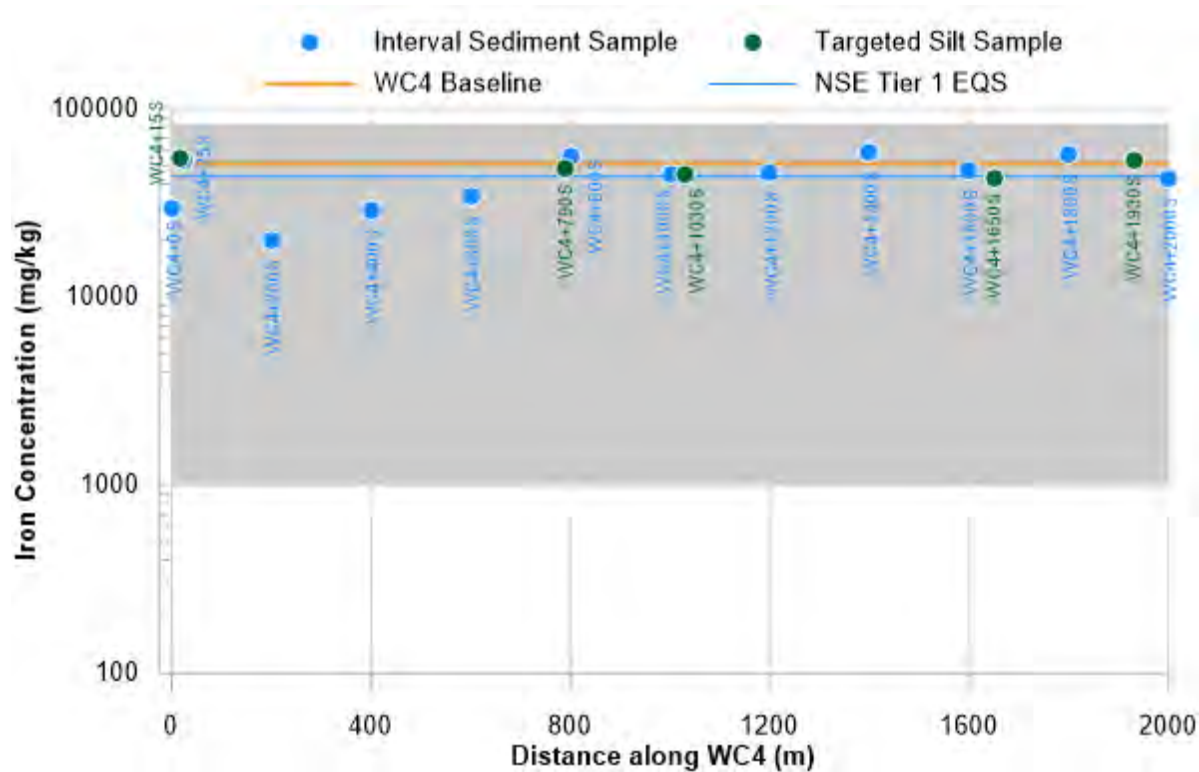
Figure D.8 Concentrations of Total Extractable Iron in WC4 Sediment (Baseline Soil Range Shaded in Grey Derived from Parks 2019, personal communication)
