Appendix C 2021 INVESTIGATION RESULTS

**FACTUAL DATA REPORT. HYDROGEOLOGICAL SITE INVESTIGATION, TOUQUOY IN-PIT
TAILINGS DISPOSAL**

**C.1 SYMBOLS AND TERMS USED ON BOREHOLE AND TEST PIT
RECORDS**

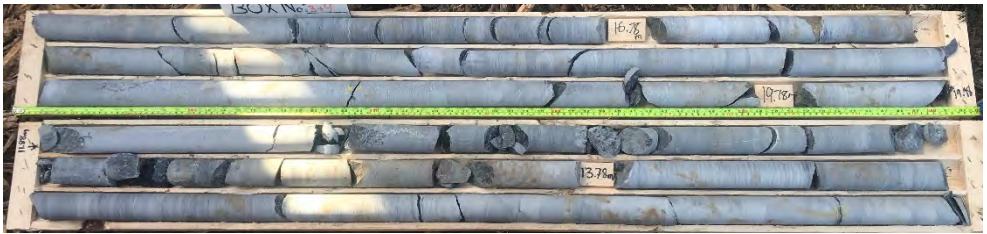
Photograph ID: 3

Borehole ID: BH21-01	
Depth from (m): 11.88	
Depth to (m): 19.98	
Core Runs: 3-6	
Core Photograph Condition: Dry	
Comments:

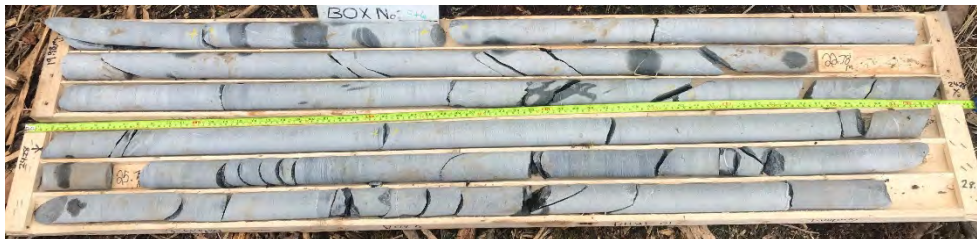
Photograph ID: 5

Borehole ID: BH21-01	
Depth from (m): 19.98	
Depth to (m): 28.37	
Core Runs: 6-8	
Core Photograph Condition: Dry	
Comments:

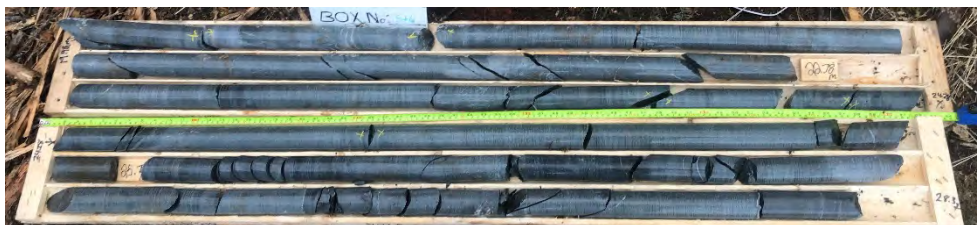
Photograph ID: 6

Borehole ID: BH21-01	
Depth from (m): 19.98	
Depth to (m): 28.37	
Core Runs: 6-8	
Core Photograph Condition: Wet	
Comments:

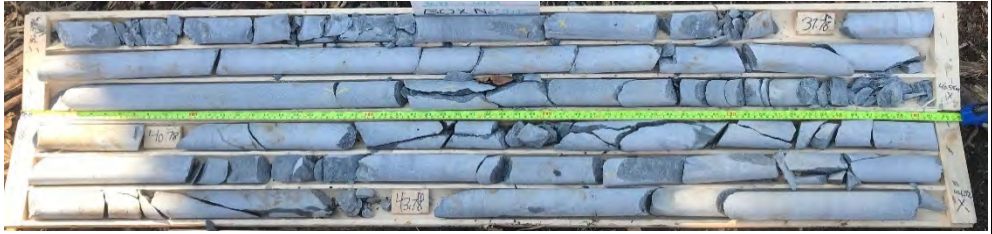
Photograph ID: 9

Borehole ID: BH21-01	
Depth from (m): 36.79	
Depth to (m): 44.52	
Core Runs: 11-13	
Core Photograph Condition: Dry	
Comments:

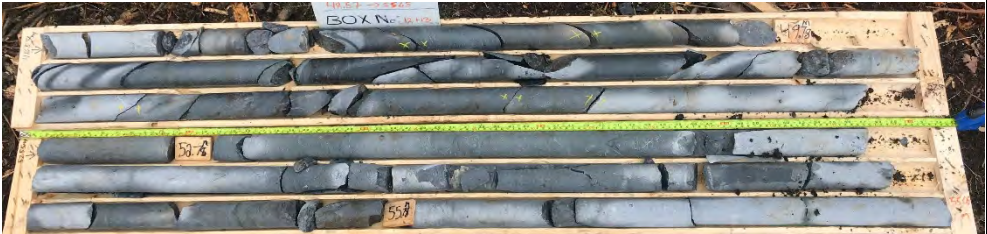
Photograph ID: 13

Borehole ID: BH21-01	
Depth from (m): 48.57	
Depth to (m): 56.65	
Core Runs: 15-18	
Core Photograph Condition: Dry	
Comments:

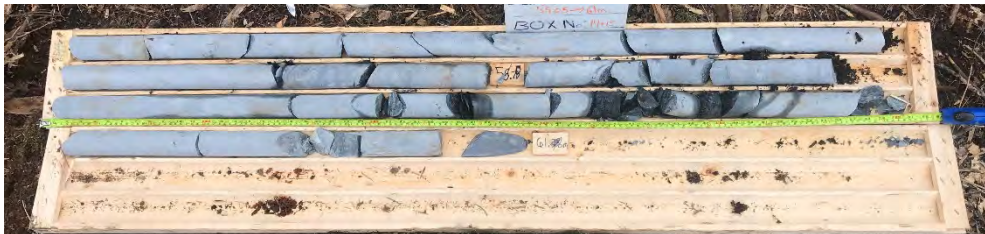
Photograph ID: 15

Borehole ID: BH21-01	
Depth from (m): 56.65	
Depth to (m): 61.00	
Core Runs: 18-20	
Core Photograph Condition: Dry	
Comments:

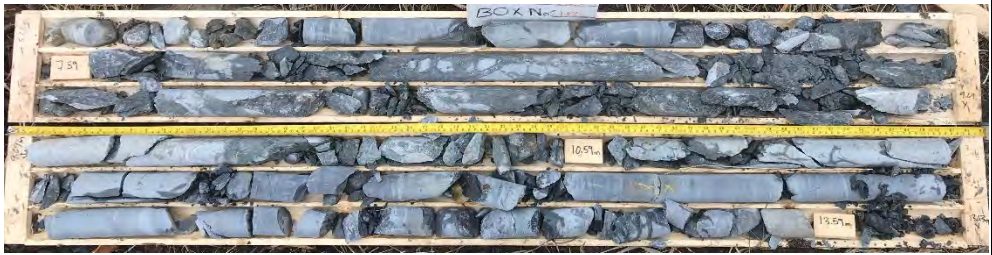
Photograph ID: 17

Borehole ID: BH21-02	
Depth from (m): 5.65	
Depth to (m): 13.63	
Core Runs: 1-3	
Core Photograph Condition: Dry	
Comments:

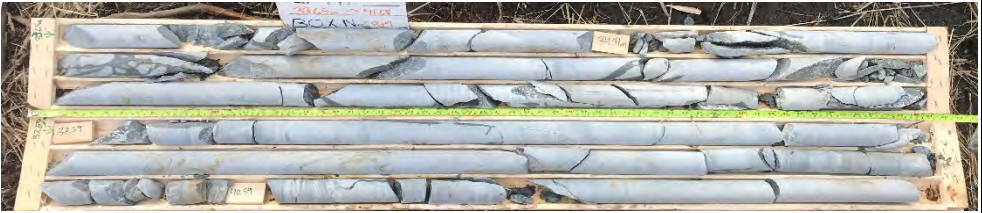
Photograph ID: 23

Borehole ID: BH21-02	
Depth from (m): 33.65	
Depth to (m): 41.68	
Core Runs: 9-12	
Core Photograph Condition: Dry	
Comments:

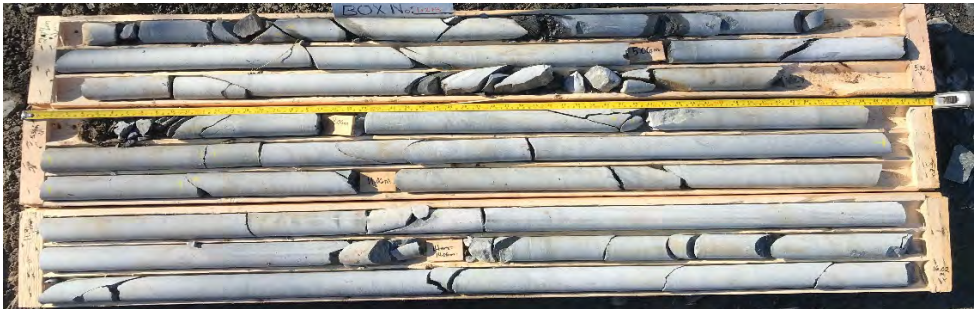
Photograph ID: 29

Borehole ID: BH21-03	
Depth from (m): 2.79	
Depth to (m): 16.02	
Core Runs: 1-5	
Core Photograph Condition: Dry	
Comments:

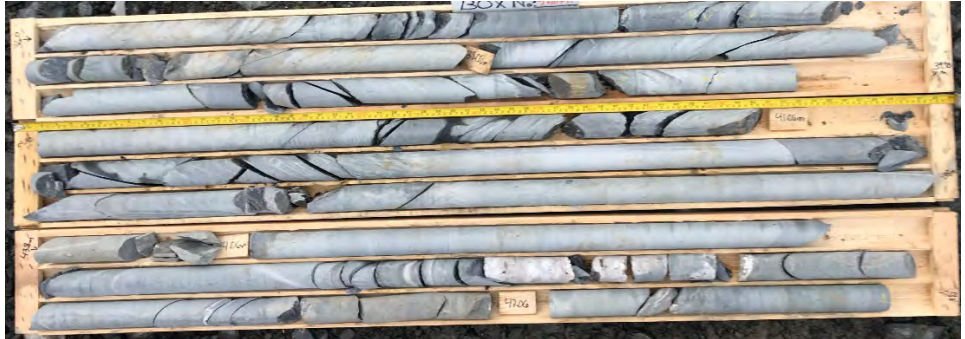
Photograph ID: 35

Borehole ID: BH21-03	
Depth from (m): 36.00	
Depth to (m): 47.62	
Core Runs: 12-16	
Core Photograph Condition: Dry	
Comments:

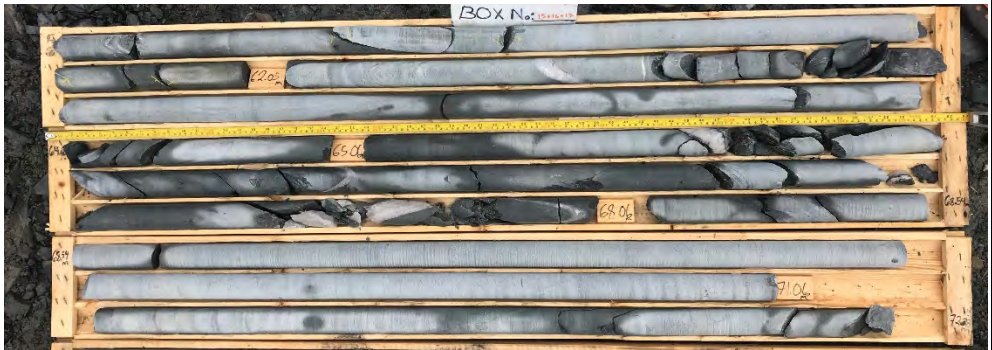
Photograph ID: 39

Borehole ID: BH21-03	
Depth from (m): 60.29	
Depth to (m): 72.38	
Core Runs: 20-24	
Core Photograph Condition: Dry	
Comments:

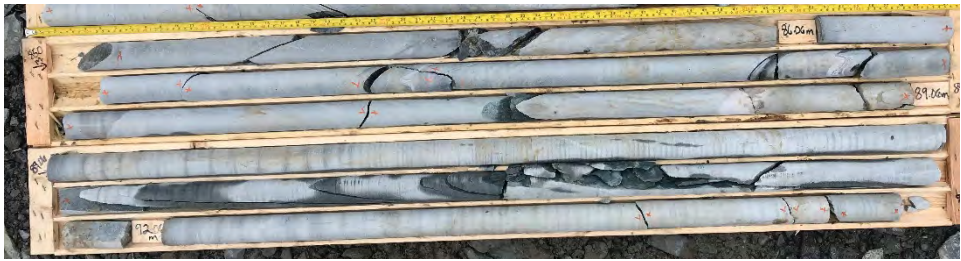
Photograph ID: 43

Borehole ID: BH21-03	
Depth from (m): 85.00	
Depth to (m): 93.37	
Core Runs: 28-31	
Core Photograph Condition: Dry	
Comments:

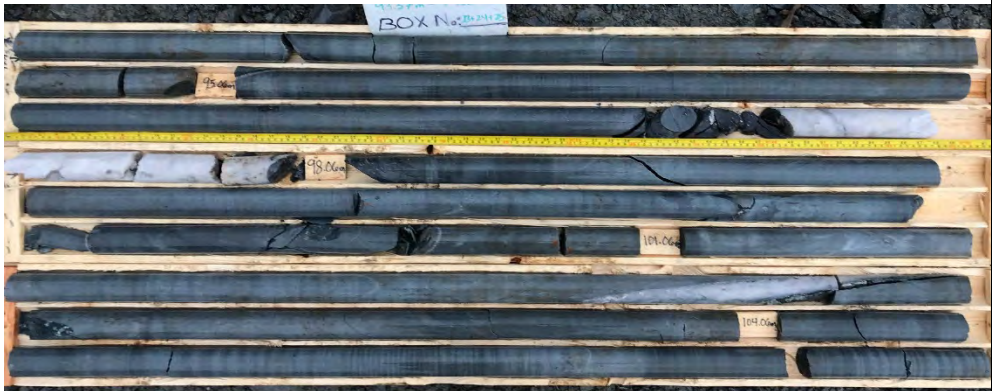
Photograph ID: 46

Borehole ID: BH21-03	
Depth from (m): 93.37	
Depth to (m): 105.80	
Core Runs: 31-35	
Core Photograph Condition: Wet	
Comments:

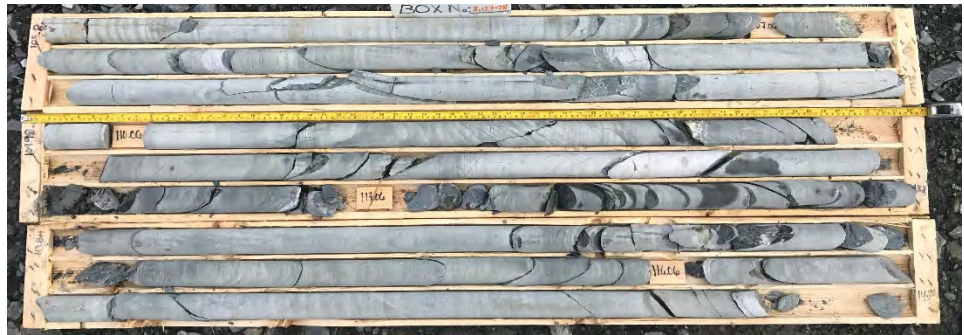
Photograph ID: 47

Borehole ID: BH21-03	
Depth from (m): 105.80	
Depth to (m): 118.15	
Core Runs: 35-39	
Core Photograph Condition: Dry	
Comments:

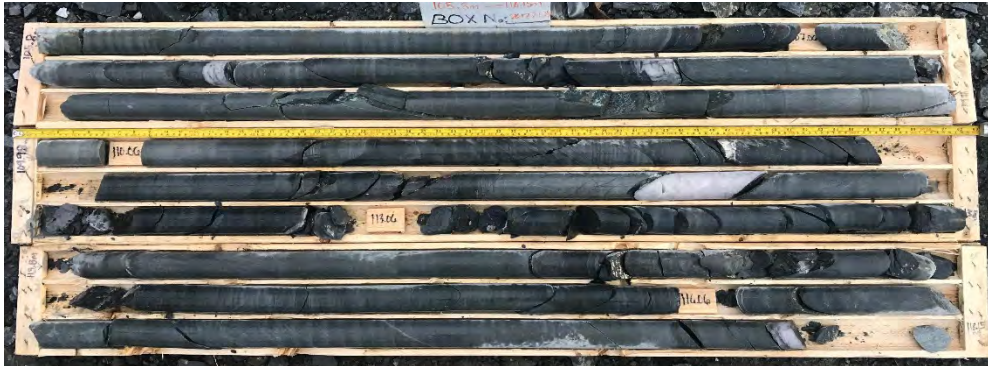
Photograph ID: 48

Borehole ID: BH21-03	
Depth from (m): 105.80	
Depth to (m): 118.15	
Core Runs: 35-39	
Core Photograph Condition: Wet	
Comments:

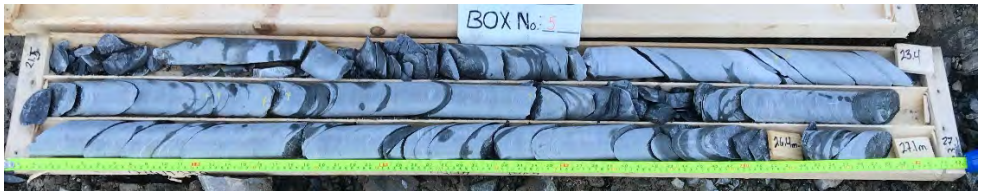
Photograph ID: 57

Borehole ID: BH21-04	
Depth from (m): 21.50	
Depth to (m): 27.10	
Core Runs: 7-9	
Core Photograph Condition: Dry	
Comments:

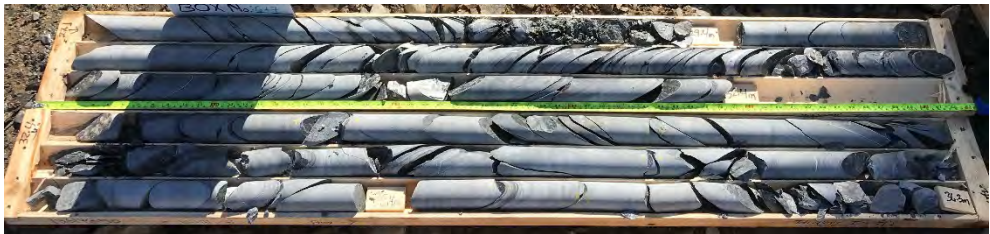
Photograph ID: 59

Borehole ID: BH21-04	
Depth from (m): 27.10	
Depth to (m): 36.30	
Core Runs: 9-12	
Core Photograph Condition: Dry	
Comments:

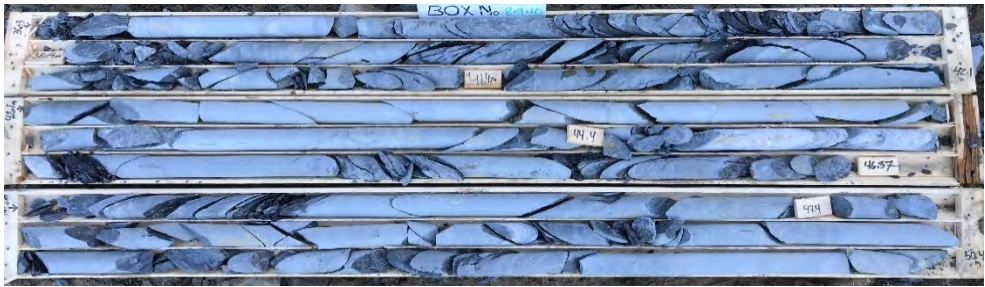
Photograph ID: 61

Borehole ID: BH21-04	
Depth from (m): 36.30	
Depth to (m): 50.40	
Core Runs: 12-17	
Core Photograph Condition: Dry	
Comments:

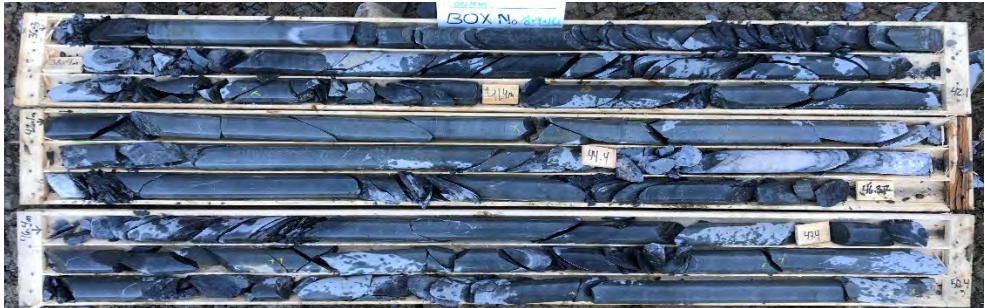
Photograph ID: 62

Borehole ID: BH21-04	
Depth from (m): 36.30	
Depth to (m): 50.40	
Core Runs: 12-17	
Core Photograph Condition: Wet	
Comments:

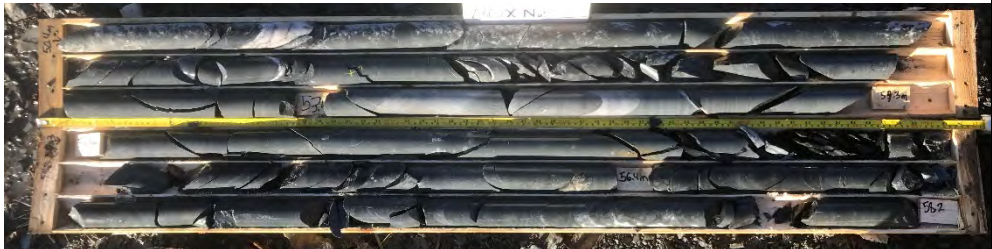
Photograph ID: 64

Borehole ID: BH21-04	
Depth from (m): 50.40	
Depth to (m): 58.20	
Core Runs: 17-20	
Core Photograph Condition: Wet	
Comments:

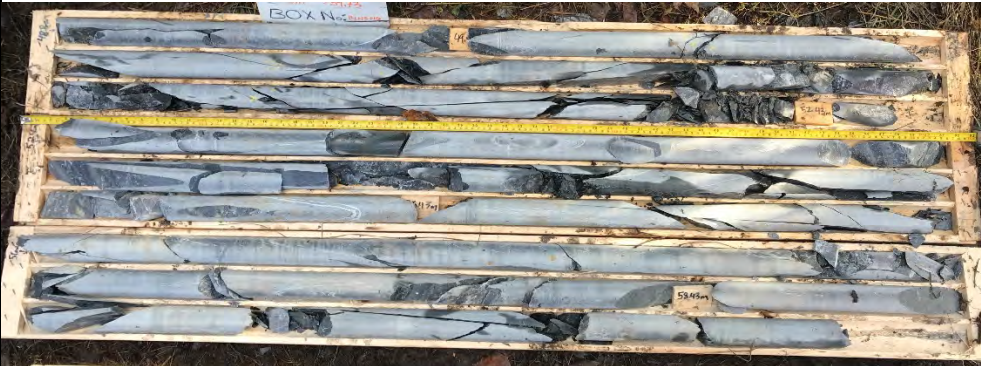
Photograph ID: 79

Borehole ID: BH21-05	
Depth from (m): 48.80	
Depth to (m): 59.73	
Core Runs: 15-19	
Core Photograph Condition: Dry	
Comments:

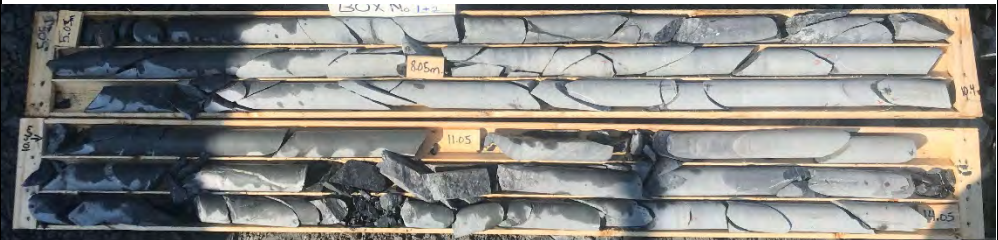
Photograph ID: 81

Borehole ID: BH21-06	
Depth from (m): 5.05	
Depth to (m): 14.05	
Core Runs: 1-3	
Core Photograph Condition: Dry	
Comments:

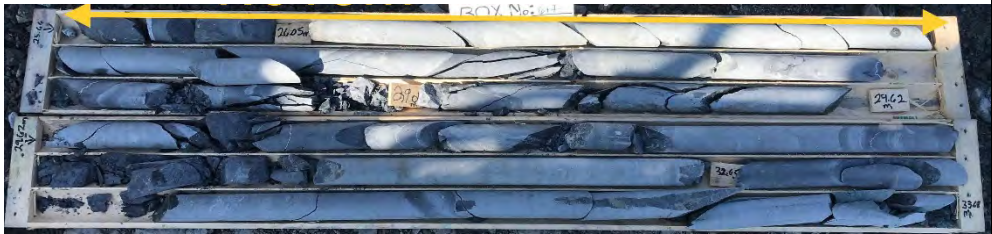
Photograph ID: 85

Borehole ID: BH21-06	
Depth from (m): 25.66	
Depth to (m): 33.68	
Core Runs: 7-10	
Core Photograph Condition: Dry	
Comments:

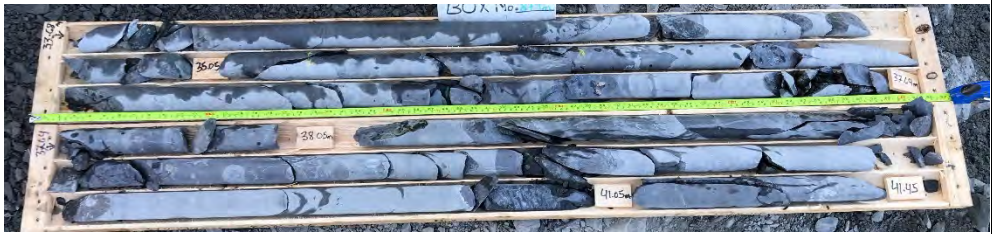
Photograph ID: 87

Borehole ID: BH21-06	
Depth from (m): 33.68	
Depth to (m): 41.45	
Core Runs: 10-13	
Core Photograph Condition: Dry	
Comments:

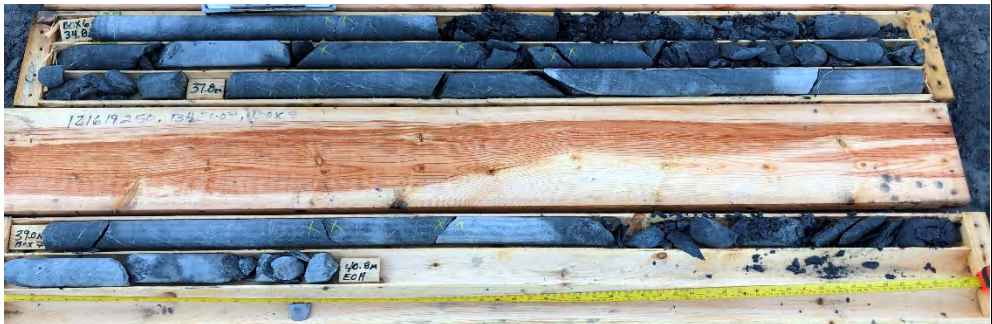
Photograph ID: 97

Borehole ID: BH21-07	
Depth from (m): 34.80	
Depth to (m): 40.80	
Core Runs: 9-11	
Core Photograph Condition: Dry	
Comments:
