**Response to DFO Request 20-HMAR-00531 Moose River
Request for Studies Halifax County, Nova Scotia**

November 1, 2021
File: 121619250.3001.104.2

DETAILED REPORT ON 2021 MOOSE RIVER HYDROMETRIC DATA

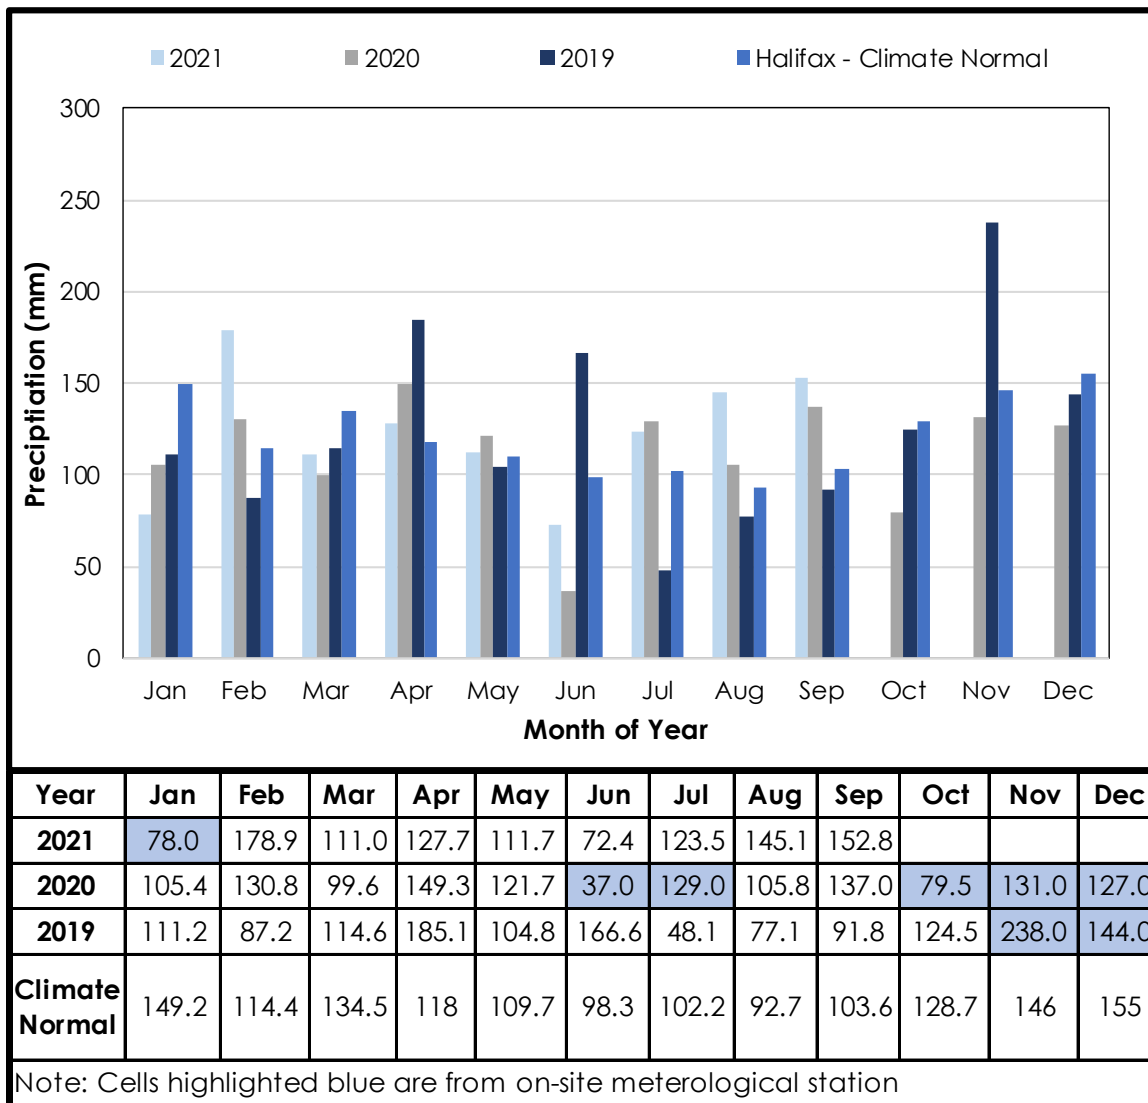
Figure 2.1 Total Precipitation Data at the Site

Consistent with routine water balance monitoring efforts onsite, climate is represented by the active Halifax International Airport climate station (Station ID 8202251)⁸. Climate normal conditions were assumed as the 1981 - 2010 climate record. In addition, climate data is represented by the on-site meteorological station, when data is available.

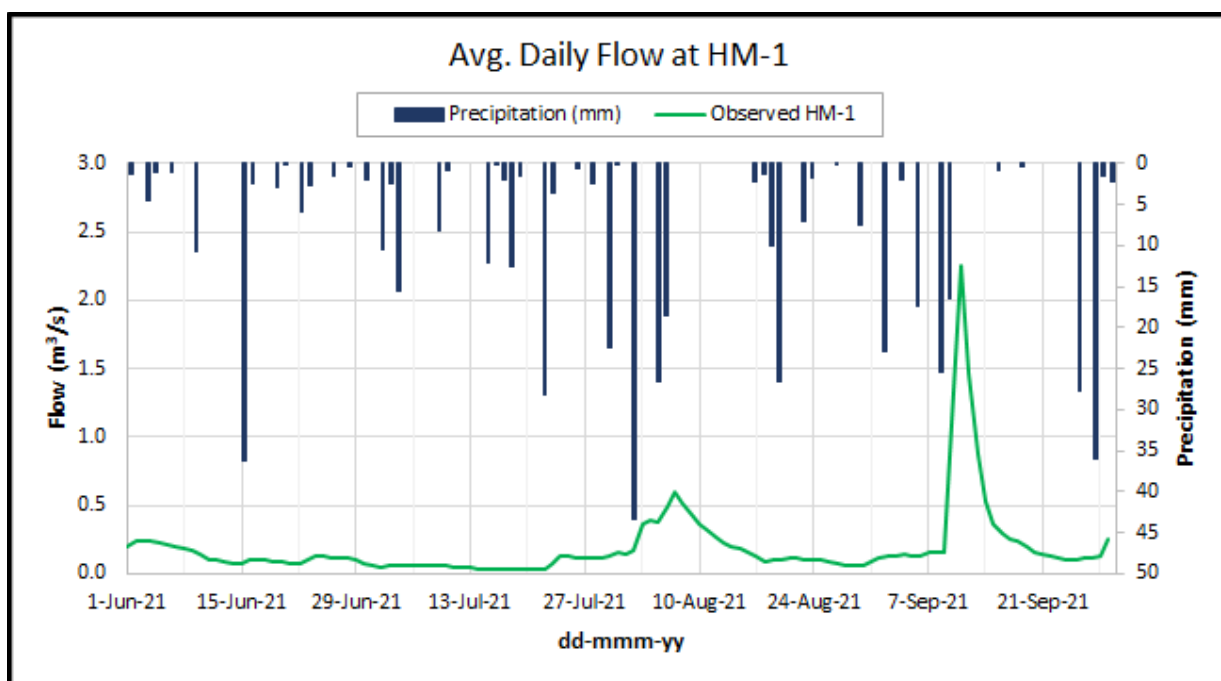
Figure 4.2 Average Daily Flow and Total Precipitation Over Time at HM-1

Figure 4.2 presents the flow-times series at HM-1 hydrometric station for the monitoring period in 2021 between June 1 and the end of September. As observed in 2019 and 2020 data (Stantec July 2021¹⁴), the results show a delay in the discharge response at HM-1 following large precipitation events, due to a delay in transit time of precipitation through the watershed (lag-time). HM-1 has a large headwater lake, Long Lake, which acts as a reservoir that can store runoff from precipitation events and release it more gradually than observed in the main channel of Moose River. Storage in Long Lake builds up from precipitation events in mid-June to mid-July, as flow in the tributary does not respond to these events. Rises in discharge rates are observed beginning mid-July to mid-August and again in mid-September.

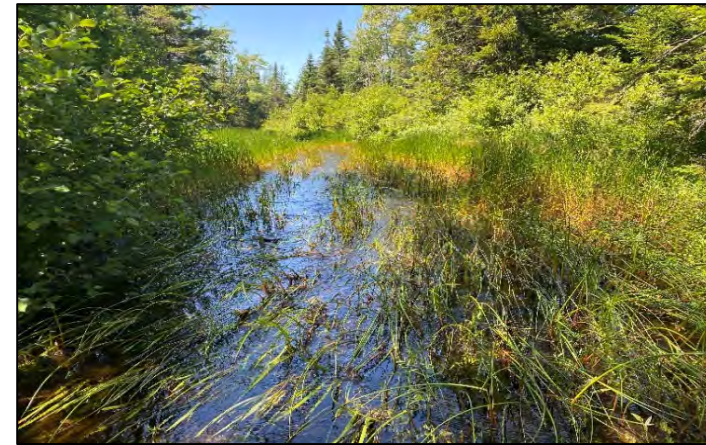
Flow Meter OTT MF pro
Fixed Point Average 40 seconds
Data Collected at site Water temperature, water level, atm. pressure
Main channel Grassy vegetation, not clear
Channel Bottom cobbles, gravel, grassy vegetation throughout
Flood Plain Tall grass, shrubs
Comments Extremely vegetated site. Recommendations made to relocate this site downstream approx. 60 m. (SW-11B)

SW-11 Facing Upstream, July 14, 2021

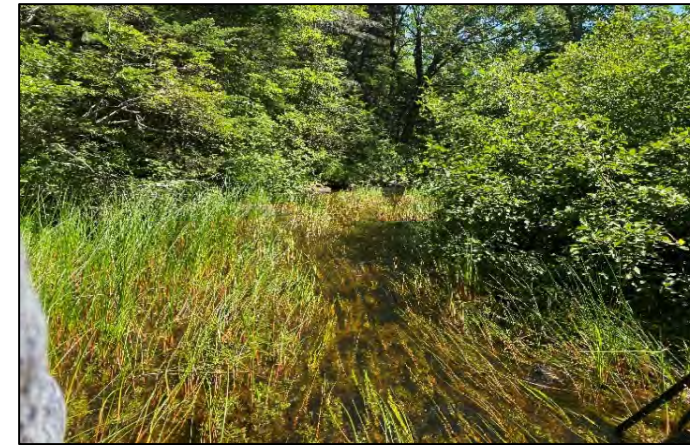
Downstream at SW-11, July 14, 2021

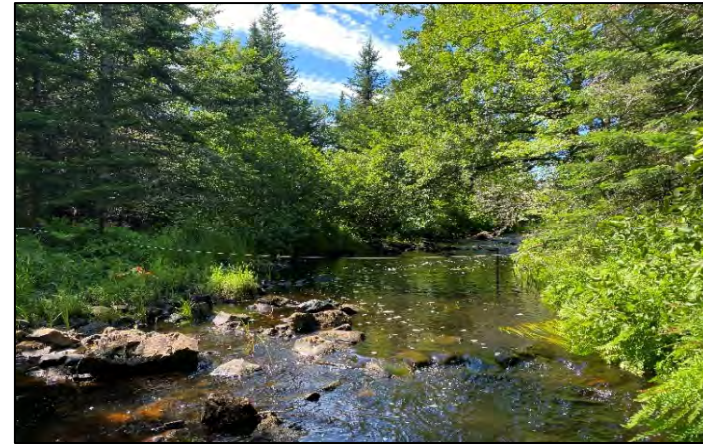
Hydrometric Station ID	▲ SW-11B	Flow meter used	OTT MF pro
Location	60 m downstream of SW-11 on Moose River	Fixed Point Average	40 seconds
Installation Date	8-Jul-21	Data Collected at site	Flow measurement, depths, and velocities
Coordinates	20T 504146E 4982519N	Main channel	Clean and winding
Access	Moose River Road	Channel Bottom	Gravel, cobble substrate with boulders near banks
Drainage Area	25.78 km ²	Flood Plain	Tall grass
Period of Record	July 2021-present	Comments	Located 60 m downstream of SW-11. At this location, Moose River narrows, and flows SE.

SW11B Facing Upstream - July 21, 2021

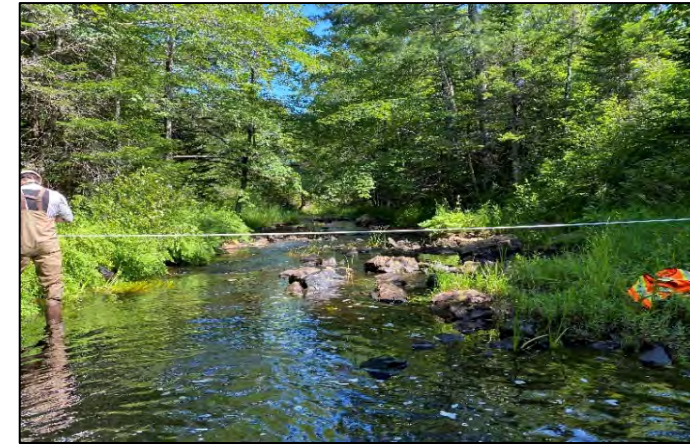
Downstream at SW11B - July 21, 2021

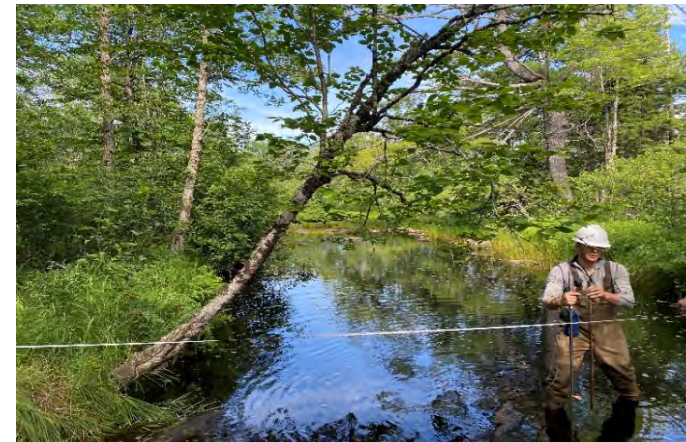
Flow Meter OTT MF pro
Fixed Point Average 40 seconds
Data Collected at site Flow measurement, depths, and velocities
Main channel Rocky, cut
Channel Bottom Gravel, cobbles and boulders
Flood Plain High rock cuts, tall grass, medium shrubs.
Comments Waterfall (drop of 1 m) under bridge approx. 30 m upstream

Downstream photo: July 21, 2021

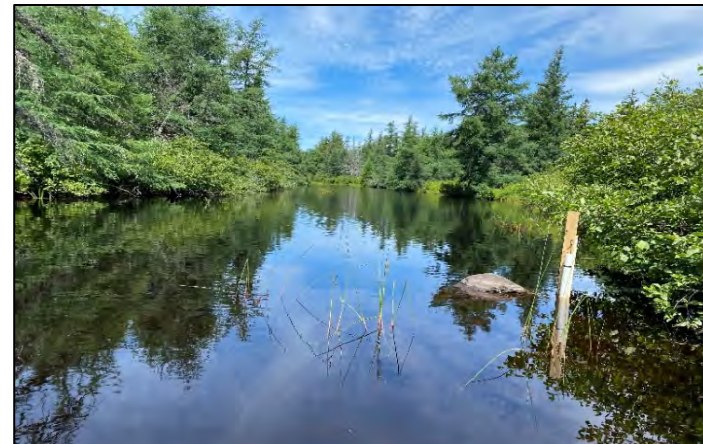
Hydrometric Station ID	▲ HM-4	Flow Meter	OTT MF pro
Location	Moose River, adjacent to open pit well OPM-2A/B	Fixed Point Average	40 seconds
Installation Date	29-Jun-21	Data Collected at site	Flow measurement, depths, and velocities
Coordinates	20T 4981021E 504156N	Main channel	Clean
Access	Western Diversion Rd.	Channel Bottom	Soft, organic bottom, with some boulders
Drainage Area	38.82 km ²	Flood Plain	Tall grass, shrubs
Period of Record	2021 to present	Comments	Almost no slope, trouble to tell which way water is flowing. Wide channel.

Upstream photo

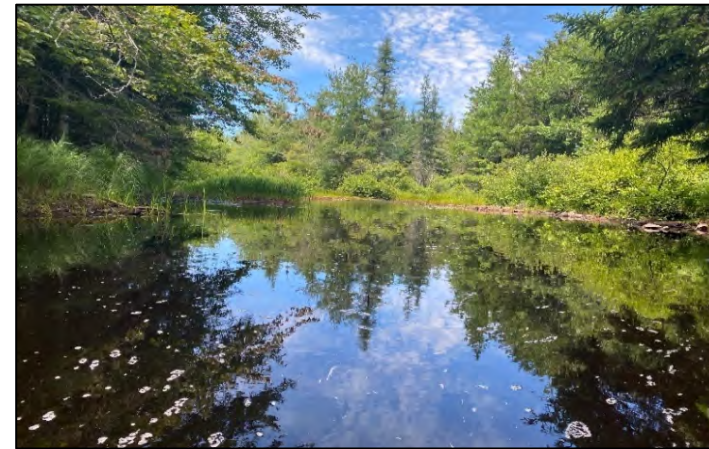
Flow Meter OTT MF pro
Fixed Point Average 40 seconds
Data Collected at site Water Temperature, Water Level, Atm. Pressure
Main channel Clear and straight
Channel Bottom Soft material, gravel, and few cobbles
Flood Plain Tall grass, trees
Comments

SW-2 Facing Upstream - July 14, 2021

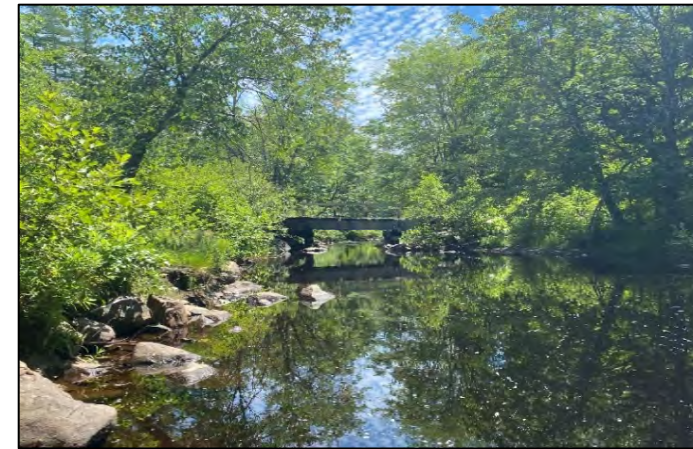
Downstream at SW-2 - July 14, 2021
