### Welshtown Quarry Water Management Plan

### WELSHTOWN QUARRY

Upper Clyde Road, Welshtown, Shelburne County, Nova Scotia

## Welshtown Quarry Expansion

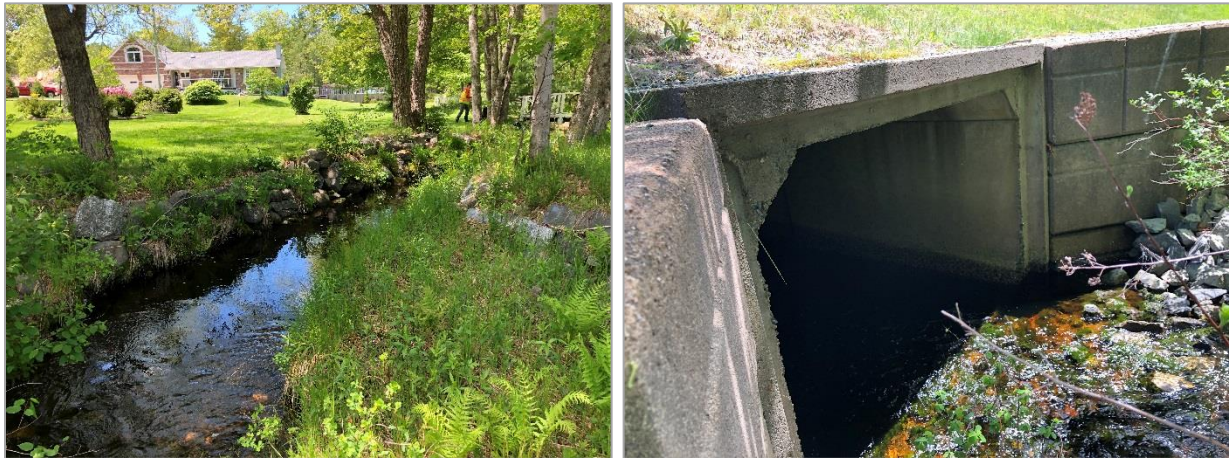
**Figure 2. Downstream site along Tributary 1 (DS1), upstream of a concrete box culvert where the stream connects with the Roseway River. June 2, 2021.**

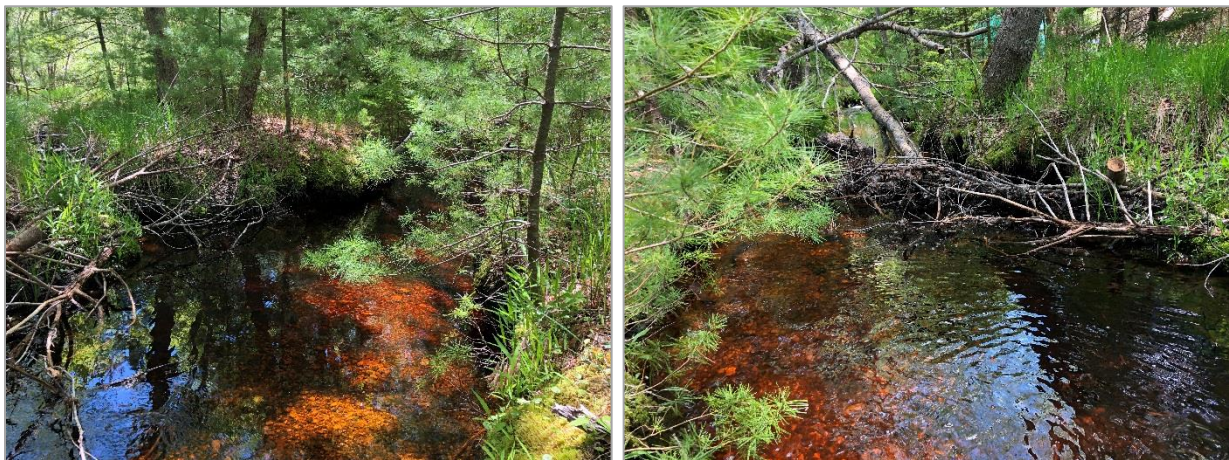
**Figure 3. Tributary 1 at the junction with Tributary 3 (DS2), looking upstream (*left photo*) and downstream (*right photo*) from the sampling site. June 2, 2021.**

Site DS2 is located on Tributary 1, immediately below its junction with Tributary 3 (Figure 3). The site, located upstream of the residential homes along Upper Clyde Road, is surrounded by a mixed wood forest consisting predominantly of red maple (*Acer rubrum*). The bottom substrate was gravel with occasional sand and fines with woody debris, leaf litter, and organic matter present on the streambed. Fallen branches and logs were also noted across the stream (Figure 3). Banks had minimal overhanging vegetation and were covered in grasses, mosses, starflower (*Lysimachia borealis*), Indian cucumber root (*Medeola virginiana*), wild lily-of-the-valley (*Maianthemum canadense*), white pine (*Pinus strobus*), fir, and maple seedlings. Exposed tree roots, woody debris, undercut banks and pool areas provided many areas for fish cover and the canopy cover of mixed coniferous/deciduous trees (fir, spruce, white pine, maple) provided significant shade to the stream. Minnow traps were used at this sampling site. Water temperature was 13.7 °C and dissolved oxygen was high at 9.45 mg/L (Table 1).

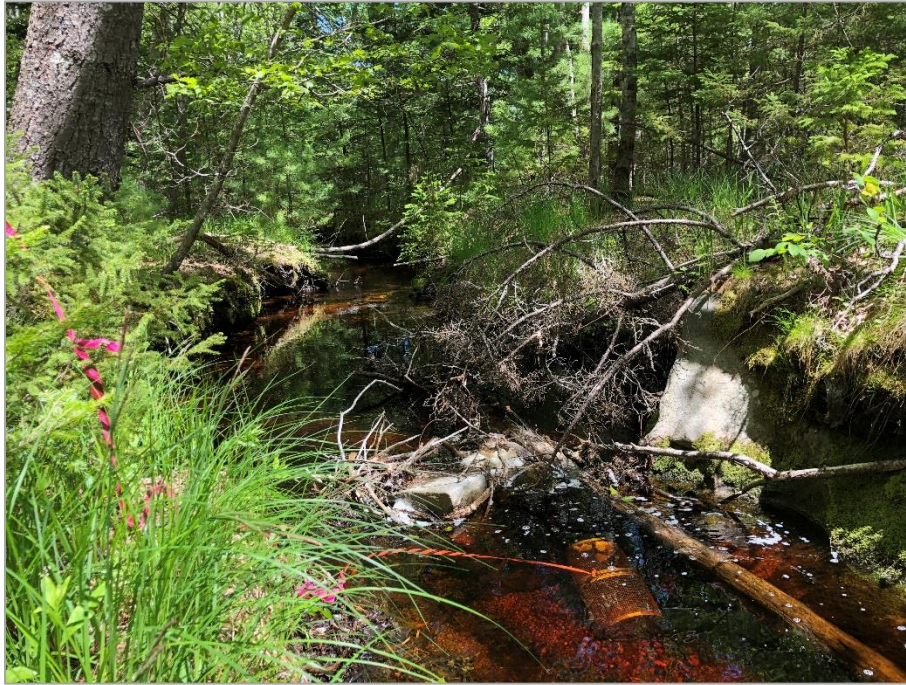
**Figure 4.** Tributary 1 where a fallen spruce tree is creating a natural deflector (DS3), looking downstream toward the fallen tree and minnow trap placed in the stream. June 2, 2021.

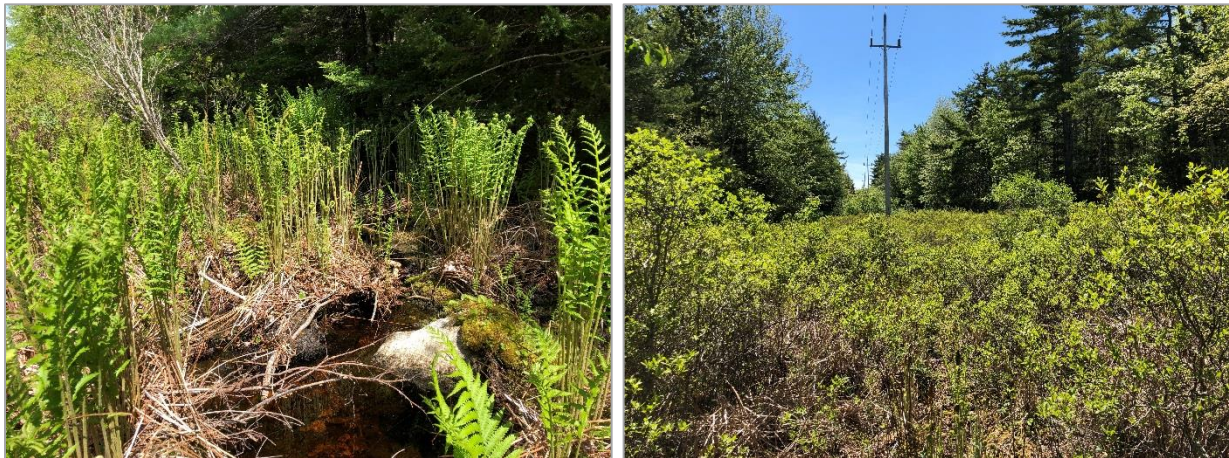
**Figure 5.** Tributary 1 at the powerline utility corridor (DS4) looking downstream (*left photo*) and at the wetland-basin (*right photo*). June 2, 2021

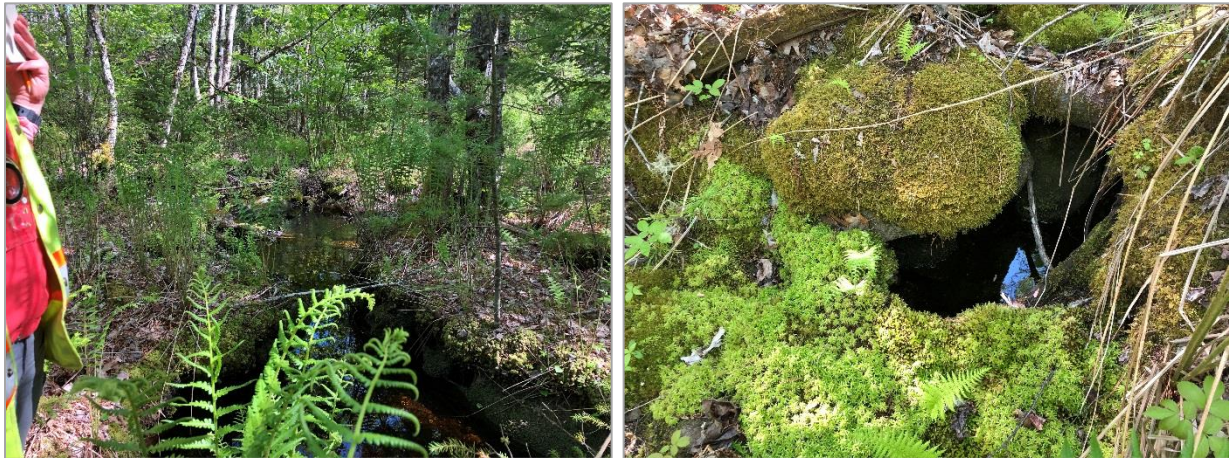
Figure 6. Tributary 1 is at sampling site US1 surrounded by mixed wood forest (*left photo*) and becomes subterranean upstream (*right photo*). June 2, 2021

Site US1 is located in a deep stretch of stream (approximately 300 m above the junction of Tributaries 1 and 2) and surrounded by a mixed coniferous/hardwood forest consisting of red maple, white pine and fir. The site had a bottom substrate of sandy gravel overlain with leaf litter and woody debris and boulder was present along the edges of the stream. Several fallen trees and logs were noted within the stream above and below the sampling site. Banks had sparse overhanging vegetation and the channel and riparian

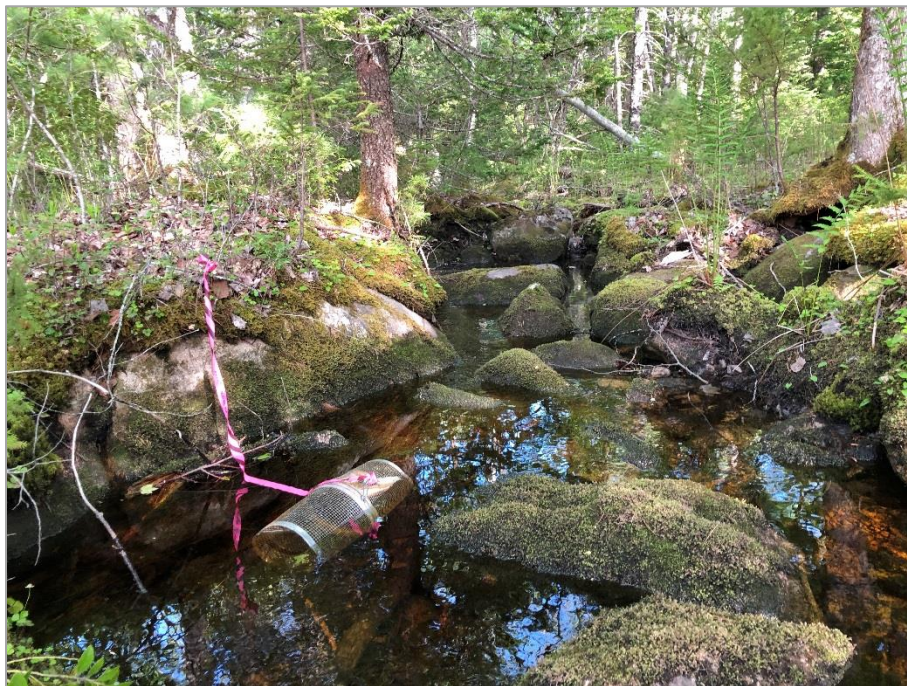
Figure 7. Tributary 1 at sampling site US2 where the stream was most easily accessible from the quarry property. June 2, 2021.

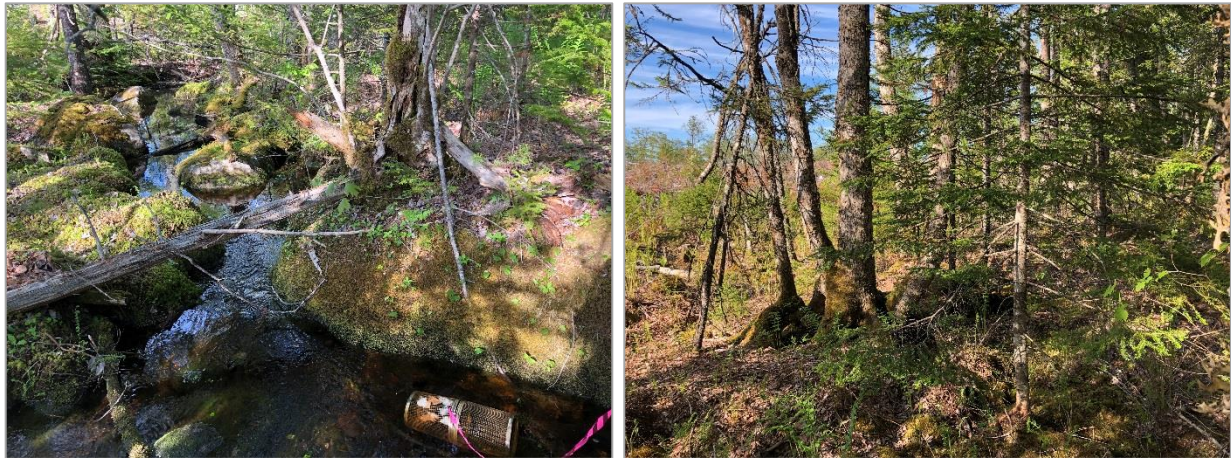
Figure 8. Furthest upstream site along Tributary 1 (US3) (*left photo*) and the logged area between the stream and quarry property (*right photo*). June 2, 2021.

Sampling site US3 is the furthest upstream along Tributary 1 and is the nearest site to the Welshtown Quarry property, and the previously identified Wetland 12. The site is also located approximately within 10 m to a cut line where logging activity adjacent to the quarry property has occurred, likely between the July 8, 2020 Environmental Assessment site visit and the June 2 and 3, 2021 site visits. Sampling was conducted in a run with clear and coloured (tan/brown) water, having a slow flow. The site had a bottom substrate of cobble and boulder with some sandy mud as well as in-stream vegetation, organics, woody debris and algae (Figure 8). Banks were stable and displayed grasses, moss, ferns, asters, threeleaf goldthread (*Coptis trifolia*), wild lily-of-the-valley (*Maianthemum canadense*), and Canadian bunchberry (*Cornus Canadensis*). Adjacent areas were forested to the south with a mixed coniferous/hardwood canopy; a logging cutline occurred to the north. Water temperature was 11.1 °C; dissolved oxygen was moderate at 8.3 mg/L (Table 1).

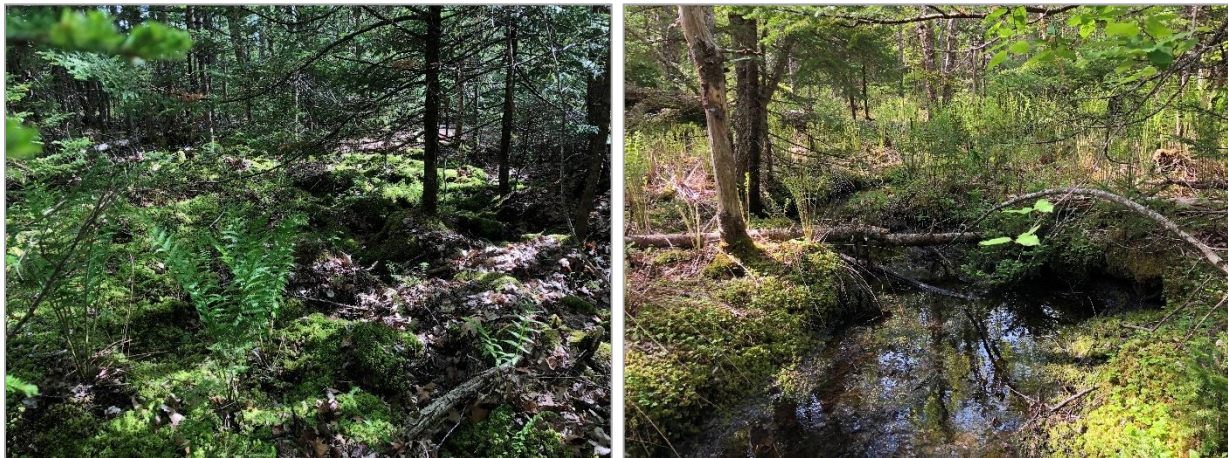
Figure 9. Upper portions of Tributary 1 where the stream becomes intermittently subterranean (*left photo*) while other areas showing channelized flow (*right photo*). June 3, 2021.

Upstream of the sampling site, the stream became intermittently subterranean and areas of channelized stream at the surface appeared to be ideal fish habitat, although no fish were visually observed during the time of the survey (Figure 9).

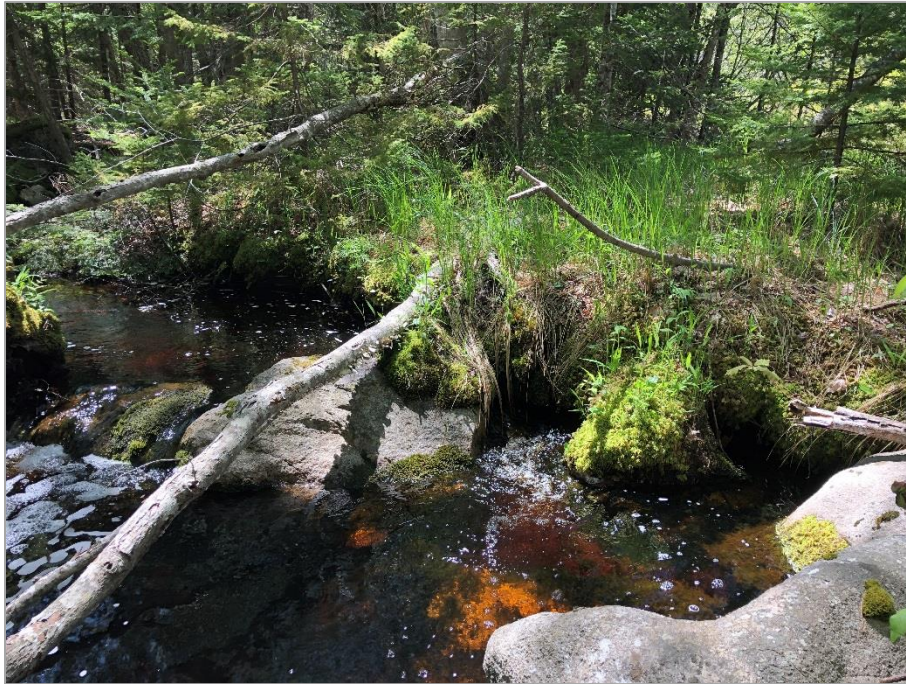
**Figure 10. Tributary 2 at sampling site T2A where the stream joins Tributary 1. Flow over a large boulder created a deep pool. June 2, 2021.**

Site T2A is on Tributary 2 and is located at the junction with Tributary 1 (Figure 1). A large boulder in the middle of the stream was observed to be directing flow to carve out a large deep pool where Tributary 2 and Tributary 1 join (Figure 10). The stream channel featured undercut banks and was 60-70% shaded by mixed coniferous/deciduous (spruce, fir, maple, oak) canopy. Sparse overhanging woodland plants including grasses, sedges, asters, wild sarsaparilla (*Aralia nudicaulis*), starflower (*Lysimachia borealis*), wild lily-of-the-valley (*Maianthemum canadense*), and sphagnum moss covered banks. Substrate consisted primarily of gravel with occasional boulder, cobble and woody debris, leaf litter and in-stream vegetation present in the stream. A minnow trap was placed in the deep pool immediately below the boulder. Water temperature was 14.2 °C and dissolved oxygen was high at 8.6 mg/L (Table 1).

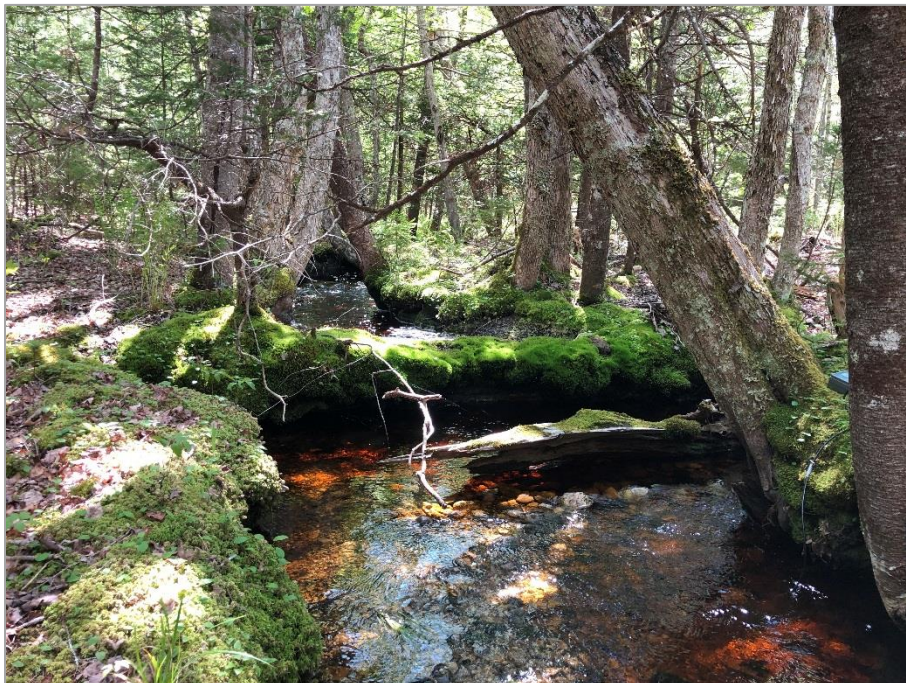
**Figure 11. Tributary 2 where a large wood structure covered in moss crosses the stream (T2B). June 2, 2021.**

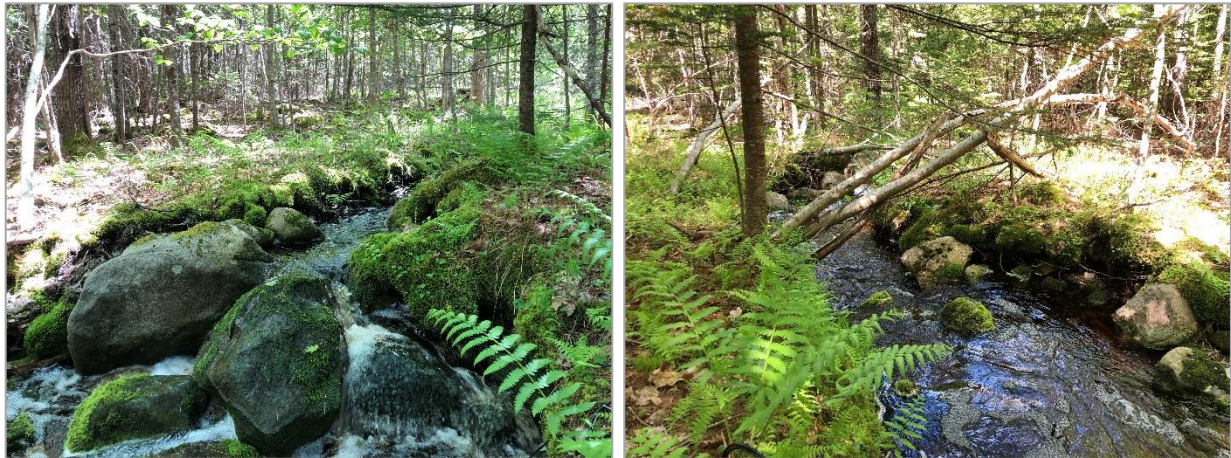
Figure 12. Tributary 2 where a series of boulders and the natural topography create step pools in the stream (T2C) (*left photo*), looking upstream toward an artificially constructed dam (*right photo*). June 2, 2021.

Site T2C is the furthest upstream site on Tributary 2. The sampling site was located upstream of an old logging road and bridge that crosses the stream. The general topography was more steeply sloped going upstream than that of the downstream sites. Large amounts of litter including tires, cans, buckets, fishing line and rope were present in the riparian zone, and areas of the stream were blocked by debris. The stream bed was predominantly boulder with cobble, gravel and occasional sand with several step-pool areas posing potential fish barriers (Figure 12). The sampling site had a stream width of approximately 1.5 m and banks were vegetated with mosses, ferns including New York fern (*Parathelypteris noveboracensis*), cinnamon fern (*Osmundastrum cinnamomeum*) and crested wood fern (*Dryopteris cristata*), American witch hazel (*Hamamelis virginiana*), wild lily-of-the-valley (*Maianthemum canadense*), fir, oak and maple.

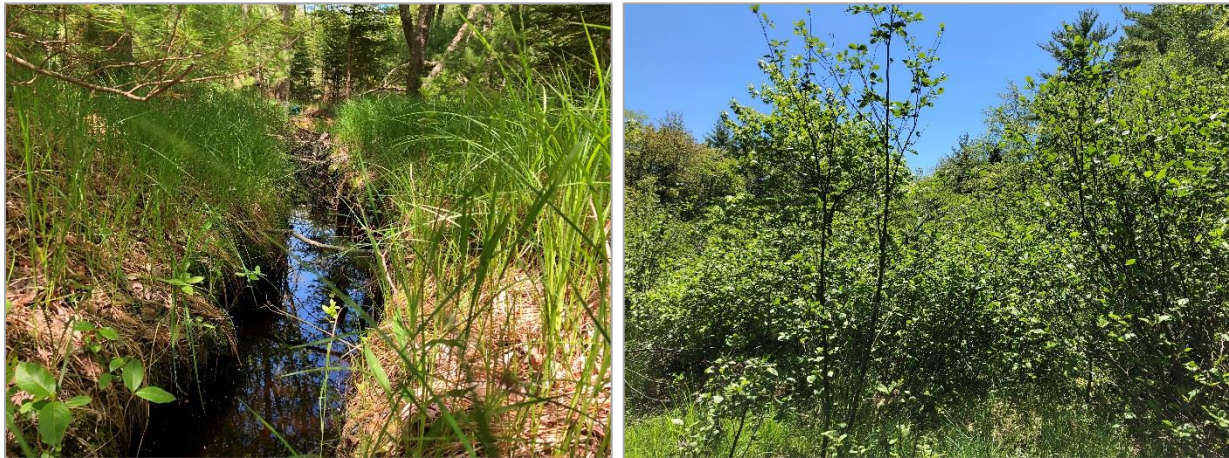
Figure 13. Tributary 3 (T3A) looking downstream toward the junction with Tributary 1 (*left photo*) and upstream of site T3A, showing an alder/red maple swamp (*right photo*). June 2, 2021.

Site T3A is located on Tributary 3 immediately upstream of the junction with Tributary 1 (Figure 1). Sampling was conducted in a slow flowing run about 50 cm wide and 15 cm deep having a bottom substrate of sand, silt and fines (Figure 13). The site had occasional in-stream vegetation (aquatic plants) and woody debris and organics were present in the stream. The stream channel was 5 % shaded and banks were vegetated with grasses, sedges, asters, alders, red maple (*Acer rubrum*) and white pine (*Pinus strobus*). A minnow trap was deployed at this site. Upstream of the sampling site, the stream became less defined moving through the alder/red maple swamp (Figure 13). Water temperature was 13.9 °C; dissolved oxygen was low at 2.8 mg/L (Table 1).

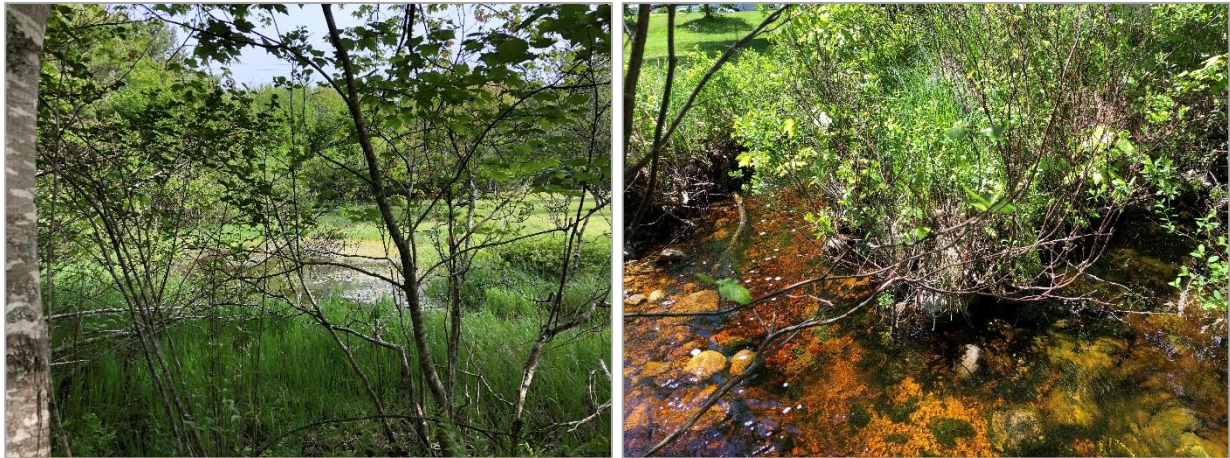
Figure 14. Modified pond on residential property (*left photo*; June 3, 2021) and the junction of the pond outflow with Tributary 1 (*right photo*; June 2, 2021).

A small pond was observed on an adjacent residential property to Tributary 1 located along Upper Clyde Road. The pond appeared to be artificial with an outlet channel flowing south to connect to Tributary 1 approximately 40 m upstream of the Upper Clyde Road culvert (Figure 14). During the time of the survey, water in the outflow stream was stagnant and algae was present.

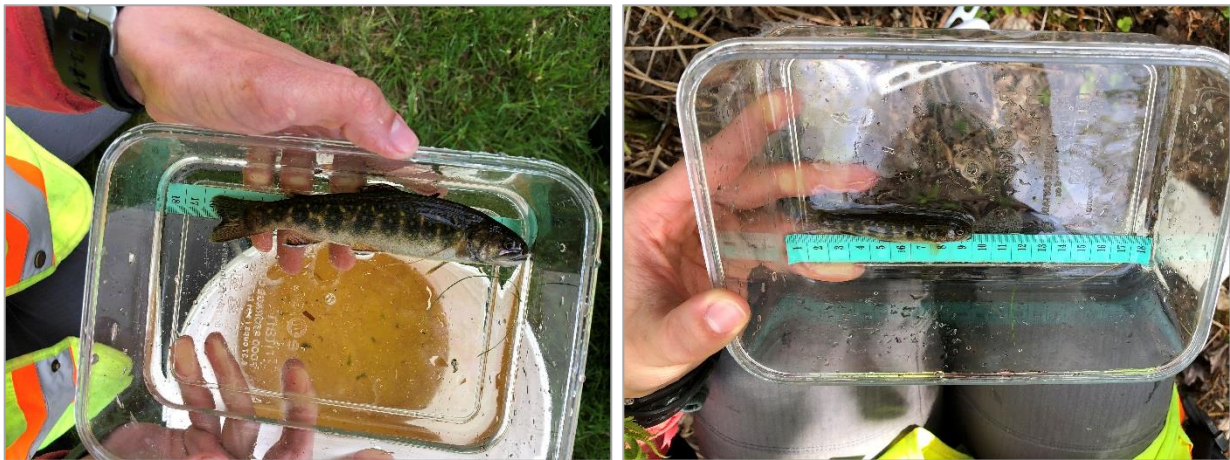
Figure 15. Brook trout observed in minnow traps placed at site DS4 (*left photo*) and at site US1 (*right photo*).

Six (6) juvenile brook trout, ranging from 8 to 16 cm in length, were observed via electrofishing and in minnow traps at sites assessed along Tributary 1 (Table 1; Figure 15). Fish were also observed swimming in a pool between sampling sites US1 and US2 (Figure 1). Suitable fish habitat was present along the reach of the brook, continuing beyond US3 (the sampling site furthest upstream), providing refugia (e.g., undercut banks, aquatic plants, overhanging vegetation, areas of subterranean flow, etc.), acceptable water quality (i.e., moderate to high dissolved oxygen), and nutrient sources.
