WATERCOURSE AND FISH HABITAT SURVEYS

Watercourse and Aquatic Habitat Surveys

Westchester Wind Project - Appendix K

February 2022 – 21-1329

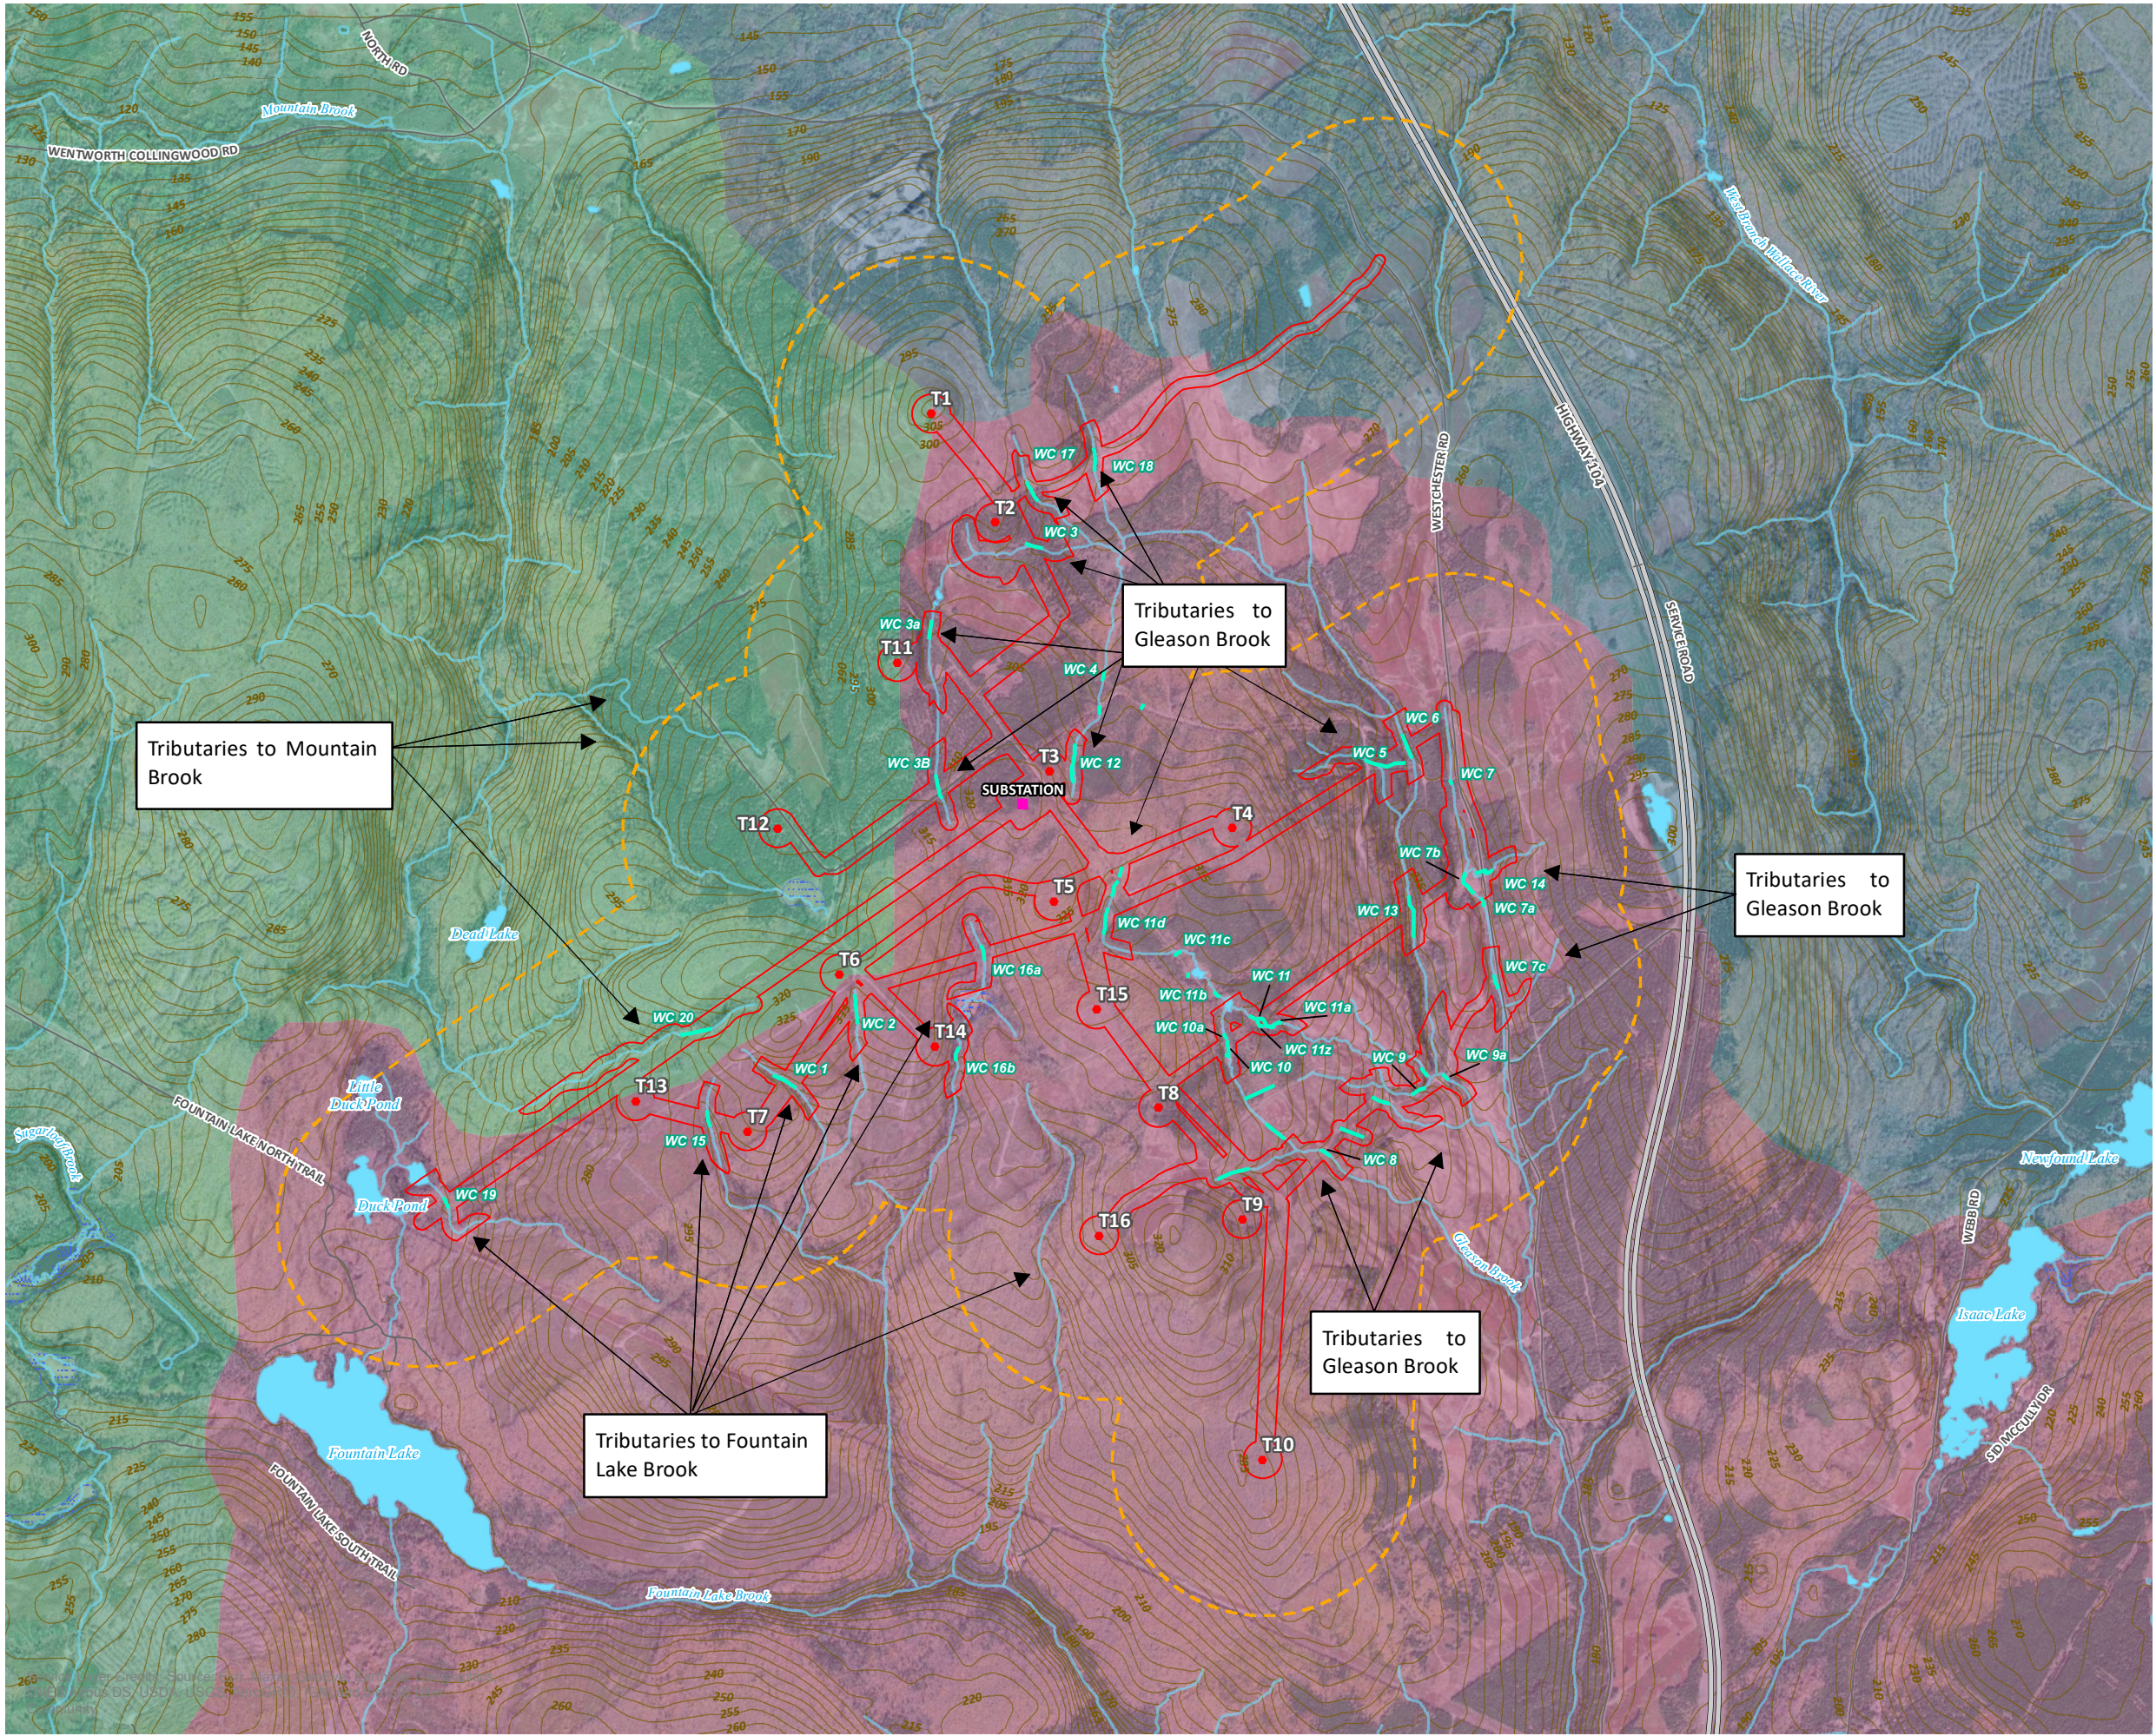
SURFACE WATER WITHIN THE
PHYSICAL ENVIRONMENT LOCAL
ASSESSMENT AREA
FIGURE K-1

The LAA for the physical environment (i.e., A 500 m buffer around all Project components, including the PDA) includes the River Philip and Wallace River secondary watersheds (IDN-1 and IDN-3 respectively), and contains several tributaries and lakes (NSE 2011). Mapped water features within the Project Area are shown on **Figure K-1**.

Gleason Brook, tributaries to Gleason Brook, tributaries to Fountain Lake Brook and tributaries to Mountain Brook enter the PDA at 31 identified locations, shown on **Figures K-1 and K-2**, respectively. In general, the watercourses within the PDA are relatively small, ephemeral to seasonally flowing. The majority of the watercourses flow in a south/south-easterly direction with the exception of the headwaters and a headwater tributary to Gleason Brook (WC12, WC4, WC3a and WC3b) which flow north, and a tributary to Mountain Brook which flows west (WC20). There are no known springs on the site.

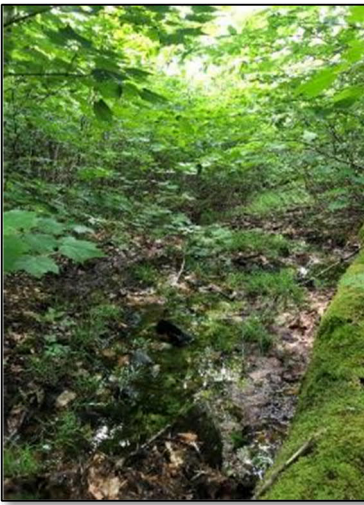
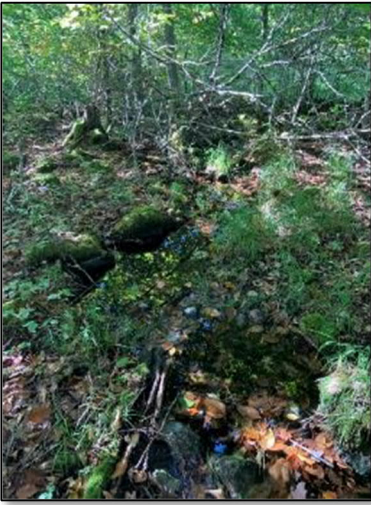
Unnamed Tributary to Fountain Lake Brook - Watercourse 1 (WC 1)	Unnamed Tributary to Fountain Lake Brook - Watercourse 2 (WC 2)	Unnamed Tributary to Gleason Brook- Watercourse 3 (WC 3)

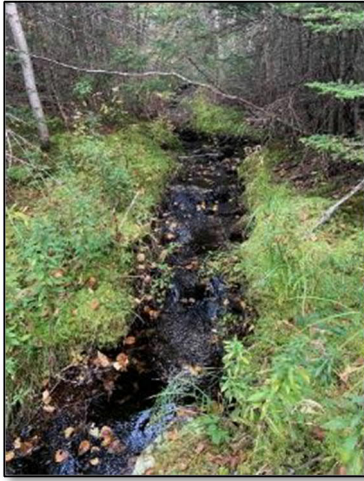
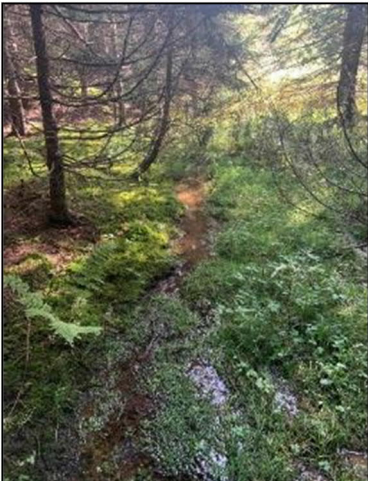
Unnamed Tributary to Gleason Brook- Watercourse 3a (WC 3a)	Unnamed Tributary to Gleason Brook- Watercourse 4 (WC 4)	Unnamed Tributary to Gleason Brook- Watercourse 5 (WC 5)

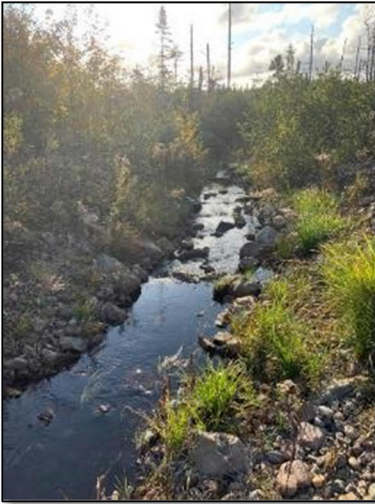
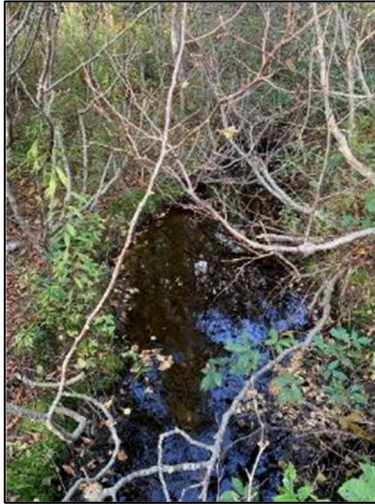
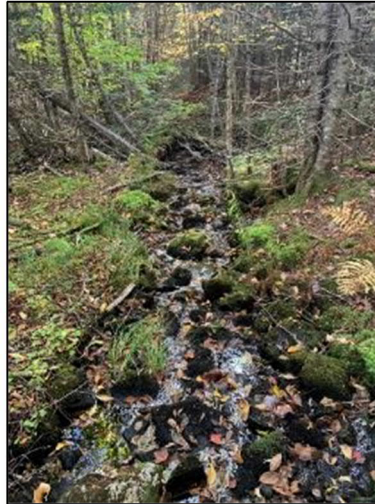
<p>Unnamed Tributary to Gleason Brook- Watercourse 11b (WC 11b)</p>	<p>Unnamed Tributary to Gleason Brook- Watercourse 11c (WC 11c)</p>	<p>Unnamed Tributary to Gleason Brook- Watercourse 11z (WC 11z)</p>

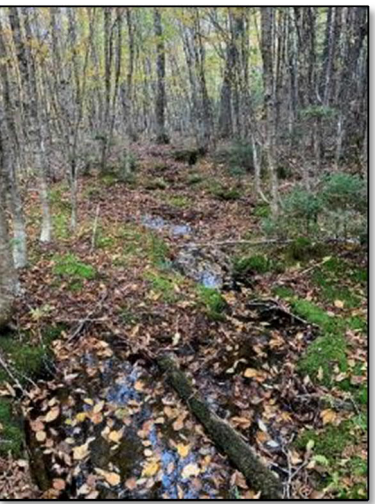
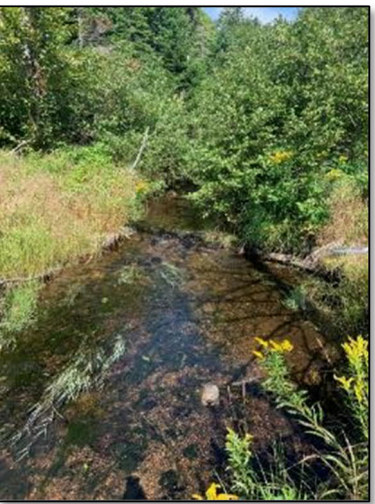
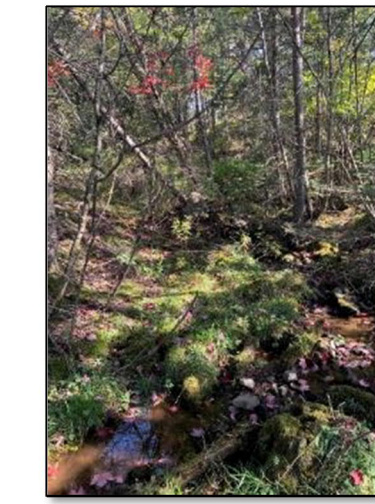
<p>Unnamed Tributary to Gleason Brook- Watercourse 12 (WC 12)</p>	<p>Gleason Brook – Watercourse 13 (WC 13)</p>	<p>Unnamed Tributary to Gleason Brook- Watercourse 14 (WC 14)</p>
