# Elmsdale Business Park Phased Expansion Class 1 Environmental Assessment Application

February, 2019

Freshwater Environment Report  
(WSP, 2016)

## **Freshwater Environment**

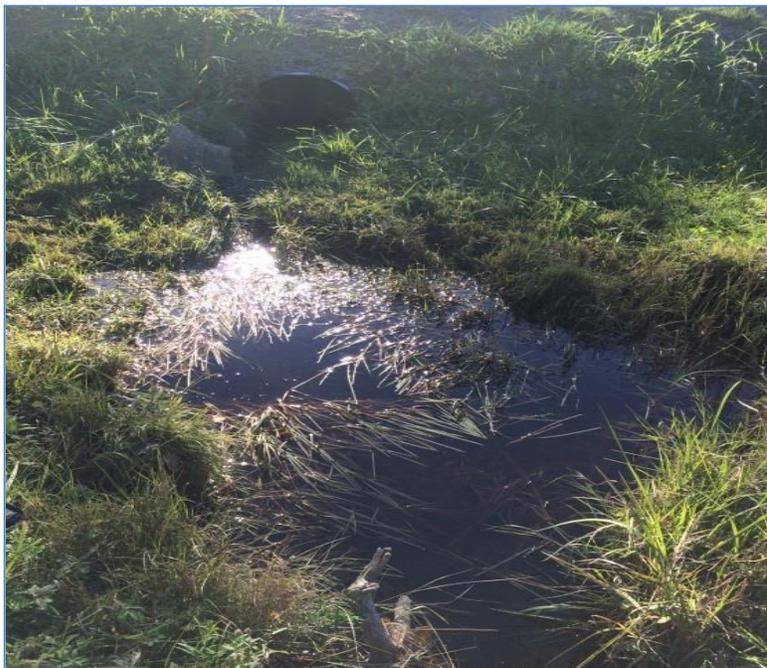
Reach 1 of Watercourse 1 begins east of Enfield Road and runs until it meets the edge of Wetland 1 (WL1) outside of the Project Study Area (Figure 6, Appendix A). This Reach has a defined channel for approximately 50 meters, but downstream towards the Project Study Area the channel becomes undefined with pockets of water throughout the whole swamp. An existing 55 cm culvert is located west of Reach 1 allowing an inlet in to WL1. The average wet width of the channel during the time of the survey was 60 cm wide and 14 cm deep. The average bank full width was 90 cm wide and 30 cm deep. The channel had vegetation growing within it and the substrate was mainly muck with very small amounts of rubble. The channel had stable banks on both sides. The canopy cover above the channel is approximately 3%; with no woody debris in the channel. The end of this Reach runs to the edge of WL1 which is dominated by alders and tall grasses.

Photo 1. Watercourse 1, Reach 1 where it crosses Enfield Road, just east of the Project Detailed Study Area (i.e., Project Footprint)

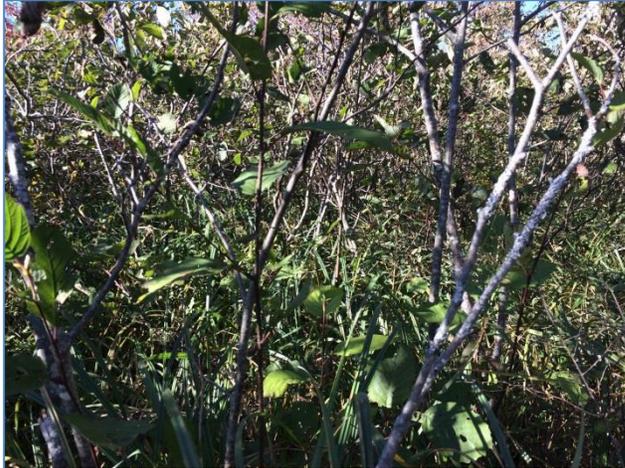
Photo 2. Shrub Swamp approximately 20 metres northeast of WC1.

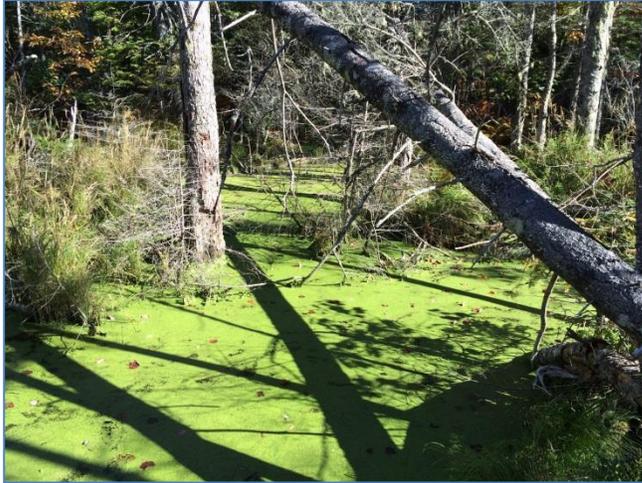
Reach 1 of Watercourse 2 (WC-2) begins in the south portion of Wetland 1 and runs downstream within Wetland 1 towards Park Road (See (Figure 6, Appendix A)). At Reach 1 the watercourse is a large pool that has an average wet stream width of approximately 25 m and depth of 30 cm. The substrate of the watercourse is made up of organic muck and leaf litter that has an odor.

The average bank full width is approximately 30 metres and 60 cm deep. During the survey no flow was observed, and the watercourse was abundant with aquatic plants and some algae. The watercourse had a large amount of blow down as well as the riparian area, which was most likely a result from hurricane Juan. No beaver dams were found during the survey; however, there was evidence of old beaver activity from tree markings. A manmade hunting tree stand, and wooden bridge was found next to the watercourse at Reach 1. The canopy cover over the Stream was approximately 50 – 60% and contained mixed wood. The water quality data collected at Reach 1 during the survey was:

- Temperature: 11.5 °C,
- Dissolved Oxygen: 27%,
- pH: 6.98, and
- Conductivity: 345  $\mu\text{S}/\text{cm}$

Photo 3. Reach 1, Watercourse 2 with abundant aquatic plants and blowdown.

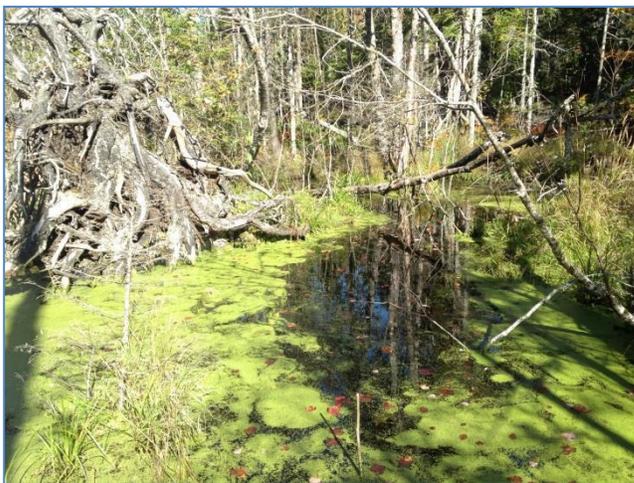
Reach 2 is located approximately 60 meters downstream from Reach 1 and is very similar with an average wet width of approximately 15 meters and average wet depth of 20 cm. The watercourse at Reach 2 consists mainly as a pool with approximately 60% canopy cover and is contiguous with Wetland 1. The substrate of the watercourse is the same as Reach 1, and contained an abundance of aquatic plants, algae, and blowdown. The stream had no flow during the survey and the riparian area consisted of wetland and mixed wood forest. Both, the left and right banks of the watercourse were stable with a slope of approximately 5%. The water quality data collected at Reach 2 during the survey was:

- Temperature: 13.21 °C,
- Dissolved Oxygen: 25.4%,
- pH: 6.93, and
- Conductivity: 365  $\mu\text{S}/\text{cm}$

Photo 4. Reach 2, No flow and abundant with aquatic plants.

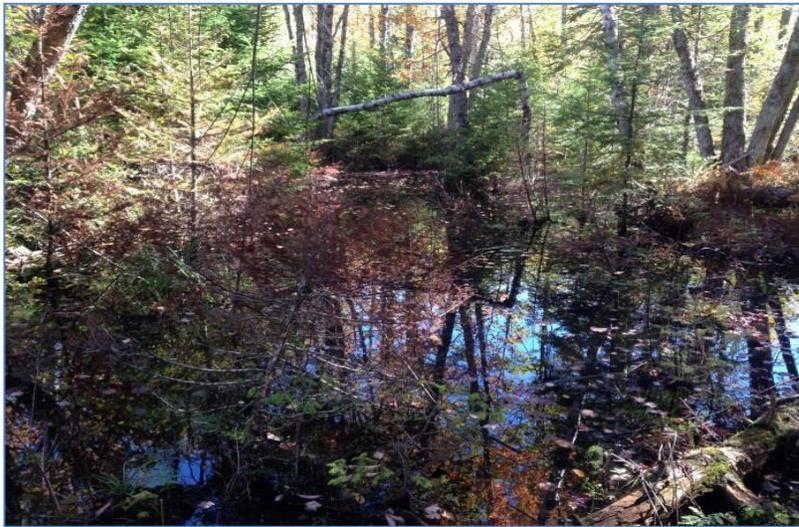
Reach 3 is located approximately 40 metres downstream from Reach 2 and is characterized by a wider, braided channel with an island that is contiguous with Wetland 1. The average wet width and depth are approximately 25 metres and 20 cm, while the average bank full width is approximately 30 metres wide and 50 cm deep. This Reach contains fewer blowdown, and less aquatic plants with no algae present. The stream substrate (organic leaf litter) and cover (60% mixed wood) are the same as Reach 2. The water quality data collected at Reach 3 during the survey was:

- Temperature: 11.41 °C,
- Dissolved Oxygen: 43%,
- pH: 6.88 ,and
- Conductivity: 345 µS/cm

Photo 5. Reach 3 with less aquatic plants and blowdown.

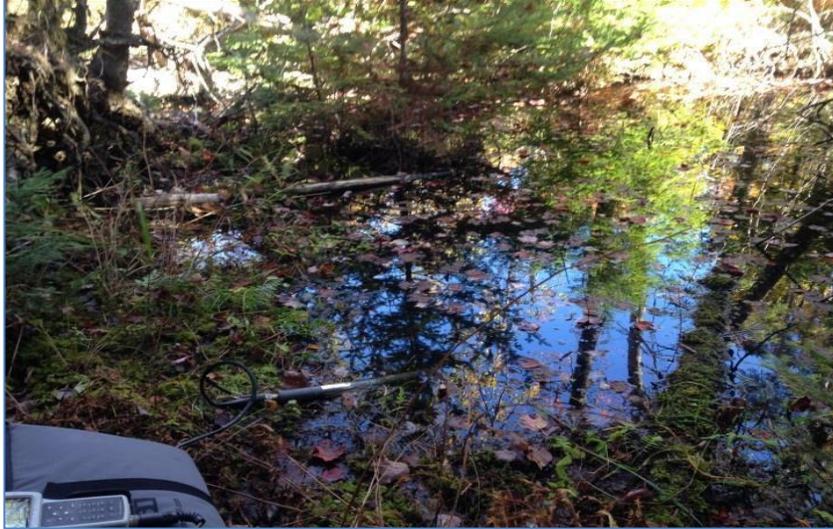
Reach 4 is located approximately 50 meters downstream from Reach 3 (Figure 6, Appendix A) and contiguous with Wetland 1. Its morphology is described as a braided channel configuration with organic leaf litter and muck channel bottom substrate. The average wet stream width is approximately 15 m wide and 15 cm deep. The average bank full width is approximately 20 metres wide and 30 cm deep. The stream bank is stable on both sides with the upstream vegetation consisting mainly of mixed wood forest. No blowdown was evident at this location on the stream. Reach 4 consisted of a large pool that had no flow. The water quality data collected at Reach 4 during the survey was:

- Temperature: 11.01 °C,
- Dissolved Oxygen: 31.7%,
- pH: 6.84, and
- Conductivity: 340 µS/cm

Photo 6. Reach 4, a braided channel with leaf litter

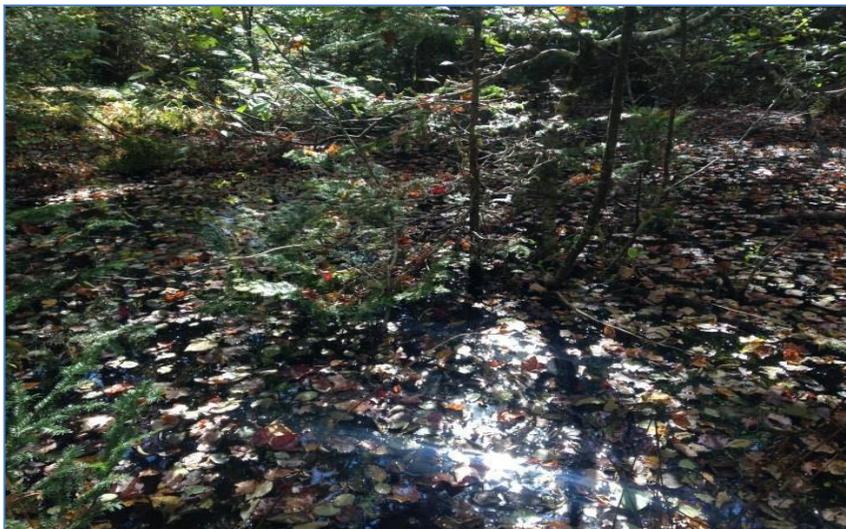
Reach 5 is located approximately 30 meters downstream of Reach 4 and is not surrounded by wetland, rather mixed forest and tall grasses. The average wet stream width is 7.4 metres wide and 38 cm deep, and the average bank full width is 9.8 meters wide and 39 cm deep. The Reach has a canopy cover of 70% and both banks are stable. The Reach has several stream types including riffle (15%), run (5%), and the majority of it is a pool (80%). During the time of the survey no flow was observed. The water quality data collected at Reach 5 during the survey was:

- Temperature: 10.82 °C,
- Dissolved Oxygen: 17.8%,
- pH: 6.75, and
- Conductivity: 345  $\mu\text{S}/\text{cm}$ .

Photo 7. Reach 5, comprised mainly of large pools with stable banks.

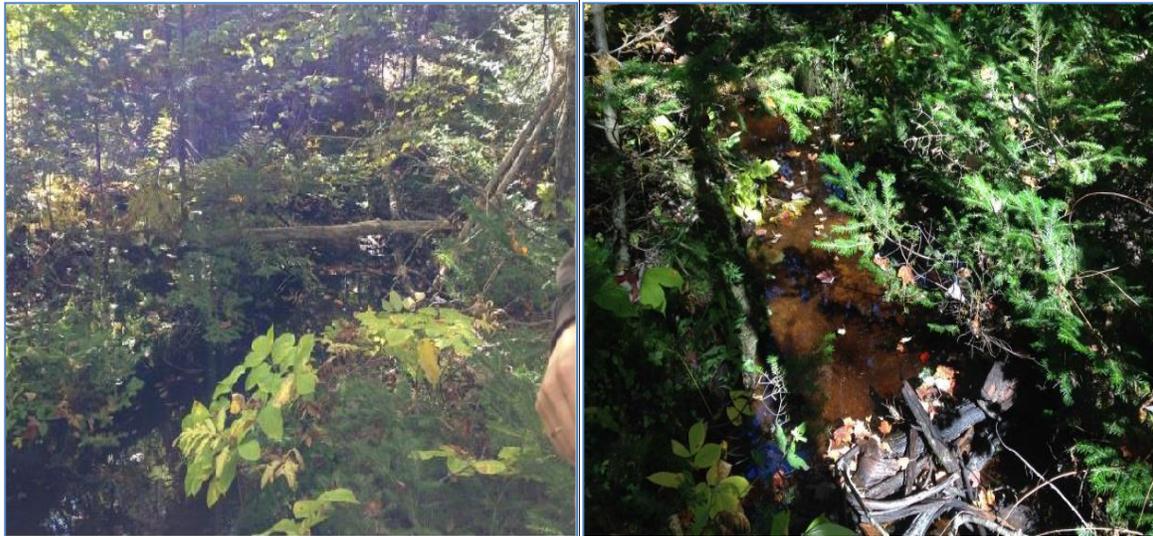
Reach 6 is located 36 metres Northwest of Park road (dirt portion) and approximately 30 metres downstream of Reach 5. This Reach is not nearly as wide and has a flow of 0.19 m/s and slope of approximately 3%. The average wet stream width is 1.09 metres and 14 cm deep, and the average bank full width is 1.55 meters and 50 cm deep. This reach has multiple braided channels approximately 10 metres upstream and turns into one defined channel at the 5-metre survey location. Both the left and right bank is stable, and the stream has a canopy cover of 70% mixed wood forest. Reach 6 has blowdown across the watercourse causing potential fish obstruction. The water quality data collected at Reach 6 during the survey was:

- Temperature: 10.89 °C,
- Dissolved Oxygen: 27.6%,
- pH: 7.68, and
- Conductivity: 345 µS/cm.

Photo 8 and 9. Reach 6, smaller watercourse channel with flow and woody debris.

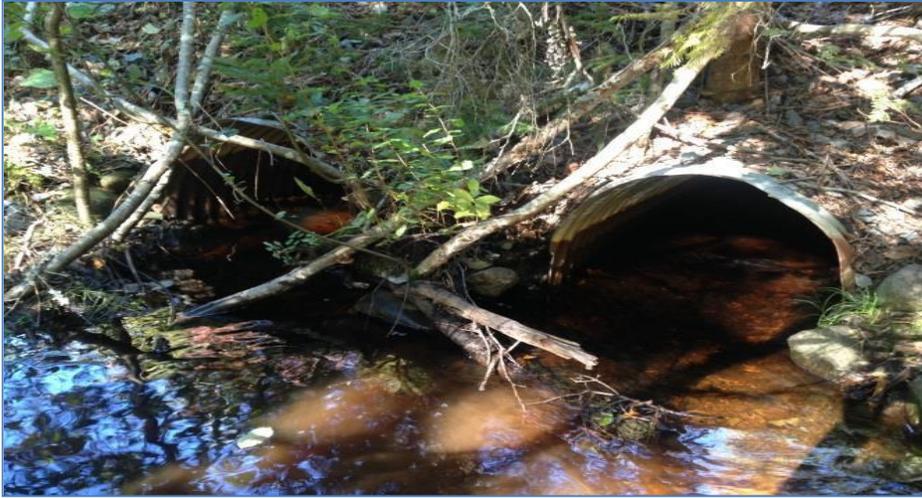
Downstream from Reach 6 a double culvert is located on Park road.

Photo 10. Existing culverts where **Watercourse 2** meets Park road.

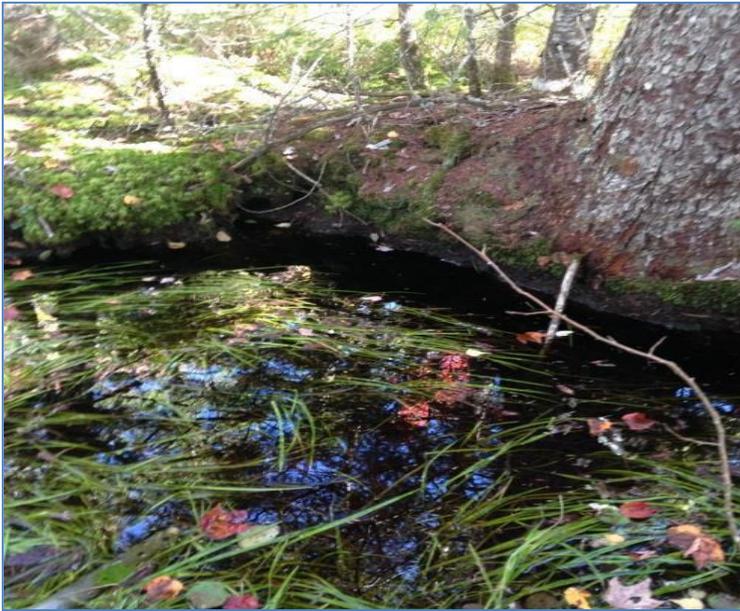
Reach 1 is located in the southeast portion of Wetland 1 and approximately 140 meters upstream from Park Road. The average wet stream width for this reach was 2.55 metres and 28 cm deep. The average bank full width is approximately 20 meters since it has a large flood plain across the wetland and the average bank full depth is 65 cm deep. The stream substrate is comprised of mainly leaf litter and muck (80%) with some rock (2%), gravel (10%), and sand (8%) with grass species growing within it. The stream has a canopy cover of 75% consisting of mixed wood. The stream was relatively flat with a slope of 1% with no flow during the time of assessment. Both banks were stable, and the right bank had a slope of 2%, while the left had a slope of 5%. The upstream vegetation consisted of a shrub dominated swamp wetland (Wetland 1). The water quality data collected at Reach 1 during the survey was:

- Temperature: 10.16 °C,
- Dissolved Oxygen: 35.9%,
- pH: 5.33, and
- Conductivity: 27  $\mu\text{S}/\text{cm}$ .

Photo 11. Reach 1 with a defined channel and pooled water.

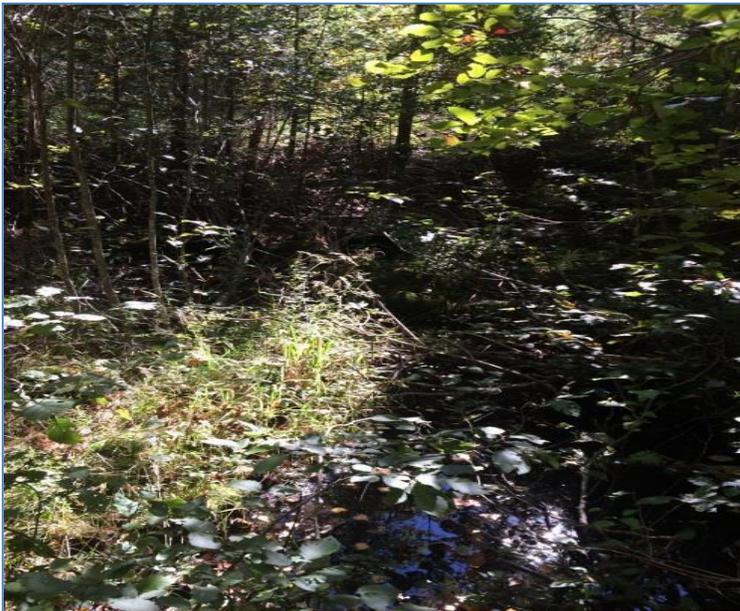
Reach 2 is located approximately 25 meters downstream of Reach 1 and had no flow with a minimal amount of water (average wet stream depth 10 cm), and a large average width (10.0 meters). The stream was less defined and was more of a flooded area with puddled water. The average full bank width was approximately 20 meters with an average depth of 40 cm. The reach consisted mainly of a run (90%), with some pooling (5%) and riffles (5%). Both banks were stable and had virtually no slope. The substrate consisted of leaf litter/ grass (95%), and a small amount of fine grained silty/sandy soils (5%). The vegetation around the stream bed consisted of a forested swamped wetland. The water quality data collected at Reach 2 during the survey was:

- Temperature: 10.27 °C,
- Dissolved Oxygen: 38.9%,
- pH: 4.89, and
- Conductivity: 26  $\mu\text{S}/\text{cm}$ .

Photo 12. Reach 2 with no flow.

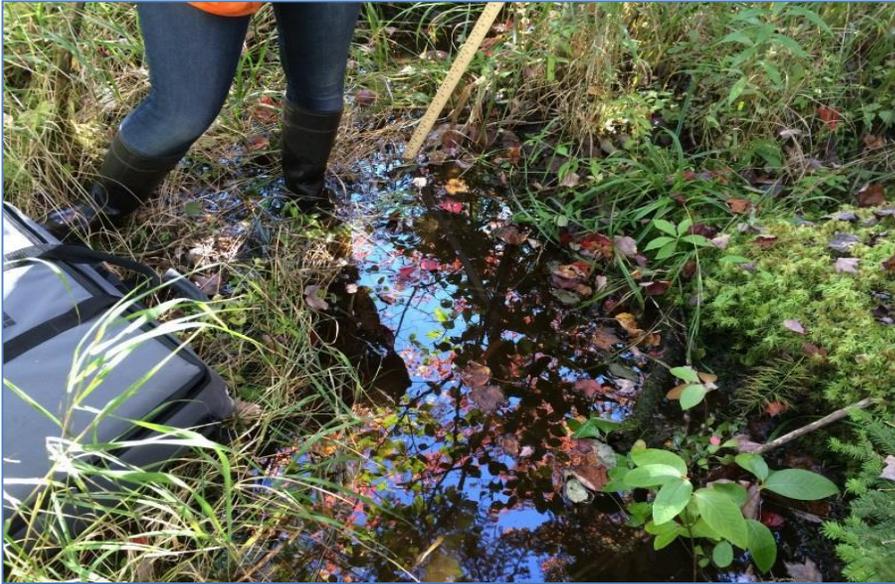
Photo 13. Watercourse 3, Reach 3

Reach 3 is located approximately 20 meters downstream from Reach 2 and is similar to Reach 1 and 2 with an abundance of grass growing within and along the streambed. The average wet width is 8 meters and the average wet depth is 15 cm deep. The channel is braided and has an average bank full width of 12 meters and an average depth of 50 cm. The stream canopy cover is 60% and is comprised of mixed wood. The stream type consists mainly of pool (60%) and runs (35%) with a small rifle (5%). During the survey the stream was not flowing. The water quality data collected at Reach 3 during the survey was:

- Temperature: 10.44 °C,
- Dissolved Oxygen: 39.9%,
- pH: 4.82, and
- Conductivity: 29  $\mu\text{S}/\text{cm}$ .

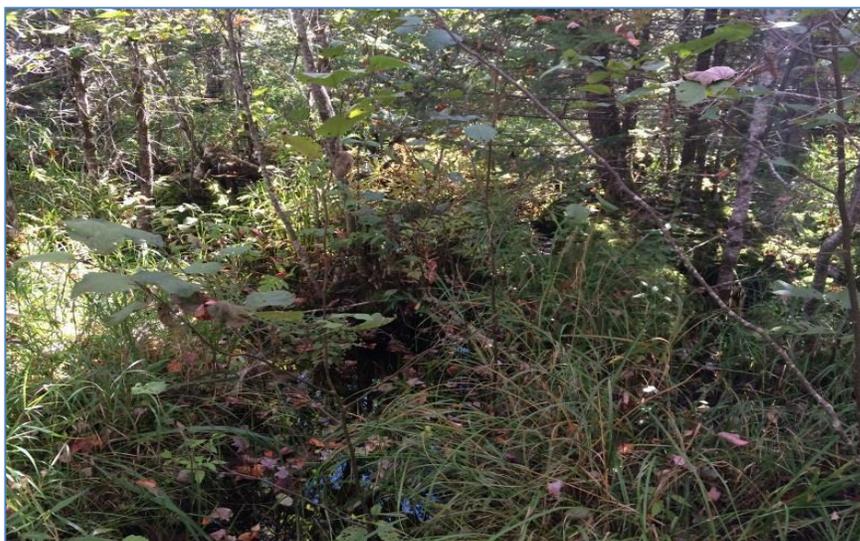
Photo 14. Watercourse 3, Reach 4

Reach 4 is located approximately 27 meters downstream of Reach 3 and is a braided stream channel that has a stream slope of 1.5% with a flow of 0.01m/s. This reach is similar to Reach 1 and 3 and has an average wet width of 0.95 meters and average depth of 25 cm. The average bank full width is 1.55 meters and the average bank full depth is 50 cm. The canopy cover is 75% mixed wood. The water quality data collected at Reach 4 during the survey was:

- Temperature: 10.45 °C,
- Dissolved Oxygen: 42%,
- pH: 4.6, and
- Conductivity: 27  $\mu\text{S}/\text{cm}$ .

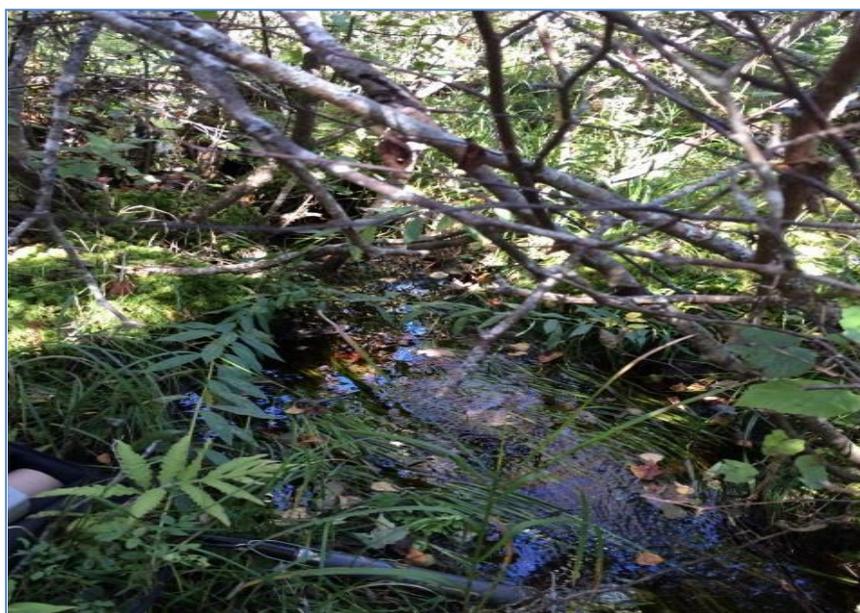
Photo 14. Watercourse 3, Reach 5

Reach 5 is located 12 meters downstream from Reach 4 and is similar to Reach 4. Reach 5 has an average wet stream width of 0.9 meters and average depth of 20 cm. The average bank full width is 1.15 meters and the average bank full stream depth is 40 cm. The canopy cover is 65% mixed wood forest. The stream type is 70% run, 20% riffle and 10% pool with a slope of 2 % and a velocity of 0.01m/s. The substrate type is primarily leaf litter and vegetation (80%) with gravel (10%), sand (8%), and rock (2%). The water quality data collected at Reach 5 during the survey was:

- Temperature: 10.45 °C,
- Dissolved Oxygen: 41.3%,
- pH: 4.58, and
- Conductivity: 27  $\mu$ S/cm.

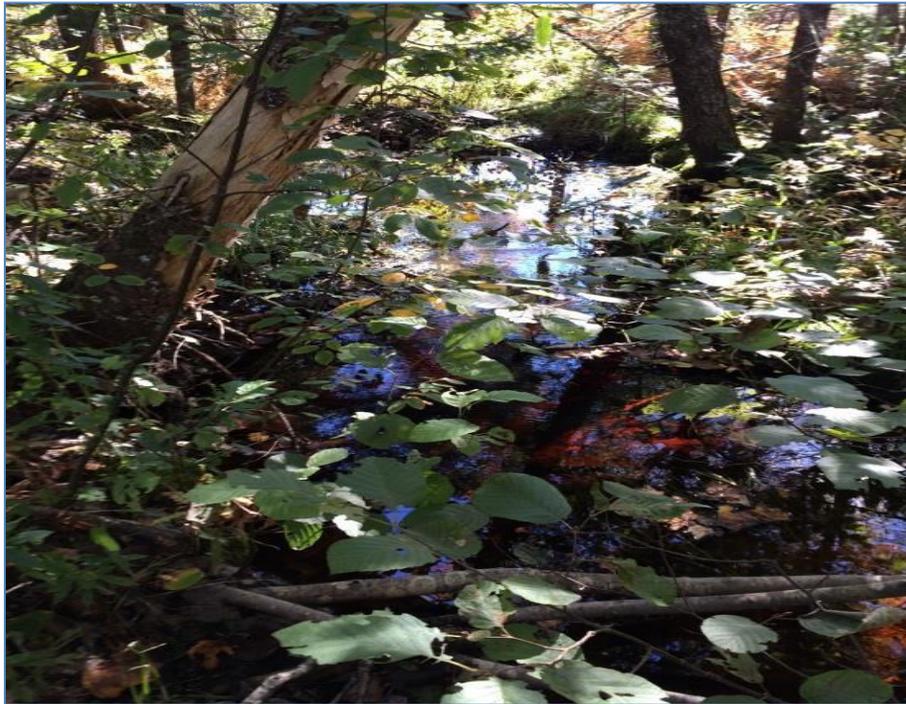
Photo 15. Watercourse 3, Reach 6

Reach 6 is located 16 metres downstream from Reach 5 and 38 metres upstream from the existing single culvert on Park rd. It has more of a defined channel and does not have grasses growing in it. The average wet stream width is 1.14 meters and the average depth is 21 cm. The average bank full width is 1.92 metres and the average bank full depth is 45 cm. The stream is sloped 0.5% and during the survey had no flow. The stream banks were stable and had approximately a 3% slope on the left and right. The stream type was mainly a pool (70%), with some riffles (28%), and runs (2%). The substrate contained a mixture of rock (12%), rubble (20%), gravel (20%), sand (30%), fines (16%), and leaf litter (2%). This and all of the other reaches of this watercourse were within the wetland. The water quality data collected at Reach 6 during the survey was:

- Temperature: 10.46 °C,
- Dissolved Oxygen: 41.4%,
- pH: 4.59, and
- Conductivity: 27  $\mu\text{S}/\text{cm}$ .

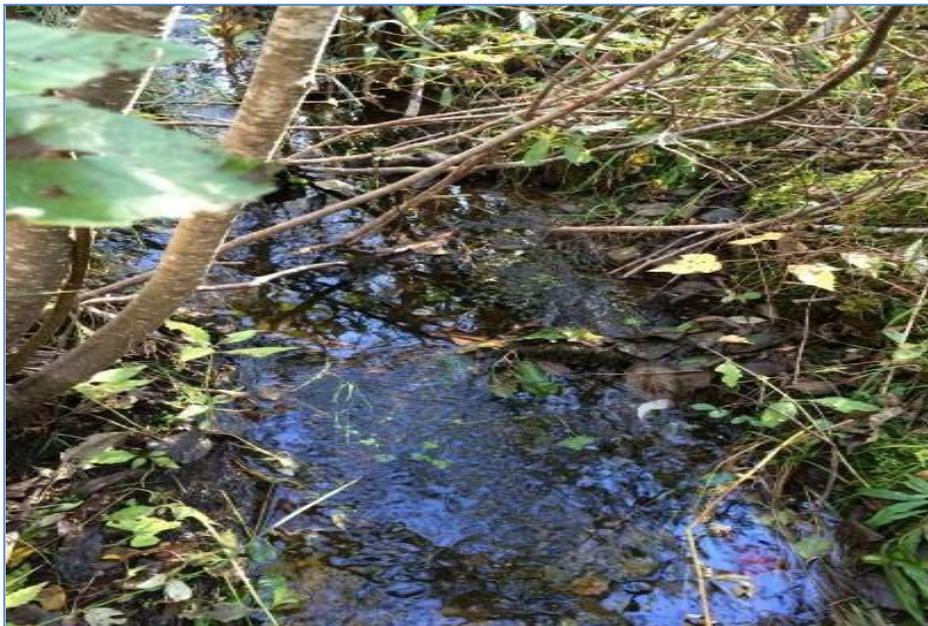
Photo 16. Watercourse 4, Reach 1

Reaches 1, 2 and 3 are located northeast of Wetland 10 on the northeast side of the project study area (See (Figure 6, Appendix A)). These reaches are very similar and have a canopy of 75-80% consisting of shrubs (mostly speckled alder) and tall grasses along the edge of the watercourse. Their left and right banks were stable (90-95%) and their average wet stream width ranged from 0.81 metres to 1.83 metres. Their average wet stream depth ranged from 3.5 cm to 13 cm. The average bank full width ranged from 2.38 metres to 1.5 meters, and 36cm to 50 cm deep. On average these three reaches were dominated by pools (40-60%), but also had riffles (20-40%) and runs (10- 40%).

Stream substrate was made up of a mixture of gravel, fines, sand, rubble and minor amounts of boulder and rock. The range of water quality data collected at Reach 1, 2, and 3 during the survey was:

- Temperature: 12 °C,
- Dissolved Oxygen: 51.7 to 60.1%,
- pH: 6.7 to 6.10, and
- Conductivity: 32-33  $\mu\text{S}/\text{cm}$ .

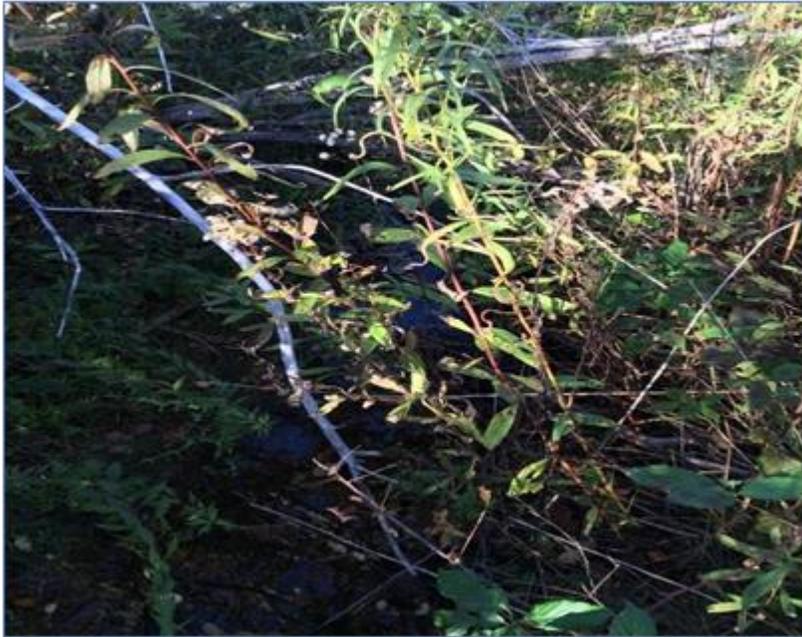
Photo 19. Watercourse 4, Reach 4

Reach 4 is located on the edge of a field 20 meters downstream from Reach 3 (See (Figure 6, Appendix A)). Reach 4 is similar to Reach 1 through 3 but has less of a channel gradient, at approximately 2%, which displayed no flow conditions during the survey. Reach 4 also has a higher percent of grasses/meadow species within the riparian area and less shrubs. The forest canopy cover at this reach is approximately 56% and the channel displays stable banks. The average wet stream width is 0.79 metres and 12 cm deep. The average bank full width is metres and 32 cm deep.

- Temperature: 11.98 °C,
- Dissolved Oxygen: 60.1%,
- pH: 6.01, and
- Conductivity: 32  $\mu$ S/cm.

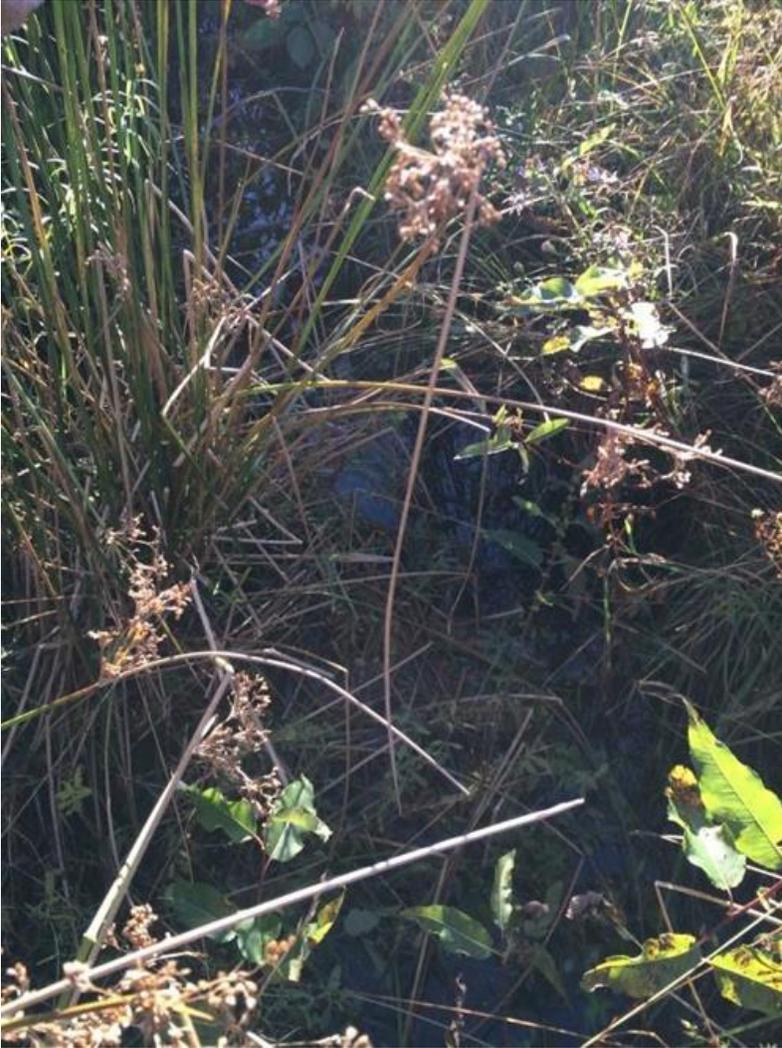
Photo 20, Watercourse 4, Reach 5

Reach 5 and 6 are located 75 meters and 35 meters upstream from Elmsdale rd. (See (Figure 6, Appendix A)). Both reaches are very similar and are within the field which appears to be used for local agriculture (hay). These reaches had stable banks and the riparian area consisted mainly of tall grasses, rushes and sedges. There stream cover was low with a 15% shrub canopy cover. The stream substrate consisted of fines (70-80%), sand (7-20%), gravel (3-5%), and some rubble (5%). The stream was flowing very slowly at Reach 5 due to a shallow channel slope of approximately 0.001m/s. NO flow was observed within Reach 6 during the fall survey

These two reaches during the survey and had an average slope of 0-0.5%. The average wet stream width range was 0.9 to 0.59 meters and the average depth range was 9 to 10 cm. The average full bank width range was 0.98 m to 1.2 metres and the depth ranged from 17 to 36 cm.

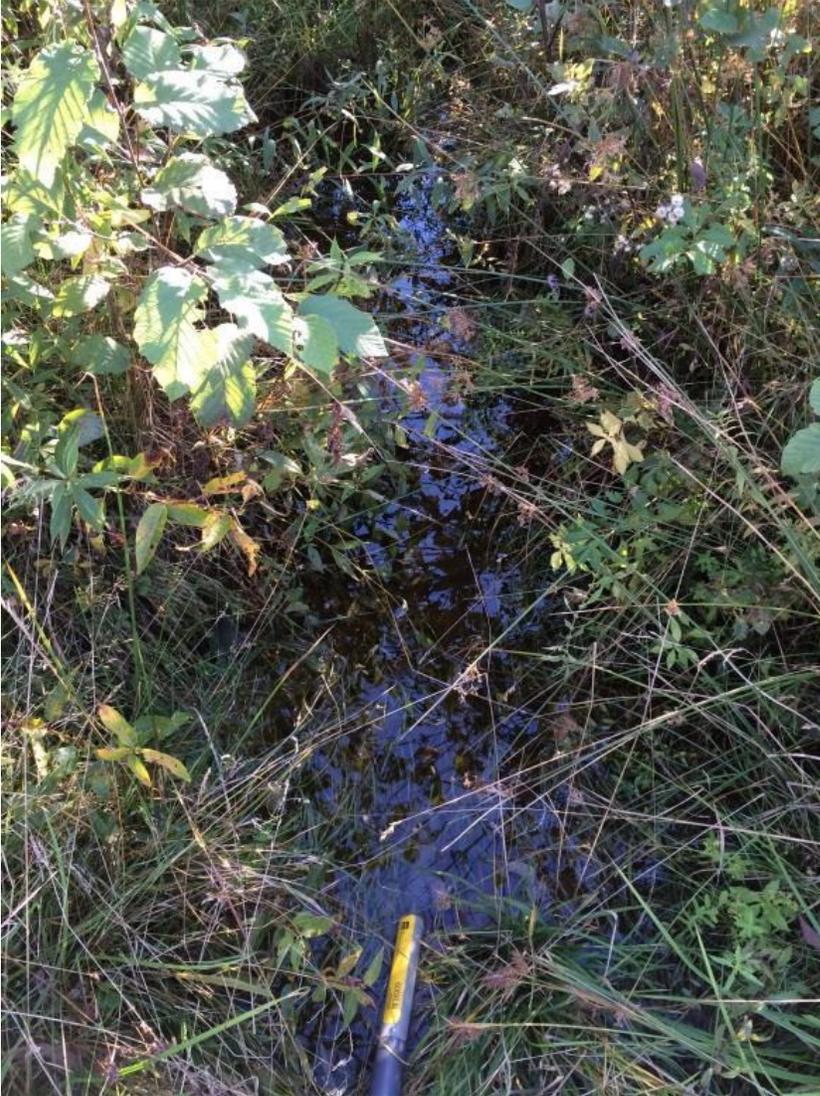
Photo 21. Watercourse 4, Reach 6

- Temperature: 11.98 to 12.05 °C,
- Dissolved Oxygen: 55.5 to 60.1%,
- pH: 5.88 to 6.01, and
- Conductivity: 32-34  $\mu\text{S}/\text{cm}$ .

Due to poor water quality, an abundance of vegetation and little to no flow during the fall spawning season the habitat within Reaches 5 and 6 of Watercourse 4 are not considered receptive to supporting fish. The watercourse disappears upstream near Wetland 1 and, therefore, Watercourse 4 is considered a wetland outlet that drains into Nine Mile River.
