Addendum to EARD

Sheet Harbour Quarry
Sheet Harbour, Halifax County

Dexter Construction Co. Ltd.

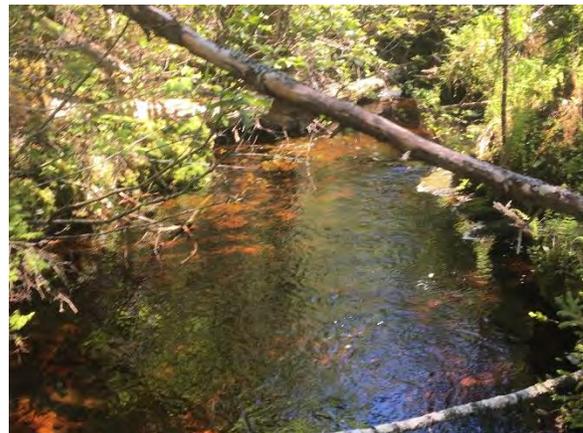
P6: Representative habitat of WC1.3 (showing spawning substrate)

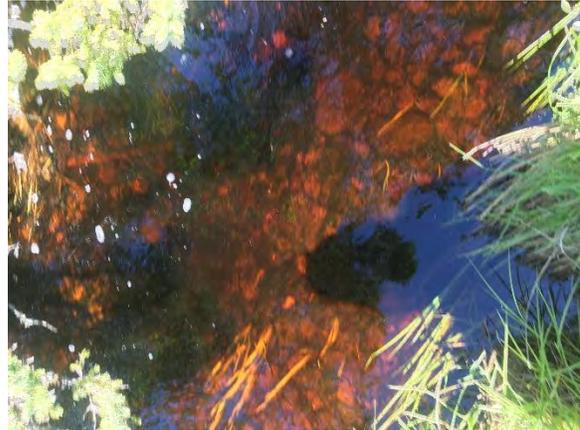
P10: Potential spawning gravels in WC2.2

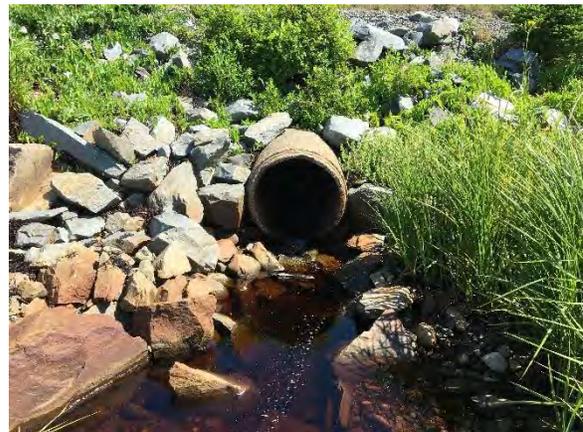
P18a: Culvert at end of Powers Cove NW CA

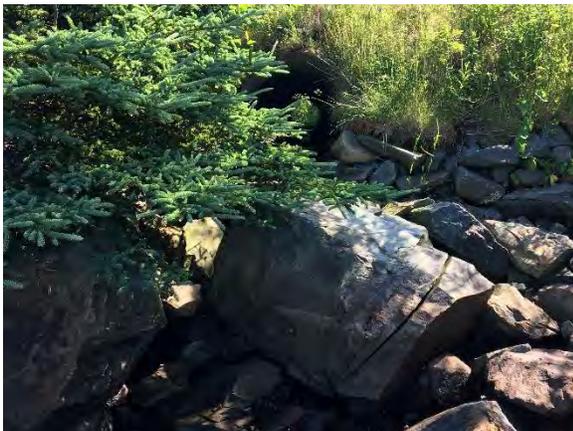
P19a: Culvert at end of Powers Cove SE CA

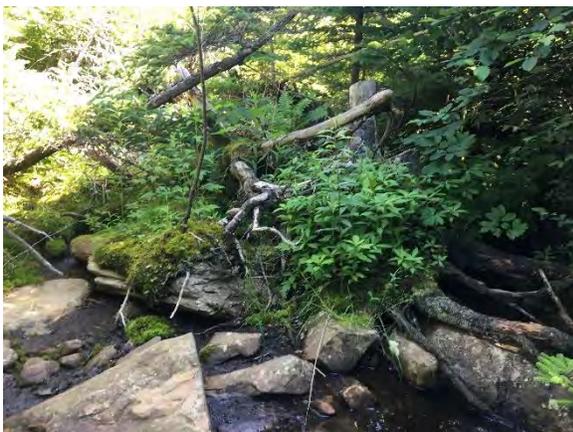
P19c: Channel lost underground 10 m east of Mushaboom Road.
