APPENDIX E  
CBCL TECHNICAL SUMMARY REPORT - FISH AND FISH  
HABITAT, WATER QUALITY, AQUATICS, AND TURTLE HABITAT  
ASSESSMENTS

# Proposed Bear Lake Wind Farm Technical Summary Report

Fish and Fish Habitat, Water Quality, Aquatics, and  
Turtle Habitat Assessments

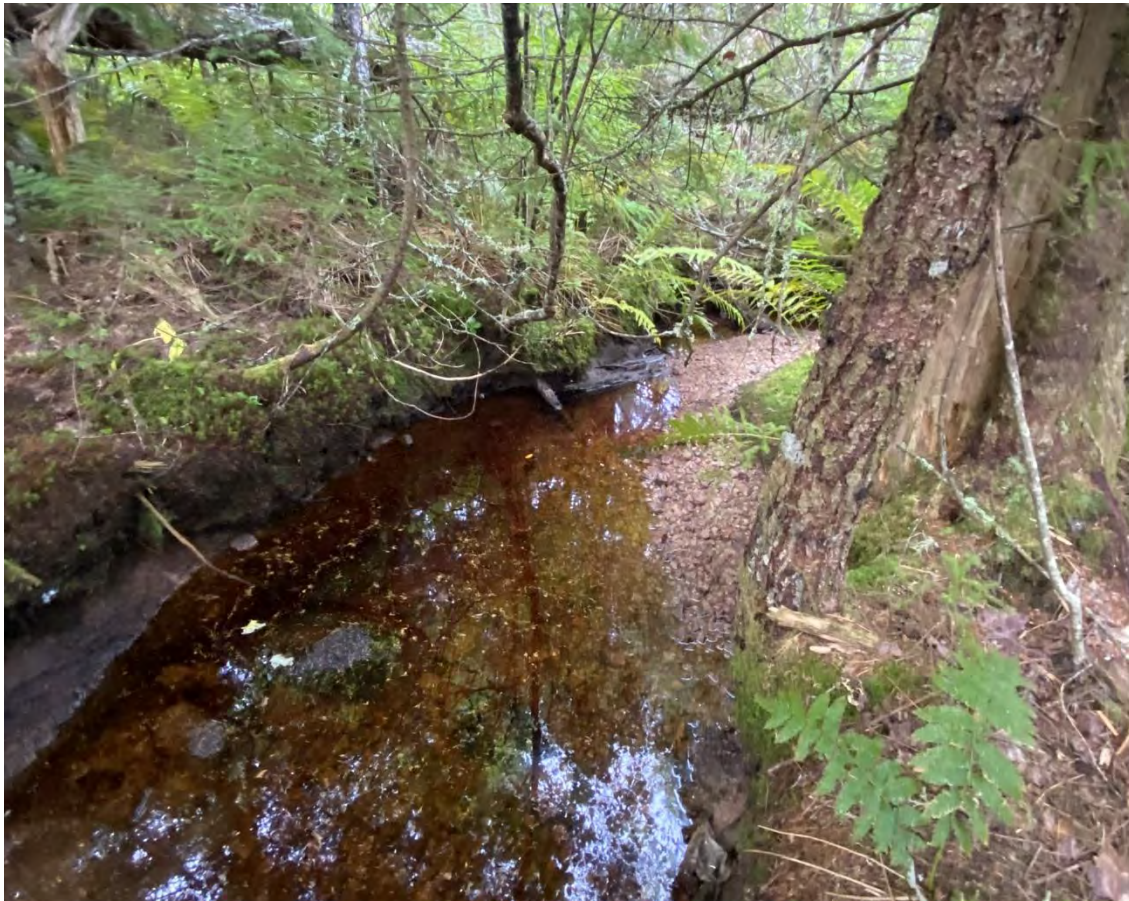
**Photo 3-1** Looking downstream from crossing at watercourse channel.

Watercourse BL-WC105-1267, is a small permanent watercourse with intermittent characteristics that is a tributary to the South Branch Avon River. The average channel and wetted widths were both 1.6 m. The dominant substrate was gravels with undercut banks deep pools and overhanging vegetation providing the most instream cover. The riparian areas were composed of mature forest with stable banks. Water quality was within recommended CCME guidelines for the protection of Aquatic Life (CCME, 2016) for dissolved oxygen. The recorded pH values were outside of them CCME guidelines. Water quality details are provided in Table 3.3, below. The watercourse moved along a sinuous path for its assessed length. Upstream of the crossing, the watercourse flows underground, and this poses a potential barrier to fish passage; however, suitable habitat for fish was observed in the Study Area.

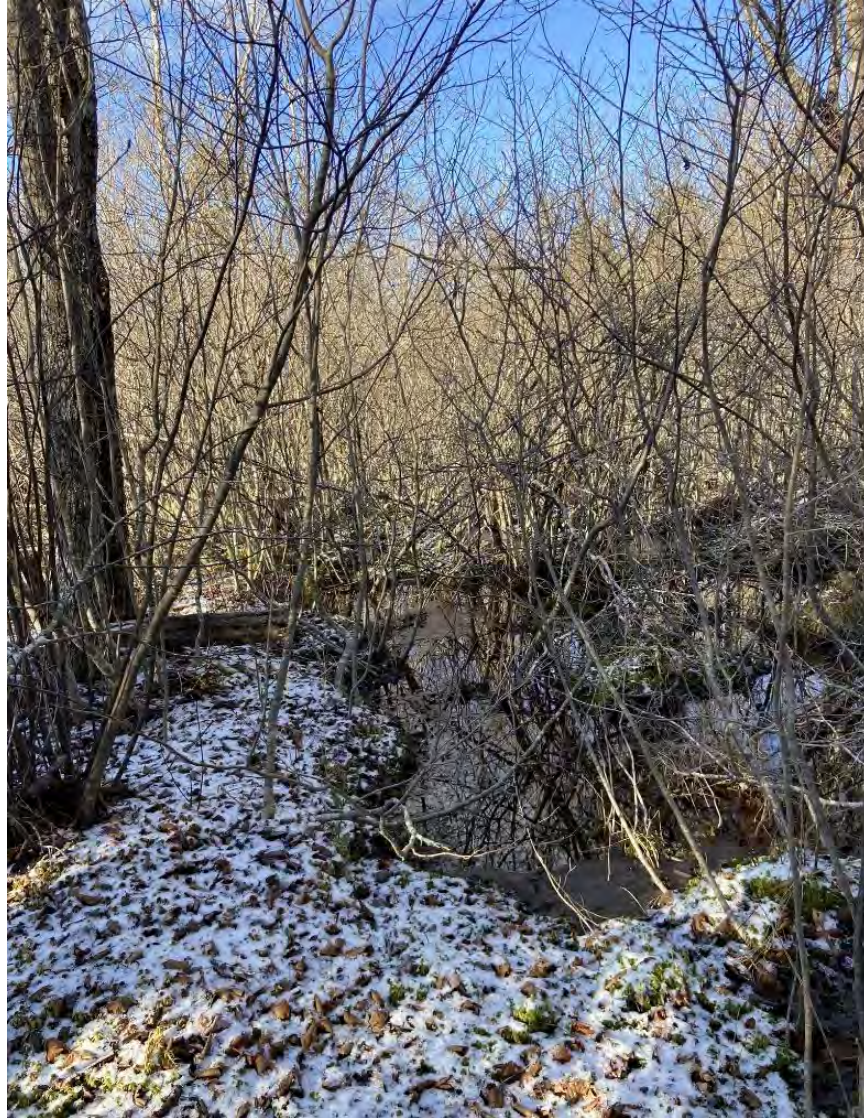
**Photo 3-2** Looking downstream, from crossing, at channel.

Watercourse BL-WC106f-2773 (tributary to Black Brook; Photo 3-2) was an intermittent with ephemeral characteristics watercourse that generally had poor conditions for fish. The average channel width was 1.7 m, with an average wetted width of 1.4 m. Water depth was on average less than 0.1 m with no deep pools. The dominant substrate was fines, with overhanging vegetation providing the main form of cover. The riparian area was composed of mature forest with stable banks. Water quality was outside of the CCME guidelines for aquatic life for DO and pH.<sup>4</sup> Upstream of the crossing the watercourse loses channelization.

No fish were observed during the assessment. However, overall, the likelihood for fish in this section of watercourse was determined to be high.

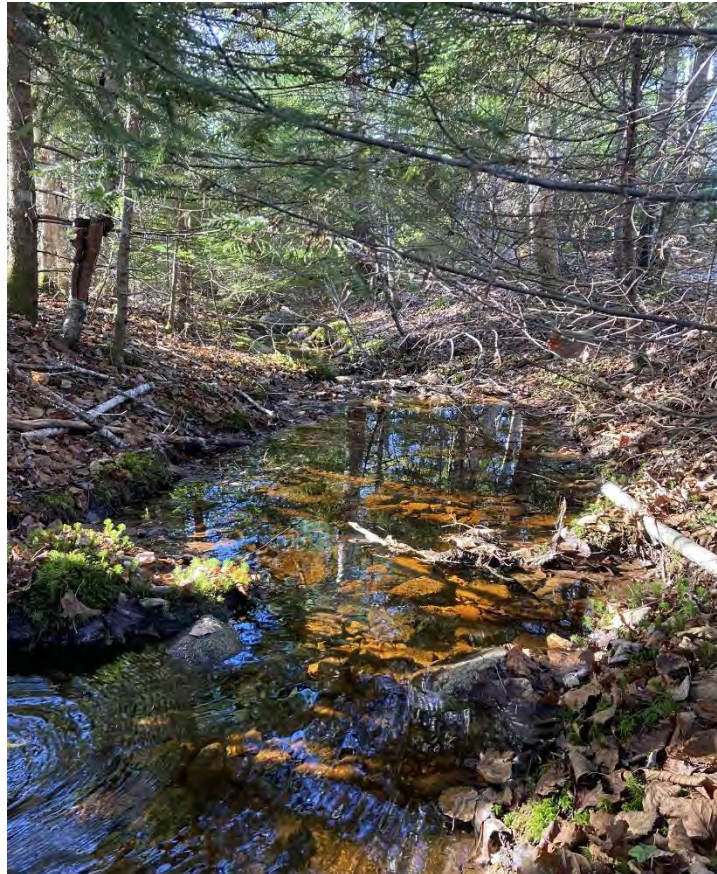
**Photo 3-3 Looking upstream, from crossing at watercourse.**

Watercourse BL-WC106g-2780 (tributary to Black Brook; Photo 3-3) was an intermittent watercourse with ephemeral characteristics that generally had poor conditions for fish. The average channel width was 1.23 m, with an average wetted width of 1.05 m. Water depth

was on average was 0.14 m with an average deep pool depth of 0.32 m. The dominant substrate was fines, with overhanging vegetation providing the main form of cover. The riparian area was composed of young forest with fairly stable banks. Water quality was outside of the CCME guidelines for aquatic life for pH. However, DO values were within CCME guidelines. Upstream of crossing the watercourse loses channelization. No fish were observed and overall, the likelihood of fish in this section of watercourse was determined to be moderate.

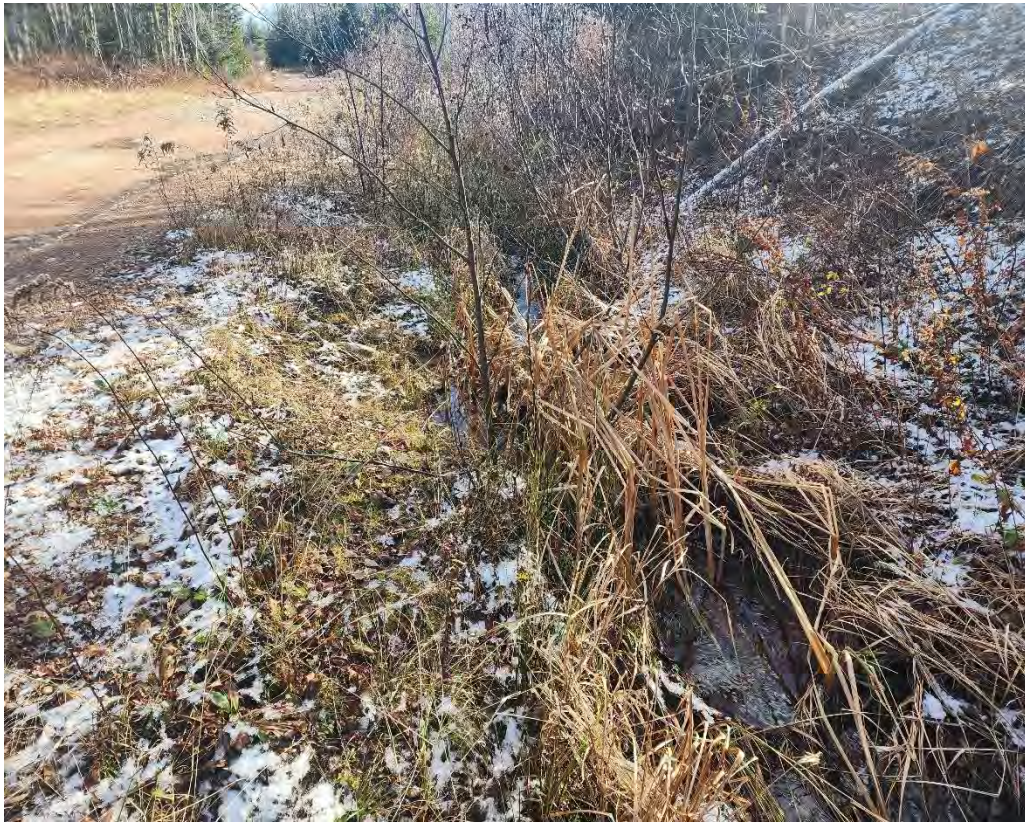
**Photo 3-4** Looking upstream at the watercourse from the crossing location.

Watercourse BL-WC106g-2958 was a small, intermittent watercourse (Photo 3-4). Average channel and wetted widths were 1.20 m and 0.90 m, respectively. Average water and pool depths were 0.09 m and 0.13 m. Dominant substrate was gravel with overhanging vegetation as the dominant instream cover type. Watercourse banks were poorly stable and vegetated with young forest. Water quality was outside of the CCME guidelines for aquatic life for pH. However, DO values were within CCME guidelines (Table 3.3). Overall, habitat quality within the assessed watercourse was moderate. The likelihood of fish presence was determined to be moderate. A sunken culverts was observed under an existing access road and may limit or prevent fish access upstream.

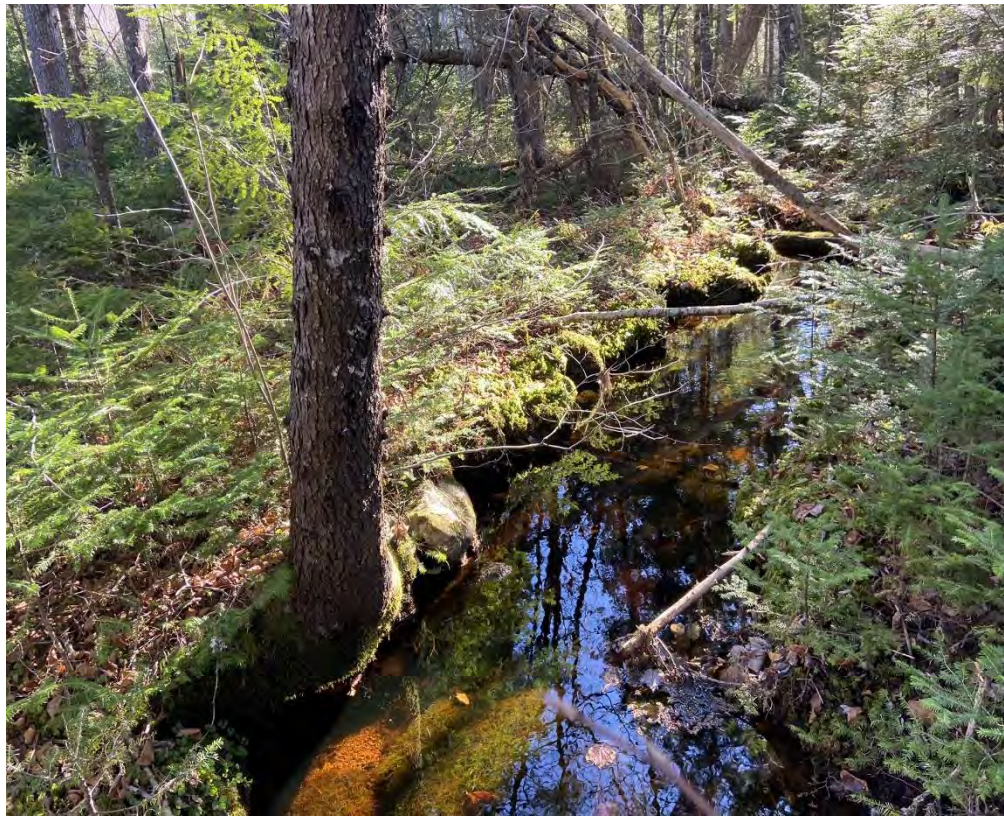
**Photo 3-5 Location where small Salmonid was observed.**

Watercourse BL-WC-201a-3333 (unnamed Tributary #1 to Southwest Brook) was a small permanent watercourse with intermittent characteristics (Photo 3-5). The watercourse had an average channel and wetted width of 2.2 m and 2.17 m, respectively. Average water depth was 0.18 m with no deep pools. Watercourse morphology was cascade, confined, and had a straight pattern. Dominant substrate was fines, with large woody debris as the dominant instream cover types. Water quality was outside of the CCME guidelines for aquatic life for pH. However, DO values were within CCME guidelines (Table 3.3). A small salmonid was observed within the watercourse.

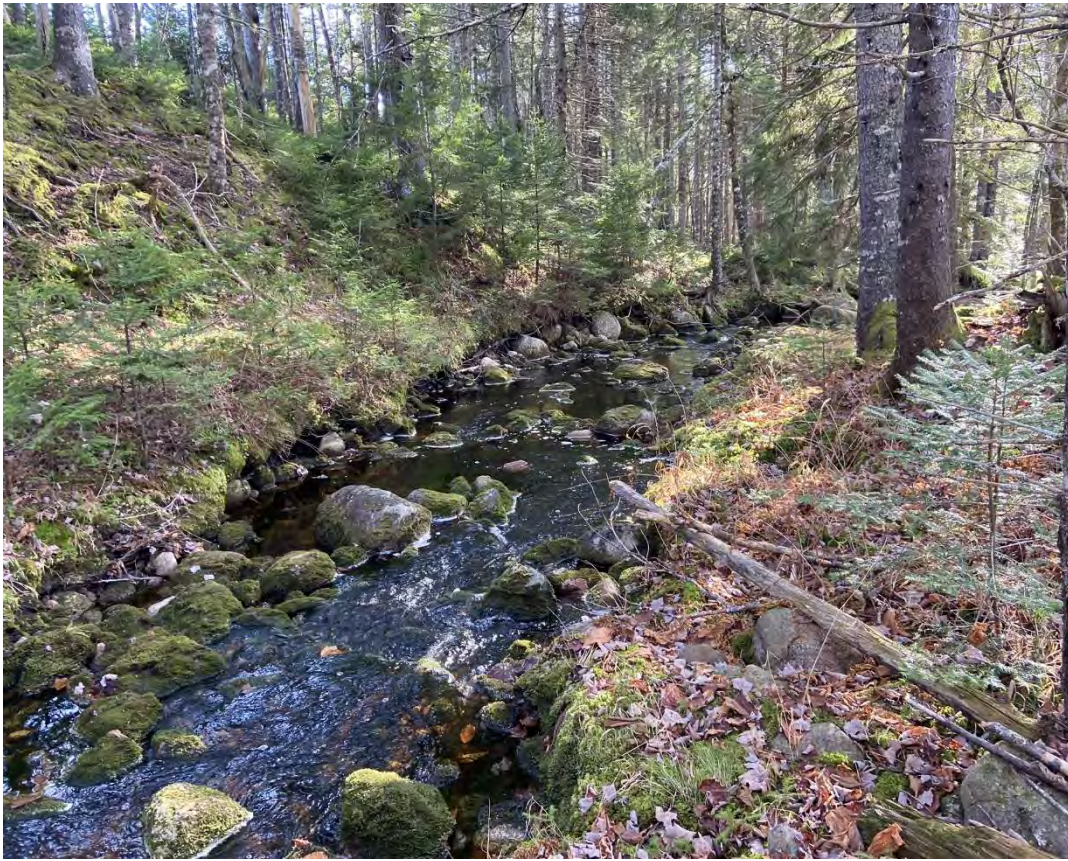
**Photo 3-6 Upstream of crossing, looking upstream.**

Watercourse BL-WC201a-3772 (Southwest Brook) was a frequently confined, small permanent watercourse (Photo 3-6). The watercourse was sinuous with run morphology. Average channel and wetted widths were 3.78 m and 3.20 m, respectively. Average water and pool depths were 0.20 m and 0.45 m, respectively. The dominant instream substrate was cobble; instream vegetation was the dominant instream cover type. Watercourse banks were vegetated with mature forest. Water quality was outside of the CCME guidelines for aquatic life for pH. However, DO values were within CCME guidelines (Table 3.3). Overall, fish habitat quality was classified as good, including for spawning, and overwintering was classified as moderate. A possible redd was identified in the watercourse. No barriers were observed within the assessed areas.

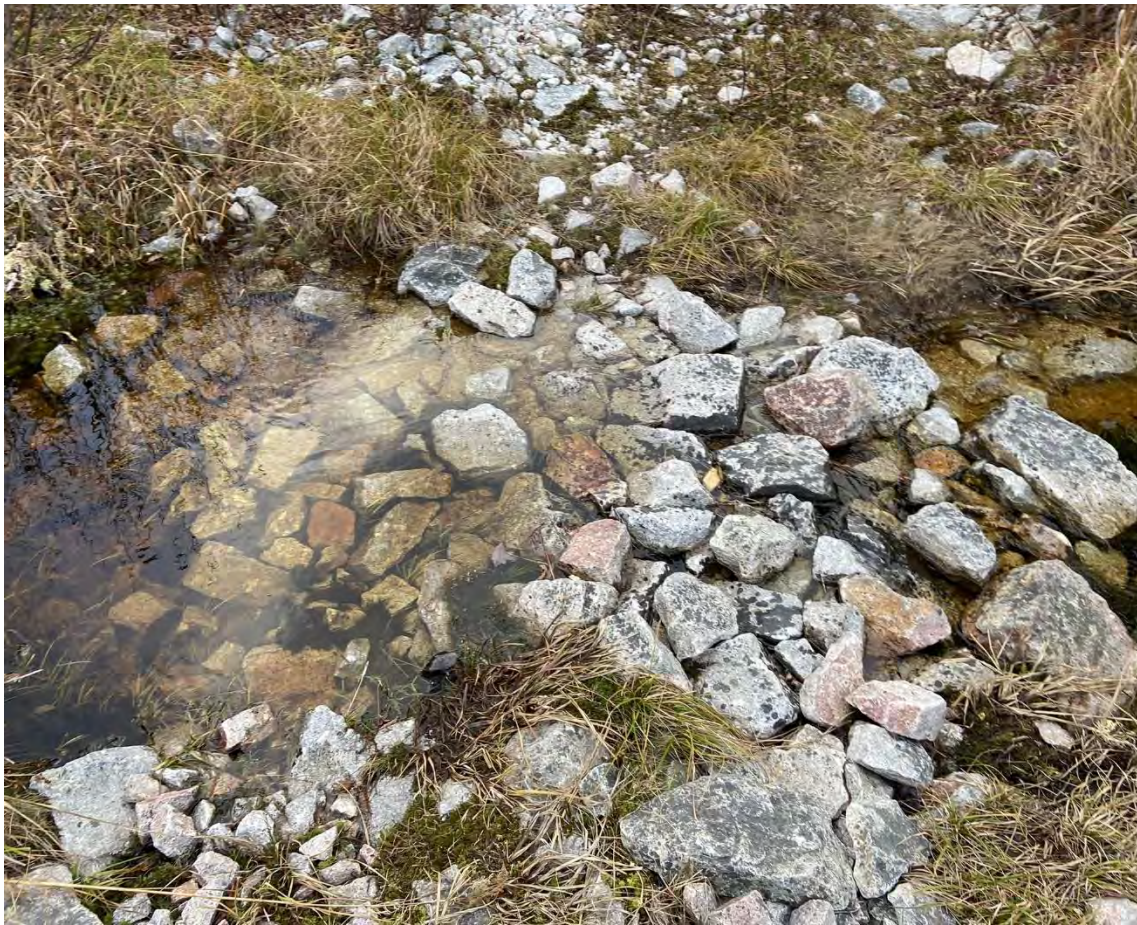
**Photo 3-7 Partial barrier downstream of crossing.**

Watercourse BL-WC-201c-3446 was a small permanent watercourse (Photo 3-7). The watercourse moved through an unconfined area with average channel and wetted widths of 2.3 m and 2.10 m, respectively. Average water and pool depths were 0.20 m and 0.33 m. Potential spawning habitat was observed within the assessed reach. Dominant substrate was gravel, with instream vegetation being the dominant type of cover present. Large amounts of blown down was also present in and around the watercourse. Water quality was outside of the CCME guidelines for aquatic life for pH. However, DO values were within CCME guidelines (Table 3.3). A possible fish barrier was located downstream of crossing it appears the water course has been partial filled in to aid in crossing.

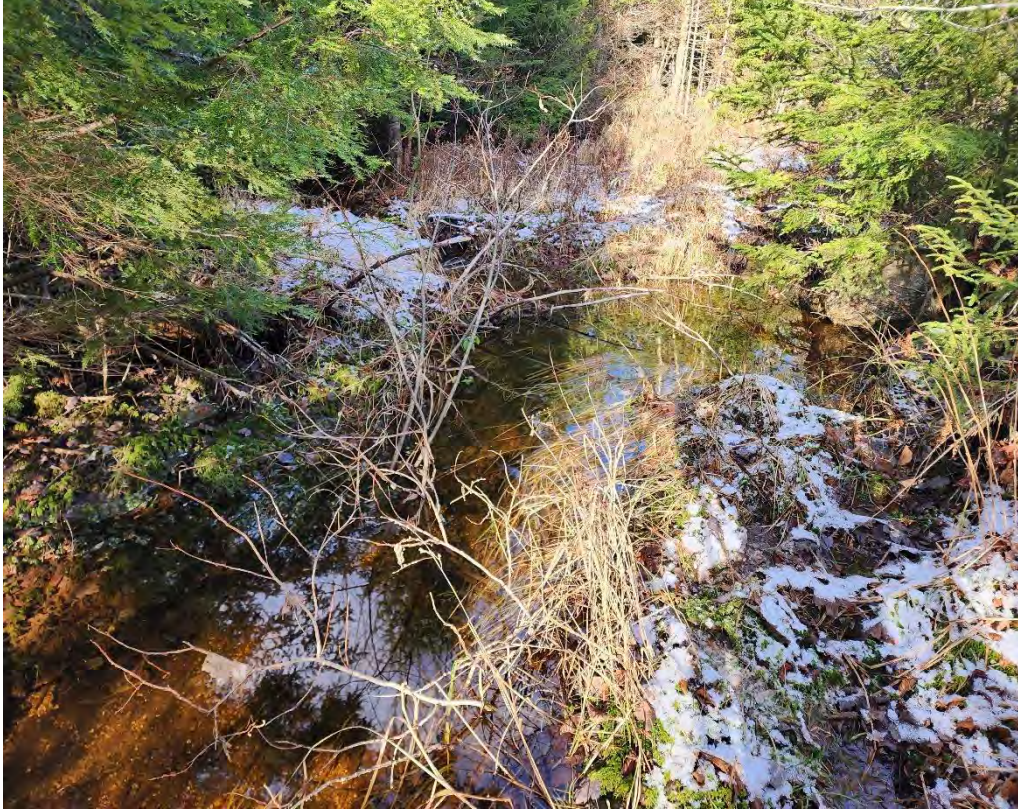
**Photo 3-8** Looking upstream at crossing location.

Watercourse BL-WC202a-2795, a tributary to the Armstrong River, was field identified as an intermittent watercourse (Photo 3-8). The watercourse flows in a straight pattern and is confined. Average channel and wetted widths were 1.77 m and 1.43 m, respectively. Average water and pool depths were 0.33 m and 0.50 m. Dominant substrate was gravel, with overhanging vegetation, providing the majority of available cover. Overall fish habitat quality was moderate, with moderate spawning, rearing, foraging, and overwintering habitat. Water quality was outside of the CCME guidelines for aquatic life for pH. However, DO values were within CCME guidelines (Table 3.3). Due to private land the downstream portion of this water course could not be assessed.

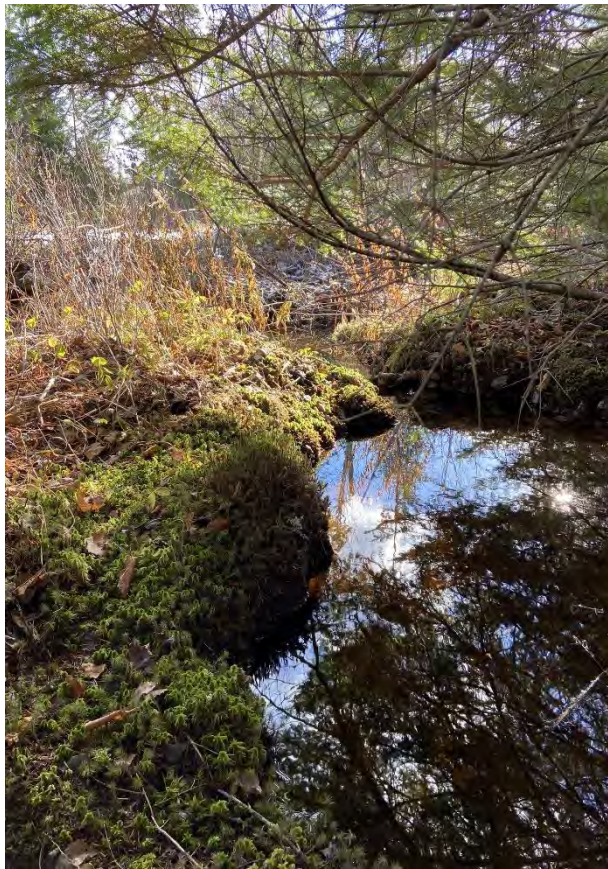
**Photo 3-9** Looking upstream at crossing location.

Watercourse BL-WC202a-3383, a tributary to the Armstrong River, was an intermittent watercourse with ephemeral characteristics (Photo 3-9). The watercourse flows in a regular meander pattern and is unconfined. Average channel and wetted widths were 1.6 m and 1.5 m, respectively. Average water and pool depths were 0.3 m and 0.4 m. The dominant instream substrate was gravel, with overhanging vegetation being the dominant cover type. Water quality was outside of the CCME guidelines for aquatic life for pH and DO (Table 3.3). Overall, fish habitat quality in the assessed section of the watercourse was poor; however, rearing and foraging, were noted to be of moderate quality. Likelihood of fish presence potential was high. The watercourse flows underground in the upstream section. Due to private land the downstream portion of this water course could not be assessed.

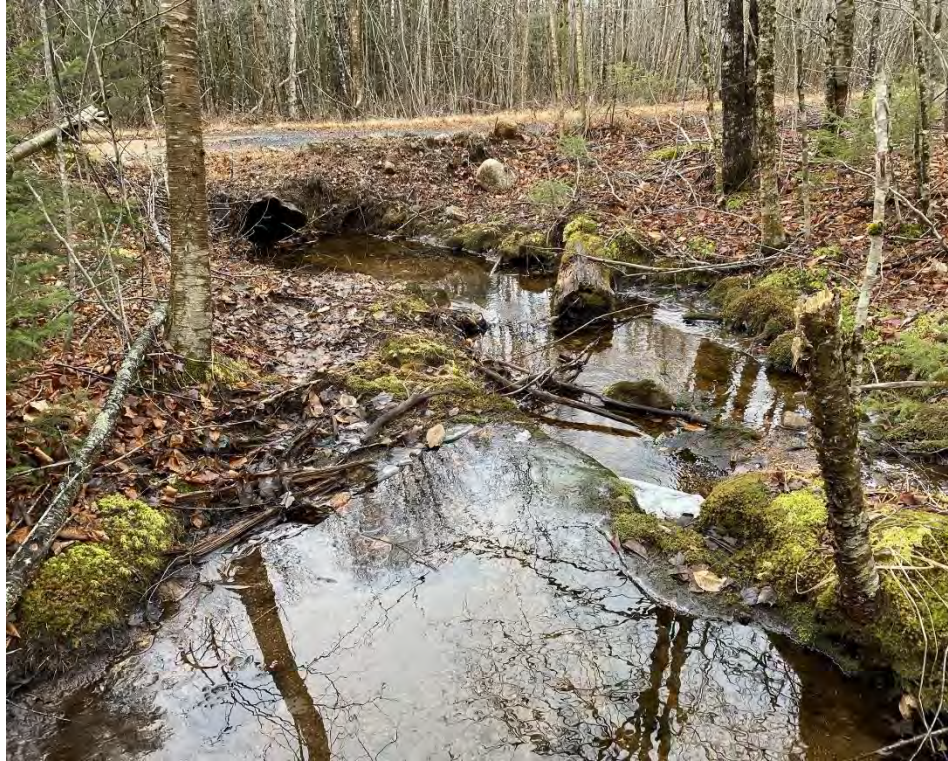
**Photo 3-10** Looking downstream at crossing location.

Watercourse BL-WC202d-669, a tributary to the Armstrong River, was an intermittent watercourse with ephemeral characteristics (Photo 3-10). The watercourse had a sinuous morphology and was unconfined within the assessed area. Average channel and wetted widths were 2.03 m and 1.7 m, respectively. Dominant substrate was fines, with subdominant gravel and cobble. The dominant instream cover type was undercut banks. Water quality was outside of the CCME guidelines for aquatic life for pH. However, DO values were within CCME guidelines (Table 3.3). Overall, habitat quality was moderate within the assessed area, despite good and poor habitat quality noted for rearing and foraging habitat, respectively. The likelihood for fish presence was moderate. Potential

barriers were noted in the assessed area log debris and a drop and damaged culvert at crossing.

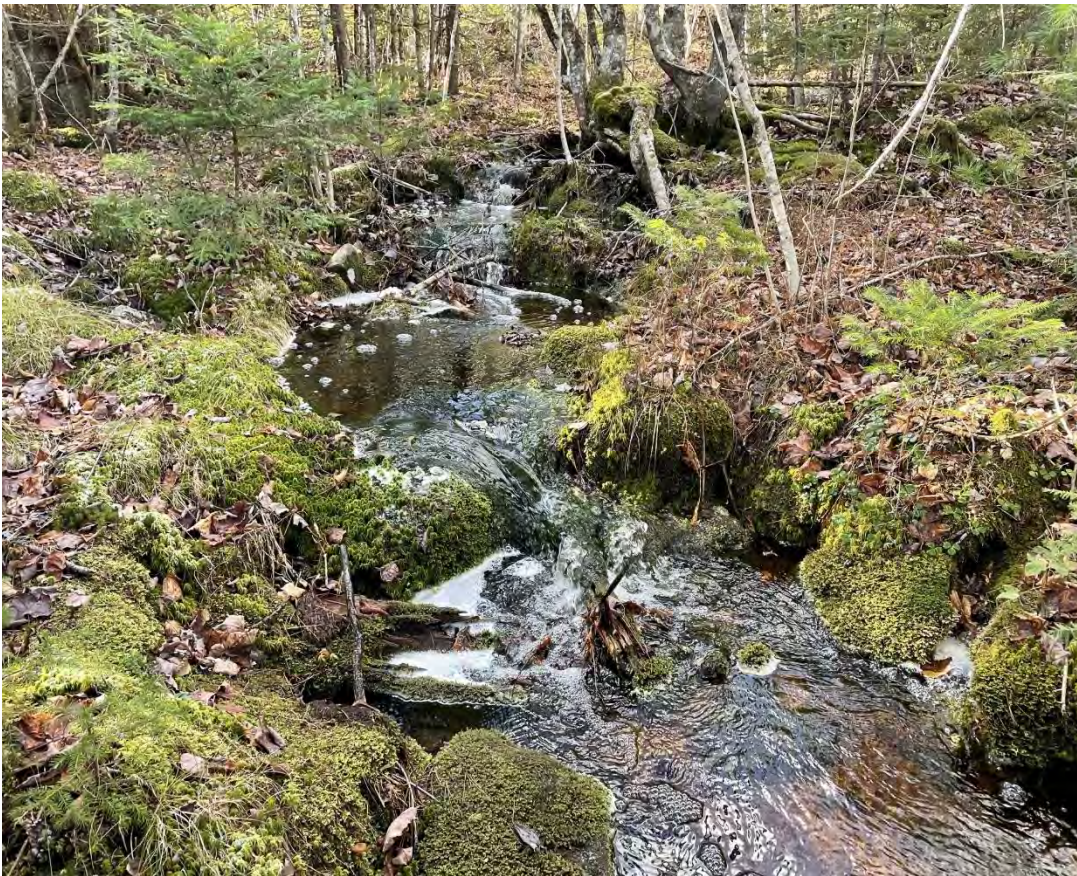
**Photo 3-11 Small cascade feature upstream.**

Watercourse BL-WC202e-2187 (Tributary to Armstrong River) is an intermittent watercourse (Photo 3-11). The watercourse was frequently confined along the assessed length. Average channel and wetted widths were 1.1 m and 1.01 m, respectively. Average water and pool depths were 0.11 m and 0.3 m. Dominant substrate was fines; instream cover was dominated by small woody debris. Riparian area was vegetated with mature, mixed forest. Water quality was outside of the CCME guidelines for aquatic life for pH. However, DO values were within CCME guidelines (Table 3.3). Overall, likelihood of fish presence was assessed as moderate. The downstream section is also fed by roadside ditch. Due to private property only the upstream portion of the crossing could be assessed.

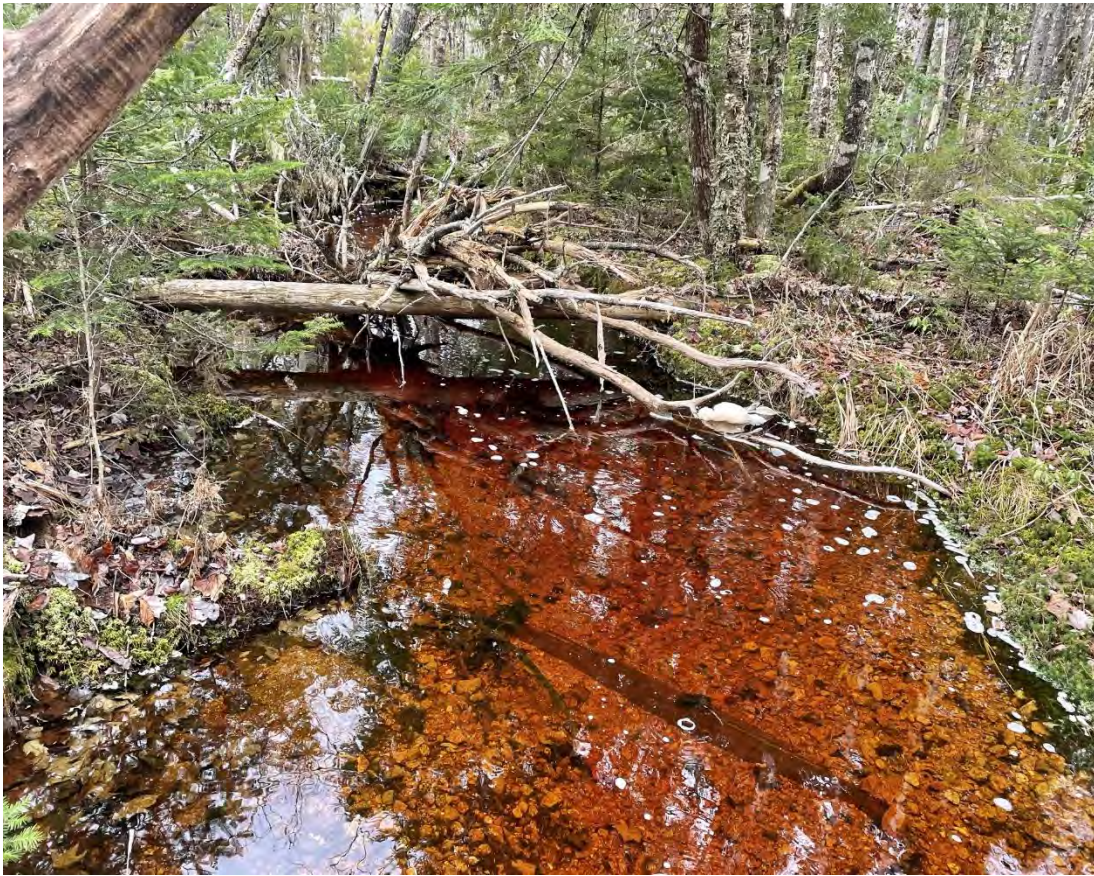
**Photo 3-12 Downstream habitat.**

Watercourse BL-WC-202e-3441 (Tributary to Armstrong River) was a confined, small permanent watercourse (Photo 3-12). The watercourse was sinuous with run morphology. Average channel and wetted widths were 2.79 m and 2.3 m, respectively. Average water and pool depths were 0.19 m and 0.44 m. Dominant instream substrates were fines and gravel, with deep pools, undercut banks, small/large woody debris, boulder, and overhanging vegetation as the trace instream cover type. Watercourse banks were vegetated with mature forest. Water quality was outside of the CCME guidelines for aquatic life for pH. However, DO values were within CCME guidelines (Table 3.3). Overall, fish habitat quality was classified as good, with spawning, foraging, migration, and overwintering classified as moderate. Blocked culvert is washing out road at crossing and may be a barrier to fish. A cascade feature downstream may also be a potential barrier to small fish. A waterfall was noted downstream as a potential full barrier to fish passage in the assessed area of the watercourse.

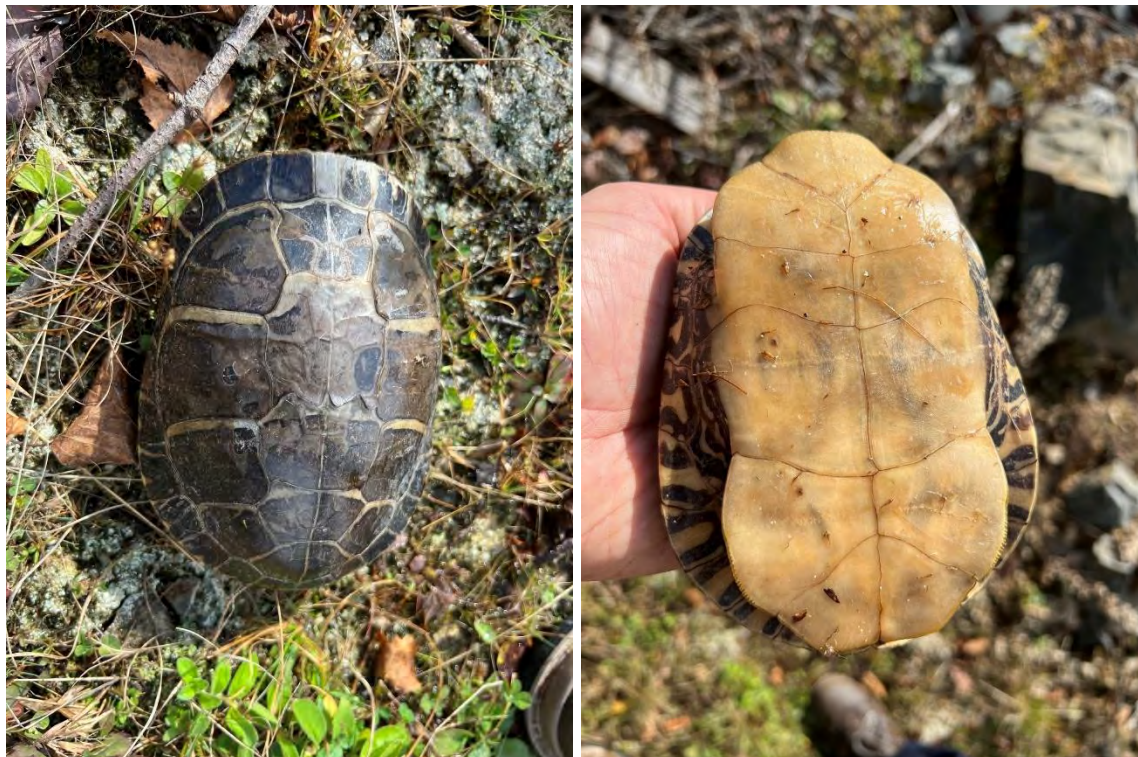
A carapace from a mature Eastern Paint Turtle was found by CBCL Staff during wetland survey on October 29, 2022, near a disturbed gravelly area midway between two considerable wetland areas with suitable summering and overwintering habitat, the closest of which was just under 200 m away. This location is indicated on Figure 3 in Appendix A. This specimen appeared to be a mature female and it is possible that it was predated on while visiting the gravelly area for nesting purposes.

**Photo 3-13 Dorsal and ventral views of an Eastern Painted Turtle carapace detected in northern portion of Study Area by CBCL ecologists on 29 October 2022.**
