## Watercourse Fact Sheet: Not Fish Habitat

WATERCOURSE INFORMATION	
<b>Watercourse ID:</b>	<b>Watercourse BL-WC106F-334</b>
General Site Location:	Bear Lake
Watercourse Assessor(s):	MB
Affiliation:	CBCL Limited
Field Assessment Date:	Oct 05 2022
UTM Coordinates:	Wp. 088 (MB)
Datum:	NAD 1983
SUBSTRATE	
Dominant	
Subdominant	
Subdominant	
Trace	
Trace	
Trace	
CHANNEL MEASUREMENTS	
Average Channel Width (m)	
Average Wetted Width (m)	
Average Bankful Depth (m)	
Average Water Depth (m)	
Average Pool Depth (m)	
WATERCOURSE MORPHOLOGY	
Watercourse Type	Ephemeral
Stage (season was very dry)	Low

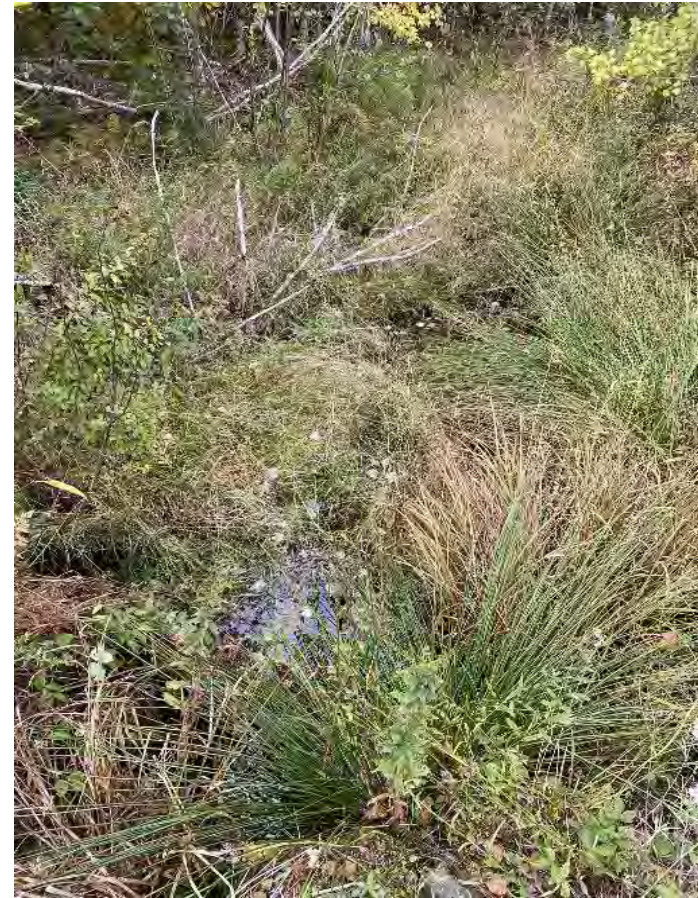
Photo 1: Approximate crossing location.

RIPARIAN VEGETATION SPECIES		
#	Common Name	Scientific Name
1		#N/A
2		#N/A
3		#N/A
4		#N/A
5		#N/A
6		#N/A
7		#N/A
8		#N/A
9		#N/A
10		#N/A
RIPARIAN INFORMATION		
Vegetation Stage		
IMPORTANT FEATURES OBSERVED		
Vegetated Across		<input checked="" type="checkbox"/>
Flows into Fish Habitat Downstream		<input type="checkbox"/>
Underground Sections or Groundwater		<input type="checkbox"/>
Surface Flow		<input checked="" type="checkbox"/>
Wetland Corridor (Flow Between Wetlands)		<input type="checkbox"/>
Barrier		<input type="checkbox"/>
Artificial Channelization		<input type="checkbox"/>
Culvert or Bridge		<input checked="" type="checkbox"/>
Water Flowing over Road (no Culvert)		<input type="checkbox"/>
No Defined Channel		<input checked="" type="checkbox"/>
ADDITIONAL NOTES		
Culvert under road, grassy channel d/s. W/c is drainage from road, flows into treed area/wetland.

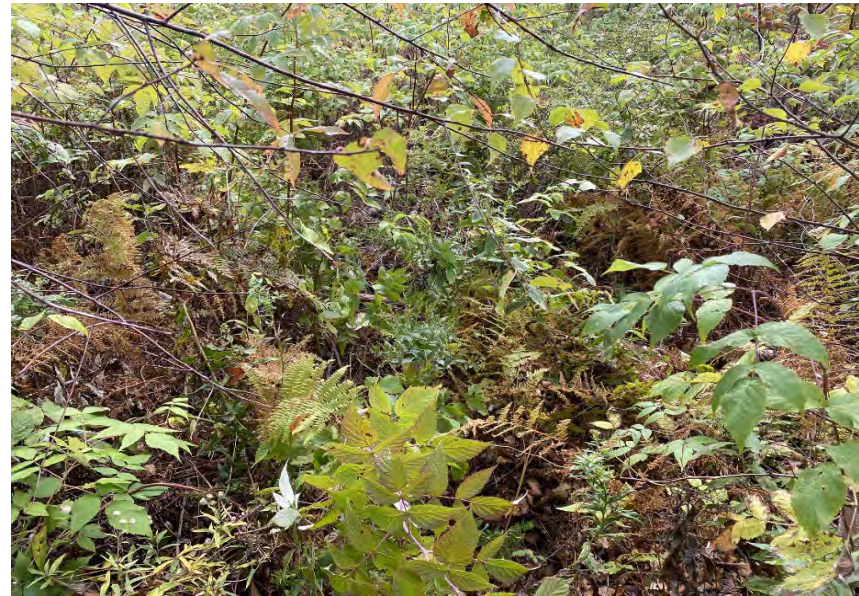
Photo 1: Habitat at approximate crossing location.

RIPARIAN VEGETATION SPECIES		
#	Common Name	Scientific Name
1		#N/A
2		#N/A
3		#N/A
4		#N/A
5		#N/A
6		#N/A
7		#N/A
8		#N/A
9		#N/A
10		#N/A
RIPARIAN INFORMATION		
Vegetation Stage	Mature Forest	
IMPORTANT FEATURES OBSERVED		
Vegetated Across	<input checked="" type="checkbox"/>	
Flows into Fish Habitat Downstream	<input type="checkbox"/>	
Underground Sections or Groundwater	<input type="checkbox"/>	
Surface Flow	<input type="checkbox"/>	
Wetland Corridor (Flow Between Wetlands)	<input type="checkbox"/>	
Barrier	<input type="checkbox"/>	
Artificial Channelization	<input type="checkbox"/>	
Culvert or Bridge	<input type="checkbox"/>	
Water Flowing over Road (no Culvert)	<input type="checkbox"/>	
No Defined Channel	<input checked="" type="checkbox"/>	
ADDITIONAL NOTES		
Start of 'orange marked channel' on maps. No channel, no water, no flow, no scour.

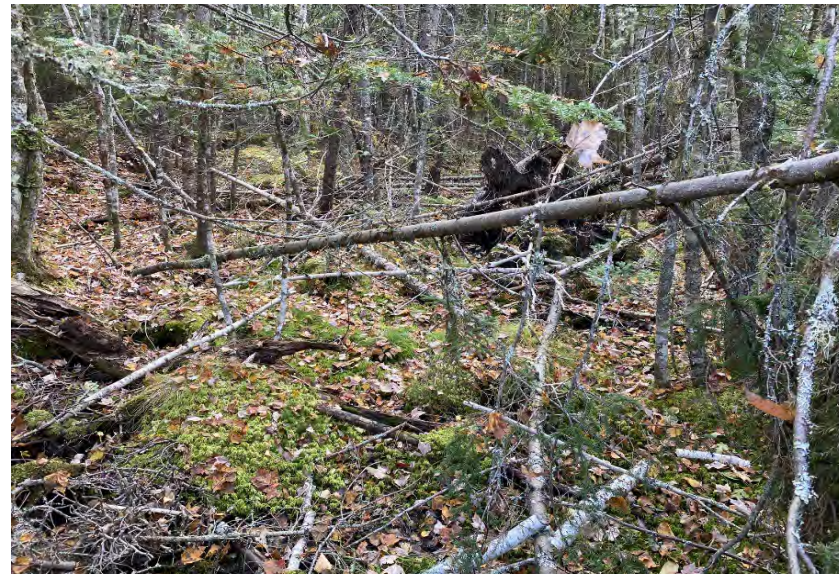
Photo 2: Habitat at WP69.

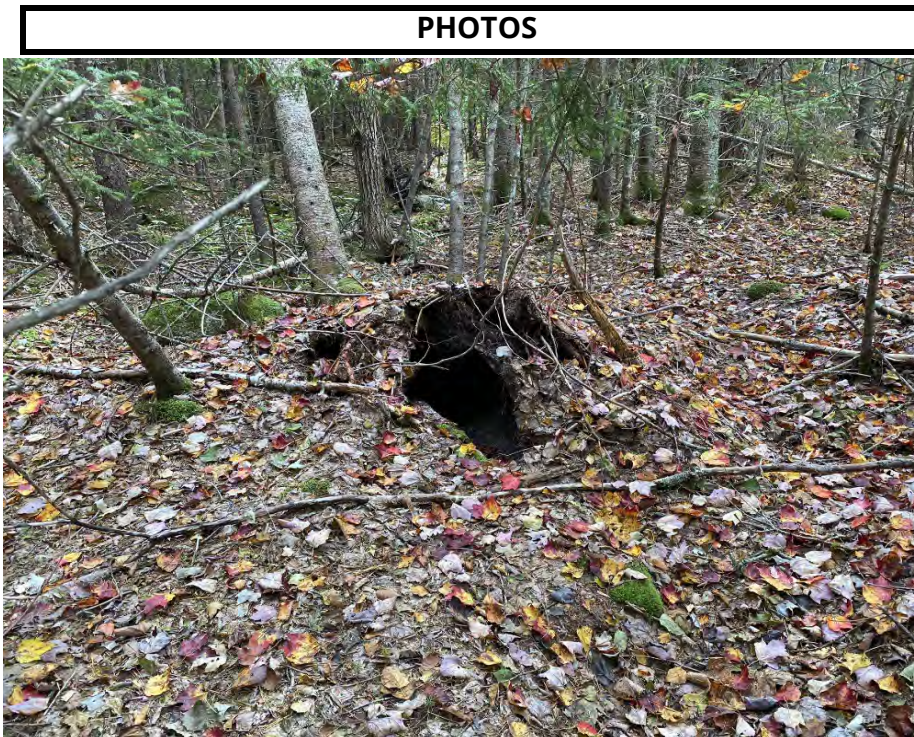
Photo 1: Approximate crossing location

RIPARIAN VEGETATION SPECIES		
#	Common Name	Scientific Name
1		#N/A
2		#N/A
3		#N/A
4		#N/A
5		#N/A
6		#N/A
7		#N/A
8		#N/A
9		#N/A
10		#N/A
RIPARIAN INFORMATION		
Vegetation Stage		
IMPORTANT FEATURES OBSERVED		
Vegetated Across		<input type="checkbox"/>
Flows into Fish Habitat Downstream		<input type="checkbox"/>
Underground Sections or Groundwater		<input checked="" type="checkbox"/>
Surface Flow		<input type="checkbox"/>
Wetland Corridor (Flow Between Wetlands)		<input type="checkbox"/>
Barrier		<input type="checkbox"/>
Artificial Channelization		<input type="checkbox"/>
Culvert or Bridge		<input type="checkbox"/>
Water Flowing over Road (no Culvert)		<input type="checkbox"/>
No Defined Channel		<input checked="" type="checkbox"/>
ADDITIONAL NOTES		
Wetted area, small pools. No overland flow. Upper end is channelized, no flow, wetted area, reeds. In heavy debris area. Ephemeral, no habitat.

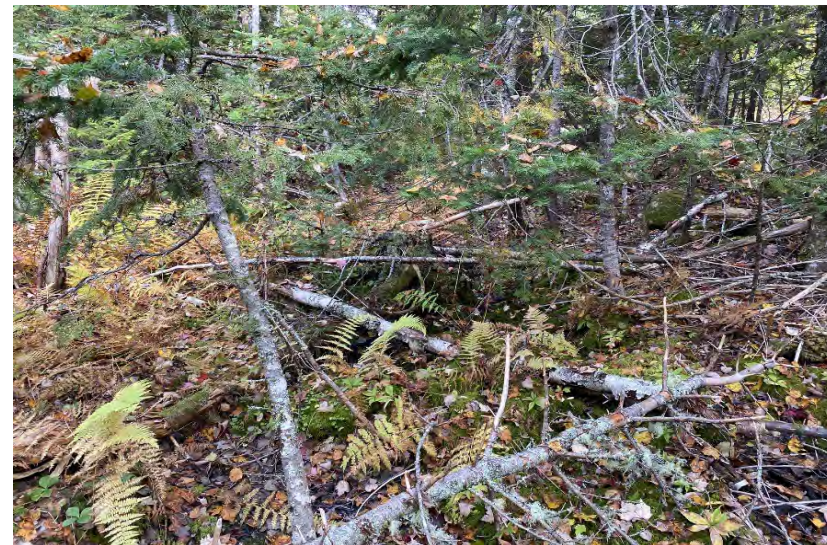
Photo 2: General surroundings around approximate crossing location

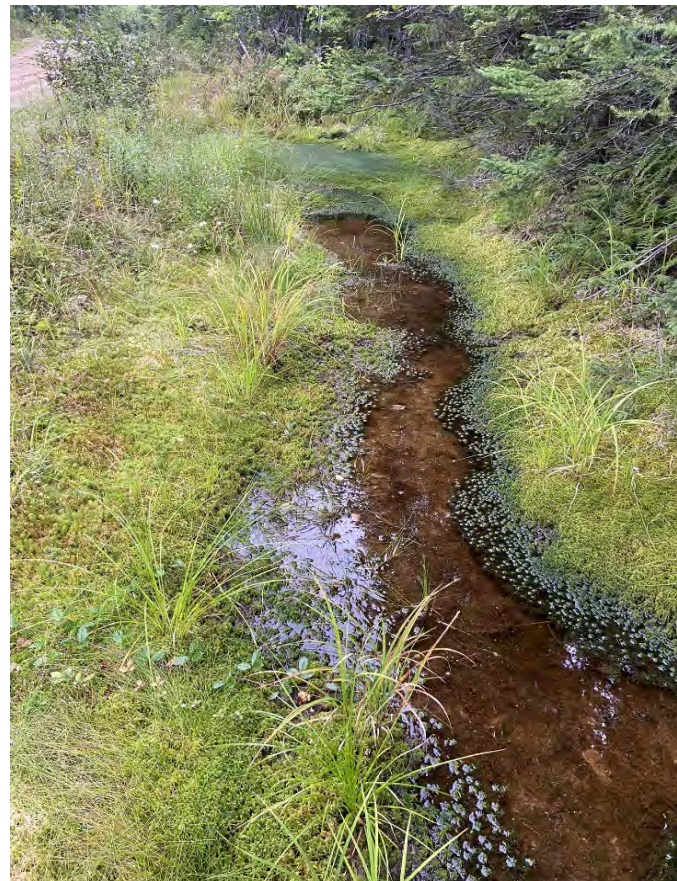
Photo 1: Upstream at crossing

RIPARIAN VEGETATION SPECIES		
#	Common Name	Scientific Name
1		#N/A
2		#N/A
3		#N/A
4		#N/A
5		#N/A
6		#N/A
7		#N/A
8		#N/A
9		#N/A
10		#N/A
RIPARIAN INFORMATION		
Vegetation Stage		
IMPORTANT FEATURES OBSERVED		
Vegetated Across		<input type="checkbox"/>
Flows into Fish Habitat Downstream		<input type="checkbox"/>
Underground Sections or Groundwater		<input type="checkbox"/>
Surface Flow		<input checked="" type="checkbox"/>
Wetland Corridor (Flow Between Wetlands)		<input type="checkbox"/>
Barrier		<input type="checkbox"/>
Artificial Channelization		<input type="checkbox"/>
Culvert or Bridge		<input type="checkbox"/>
Water Flowing over Road (no Culvert)		<input type="checkbox"/>
No Defined Channel		<input type="checkbox"/>
ADDITIONAL NOTES		
Pink line, ephemeral drainage in ditch.

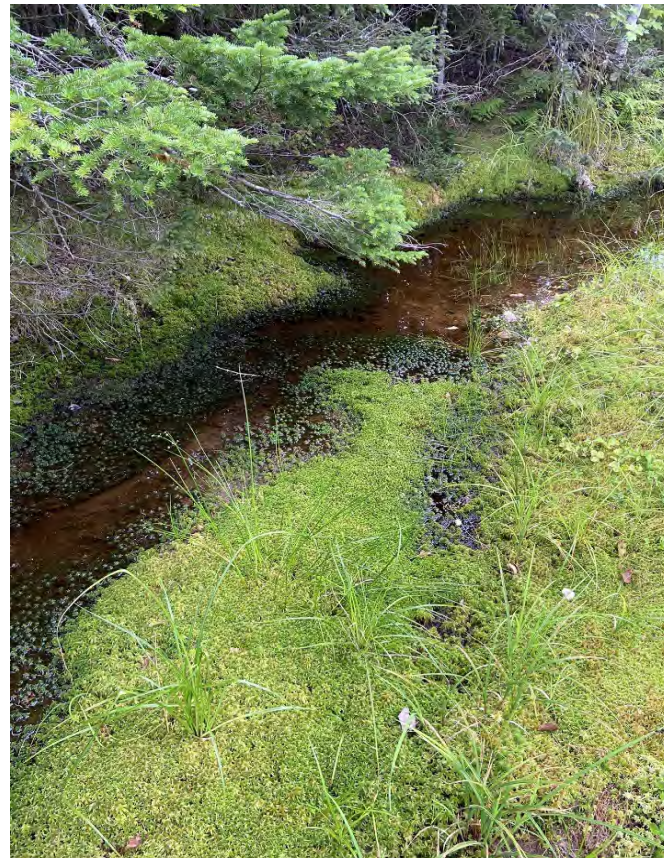
Photo 2: Downstream at crossing

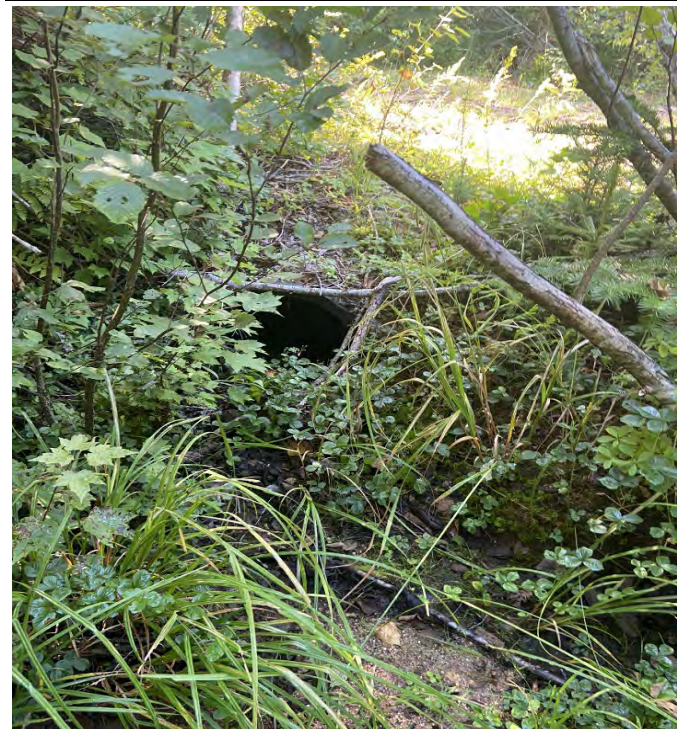
Photo 1: Culvert at crossing

RIPARIAN VEGETATION SPECIES		
#	Common Name	Scientific Name
1		#N/A
2		#N/A
3		#N/A
4		#N/A
5		#N/A
6		#N/A
7		#N/A
8		#N/A
9		#N/A
10		#N/A
RIPARIAN INFORMATION		
Vegetation Stage		
IMPORTANT FEATURES OBSERVED		
Vegetated Across		<input type="checkbox"/>
Flows into Fish Habitat Downstream		<input type="checkbox"/>
Underground Sections or Groundwater		<input type="checkbox"/>
Surface Flow		<input checked="" type="checkbox"/>
Wetland Corridor (Flow Between Wetlands)		<input type="checkbox"/>
Barrier		<input type="checkbox"/>
Artificial Channelization		<input type="checkbox"/>
Culvert or Bridge		<input checked="" type="checkbox"/>
Water Flowing over Road (no Culvert)		<input type="checkbox"/>
No Defined Channel		<input checked="" type="checkbox"/>
ADDITIONAL NOTES		
<p>Plunge pool at crossing 140cm channel, 28cm depth channel appears to dissipate or run along the surface DS, US channel no water 41cm. Watercourse runs along ditch of road channel change from defined to undefined. Wp.1651 US no channel. Ephemeral WC with intermittent characteristics, likely connect to F/Q</p>

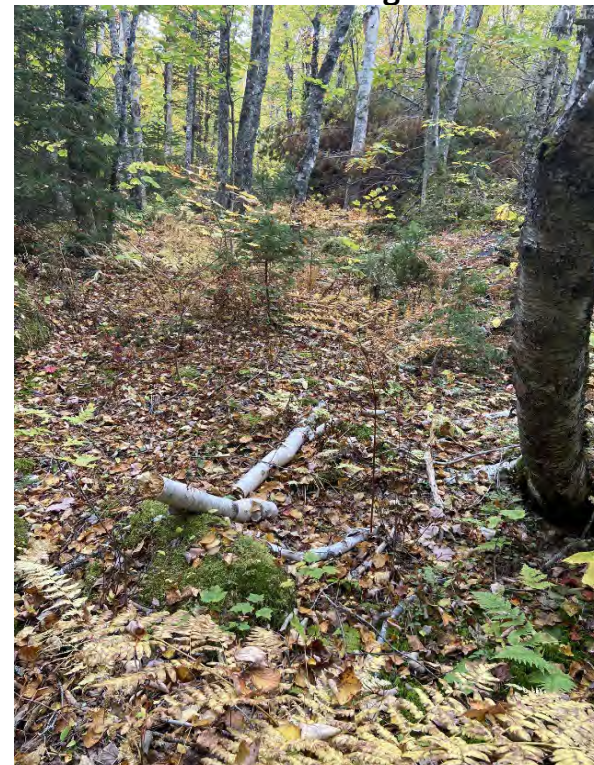
Photo 2: No channel (U/S)

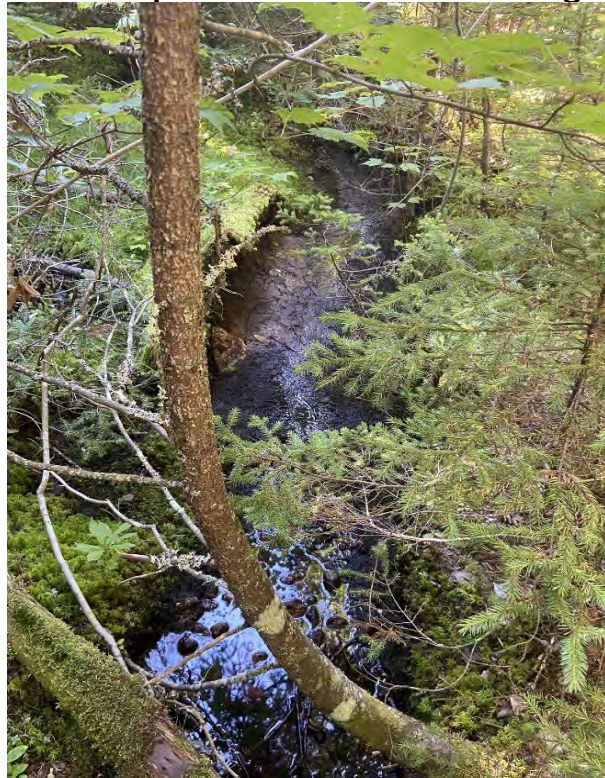
Photo 2: No channel (U/S)

RIPARIAN VEGETATION SPECIES		
#	Common Name	Scientific Name
1		#N/A
2		#N/A
3		#N/A
4		#N/A
5		#N/A
6		#N/A
7		#N/A
8		#N/A
9		#N/A
10		#N/A
RIPARIAN INFORMATION		
Vegetation Stage		
IMPORTANT FEATURES OBSERVED		
Vegetated Across		<input type="checkbox"/>
Flows into Fish Habitat Downstream		<input type="checkbox"/>
Underground Sections or Groundwater		<input checked="" type="checkbox"/>
Surface Flow		<input checked="" type="checkbox"/>
Wetland Corridor (Flow Between Wetlands)		<input type="checkbox"/>
Barrier		<input type="checkbox"/>
Artificial Channelization		<input type="checkbox"/>
Culvert or Bridge		<input type="checkbox"/>
Water Flowing over Road (no Culvert)		<input type="checkbox"/>
No Defined Channel		<input checked="" type="checkbox"/>
ADDITIONAL NOTES		
Ephemeral drainage, no defined channel, looks like it flows under boulders. DS Channeled area, might be old tire track from 30-40 years ago. Two "channels" seen but overtime the flow used the tracks - no flow, standing water. "channel" 67cm, 10cm deep.

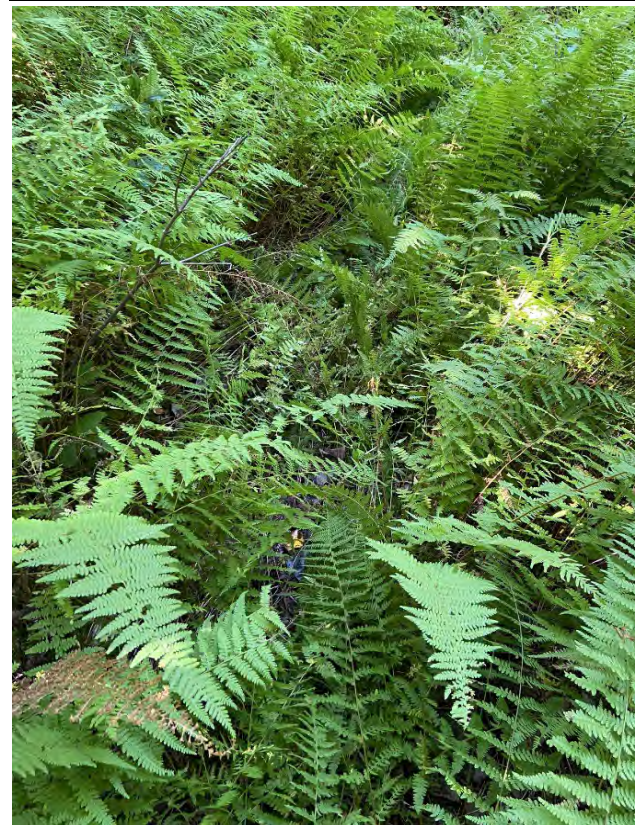
Photo 1: Culvert at crossing

RIPARIAN VEGETATION SPECIES		
#	Common Name	Scientific Name
1		#N/A
2		#N/A
3		#N/A
4		#N/A
5		#N/A
6		#N/A
7		#N/A
8		#N/A
9		#N/A
10		#N/A
RIPARIAN INFORMATION		
Vegetation Stage		
IMPORTANT FEATURES OBSERVED		
Vegetated Across		<input type="checkbox"/>
Flows into Fish Habitat Downstream		<input type="checkbox"/>
Underground Sections or Groundwater		<input type="checkbox"/>
Surface Flow		<input checked="" type="checkbox"/>
Wetland Corridor (Flow Between Wetlands)		<input type="checkbox"/>
Barrier		<input type="checkbox"/>
Artificial Channelization		<input type="checkbox"/>
Culvert or Bridge		<input checked="" type="checkbox"/>
Water Flowing over Road (no Culvert)		<input type="checkbox"/>
No Defined Channel		<input type="checkbox"/>
ADDITIONAL NOTES		
Wp. 1654 - U/S no water, channelized here. At crossing surface flow, no channel, no water.

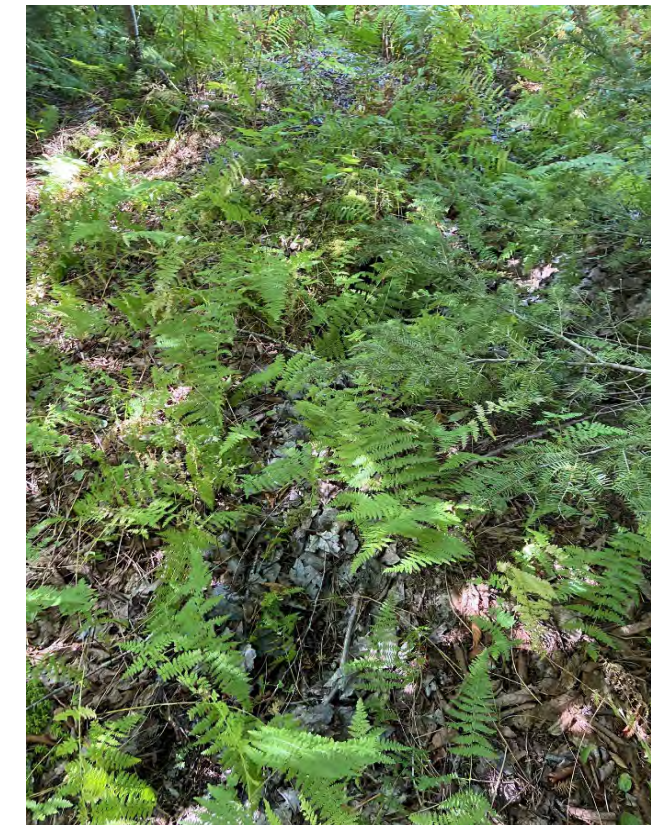
Photo 2: Upstream, slight channelization, no water.

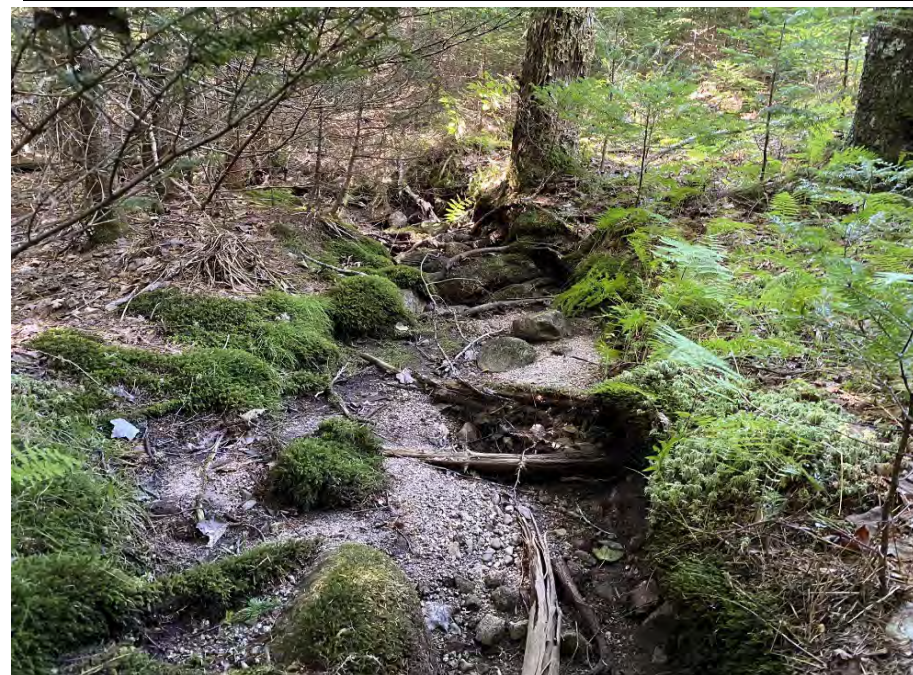
Photo 1: Upstream at assumed crossing

RIPARIAN VEGETATION SPECIES		
#	Common Name	Scientific Name
1		#N/A
2		#N/A
3		#N/A
4		#N/A
5		#N/A
6		#N/A
7		#N/A
8		#N/A
9		#N/A
10		#N/A
RIPARIAN INFORMATION		
Vegetation Stage		
IMPORTANT FEATURES OBSERVED		
Vegetated Across		<input checked="" type="checkbox"/>
Flows into Fish Habitat Downstream		<input type="checkbox"/>
Underground Sections or Groundwater		<input type="checkbox"/>
Surface Flow		<input type="checkbox"/>
Wetland Corridor (Flow Between Wetlands)		<input type="checkbox"/>
Barrier		<input type="checkbox"/>
Artificial Channelization		<input type="checkbox"/>
Culvert or Bridge		<input type="checkbox"/>
Water Flowing over Road (no Culvert)		<input type="checkbox"/>
No Defined Channel		<input checked="" type="checkbox"/>
ADDITIONAL NOTES		
Evidence of scour, pool (areas), Potential undercut banks, small woody debris, good overhead cover. No water at time of visit. Not permanent.

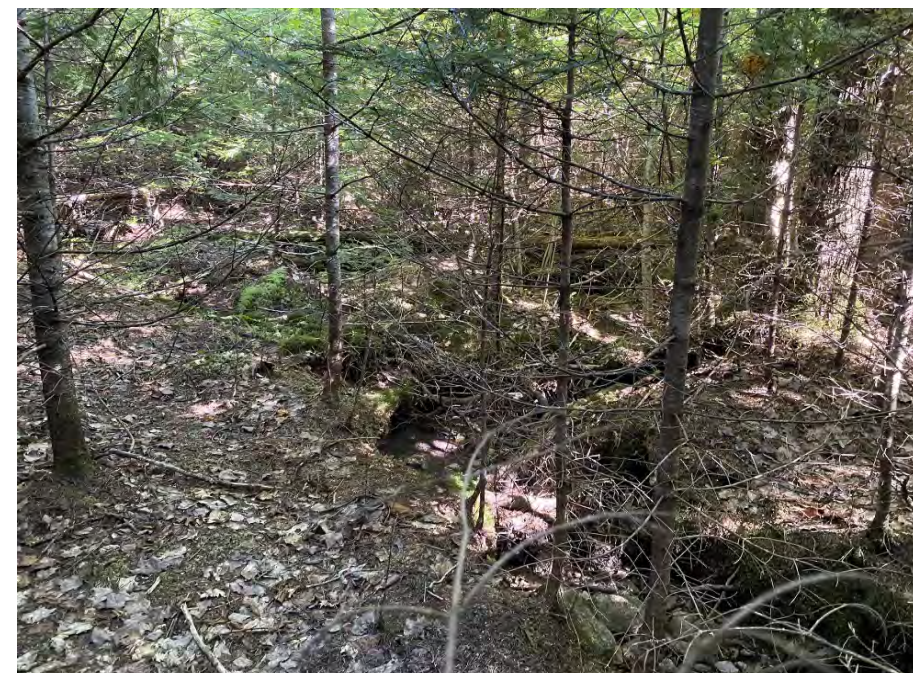
Photo 2: Downstream at assumed crossing

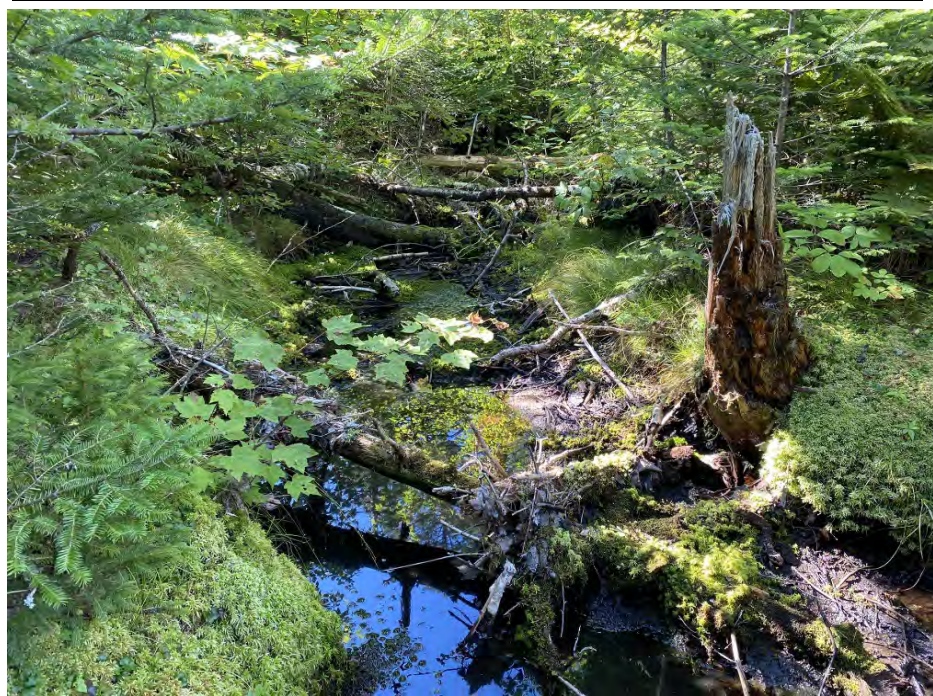
Photo 1: Upstream at assumed crossing

RIPARIAN VEGETATION SPECIES		
#	Common Name	Scientific Name
1		#N/A
2		#N/A
3		#N/A
4		#N/A
5		#N/A
6		#N/A
7		#N/A
8		#N/A
9		#N/A
10		#N/A
RIPARIAN INFORMATION		
Vegetation Stage		
IMPORTANT FEATURES OBSERVED		
Vegetated Across		<input type="checkbox"/>
Flows into Fish Habitat Downstream		<input type="checkbox"/>
Underground Sections or Groundwater		<input checked="" type="checkbox"/>
Surface Flow		<input checked="" type="checkbox"/>
Wetland Corridor (Flow Between Wetlands)		<input type="checkbox"/>
Barrier		<input type="checkbox"/>
Artificial Channelization		<input type="checkbox"/>
Culvert or Bridge		<input type="checkbox"/>
Water Flowing over Road (no Culvert)		<input type="checkbox"/>
No Defined Channel		<input type="checkbox"/>
ADDITIONAL NOTES		
Wetted, low flow channel. Permanently wetted, almost no flow, instream sphagnum mosses, film, sheen on surface, channel continues D/S subsurface sections but wetted sm. channel. Culvert likely needed for crossing.

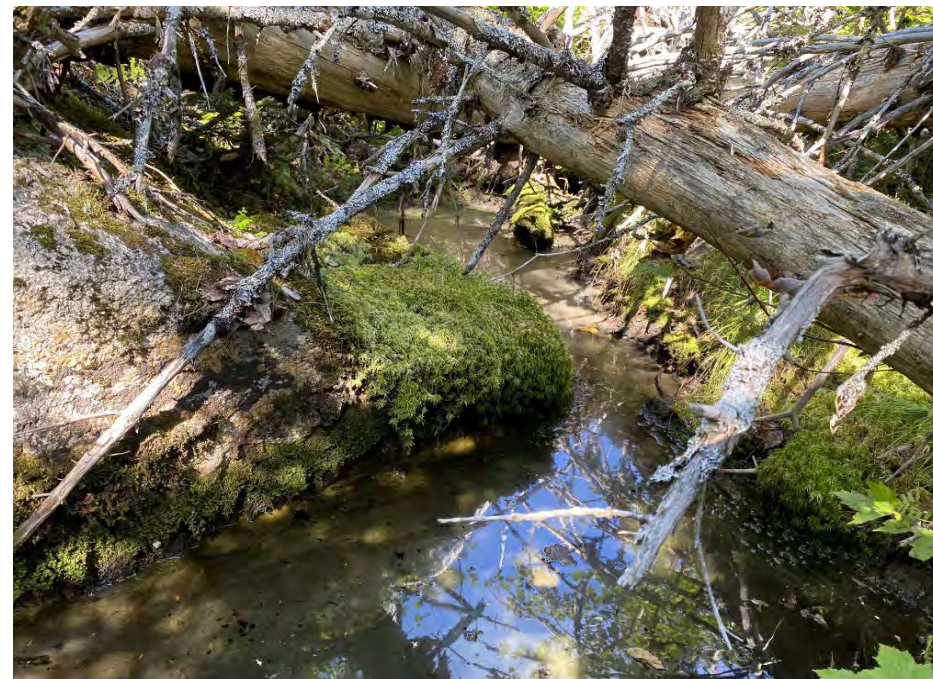
Photo 2: Downstream at assumed crossing

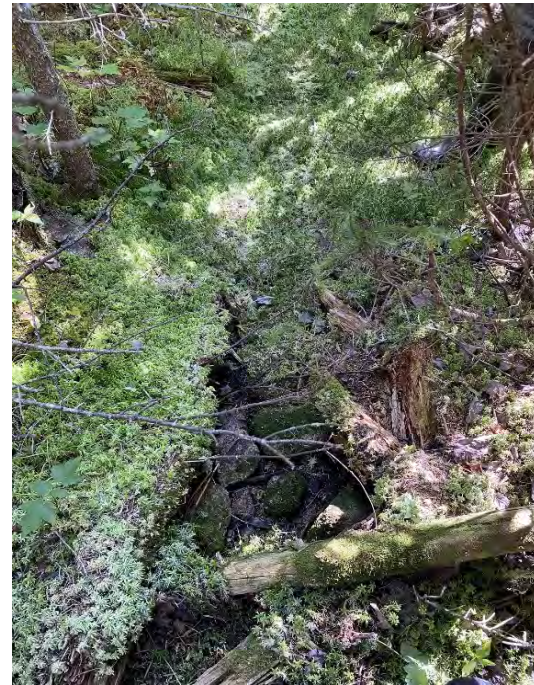
Photo 1: Upstream at approximate crossing location.

RIPARIAN VEGETATION SPECIES		
#	Common Name	Scientific Name
1		#N/A
2		#N/A
3		#N/A
4		#N/A
5		#N/A
6		#N/A
7		#N/A
8		#N/A
9		#N/A
10		#N/A
RIPARIAN INFORMATION		
Vegetation Stage		
IMPORTANT FEATURES OBSERVED		
Vegetated Across		<input checked="" type="checkbox"/>
Flows into Fish Habitat Downstream		<input type="checkbox"/>
Underground Sections or Groundwater		<input type="checkbox"/>
Surface Flow		<input type="checkbox"/>
Wetland Corridor (Flow Between Wetlands)		<input type="checkbox"/>
Barrier		<input type="checkbox"/>
Artificial Channelization		<input type="checkbox"/>
Culvert or Bridge		<input type="checkbox"/>
Water Flowing over Road (no Culvert)		<input type="checkbox"/>
No Defined Channel		<input checked="" type="checkbox"/>
ADDITIONAL NOTES		
Wp.46 No channel, no water, no flow, bog/wetland. Wp.47 No channel, wetted area, potential pooling areas, no flow, no water.

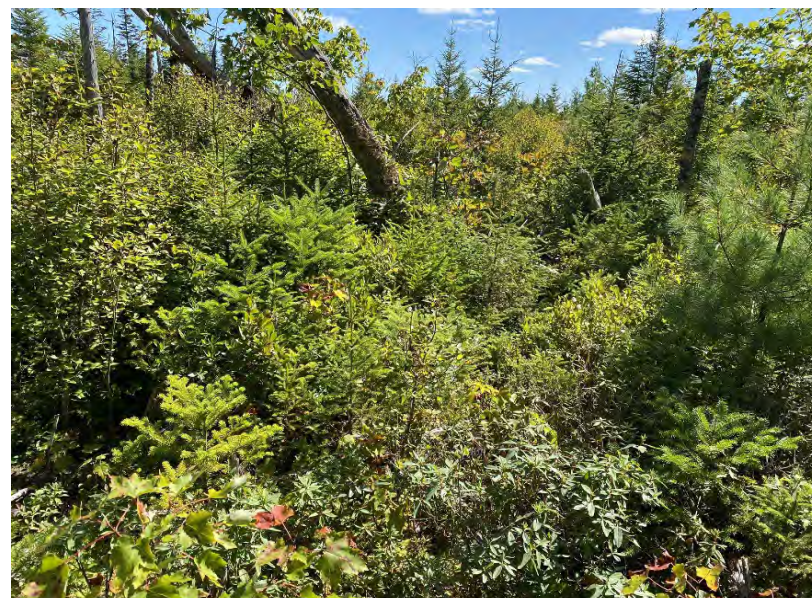
Photo 2: Downstream at approximate crossing location.

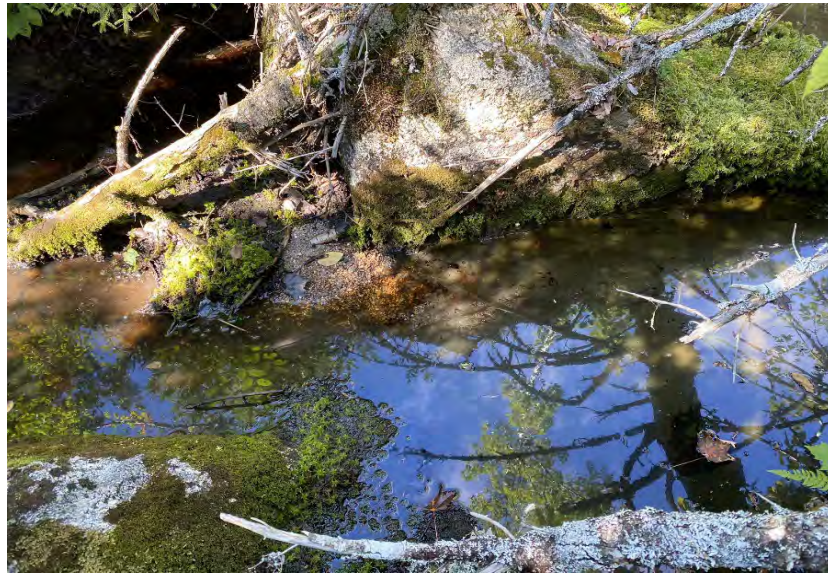
Photo 1: Water barely flowing at site.

RIPARIAN VEGETATION SPECIES		
#	Common Name	Scientific Name
1		#N/A
2		#N/A
3		#N/A
4		#N/A
5		#N/A
6		#N/A
7		#N/A
8		#N/A
9		#N/A
10		#N/A
RIPARIAN INFORMATION		
Vegetation Stage	Mature Forest	
IMPORTANT FEATURES OBSERVED		
Vegetated Across	<input type="checkbox"/>	
Flows into Fish Habitat Downstream	<input type="checkbox"/>	
Underground Sections or Groundwater	<input checked="" type="checkbox"/>	
Surface Flow	<input checked="" type="checkbox"/>	
Wetland Corridor (Flow Between Wetlands)	<input type="checkbox"/>	
Barrier	<input type="checkbox"/>	
Artificial Channelization	<input type="checkbox"/>	
Culvert or Bridge	<input type="checkbox"/>	
Water Flowing over Road (no Culvert)	<input type="checkbox"/>	
No Defined Channel	<input type="checkbox"/>	
ADDITIONAL NOTES		
Wetted, low flow channel. Lots of SWD and LWD. Good cover. Substrates: fines, small gravel, boulders. Permanently wetted, almost no flow. Instream sphag, mosses. Film/sheen on surface of water. Channel continues downstream into subsurface sections, but in small wetted channel.

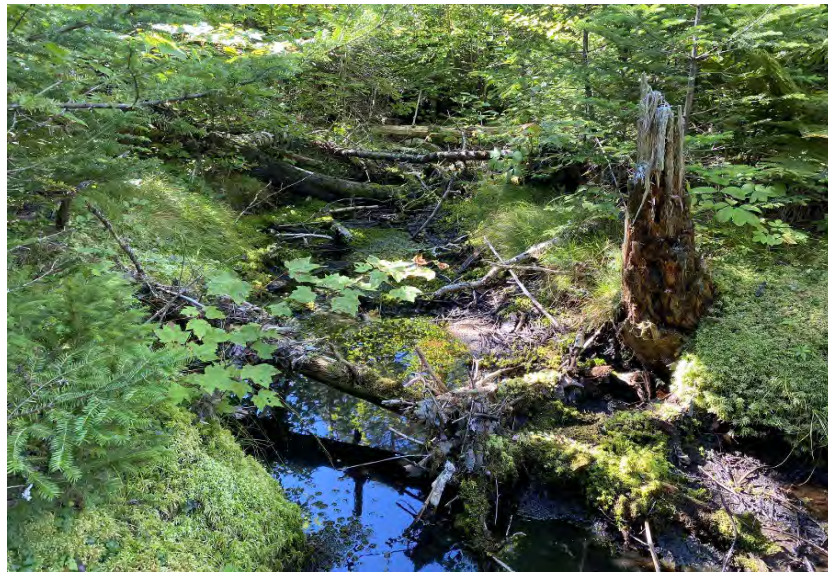
Photo 2: Downstream at Crossing

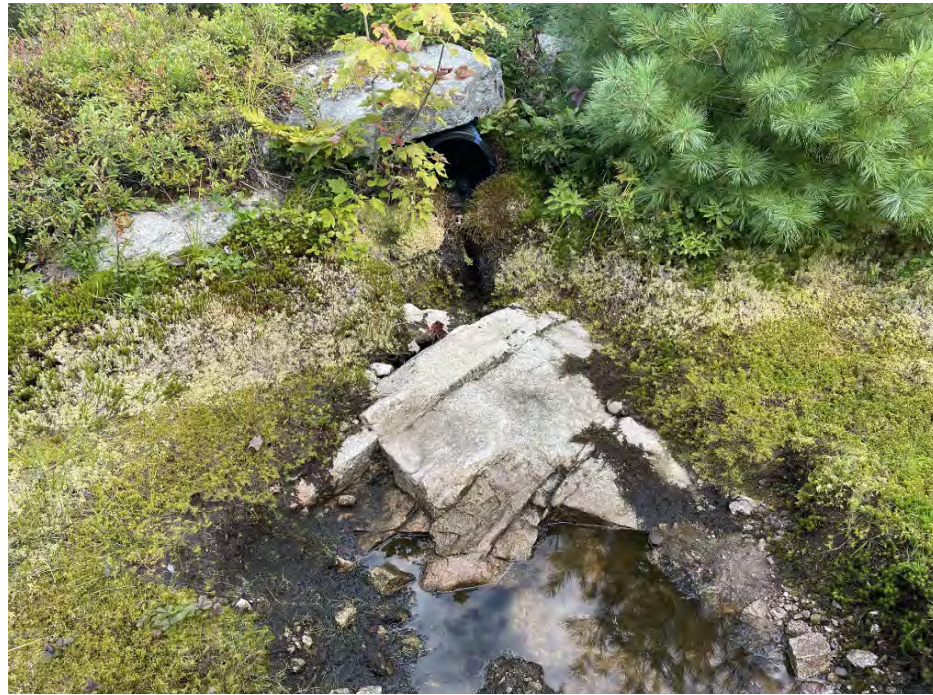
Photo 1: Culvert looking downstream of crossing location.

RIPARIAN VEGETATION SPECIES		
#	Common Name	Scientific Name
1		#N/A
2		#N/A
3		#N/A
4		#N/A
5		#N/A
6		#N/A
7		#N/A
8		#N/A
9		#N/A
10		#N/A
RIPARIAN INFORMATION		
Vegetation Stage		
IMPORTANT FEATURES OBSERVED		
Vegetated Across		<input type="checkbox"/>
Flows into Fish Habitat Downstream		<input type="checkbox"/>
Underground Sections or Groundwater		<input type="checkbox"/>
Surface Flow		<input type="checkbox"/>
Wetland Corridor (Flow Between Wetlands)		<input type="checkbox"/>
Barrier		<input type="checkbox"/>
Artificial Channelization		<input type="checkbox"/>
Culvert or Bridge		<input type="checkbox"/>
Water Flowing over Road (no Culvert)		<input type="checkbox"/>
No Defined Channel		<input checked="" type="checkbox"/>
ADDITIONAL NOTES		
Not fish habitat, no channel, no water.

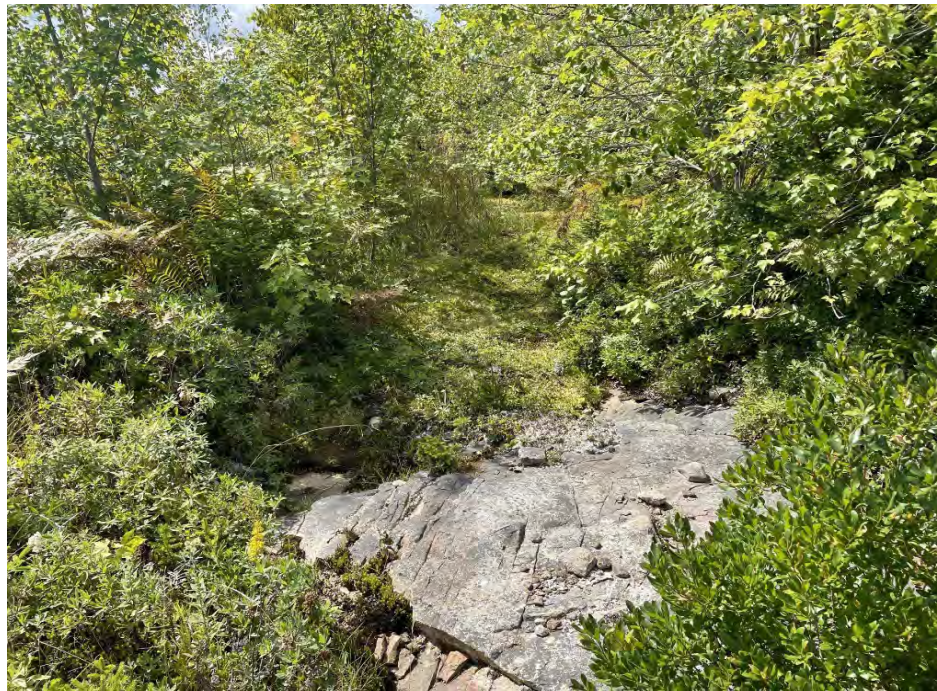
Photo 2: Upstream channel

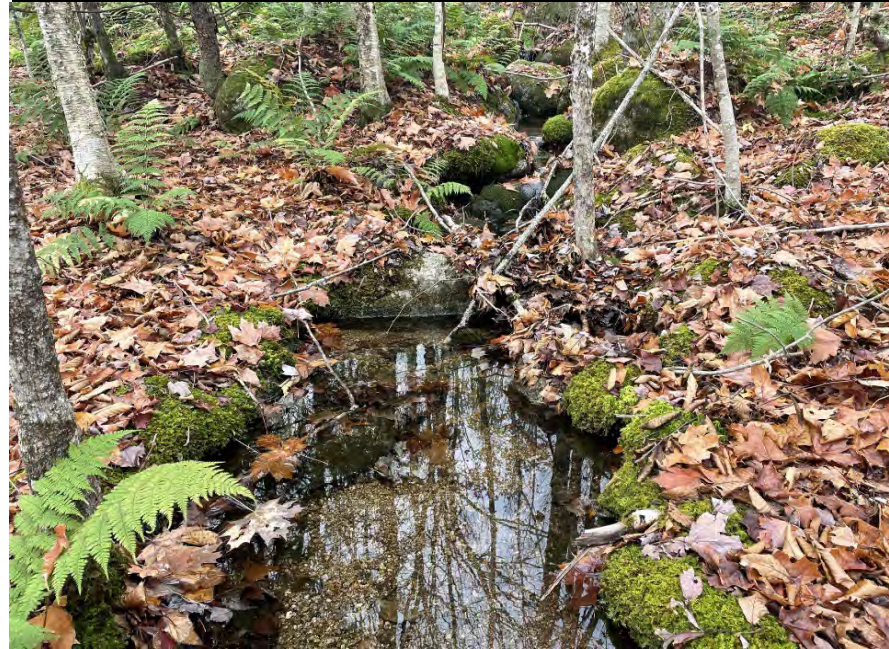
Photo 1: Approximate crossing location.

RIPARIAN VEGETATION SPECIES		
#	Common Name	Scientific Name
1		#N/A
2		#N/A
3		#N/A
4		#N/A
5		#N/A
6		#N/A
7		#N/A
8		#N/A
9		#N/A
10		#N/A
RIPARIAN INFORMATION		
Vegetation Stage		
IMPORTANT FEATURES OBSERVED		
Vegetated Across		<input type="checkbox"/>
Flows into Fish Habitat Downstream		<input type="checkbox"/>
Underground Sections or Groundwater		<input type="checkbox"/>
Surface Flow		<input type="checkbox"/>
Wetland Corridor (Flow Between Wetlands)		<input type="checkbox"/>
Barrier		<input checked="" type="checkbox"/>
Artificial Channelization		<input type="checkbox"/>
Culvert or Bridge		<input type="checkbox"/>
Water Flowing over Road (no Culvert)		<input type="checkbox"/>
No Defined Channel		<input type="checkbox"/>
ADDITIONAL NOTES		
Ruled out as fish habitat due to slope and barriers. Steep habitat.

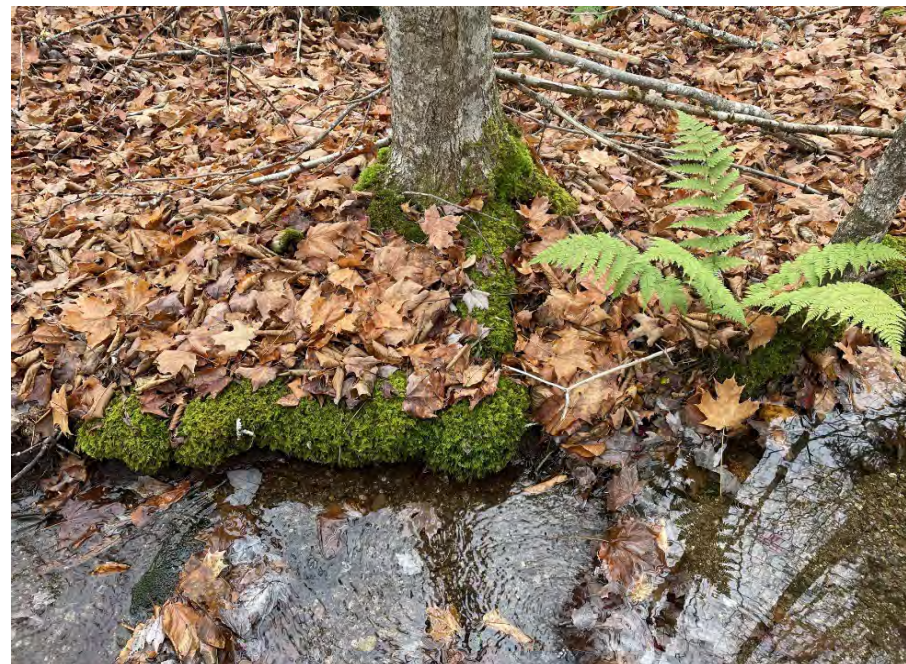
Photo 2: General habitat around WC BL-WC202b-576

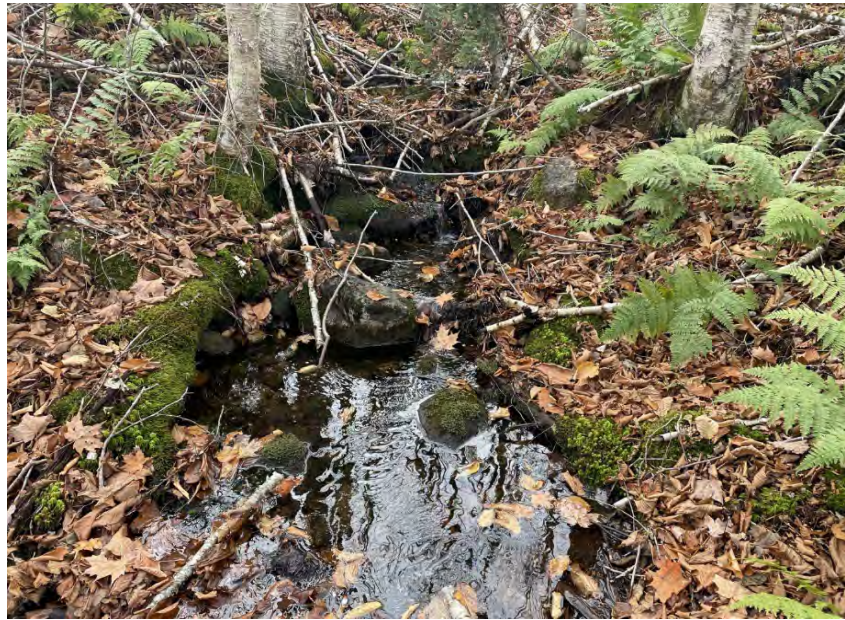
Photo 1: Upstream at Crossing

RIPARIAN VEGETATION SPECIES		
#	Common Name	Scientific Name
1		#N/A
2		#N/A
3		#N/A
4		#N/A
5		#N/A
6		#N/A
7		#N/A
8		#N/A
9		#N/A
10		#N/A
RIPARIAN INFORMATION		
Vegetation Stage		
IMPORTANT FEATURES OBSERVED		
Vegetated Across		<input type="checkbox"/>
Flows into Fish Habitat Downstream		<input type="checkbox"/>
Underground Sections or Groundwater		<input checked="" type="checkbox"/>
Surface Flow		<input type="checkbox"/>
Wetland Corridor (Flow Between Wetlands)		<input type="checkbox"/>
Barrier		<input checked="" type="checkbox"/>
Artificial Channelization		<input type="checkbox"/>
Culvert or Bridge		<input type="checkbox"/>
Water Flowing over Road (no Culvert)		<input type="checkbox"/>
No Defined Channel		<input type="checkbox"/>
ADDITIONAL NOTES		
Determined not to be fish habitat.

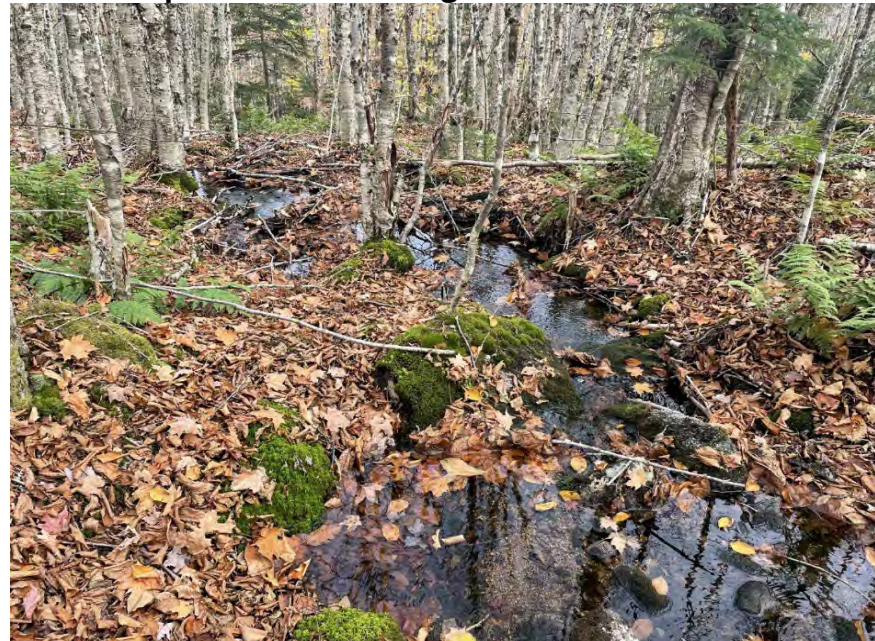
Photo 2: Downstream at Crossing

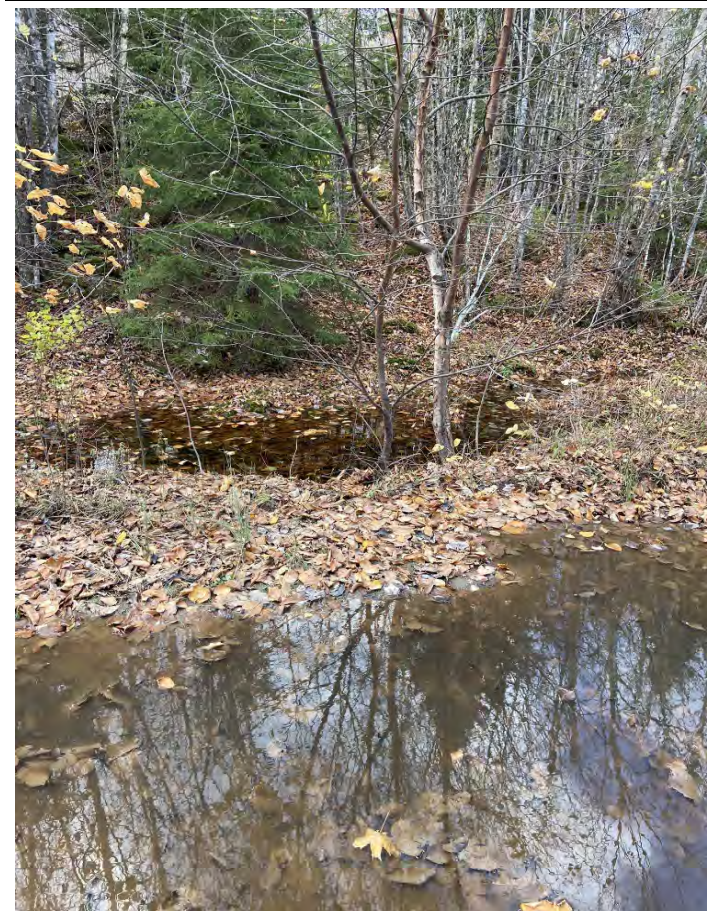
Photo 1: Upstream at approximate crossing location.

RIPARIAN VEGETATION SPECIES		
#	Common Name	Scientific Name
1		#N/A
2		#N/A
3		#N/A
4		#N/A
5		#N/A
6		#N/A
7		#N/A
8		#N/A
9		#N/A
10		#N/A
RIPARIAN INFORMATION		
Vegetation Stage		
IMPORTANT FEATURES OBSERVED		
Vegetated Across		<input type="checkbox"/>
Flows into Fish Habitat Downstream		<input type="checkbox"/>
Underground Sections or Groundwater		<input type="checkbox"/>
Surface Flow		<input checked="" type="checkbox"/>
Wetland Corridor (Flow Between Wetlands)		<input type="checkbox"/>
Barrier		<input type="checkbox"/>
Artificial Channelization		<input type="checkbox"/>
Culvert or Bridge		<input checked="" type="checkbox"/>
Water Flowing over Road (no Culvert)		<input type="checkbox"/>
No Defined Channel		<input type="checkbox"/>
ADDITIONAL NOTES		
Culvert located at crossing.

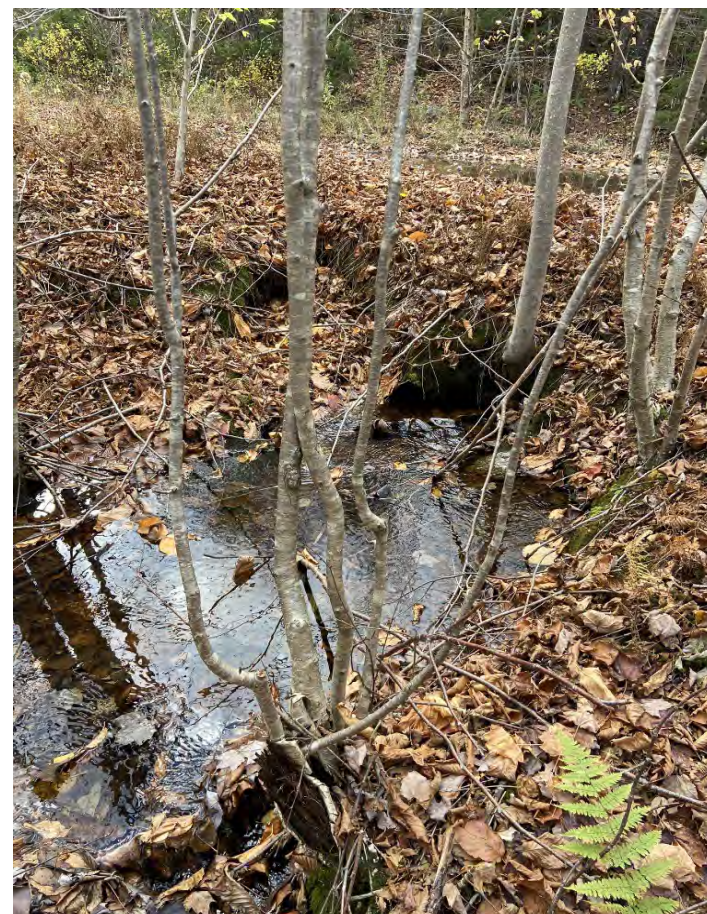
Photo 2: Downstream at approximate crossing location.

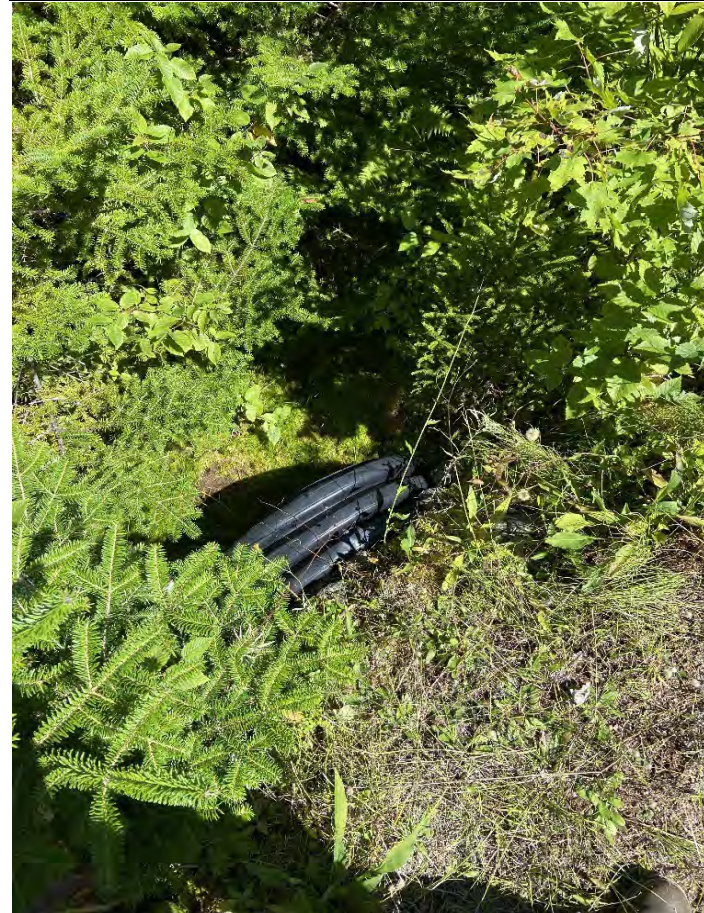
Photo 1: Upstream at approximate crossing location.

RIPARIAN VEGETATION SPECIES		
#	Common Name	Scientific Name
1		#N/A
2		#N/A
3		#N/A
4		#N/A
5		#N/A
6		#N/A
7		#N/A
8		#N/A
9		#N/A
10		#N/A
RIPARIAN INFORMATION		
Vegetation Stage		
IMPORTANT FEATURES OBSERVED		
Vegetated Across		<input checked="" type="checkbox"/>
Flows into Fish Habitat Downstream		<input type="checkbox"/>
Underground Sections or Groundwater		<input type="checkbox"/>
Surface Flow		<input type="checkbox"/>
Wetland Corridor (Flow Between Wetlands)		<input type="checkbox"/>
Barrier		<input type="checkbox"/>
Artificial Channelization		<input type="checkbox"/>
Culvert or Bridge		<input checked="" type="checkbox"/>
Water Flowing over Road (no Culvert)		<input type="checkbox"/>
No Defined Channel		<input checked="" type="checkbox"/>
ADDITIONAL NOTES		
Not fish habitat.

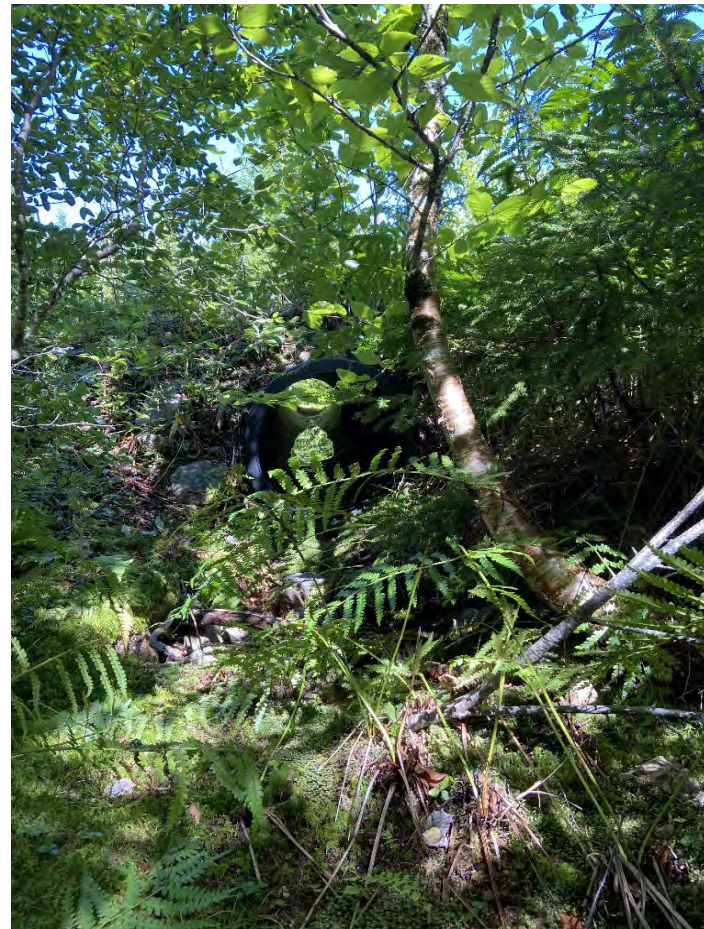
Photo 2: Downstream at approximate crossing location.

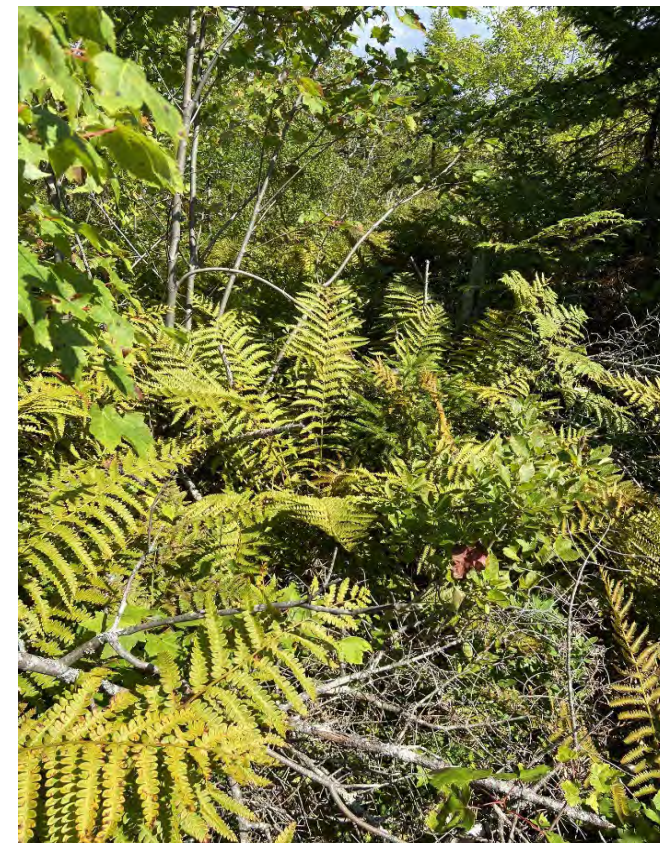
Photo 2: Downstream, no channel, ephemeral drainage in wetland

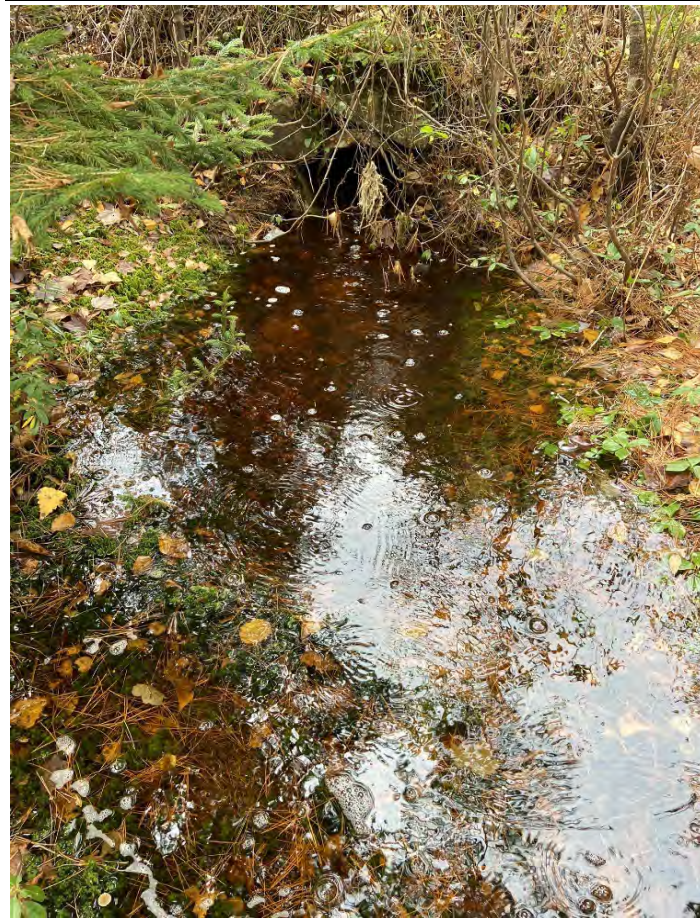
Photo 1: Flow at crossing through culvert after heavy rainfall event

RIPARIAN VEGETATION SPECIES		
#	Common Name	Scientific Name
1		#N/A
2		#N/A
3		#N/A
4		#N/A
5		#N/A
6		#N/A
7		#N/A
8		#N/A
9		#N/A
10		#N/A
RIPARIAN INFORMATION		
Vegetation Stage		
IMPORTANT FEATURES OBSERVED		
Vegetated Across		<input type="checkbox"/>
Flows into Fish Habitat Downstream		<input type="checkbox"/>
Underground Sections or Groundwater		<input checked="" type="checkbox"/>
Surface Flow		<input type="checkbox"/>
Wetland Corridor (Flow Between Wetlands)		<input type="checkbox"/>
Barrier		<input type="checkbox"/>
Artificial Channelization		<input type="checkbox"/>
Culvert or Bridge		<input checked="" type="checkbox"/>
Water Flowing over Road (no Culvert)		<input type="checkbox"/>
No Defined Channel		<input checked="" type="checkbox"/>
ADDITIONAL NOTES		
Flowing well through culvert at crossing after heavy rain event,- No defined channel. Wp.1813 start to channelize @D/S for appox 10-20m. Wp.1814 Underground flow heard, no channel seen.
