## Watercourse Fact Sheet: Not Fish Habitat

WATERCOURSE INFORMATION	
<b>Watercourse ID:</b>	<b>Watercourse BL-WC106F-334</b>
General Site Location:	Bear Lake
Watercourse Assessor(s):	MB
Affiliation:	CBCL Limited
Field Assessment Date:	Oct 05 2022
UTM Coordinates:	Wp. 088 (MB)
Datum:	NAD 1983
SUBSTRATE	
Dominant	
Subdominant	
Subdominant	
Trace	
Trace	
Trace	
CHANNEL MEASUREMENTS	
Average Channel Width (m)	
Average Wetted Width (m)	
Average Bankful Depth (m)	
Average Water Depth (m)	
Average Pool Depth (m)	
WATERCOURSE MORPHOLOGY	
Watercourse Type	Ephemeral
Stage (season was very dry)	Low

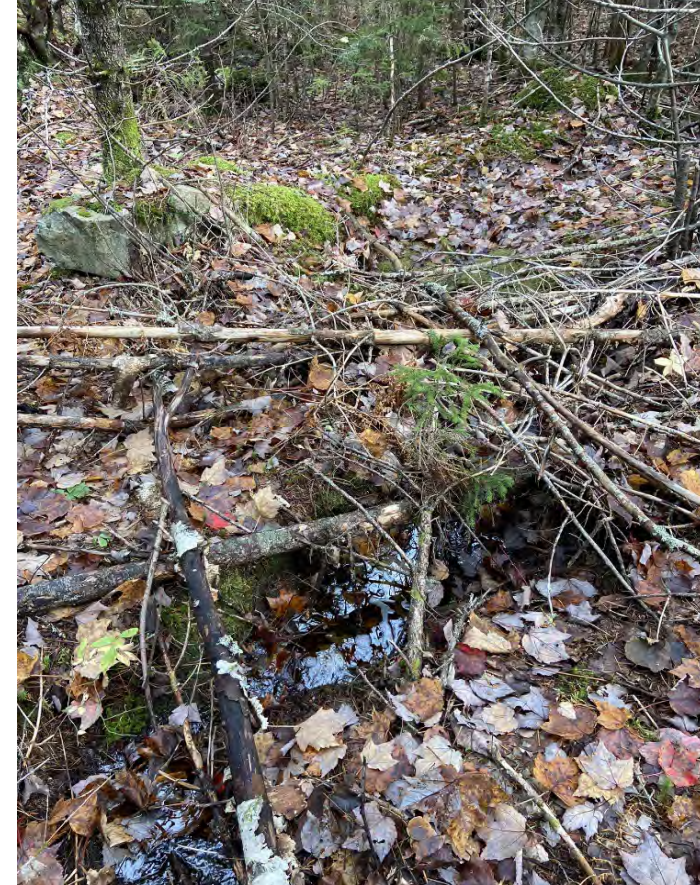
Photo 2: Slight channelization downstream

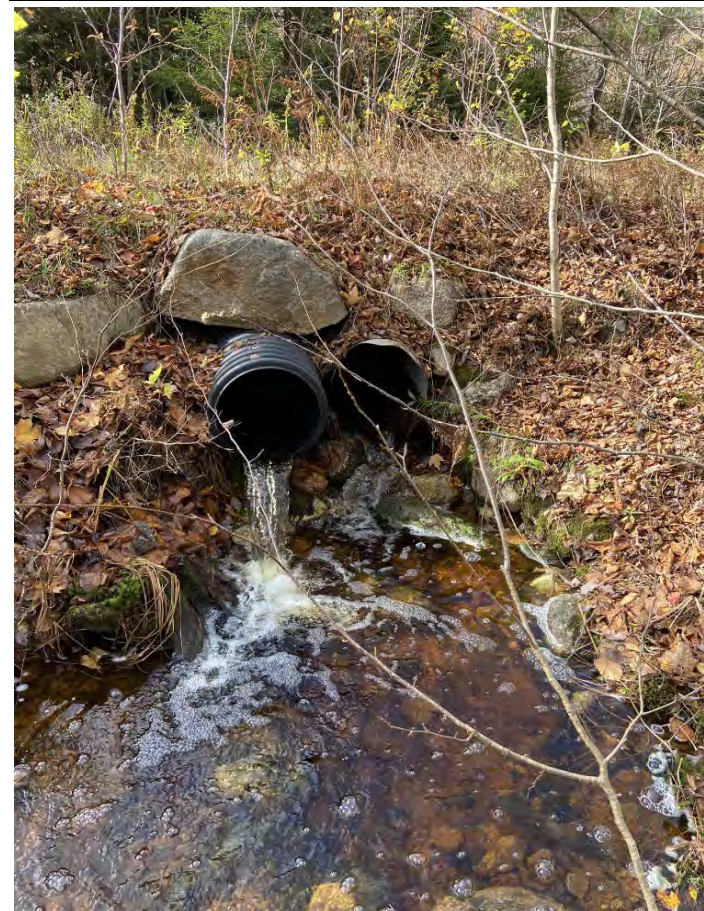
Photo 1: Upstream at crossing

RIPARIAN VEGETATION SPECIES		
#	Common Name	Scientific Name
1		#N/A
2		#N/A
3		#N/A
4		#N/A
5		#N/A
6		#N/A
7		#N/A
8		#N/A
9		#N/A
10		#N/A
RIPARIAN INFORMATION		
Vegetation Stage		
IMPORTANT FEATURES OBSERVED		
Vegetated Across		<input type="checkbox"/>
Flows into Fish Habitat Downstream		<input type="checkbox"/>
Underground Sections or Groundwater		<input type="checkbox"/>
Surface Flow		<input type="checkbox"/>
Wetland Corridor (Flow Between Wetlands)		<input type="checkbox"/>
Barrier		<input type="checkbox"/>
Artificial Channelization		<input type="checkbox"/>
Culvert or Bridge		<input checked="" type="checkbox"/>
Water Flowing over Road (no Culvert)		<input type="checkbox"/>
No Defined Channel		<input type="checkbox"/>
ADDITIONAL NOTES		
Intermittent channels, likely joins permanent watercourse D/S. Wp.1835 Pileated Woodpecker activity on tree.

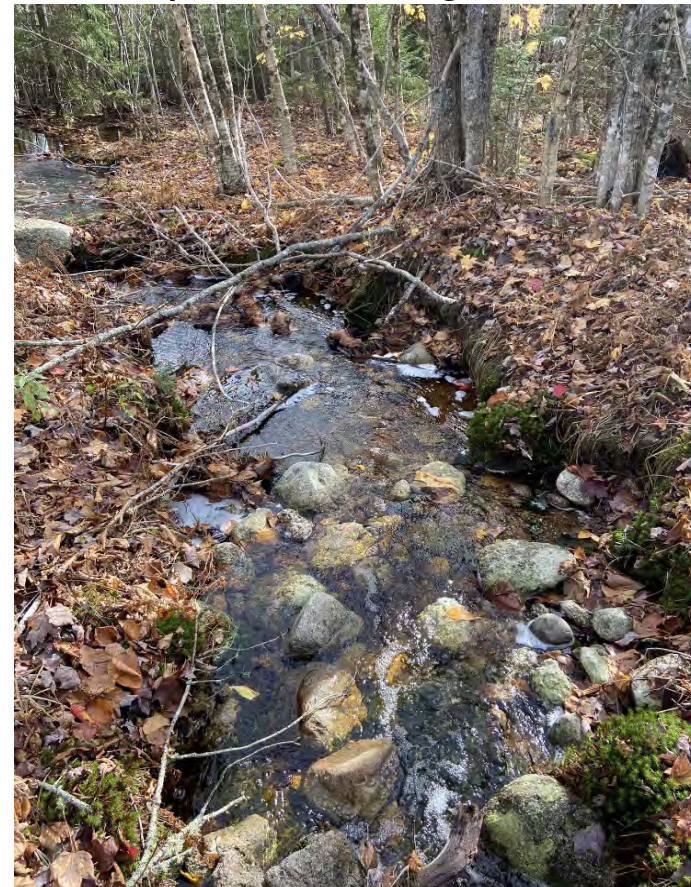
Photo 2: Downstream of crossing

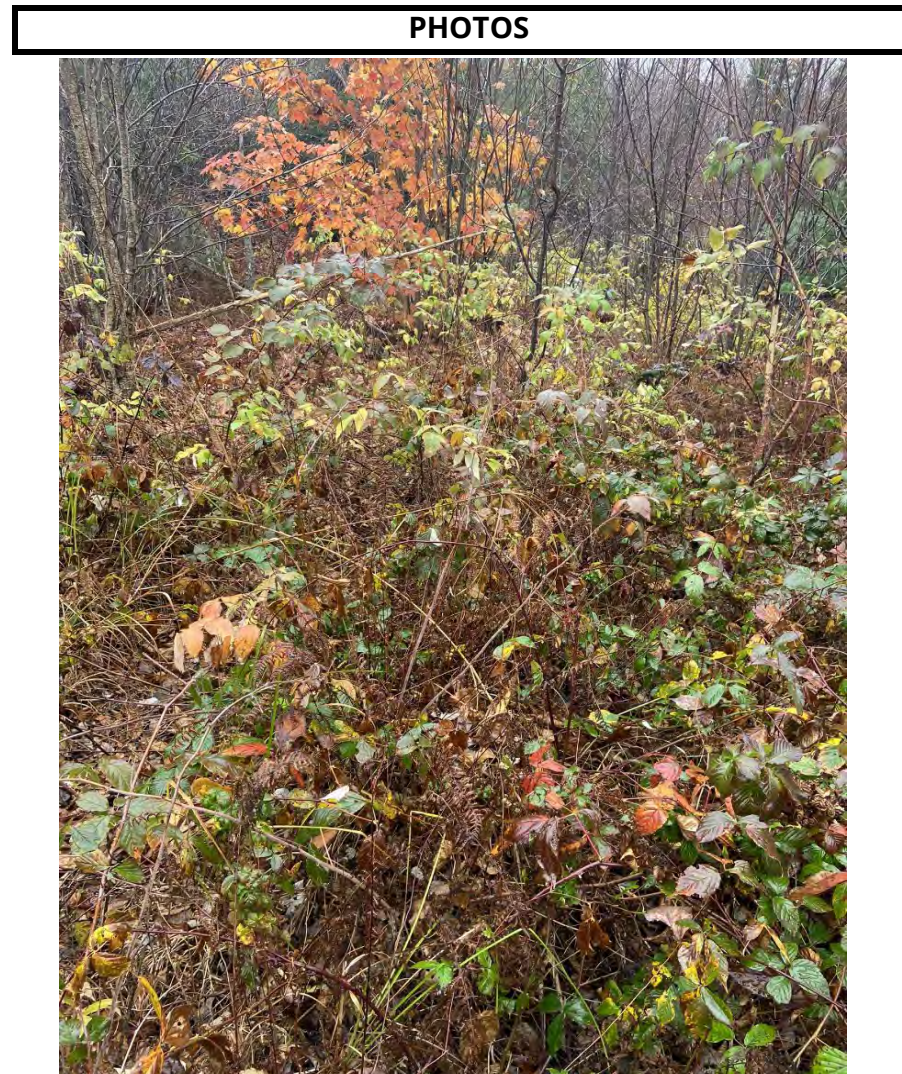
Photo 1: Approximate crossing location

RIPARIAN VEGETATION SPECIES		
#	Common Name	Scientific Name
1		#N/A
2		#N/A
3		#N/A
4		#N/A
5		#N/A
6		#N/A
7		#N/A
8		#N/A
9		#N/A
10		#N/A
RIPARIAN INFORMATION		
Vegetation Stage		
IMPORTANT FEATURES OBSERVED		
Vegetated Across		<input type="checkbox"/>
Flows into Fish Habitat Downstream		<input type="checkbox"/>
Underground Sections or Groundwater		<input type="checkbox"/>
Surface Flow		<input type="checkbox"/>
Wetland Corridor (Flow Between Wetlands)		<input type="checkbox"/>
Barrier		<input type="checkbox"/>
Artificial Channelization		<input type="checkbox"/>
Culvert or Bridge		<input type="checkbox"/>
Water Flowing over Road (no Culvert)		<input type="checkbox"/>
No Defined Channel		<input checked="" type="checkbox"/>
ADDITIONAL NOTES		
Ephemeral - No channel

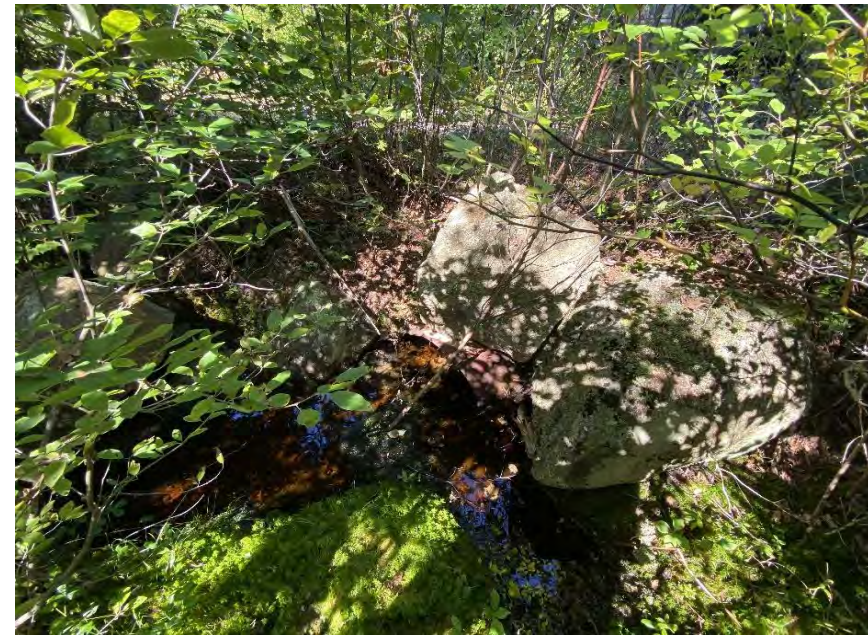
Photo 1: Upstream at Crossing

RIPARIAN VEGETATION SPECIES		
#	Common Name	Scientific Name
1		#N/A
2		#N/A
3		#N/A
4		#N/A
5		#N/A
6		#N/A
7		#N/A
8		#N/A
9		#N/A
10		#N/A
RIPARIAN INFORMATION		
Vegetation Stage		
IMPORTANT FEATURES OBSERVED		
Vegetated Across		<input type="checkbox"/>
Flows into Fish Habitat Downstream		<input type="checkbox"/>
Underground Sections or Groundwater		<input type="checkbox"/>
Surface Flow		<input type="checkbox"/>
Wetland Corridor (Flow Between Wetlands)		<input type="checkbox"/>
Barrier		<input type="checkbox"/>
Artificial Channelization		<input type="checkbox"/>
Culvert or Bridge		<input checked="" type="checkbox"/>
Water Flowing over Road (no Culvert)		<input type="checkbox"/>
No Defined Channel		<input checked="" type="checkbox"/>
ADDITIONAL NOTES		
Ephemeral bog on D/S side of road - no sign of channel; connection, very rocky, more rock barren than bog.

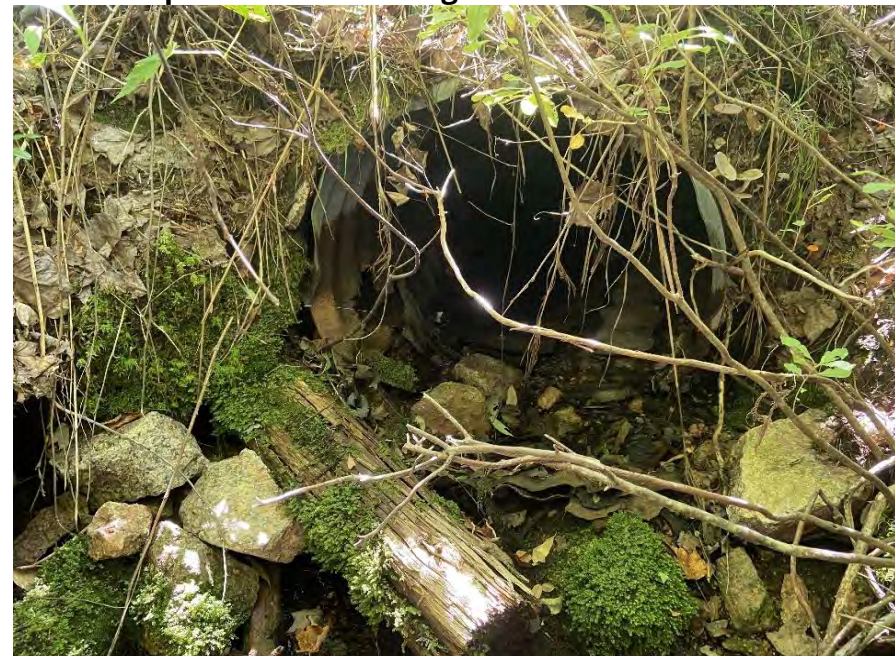
Photo 2: U/S Culvert showing low water level

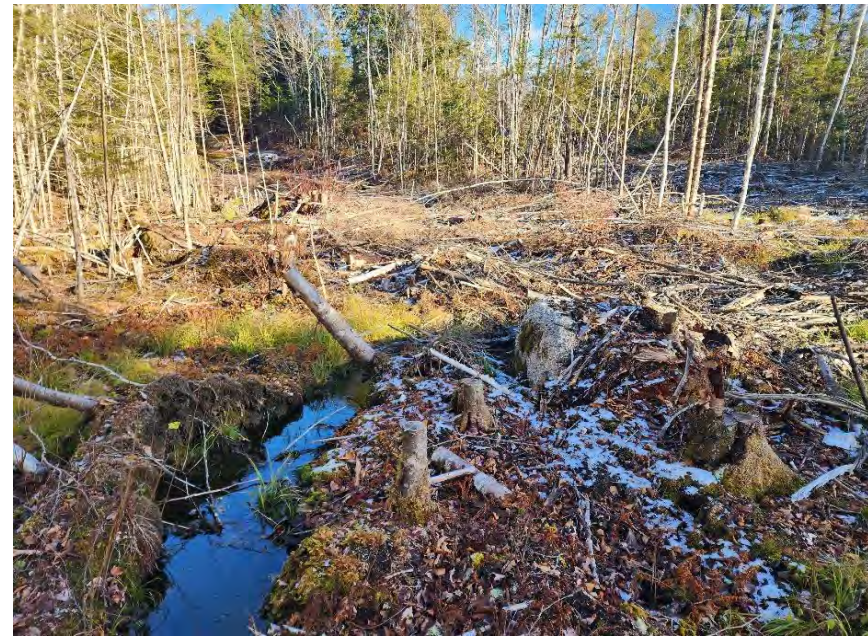
Photo 1: Upstream at Crossing

RIPARIAN VEGETATION SPECIES		
#	Common Name	Scientific Name
1	Sphagnum Moss	#N/A
2	Red Maple	<i>Acer rubrum</i>
3	Balsam Fir	<i>Abies balsamea</i>
4	Grasses	#N/A
5	Cinnamon Fern	<i>Osmunda cinnamomea</i>
6	White Pine	#N/A
7	Red Spruce	<i>Picea rubens</i>
8		#N/A
9		#N/A
10		#N/A
RIPARIAN INFORMATION		
Vegetation Stage	Young Forest	
IMPORTANT FEATURES OBSERVED		
Vegetated Across	<input checked="" type="checkbox"/>	
Flows into Fish Habitat Downstream	<input type="checkbox"/>	
Underground Sections or Groundwater	<input checked="" type="checkbox"/>	
Surface Flow	<input type="checkbox"/>	
Wetland Corridor (Flow Between Wetlands)	<input type="checkbox"/>	
Barrier	<input type="checkbox"/>	
Artificial Channelization	<input type="checkbox"/>	
Culvert or Bridge	<input type="checkbox"/>	
Water Flowing over Road (no Culvert)	<input type="checkbox"/>	
No Defined Channel	<input checked="" type="checkbox"/>	
ADDITIONAL NOTES		
Wp.1355- pix @ 13:53 No observed channel, no WC signs, area likely WL within a clearcut. Sphagnum moss donminates ground cover, Rocky limited topsoil. Likely water movement undermoss.

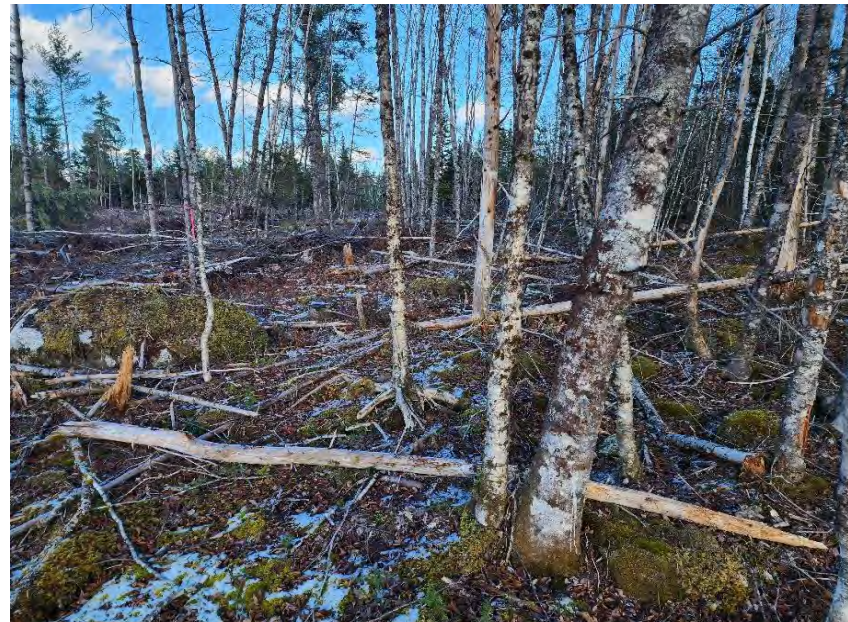
Photo 2: Downstream at Crossing

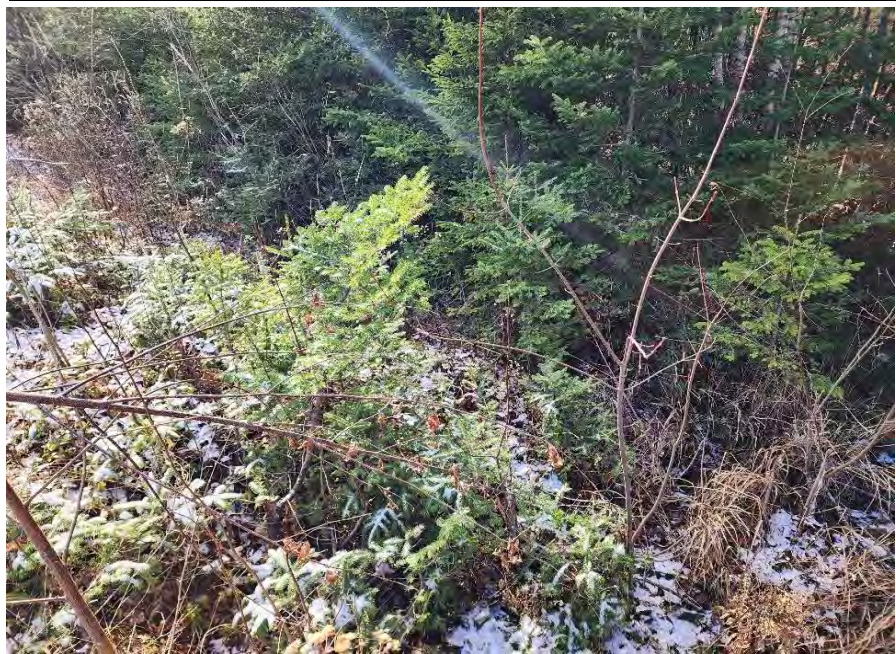
Photo 1: Upstream at Crossing

RIPARIAN VEGETATION SPECIES		
#	Common Name	Scientific Name
1	Balsam Fir	<i>Abies balsamea</i>
2	Red Maple	<i>Acer rubrum</i>
3	Common Cattail	#N/A
4	White Spruce	<i>Picea glauca</i>
5	Paper Birch	<i>Betula papyrifera</i>
6	White Pine	#N/A
7	Speckled Alder	<i>Alnus incana</i>
8		#N/A
9		#N/A
10		#N/A
RIPARIAN INFORMATION		
Vegetation Stage	Young Forest	
IMPORTANT FEATURES OBSERVED		
Vegetated Across	<input type="checkbox"/>	
Flows into Fish Habitat Downstream	<input type="checkbox"/>	
Underground Sections or Groundwater	<input checked="" type="checkbox"/>	
Surface Flow	<input type="checkbox"/>	
Wetland Corridor (Flow Between Wetlands)	<input type="checkbox"/>	
Barrier	<input type="checkbox"/>	
Artificial Channelization	<input type="checkbox"/>	
Culvert or Bridge	<input checked="" type="checkbox"/>	
Water Flowing over Road (no Culvert)	<input type="checkbox"/>	
No Defined Channel	<input checked="" type="checkbox"/>

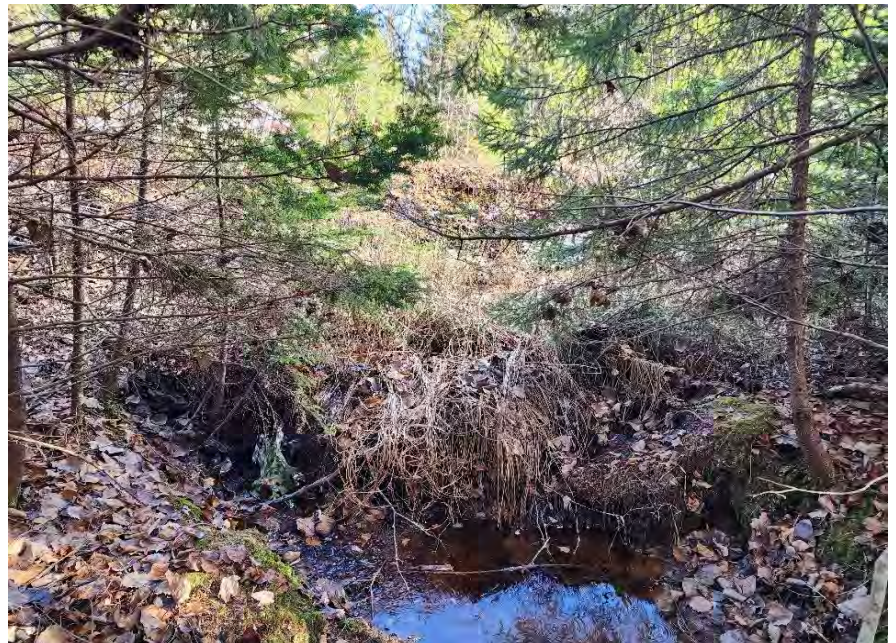
Photo 2: Downstream at Crossing, completely covered culvert

ADDITIONAL NOTES		
Not fish habitat, 1335 WC loses channelization, spreads into many ponds & underground section. @ marked WC location = no channel. Xing considered to be at culvert

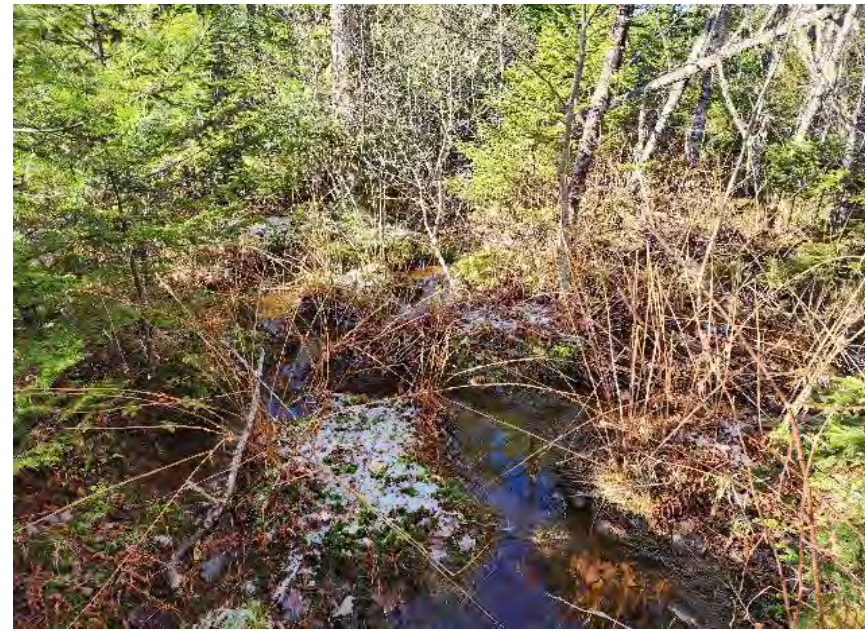
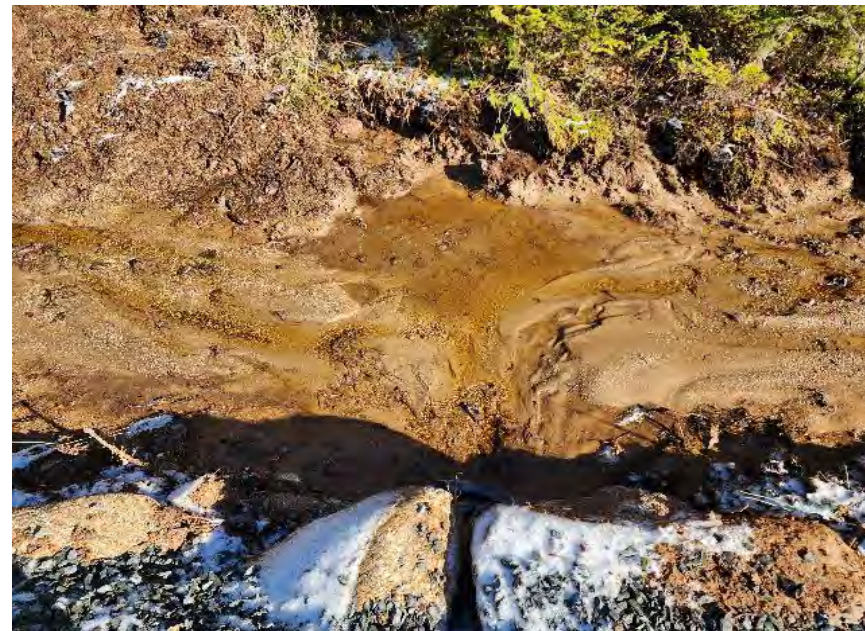
ADDITIONAL NOTES		
Culvert was replaced w/o environmental input, Wp. 1343-WC loses channelization in WL, dry sections, NOT fish habitat

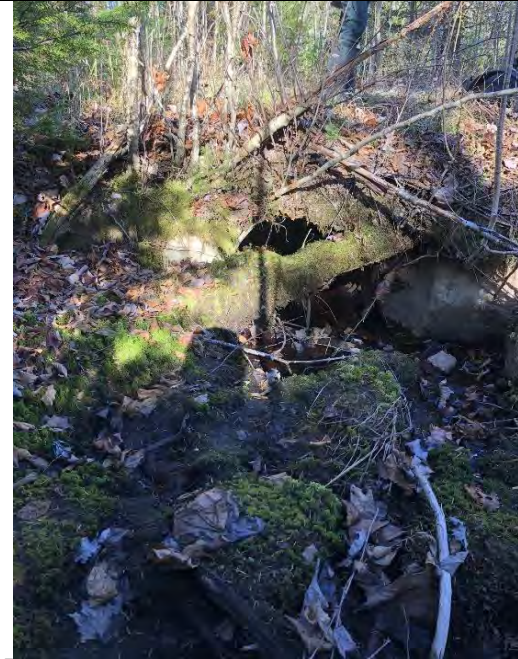
Photo 1: Upstream at Crossing

RIPARIAN VEGETATION SPECIES		
#	Common Name	Scientific Name
1	Balsam Fir	<i>Abies balsamea</i>
2	Yellow Birch	<i>Betula alleghaniensis</i>
3	Red Maple	<i>Acer rubrum</i>
4	Sphagnum	#N/A
5		#N/A
6		#N/A
7		#N/A
8		#N/A
9		#N/A
10		#N/A
RIPARIAN INFORMATION		
Vegetation Stage	Mature Forest	
IMPORTANT FEATURES OBSERVED		
Vegetated Across	<input type="checkbox"/>	
Flows into Fish Habitat Downstream	<input type="checkbox"/>	
Underground Sections or Groundwater	<input checked="" type="checkbox"/>	
Surface Flow	<input type="checkbox"/>	
Wetland Corridor (Flow Between Wetlands)	<input type="checkbox"/>	
Barrier	<input type="checkbox"/>	
Artificial Channelization	<input type="checkbox"/>	
Culvert or Bridge	<input checked="" type="checkbox"/>	
Water Flowing over Road (no Culvert)	<input type="checkbox"/>	
No Defined Channel	<input checked="" type="checkbox"/>	
ADDITIONAL NOTES		
WC feature not observed, in WL, no watercourse flowing through, WL drains into Bear Lake. Water above and below ground. Not a fish passage/habitat.

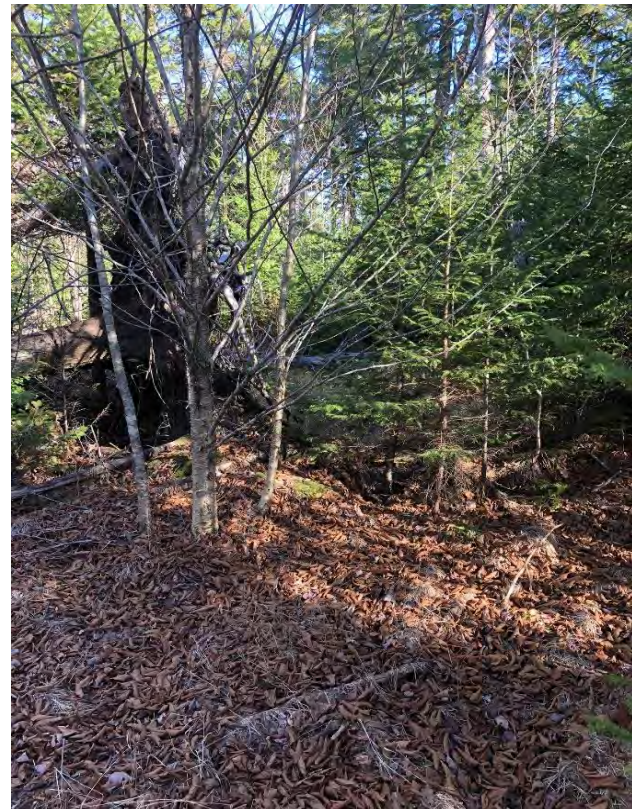
Photo 2: Downstream at Crossing

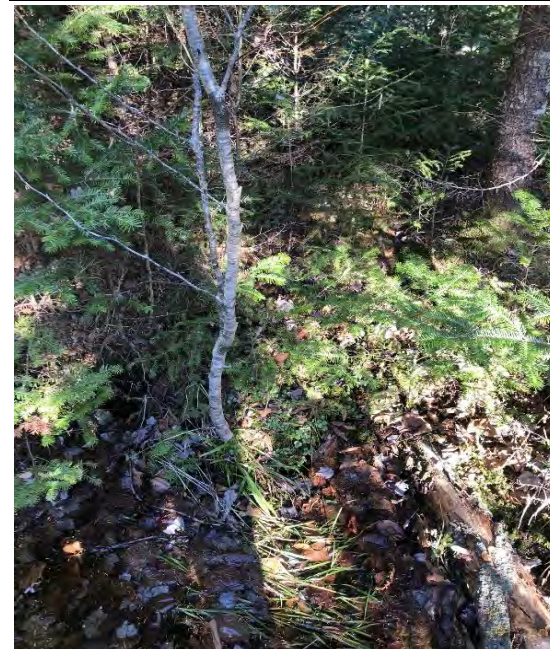
Photo 1: Upstream at Crossing, no defined WC.

RIPARIAN VEGETATION SPECIES		
#	Common Name	Scientific Name
1	Cinnamon Fern	<i>Osmunda cinnamomea</i>
2	Balsam Fir	<i>Abies balsamea</i>
3	Red Maple	<i>Acer rubrum</i>
4	Shagnum	#N/A
5	Yellow Birch	<i>Betula alleghaniensis</i>
6	Goldenrod Sp.	#N/A
7		#N/A
8		#N/A
9		#N/A
10		#N/A
RIPARIAN INFORMATION		
Vegetation Stage	Mature Forest	
IMPORTANT FEATURES OBSERVED		
Vegetated Across	<input type="checkbox"/>	
Flows into Fish Habitat Downstream	<input type="checkbox"/>	
Underground Sections or Groundwater	<input type="checkbox"/>	
Surface Flow	<input type="checkbox"/>	
Wetland Corridor (Flow Between Wetlands)	<input type="checkbox"/>	
Barrier	<input type="checkbox"/>	
Artificial Channelization	<input type="checkbox"/>	
Culvert or Bridge	<input type="checkbox"/>	
Water Flowing over Road (no Culvert)	<input type="checkbox"/>	
No Defined Channel	<input type="checkbox"/>	
ADDITIONAL NOTES		
Only one measurement taken, WC is outside of footprint. Not fish habitat.

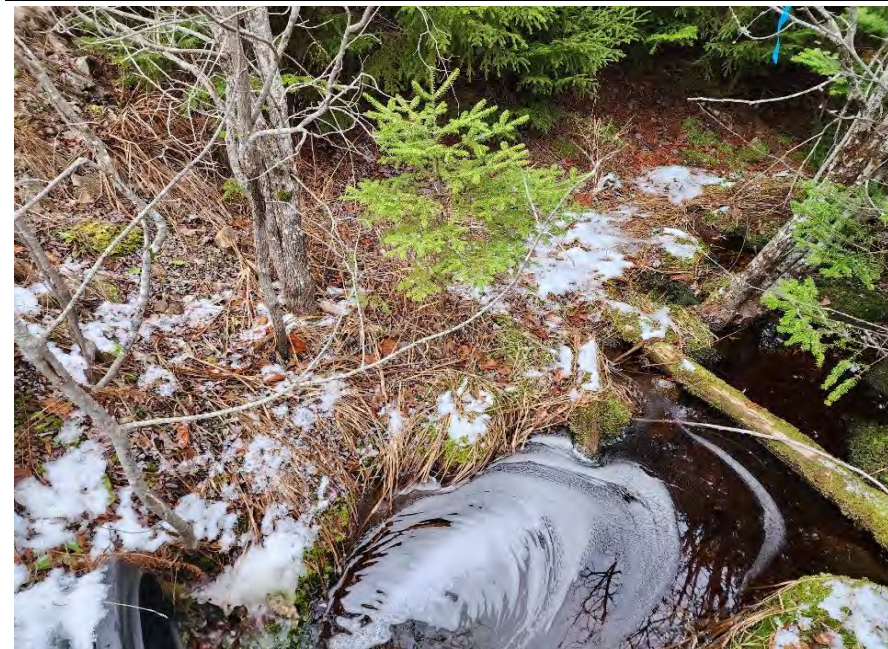
Photo 1: Upstream at Crossing with culvert

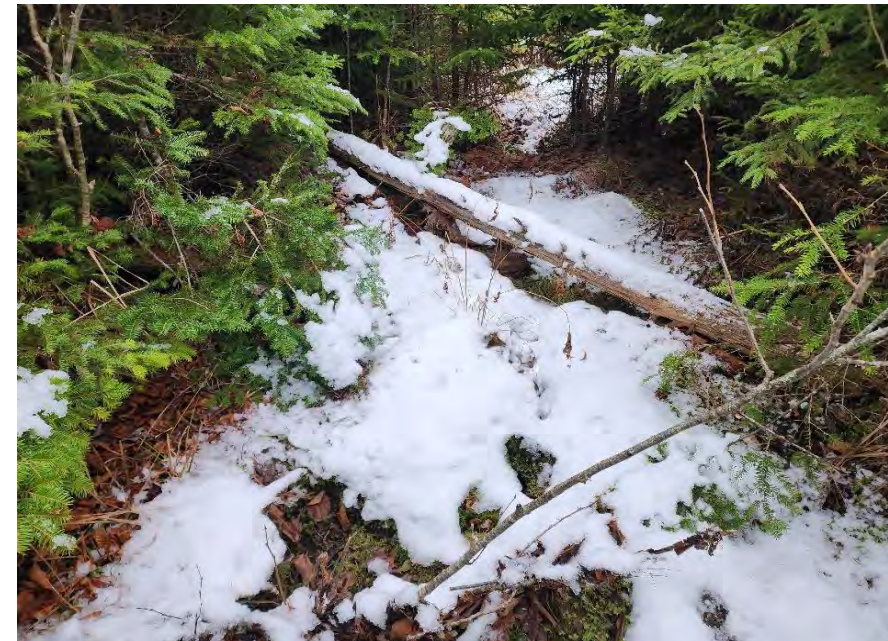
Photo 2: Downstream at Crossing, no channel, no sign of WC

ADDITIONAL NOTES		
Not fish habitat, channelization ends. Watercourse moves underground (d/s). Wetland, no u/s channel.

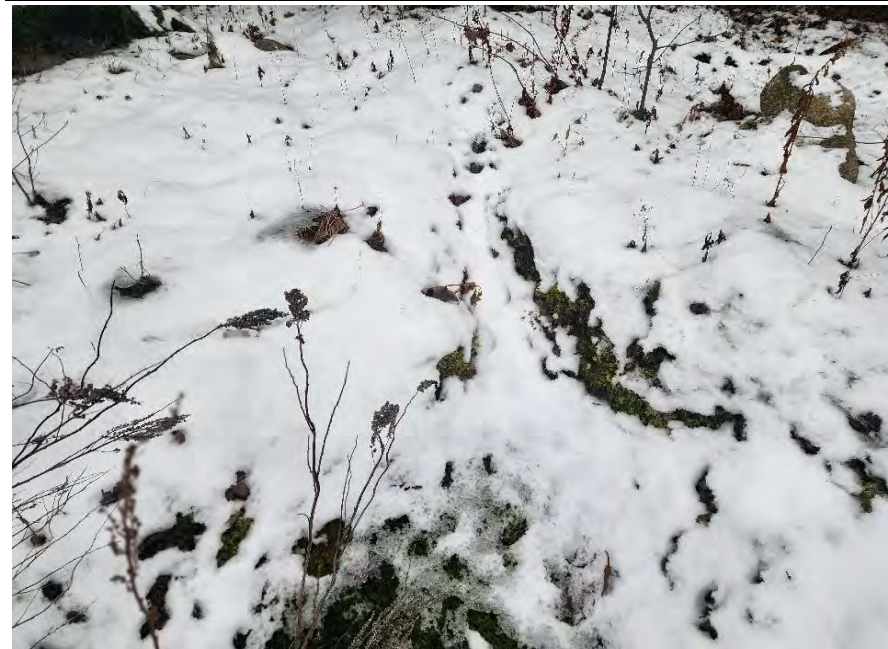
Photo 1: Upstream at Crossing

RIPARIAN VEGETATION SPECIES		
#	Common Name	Scientific Name
1	Sphagnum moss	#N/A
2		#N/A
3		#N/A
4		#N/A
5		#N/A
6		#N/A
7		#N/A
8		#N/A
9		#N/A
10		#N/A
RIPARIAN INFORMATION		
Vegetation Stage		
IMPORTANT FEATURES OBSERVED		
Vegetated Across		<input checked="" type="checkbox"/>
Flows into Fish Habitat Downstream		<input type="checkbox"/>
Underground Sections or Groundwater		<input type="checkbox"/>
Surface Flow		<input type="checkbox"/>
Wetland Corridor (Flow Between Wetlands)		<input type="checkbox"/>
Barrier		<input type="checkbox"/>
Artificial Channelization		<input type="checkbox"/>
Culvert or Bridge		<input type="checkbox"/>
Water Flowing over Road (no Culvert)		<input type="checkbox"/>
No Defined Channel		<input checked="" type="checkbox"/>
ADDITIONAL NOTES		
No channel in U/S area wetland, pooled area, D/S of culvert, no channel. Becomes sphag moss, bog area. Not fish habitat.

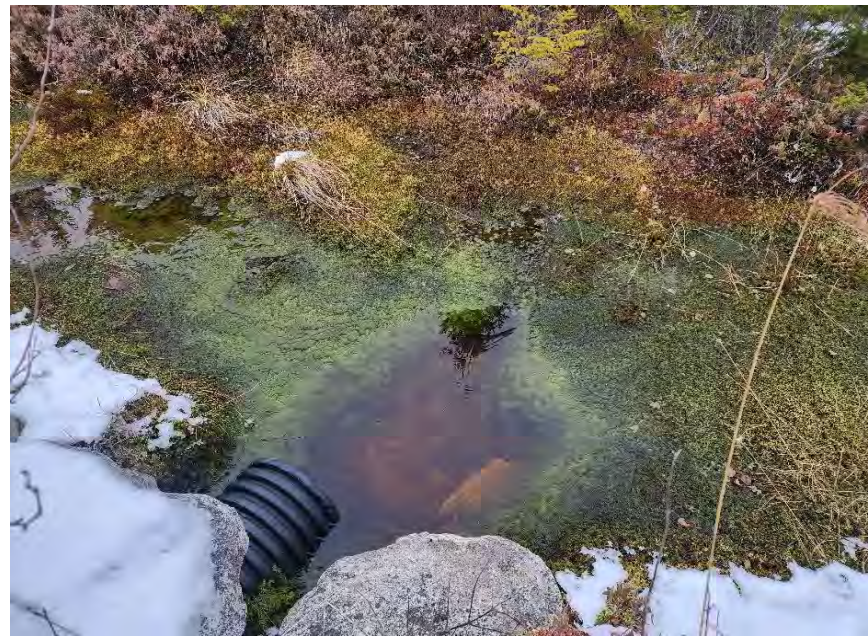
Photo 1: Culvert upstream at Crossing

RIPARIAN VEGETATION SPECIES		
#	Common Name	Scientific Name
1	Balsam Fir	<i>Abies balsamea</i>
2	Red Spruce	<i>Picea rubens</i>
3	Red Maple	<i>Acer rubrum</i>
4	Sphagnum	#N/A
5		#N/A
6		#N/A
7		#N/A
8		#N/A
9		#N/A
10		#N/A
RIPARIAN INFORMATION		
Vegetation Stage	Pole-Sapling	
IMPORTANT FEATURES OBSERVED		
Vegetated Across	<input type="checkbox"/>	
Flows into Fish Habitat Downstream	<input type="checkbox"/>	
Underground Sections or Groundwater	<input checked="" type="checkbox"/>	
Surface Flow	<input type="checkbox"/>	
Wetland Corridor (Flow Between Wetlands)	<input type="checkbox"/>	
Barrier	<input type="checkbox"/>	
Artificial Channelization	<input type="checkbox"/>	
Culvert or Bridge	<input checked="" type="checkbox"/>	
Water Flowing over Road (no Culvert)	<input type="checkbox"/>	
No Defined Channel	<input type="checkbox"/>	
ADDITIONAL NOTES		
Water Sample #8, @ 13:11. WC becomes underground ephemeral 30m from crossing. Not fish habitat

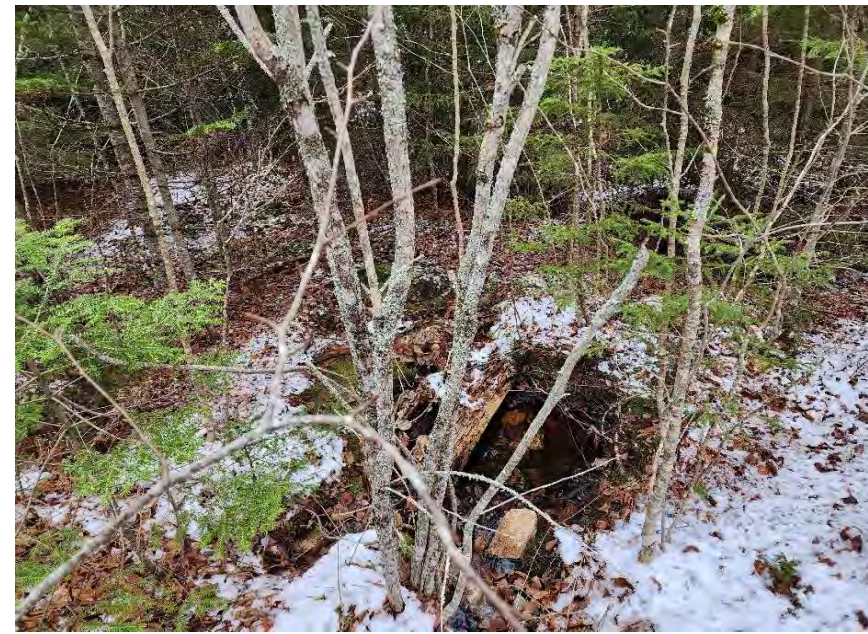
Photo 1: Upstream at Crossing

RIPARIAN VEGETATION SPECIES		
#	Common Name	Scientific Name
1	Speckled Alder	<i>Alnus incana</i>
2	Balsam Fir	<i>Abies balsamea</i>
3		#N/A
4		#N/A
5		#N/A
6		#N/A
7		#N/A
8		#N/A
9		#N/A
10		#N/A
RIPARIAN INFORMATION		
Vegetation Stage		
IMPORTANT FEATURES OBSERVED		
Vegetated Across	<input type="checkbox"/>	
Flows into Fish Habitat Downstream	<input type="checkbox"/>	
Underground Sections or Groundwater	<input checked="" type="checkbox"/>	
Surface Flow	<input type="checkbox"/>	
Wetland Corridor (Flow Between Wetlands)	<input type="checkbox"/>	
Barrier	<input type="checkbox"/>	
Artificial Channelization	<input type="checkbox"/>	
Culvert or Bridge	<input type="checkbox"/>	
Water Flowing over Road (no Culvert)	<input type="checkbox"/>	
No Defined Channel	<input checked="" type="checkbox"/>	
ADDITIONAL NOTES		
Ditch runs paralell to road, mostly sphagnum and wet leaves, very small channelized area D/S before transitions to underground emph. Road drainage - Not fish habitat

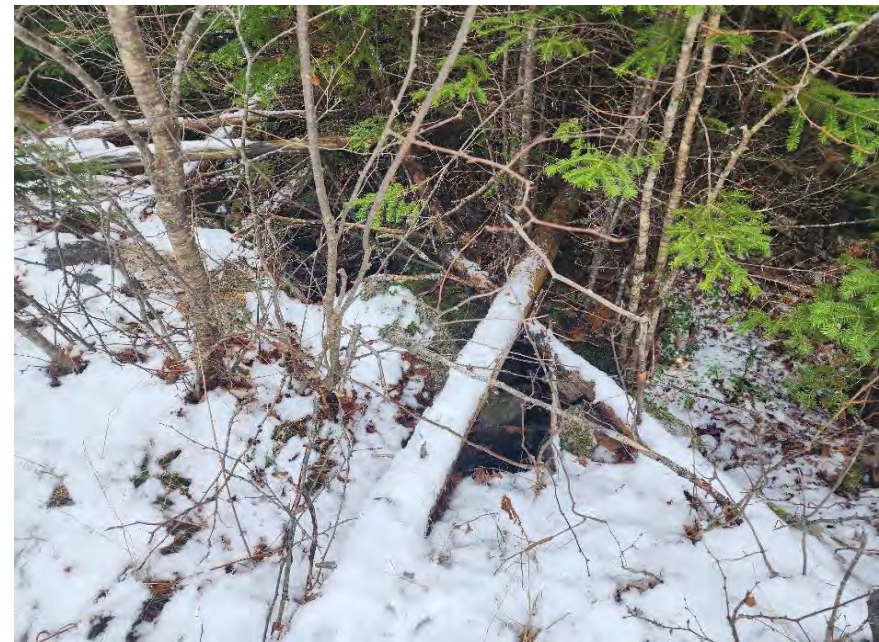
Photo 1: Upstream at Crossing

RIPARIAN VEGETATION SPECIES		
#	Common Name	Scientific Name
1		#N/A
2		#N/A
3		#N/A
4		#N/A
5		#N/A
6		#N/A
7		#N/A
8		#N/A
9		#N/A
10		#N/A
RIPARIAN INFORMATION		
Vegetation Stage		
IMPORTANT FEATURES OBSERVED		
Vegetated Across		<input type="checkbox"/>
Flows into Fish Habitat Downstream		<input type="checkbox"/>
Underground Sections or Groundwater		<input type="checkbox"/>
Surface Flow		<input checked="" type="checkbox"/>
Wetland Corridor (Flow Between Wetlands)		<input type="checkbox"/>
Barrier		<input type="checkbox"/>
Artificial Channelization		<input type="checkbox"/>
Culvert or Bridge		<input type="checkbox"/>
Water Flowing over Road (no Culvert)		<input type="checkbox"/>
No Defined Channel		<input checked="" type="checkbox"/>
ADDITIONAL NOTES		
Woods drainage, mossy rocks, wet leaves, seasonal drainage. Not fish habitat
