STRUM CONSULTING/2022. MAINLAND MOOSE ASSESSMENT.
L8005 TRANSMISSION LINE RIGHT-OF-WAY, CUMBERLAND AND
COLCHESTER COUNTIES

Re: Mainland Moose Assessment
L8005 Transmission Line Right-of-way, Cumberland and Colchester Counties, NS

Strum Consulting was retained to complete a Mainland moose (*Alces alces americana*) assessment along the proposed L8005 Transmission Line Right-of-Way (ROW) (the Project).

The proposed Project consists of a High-voltage transmission line that extends from Lower Onslow, NS, to the New Brunswick/Nova Scotia border near Amherst, NS. The L8005 ROW runs parallel along the northeast side of the existing L8001 transmission line.

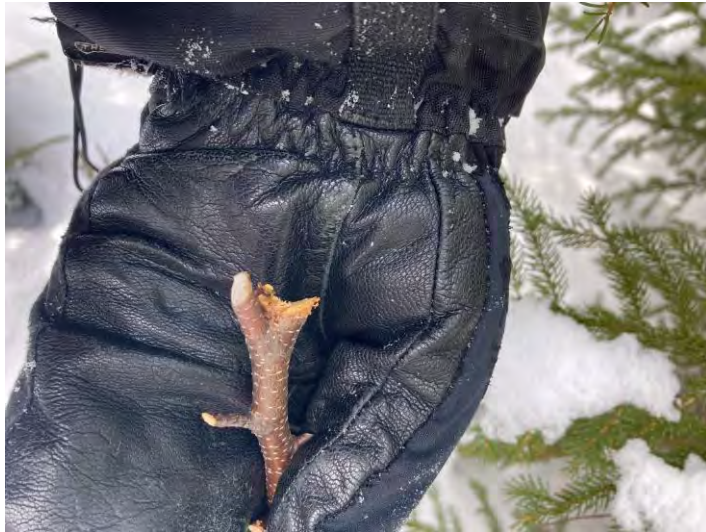
Photo 5: Mainland moose browse (*Alces alces*) browse, found in woods northwest of Truemanville. (Transect # 19)

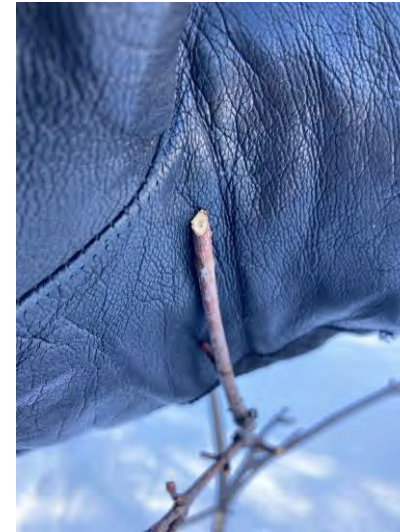
Photo 6: Probable Mainland moose (*Alces alces*) browse, found within transmission line corridor north of Warren.
