## Appendix D

### Freshwater Environment Report

## Freshwater Environment

### Fish Habitat

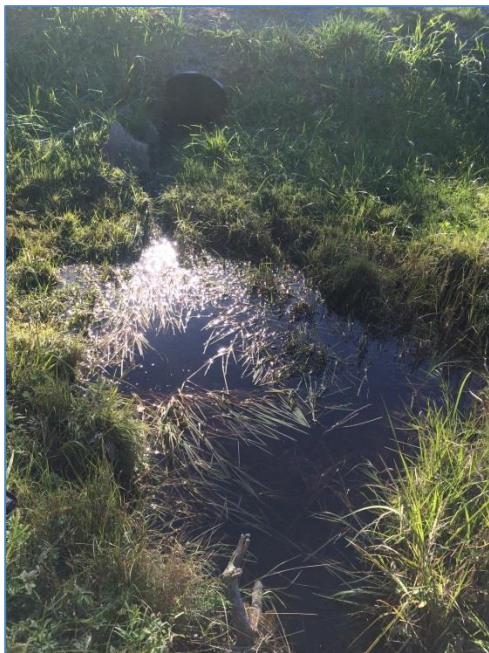
Reach 1 begins east of Enfield Road and runs until it meets the edge of WL1 outside of the Project Study Area (See Figure XX). This Reach has a defined channel for approximately 50 meters, but downstream towards the Project Study Area the channel becomes undefined with pockets of water throughout the whole swamp. An existing 55 cm culvert is located west of Reach 1 allowing an inlet in to WL1. The average wet width of the channel during the time of the survey was 60 cm wide and 14 cm deep. The average bank full width was 90 cm wide and 30 cm deep. The channel had vegetation growing within it and the substrate was mainly muck with very small amounts of rubble. The channel had stable banks on both sides. The canopy cover above the channel is approximately 3%; with no woody debris in the channel. The end of this reach runs to the edge of WL1 which is dominated by alders and tall grasses.

Photo 1. Drainage channel at Reach 1 outside of the Project Study Area

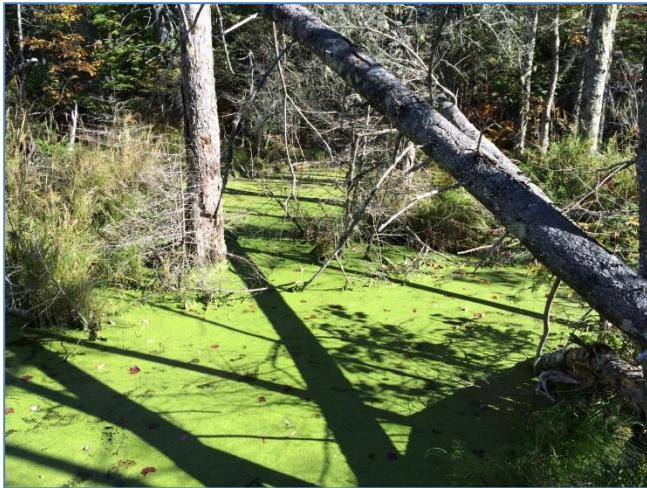
Reach 1 of Watercourse 2 (WC-2) begins in the south portion of Wetland 1 and runs downstream within Wetland 1 towards Park Road (See Figure XX). At reach 1 the watercourse is a large pool that has an average wet stream width of approximately 25 m and depth of 30 cm. The substrate of the watercourse is made up of organic muck and leaf litter that has an odor. The average bank full width is approximately 30 metres and 60 cm deep. During the survey no flow was observed, and the watercourse was abundant with aquatic plants and some algae. The watercourse had a large amount of blow down as well as the riparian area, which was most likely a result from hurricane Juan. No beaver dams were found during the survey; however there was evidence of old beaver activity from tree markings. A manmade hunting tree stand and wooden bridge was found next to the watercourse at Reach 1. The canopy cover over the Stream was approximately 50 – 60% and contained mixedwood. The water quality data collected at reach 1 during the survey was:

- Temperature: 11.5 °C,
- Dissolved Oxygen: 27%,
- pH: 6.98, and
- Conductivity: 345 µS/cm

Photo 3. Reach 1, Watercourse 2 with abundant aquatic plants and blowdown.

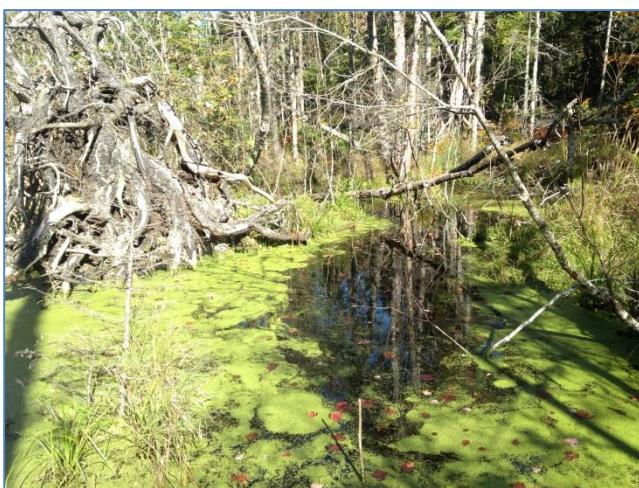
Reach 2 is located approximately 60 meters downstream from Reach 1 and is very similar with an average wet width of approximately 15 meters and average wet depth of 20 cm. The watercourse at reach 2 consists mainly as a pool with approximately 60% canopy cover and is contiguous with wetland 1. The substrate of the watercourse is the same as Reach 1, and contained an abundance of aquatic plants, algae, and blowdown. The stream had no flow during the survey and the riparian area consisted of wetland and mixed wood forest. Both, the left and right banks of the watercourse were stable with a slope of approximately 5%. The water quality data collected at reach 2 during the survey was:

- Temperature: 13.21 °C,
- Dissolved Oxygen: 25.4%,
- pH: 6.93, and
- Conductivity: 365 µS/cm

Photo 4. Reach 2, No flow and abundant with aquatic plants.

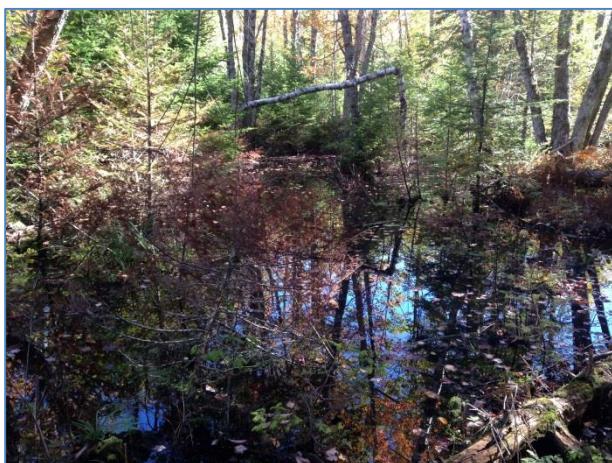
Reach 3 is located approximately 40 metres downstream from reach 2 and is wider, but is braided with an island contiguous with wetland 1. The average wet width and depth are approximately 25 metres and 20 cm, while the average bank full width is approximately 30 metres wide and 50 cm deep. This reach contains fewer blowdown, and less aquatic plants with no algae present. The stream substrate (organic leaf litter) and cover (60% mixedwood) are the same as reach 2. The water quality data collected at reach 3 during the survey was:

- Temperature: 11.41 °C,
- Dissolved Oxygen: 43%,
- pH: 6.88 ,and
- Conductivity: 345 µS/cm

Photo 5. Reach 3 with less aquatic plants and blowdown.

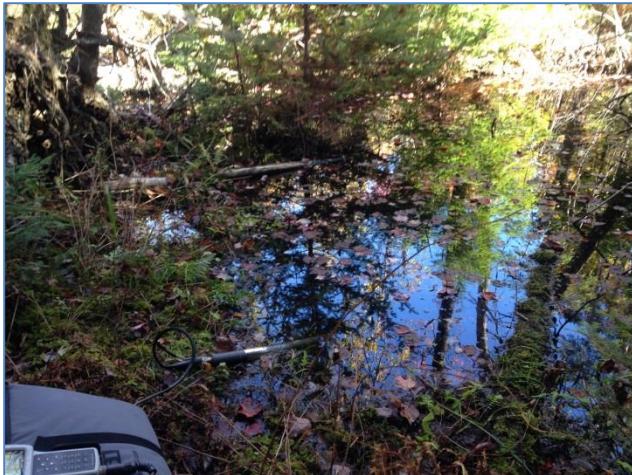
Reach 4 is located approximately 50 meters downstream from reach 3 (See Figure XX) and contiguous with wetland 1. It is braided and has an organic leaf litter bottom with muck. The average wet stream width is approximately 15 m wide and 15 cm deep. The average bank full width is approximately 20 metres wide and 30 cm deep. The stream bank is stable on both sides with the upstream vegetation consisting mainly of mixedwood forest. No blowdown was evident at this location on the stream. Reach 4 consisted of a large pool that had no flow. The water quality data collected at reach 4 during the survey was:

- Temperature: 11.01 °C,
- Dissolved Oxygen: 31.7%,
- pH: 6.84 ,and
- Conductivity: 340 µS/cm

Photo 6. Reach 4, a braided channel with leaf litter

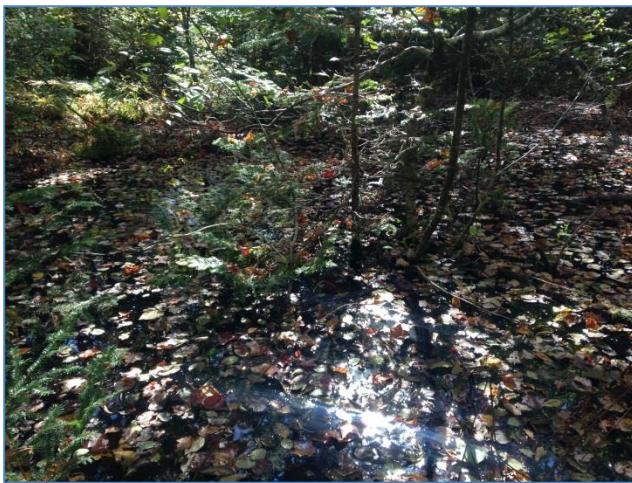
Reach 5 is located approximately 30 meters downstream of reach 4 and is not surrounded by wetland, rather mixed forest and tall grasses. The average wet stream width is 7.4 metres wide and 38 cm deep, and the average bank full width is 9.8 meters wide and 39 cm deep. The reach has a canopy cover of 70% and both banks are stable. The reach has several stream types including riffle (15%), run (5%), and the majority of it is a pool (80%). During the time of the survey no flow was observed. The water quality data collected at reach 5 during the survey was:

- Temperature: 10.82 °C,
- Dissolved Oxygen: 17.8%,
- pH: 6.75 ,and
- Conductivity: 345  $\mu\text{S}/\text{cm}$ .

Photo 7. Reach 5, comprised mainly of a large pool with stable banks.

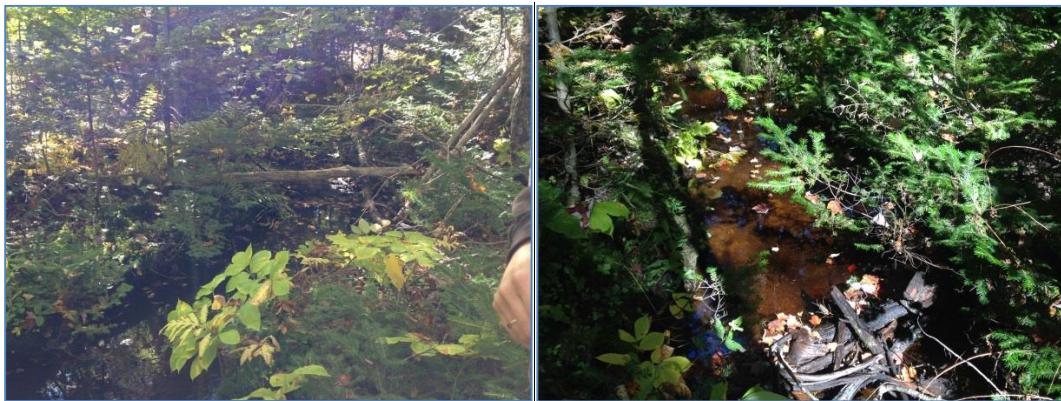
Reach 6 is located 36 metres Northwest of Park road (dirt portion) and approximately 30 metres downstream of reach 5. This reach is not nearly as wide and has a flow of 0.19 m/s and slope of

3%. The average wet stream width is 1.09 metres and 14 cm deep, and the average bank full width is 1.55 meters and 50 cm deep. This reach has multiple braided channels approximately 10 meters upstream and turns into one defined channel at the 5 meter survey location. Both the left and right bank is stable and the stream has a canopy cover of 70% mixedwood forest. Reach 6 has blowdown across the watercourse causing potential fish obstruction. The water quality data collected at reach 6 during the survey was:

- Temperature: 10.89 °C,
- Dissolved Oxygen: 27.6%,
- pH: 7.68 ,and
- Conductivity: 345 µS/cm.

Photo 8 and 9. Reach 6, smaller watercourse channel with flow and woody debris.

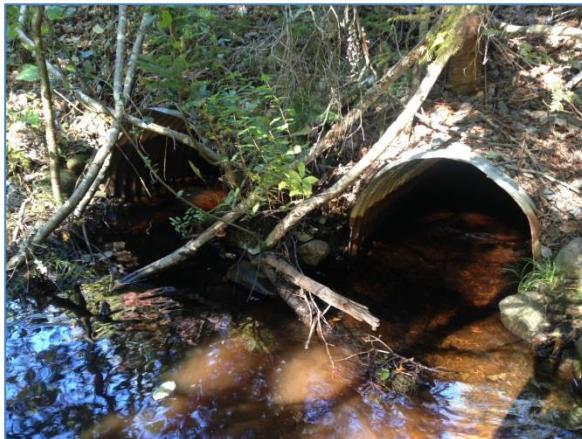
Downstream from reach 6 a double culvert is located on Park road.

Photo 10. Existing culverts where watercourse 2 meets Park road.

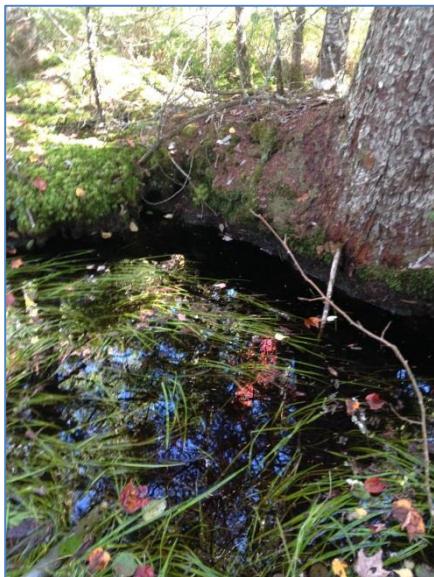
Reach 1 is located in the southeast portion of wetland 1 and approximately 140 meters upstream from Park Road. The average wet stream width for this reach was 2.55 metres and 28 cm deep. The average bank full width is approximately 20 meters since it has a large flood plain across the wetland and the average bank full depth is 65 cm deep. The stream substrate is comprised of mainly leaf litter and muck (80%) with some rock (2%), gravel (10%), and sand (8%) with grass species growing within it.. The stream has a canopy cover of 75% consisting of mixed wood. The stream was relatively flat with a slope of 1% with no flow during the time of assessment. Both banks were stable and the right bank had a slope of 2%, while the left had a slope of 5%. The upstream vegetation consisted of a shrub dominated swamp wetland (wetland 1). The water quality data collected at reach 1 during the survey was:

- Temperature: 10.16 °C,
- Dissolved Oxygen: 35.9%,
- pH: 5.33 ,and
- Conductivity: 27 µS/cm.

Upstream of this reach the watercourse does not have a defined channel and turns into puddled water within the wetland. Based on field surveys the watercourse is an outlet for wetland 1.

Photo 11. Reach 1 with a defined channel and pooled water.

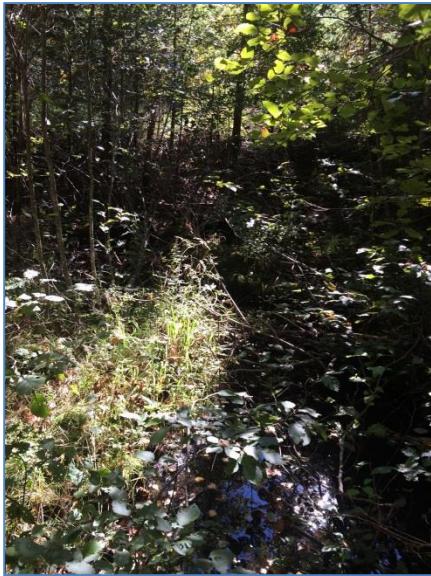
Reach 2 is located approximately 25 meters downstream of Reach 1 and had no flow with a minimal amount of water (average wet stream depth 10 cm), and a large average width (10.0 meters). The stream was less defined and was more of a flooded area with puddled water. The average full bank width was approximately 20 meters with an average depth of 40 cm. The reach consisted mainly of a run (90%), with some pooling (5%) and riffles (5%). Both banks were stable and the reach had no slope. The substrate was made up of leaf litter/ grass (95%), and a small amount of fine grains (5%). The vegetation around the stream bed consisted of a forested swamped wetland. The water quality data collected at reach 2 during the survey was:

- Temperature: 10.27 °C,

- Dissolved Oxygen: 38.9%,
- pH: 4.89 ,and
- Conductivity: 26 µS/cm.

Photo 12. Reach 2 with no flow.

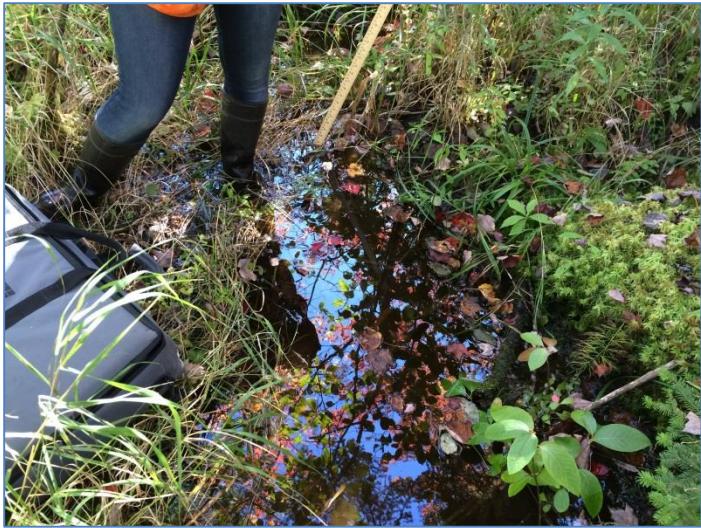
Reach 3 is located approximately 20 meters downstream from reach 2 and is similar to reach 1 and 2 with an abundance of grass growing within and along the streambed. The average wet width is 8 meters and the average wet depth is 15 cm deep. The channel is braided and has an average bank full width of 12 meters and an average depth of 50 cm. The stream canopy cover is 60% and is comprised of mixed wood. The stream type consists mainly of pool (60%), and runs (35%) with a small riffle (5%). During the survey the stream was not flowing. The water quality data collected at reach 3 during the survey was:

- Temperature: 10.44 °C,
- Dissolved Oxygen: 39.9%,
- pH: 4.82 ,and
- Conductivity: 29 µS/cm.

Photo 13. Watercourse 3, Reach 3

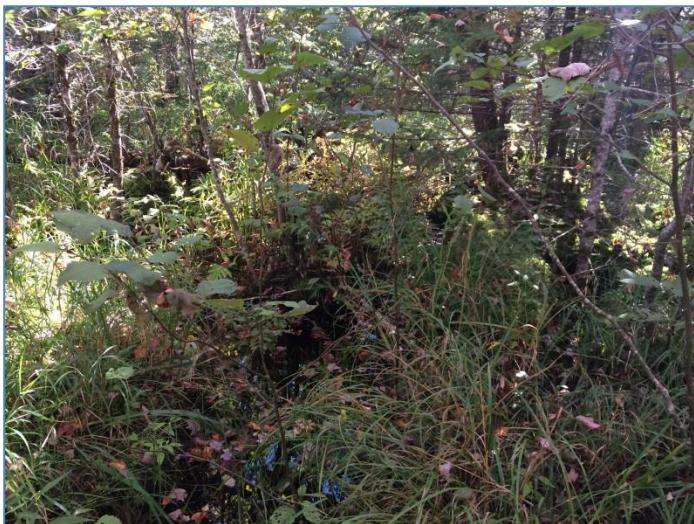
Reach 4 is located approximately 27 meters downstream of reach 3 and is a braided stream channel that has a stream slope of 1.5% with a flow of 0.01m/s. This reach is similar to reach 1 and 3 and has an average wet width of 0.95 meters and average depth of 25 cm. The average bank full width is 1.55 meters and the average bank full depth is 50 cm. The canopy cover is 75% mixed wood. The water quality data collected at reach 4 during the survey was:

- Temperature: 10.45 °C,
- Dissolved Oxygen: 42%,
- pH: 4.6 ,and
- Conductivity: 27 µS/cm.

Photo 14. Watercourse 3, Reach 4

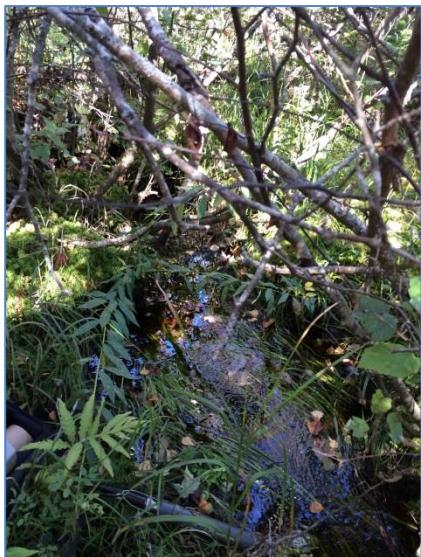
Reach 5 is located 12 meters downstream from reach 4 and is similar to reach 4. Reach 5 has an average wet stream width of 0.9 meters and average depth of 20 cm. The average bank full width is 1.15 meters and the average bank full stream depth is 40 cm. The canopy cover is 65% mixedwood. The stream type is 70% run, 20% riffle and 10% pool with a slope of 2 % and a velocity of 0.01m/s. The substrate type is primarily leaf litter and vegetation (80%) with gravel (10%), sand (8%), and rock (2%). The water quality data collected at reach 5 during the survey was:

- Temperature: 10.45 °C,
- Dissolved Oxygen: 41.3%,
- pH: 4.58 ,and
- Conductivity: 27 µS/cm.

Photo 14. Watercourse 3, Reach 5

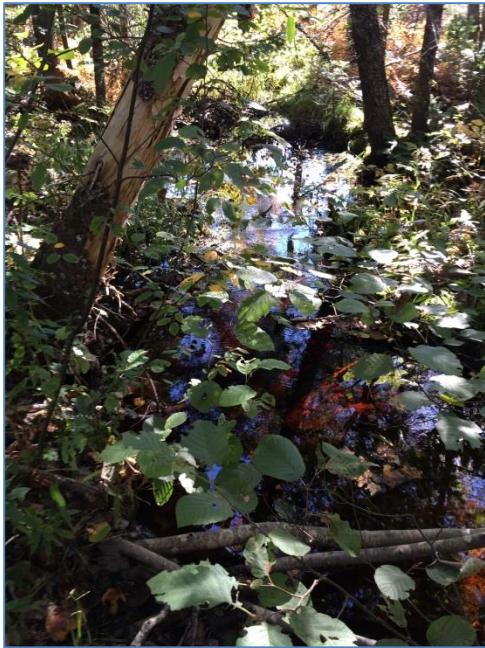
Reach 6 is located 16 metres downstream from reach 5 and 38 metres upstream from the existing single culvert on Park rd. It has more of a defined channel and does not have grasses growing in it. The average wet stream width is 1.14 meters and the average depth is 21 cm. The average bank full width is 1.92 metres and the average bank full depth is 45 cm. The stream is sloped 0.5% and during the survey had no flow. The stream banks were stable and had approximately a 3% slope on the left and right. The stream type was mainly a pool (70%), with some riffles (28%), and runs (2%). The substrate contained a mixture of rock (12%), rubble (20%), gravel (20%), sand (30%), fines (16%), and leaf litter (2%). Like all of the other reaches, this reach was within the wetland. The water quality data collected at reach 6 during the survey was:

- Temperature: 10.46 °C,
- Dissolved Oxygen: 41.4%,
- pH: 4.59 ,and
- Conductivity: 27 µS/cm.

Photo 15. Watercourse 3, Reach 6

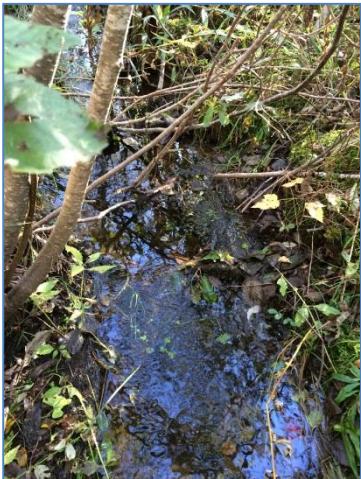
Reach 1, 2 and 3 are located northeast of wetland 10 on the northeast side of the project study area (See Figure XX). These reaches are very similar and have a canopy of 75-80% consisting of shrubs (mostly speckled alder) and tall grasses along the edge of the watercourse. Their left and right banks were stable (90-95%) and their average wet stream width ranged from 1.83 metres to 0.81 meters. Their average wet stream depth ranged from 3.5 cm to 13 cm. The average bank full width ranged from 2.38 metres to 1.5 meters, and 36cm to 50 cm deep. On average these three reaches were dominated by pools (40-60%), but also had riffles (20-40%) and runs (10-40%). The stream substrate was made up of a mixture of gravel, fines, sand, rubble and minor amounts of boulder and rock. The range of water quality data collected at reach 1, 2, and 3 during the survey was:

- Temperature: 12 °C,
- Dissolved Oxygen: 51.7 to 60.1%,
- pH: 6.7 to 6.10 ,and
- Conductivity: 32-33 µS/cm.

Photo 16. Watercourse 4, Reach 1

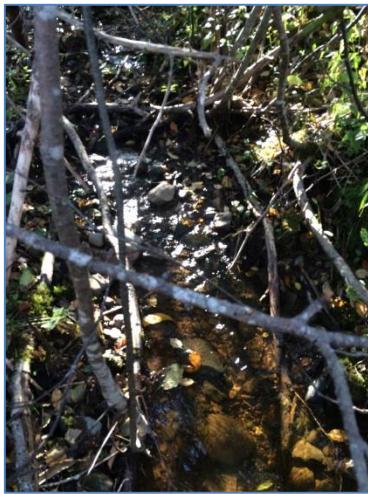
Photo 17. Watercourse 4, Reach 2

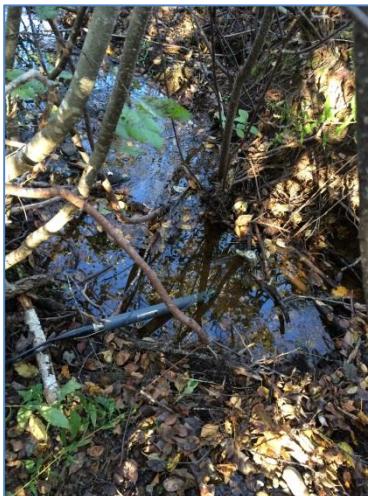
Photo 18. Watercourse 4, Reach 3

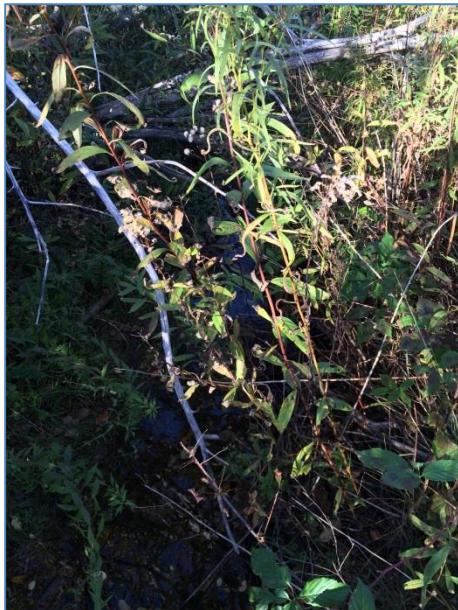
Reach 4 is located on the edge of a field 20 meters downstream from reach 3 (See Figure XX). Reach 4 is similar to reach 1 through 3, but has less of a watercourse slope (2%) and did not have any flow during the survey. Reach 4 also has a higher percent of grasses/meadow species within the riparian area and less shrubs. The reach canopy cover is 56% and has stable banks. The average wet stream width is 0.79 metres and 12 cm deep. The average bank full width is 1.02 metres and 32 cm deep. The water quality data collected at reach 4 during the survey was:

- Temperature: 11.98 °C,
- Dissolved Oxygen: 60.1%,
- pH: 6.01 ,and
- Conductivity: 32 µS/cm.

Photo 19. Watercourse 4, Reach 4

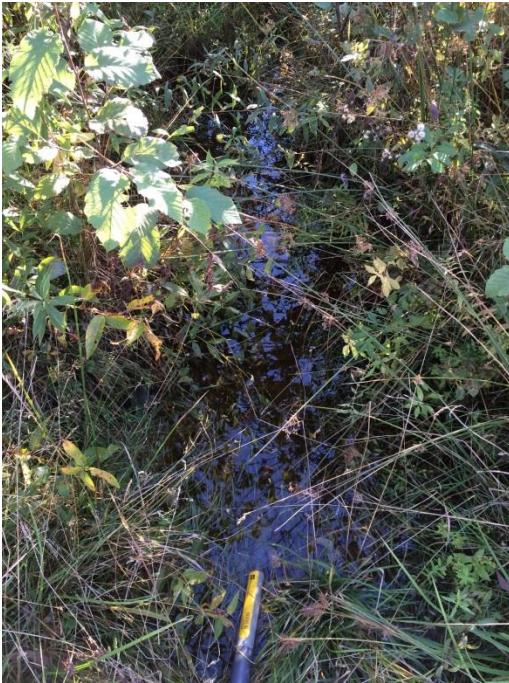
Reach 5 and 6 are located 75 meters and 35 meters upstream from Elmsdale rd. (See figure XX). Both reaches are very similar and are within the field which appears to be used for local agriculture (hay). These reaches had stable banks and the riparian area consisted mainly of tall grasses, rushes and sedges. There stream cover was low with a 15% shrub canopy cover. The stream substrate consisted of fines (70-80%), sand (7-20%), gravel (3-5%), and some rubble (5%). The stream was flowing very slowly at reach 5 (0.001m/s) and had no flow at reach 6. These two reaches during the survey and had an average slope of 0-0.5%. The average wet stream width range was 0.9 to 0.59 meters and the average depth range was 9 to 10 cm. The average full bank width range was 0.98 m to 1.2 metres and the depth ranged from 17 to 36 cm. The range of water quality data collected at reach 5 and 6 during the survey was:

- Temperature: 11.98 to 12.05 °C,
- Dissolved Oxygen: 55.5 to 60.1%,
- pH: 5.88 to 6.01 ,and
- Conductivity: 32-34 µS/cm.

Photo 20. Watercourse 4, Reach 5

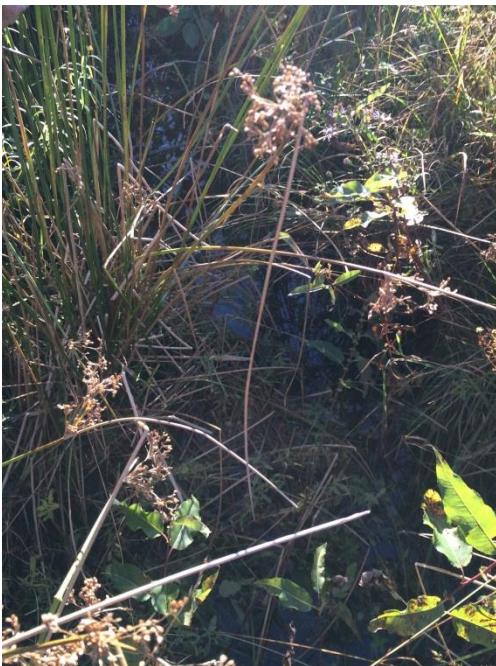
Photo 21. Watercourse 4, Reach 6
